Assessment and Evaluation of Timber Piles Used in Nebraska for Retrofit and Rating

**Department of Civil and Environmental Engineering
Florida International University
Miami, Florida**

Sponsored By
Nebraska Department of Roads

April, 2014

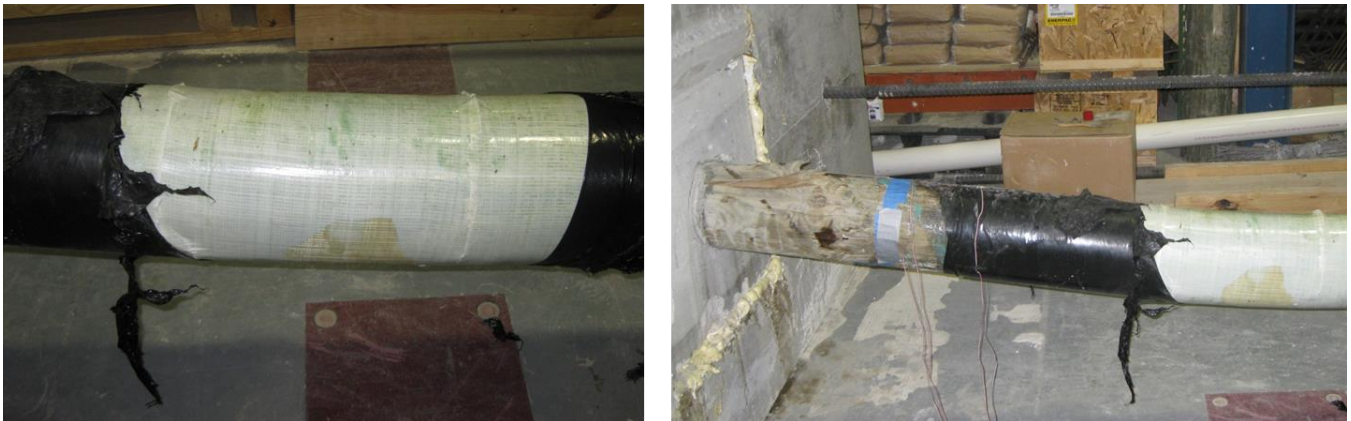
Specimen 2, with 1.5 inch deep damage filled with resin, showed the lowest ultimate load capacity (95 kips) among the five specimens tested as part of this study. This specimen failed mainly due to large gradual deflection at the repair location. FRP jacket was damaged at the two ends of the 14 inch long damaged region. The test was continued even after the large downward deflection of the repaired region that resulted in cracking of the fixed end of the pile.

Figure 5.8: Failure of specimen 2 (1.5 inch deep damage filled with resin)

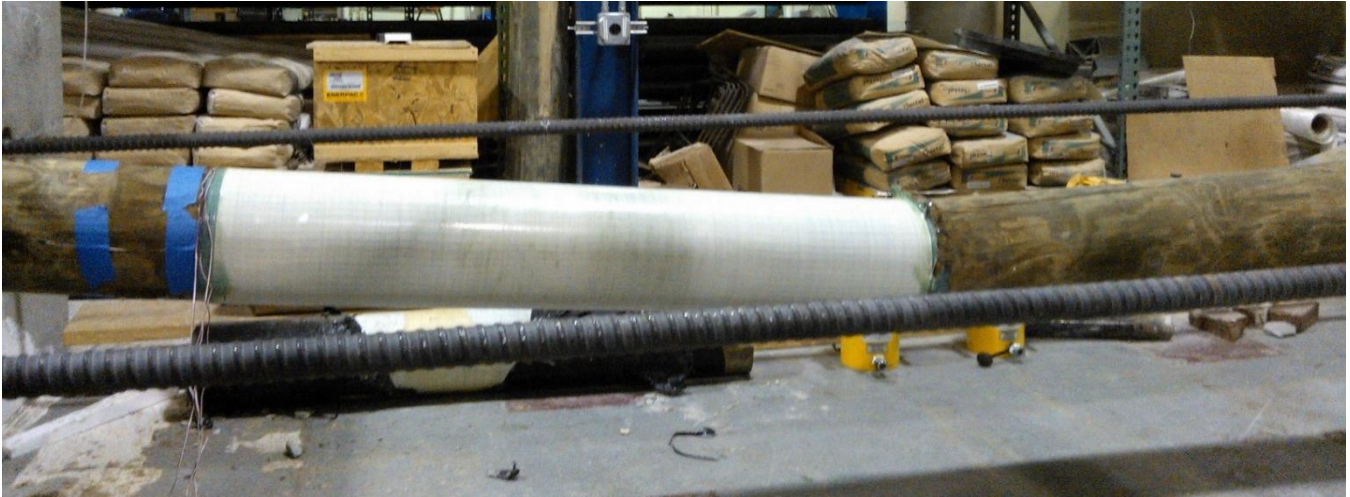
failed specimen indicated bending type failure resulting in crumpling top fibers and splintering bottom fibers. No damage of FRP wrap was observed during this test.

Figure 5.9: Failure of specimen 3 (2 inch deep damage filled with grout)

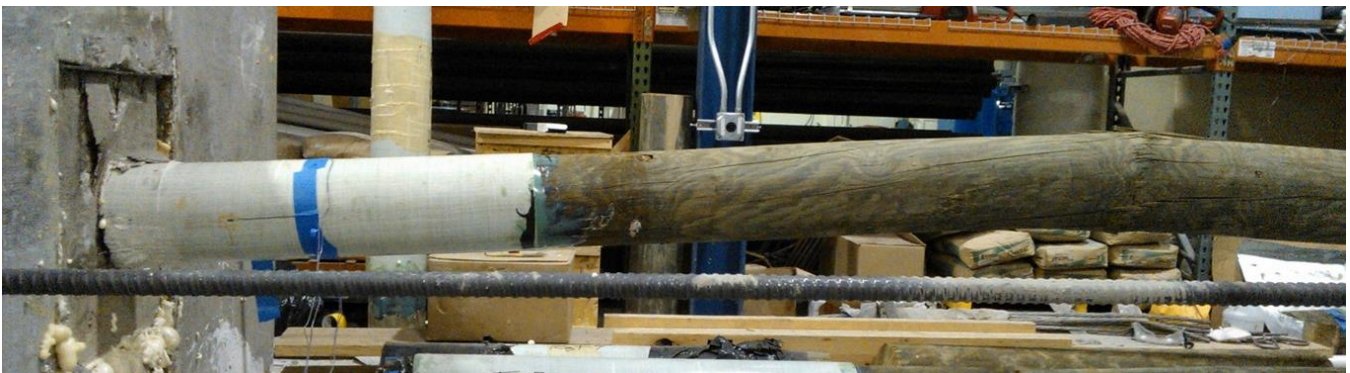
Specimen 4 also had 2 inch deep damage filled with grout similar to specimen 3 however; the location of damaged region was different from specimen 3. In specimen 4, the damaged region was placed at the most critical location (fixed end) in an attempt to fail the specimen in damaged region. The failure of this specimen however appeared away from the damaged region during the test. The specimen took approximately 170 kip maximum axial load before failure.

Figure 5.10: Failure of specimen 4 (2 inch deep damage filled with grout)
