Report MPMC-04

# Evaluation of Dowel Bar Inserter Practices in PCC Pavements with Magnetic Tomography Technology

**Evaluation of Dowel Bar Inserter Practices in PCC Pavements with  
Magnetic Tomography Technology**

December 2016

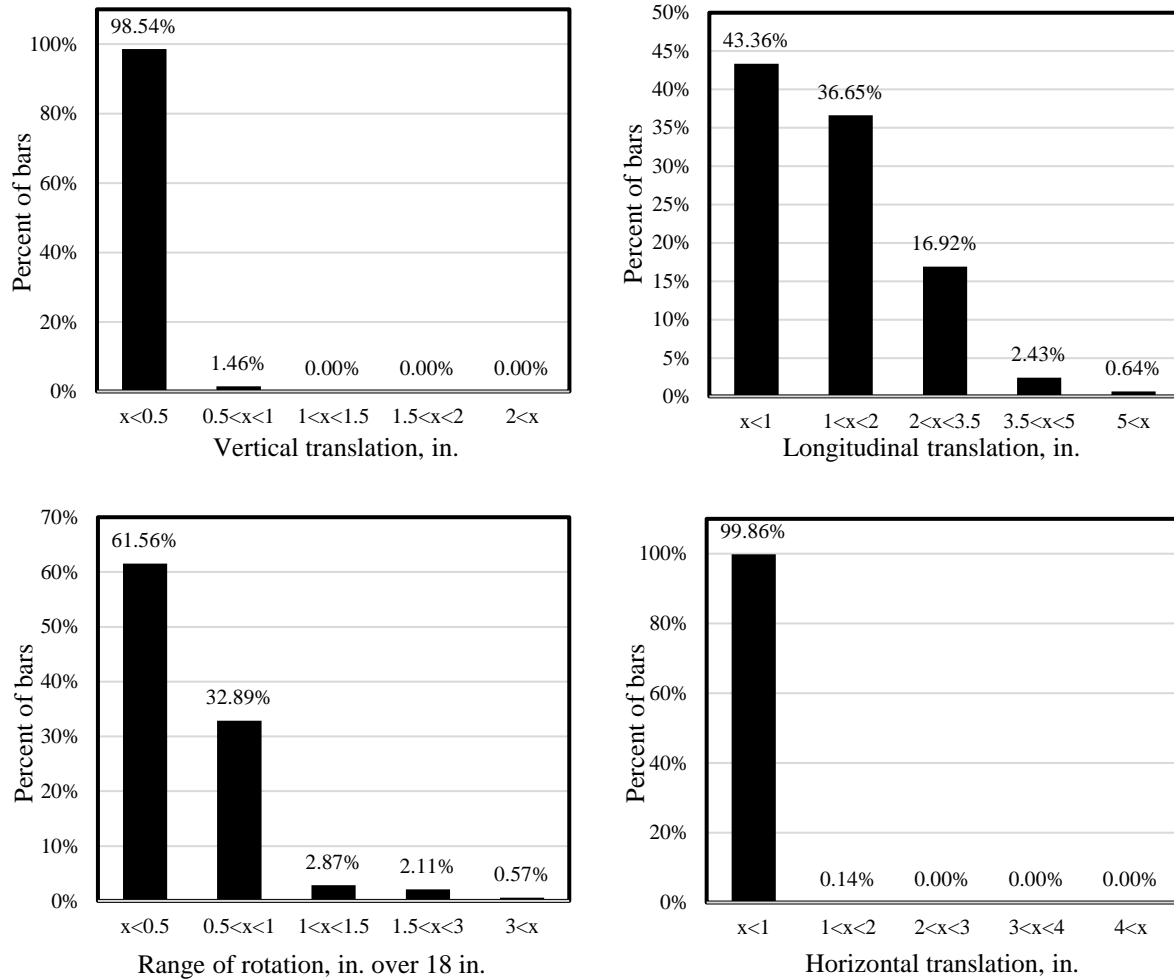
**Figure 3.1** Dowel misalignment values of Hooper project

Figure 3.1 shows the dowel positions for the 110 joints scanned in the US 275 “Hooper” project, which was completed in 2009. It can be seen that vertical and horizontal translation of the dowels is not a concern, while high longitudinal translation and rotation of the dowels is present. Approximately 20% of the dowels fall outside acceptance criteria for longitudinal translation (2.0-2.1 inches), and 1 joint has to be rejected based on ACPA and FHWA rejection criteria due to average longitudinal translation of 5.1 inches. However, it should be noted that no distress was observed during the field performance measurement of this joint.

As for dowel rotation, 6% of the dowels fall outside acceptance criteria and 3% of the bars should be rejected based on ACPA and FHWA criteria. Many of the dowels with high values of rotation were in the same joint that should be rejected due to longitudinal translation. Three missing dowels were also identified on separate joints in the Hooper project. All of the missing dowels lay in the vehicle wheel-path and thus the load distribution among dowels is expected to be adversely affected.

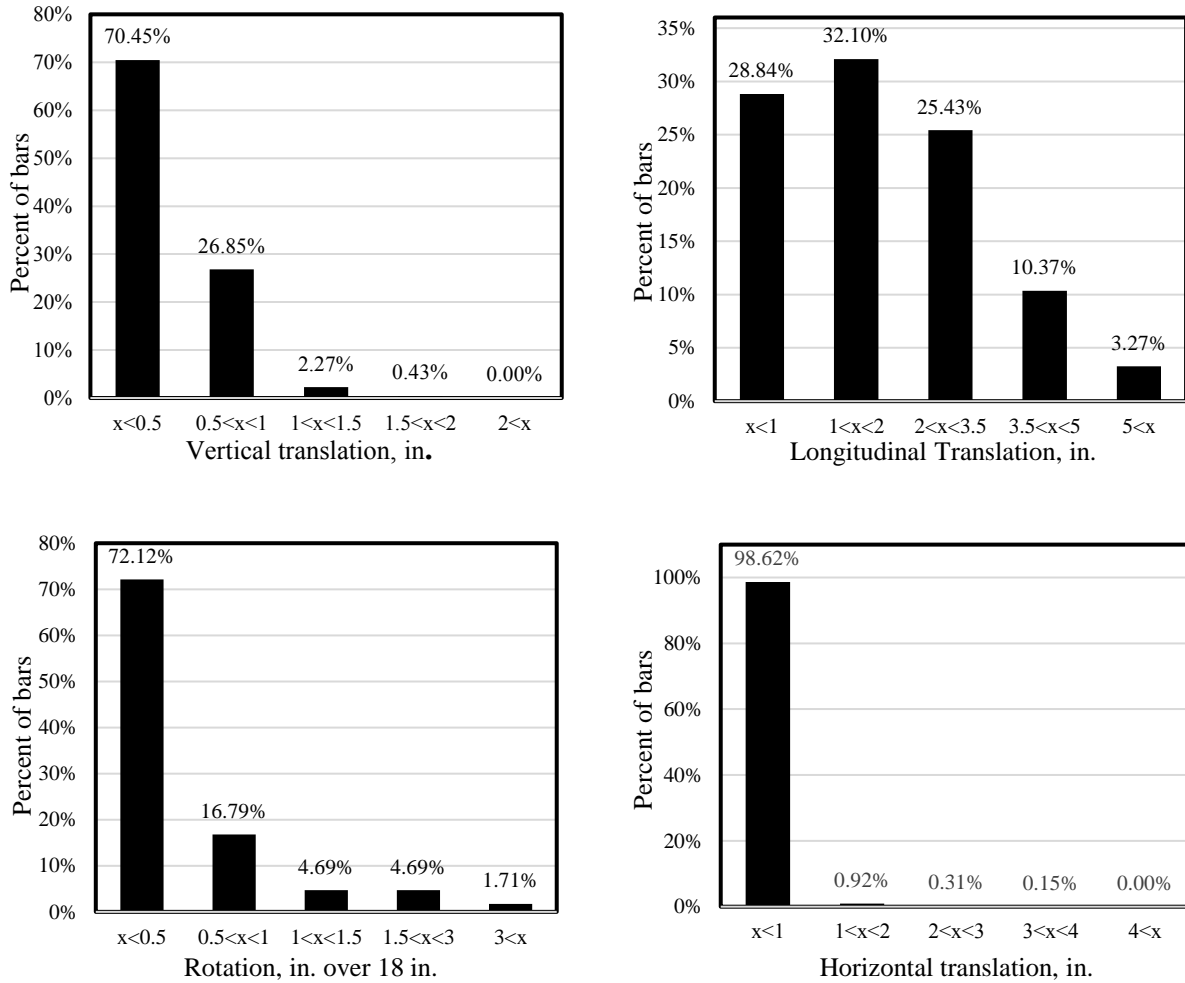
**Figure 3.2** Dowel misalignment values of Kimball project

The dowel misalignment values of the 55 joints in SR 71 “Kimball” project can be seen in figure 3.2. Compared to the previous project, higher longitudinal and vertical translation of the dowels can be seen. Only 60% of the dowels showed acceptable longitudinal translation values, and 3 joints should be rejected based on ACPA and FHWA criteria. However, 97% of dowels presented acceptable vertical translations, and the other 3% still have sufficient concrete cover based on all criteria. Regarding rotational misalignment, four joints will be rejected based on the criteria of all agencies, two of which also had excessive longitudinal translations.

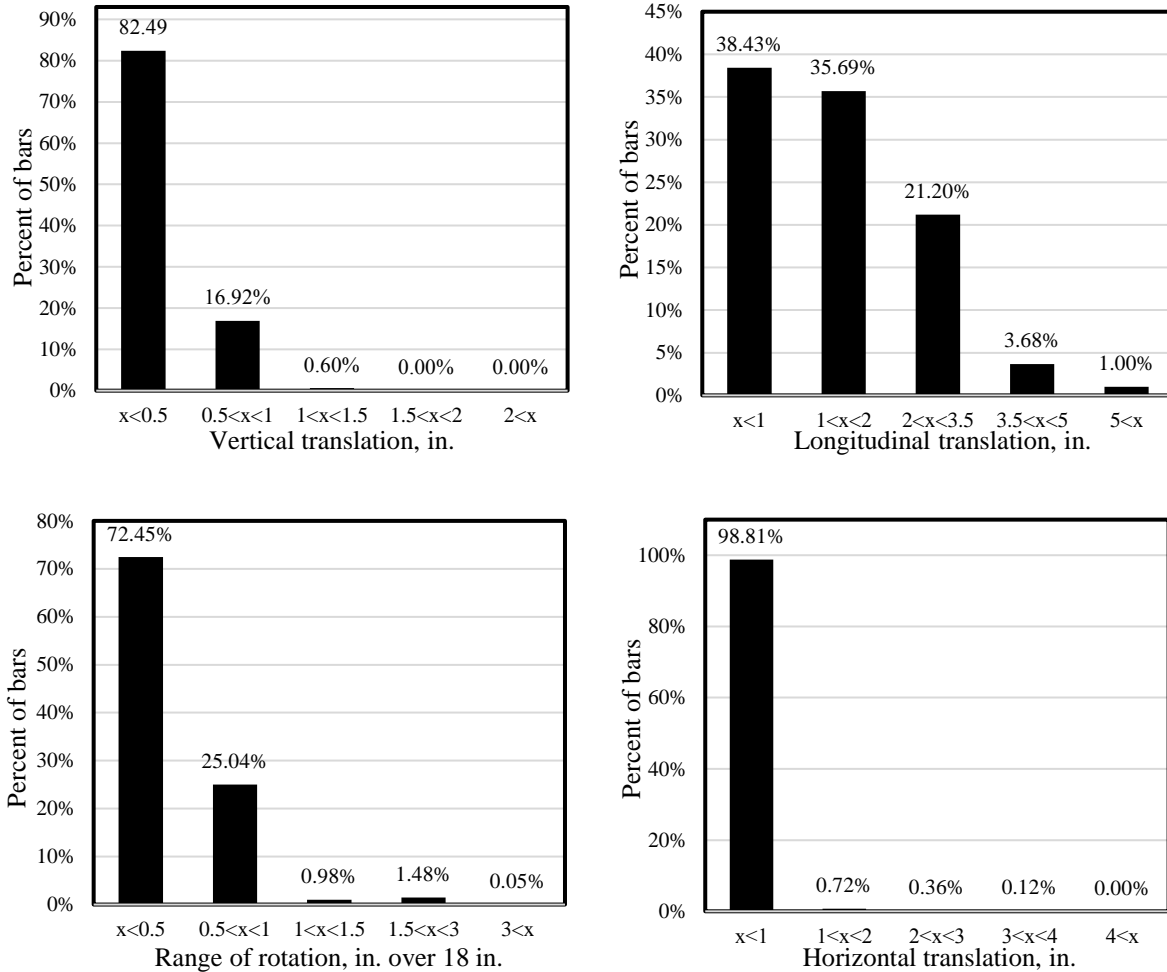
**Figure 3.3** Dowel misalignment values of Roscoe project

The dowel misalignment values of the I-80 project “Roscoe”, and the US 275 project “Norfolk” can be seen in figures 3.3 and 3.4. The number of joints scanned for the projects were 155 and 175, respectively. The east and west directions of Norfolk were completed in 2005 and 2009 respectively, while Roscoe was completed in 2012. Similar to previous projects, both Norfolk and Roscoe showed acceptable vertical and horizontal translations. The dowels in Roscoe project have higher longitudinal translation with 35% of dowels falling outside acceptance criteria of national agencies , and 3 joints that have to be rejected, while Norfolk has 12% of dowels outside

acceptance criteria and 3 joints that need corrective action. It can be noted that field investigation showed zero to 1 mm. faulting for those three joints.

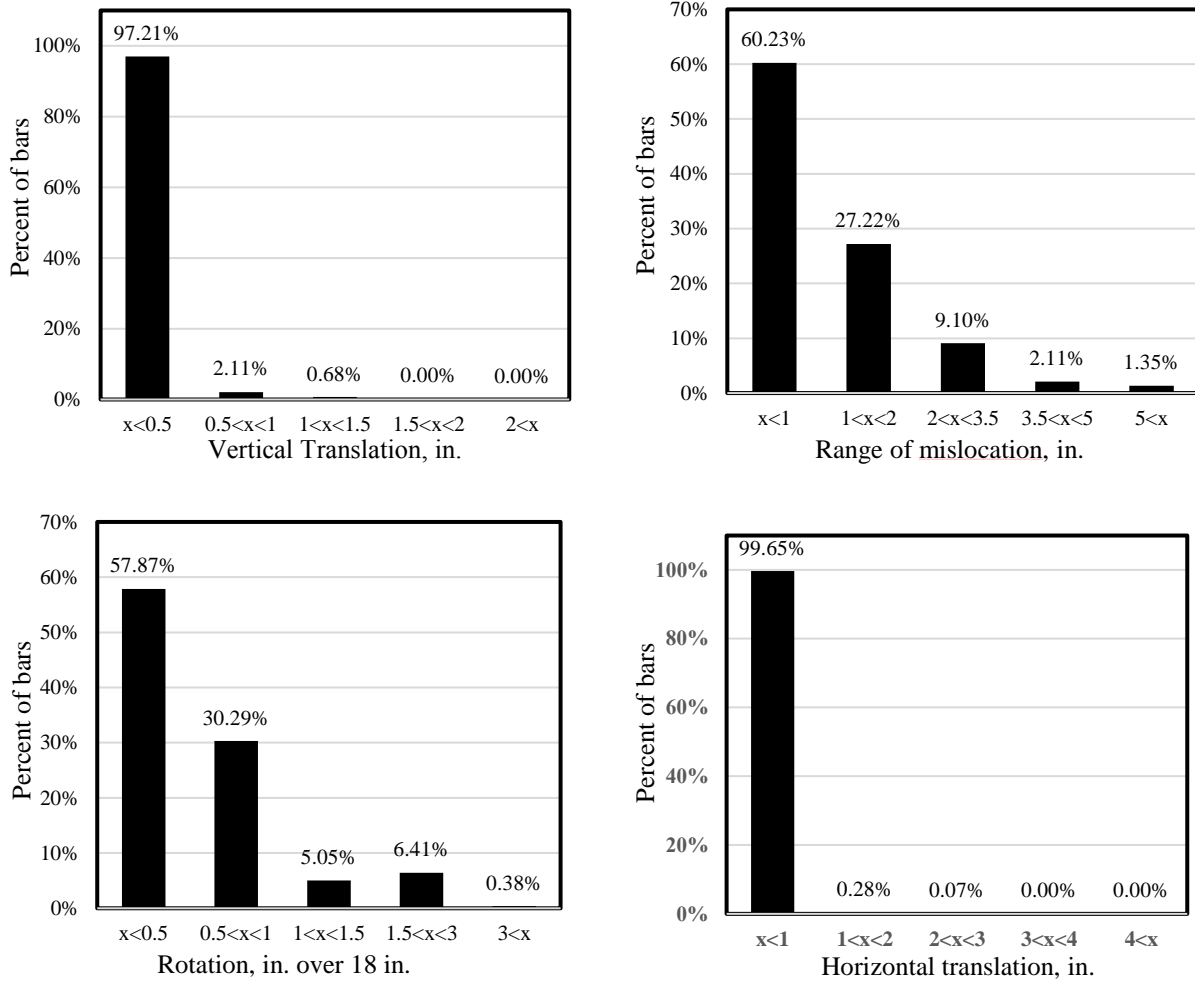
**Figure 3.4** Dowel misalignment for Norfolk project

The Norfolk project has higher rotational misalignment compared to Roscoe, with 12% outside acceptable tolerances compared to less than 3% for Roscoe. Seven percent of Norfolk joints fall outside the rejection criteria of FHWA and ACPA, compared to less than 2% for Roscoe.

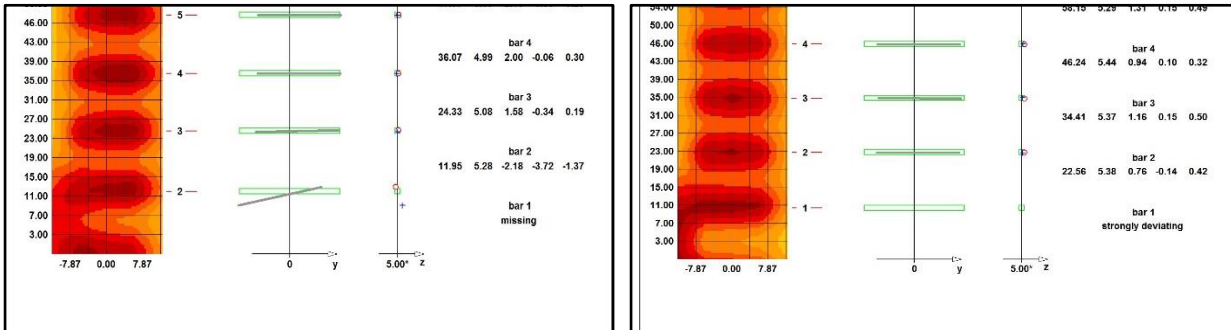
**Figure 3.6** Tie bar interference

Interference from tie bars were observed in approximately 20% of the joints in the Norfolk project. Figure 3.6 shows examples of the interferences in two of the joints. Such joints have been excluded from the data investigation and analysis due to high measurement errors, which make the results unreliable.

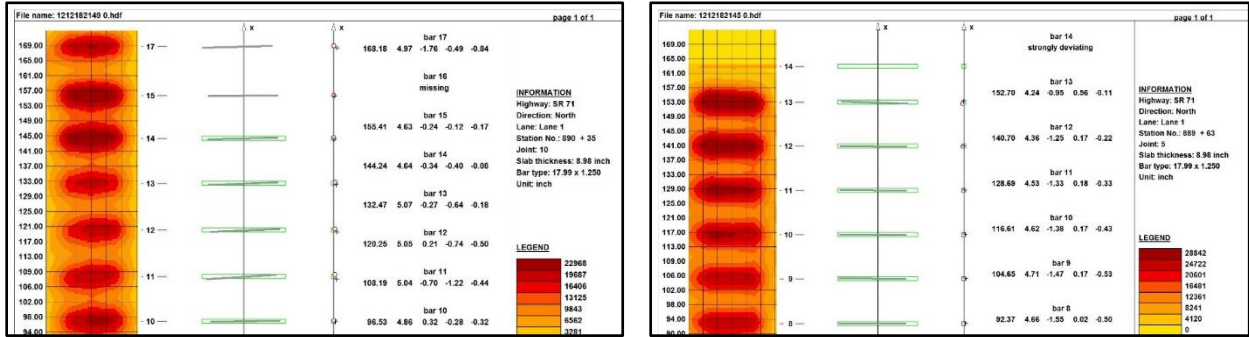
Figure 3.7 Erroneous dowel identification by MagnoProof software

A few instances of the MagnoProof software mistakenly identifying the dowels as missing or strongly deviating was also encountered during data investigation. Examples of such joints are shown in figure 3.7. Such occurrences, together with the existence of foreign metals that can affect

the results, show that the results provided by the software are not always correct, and manual inspection of individual joint contours is necessary for a reliable quality assurance approach.

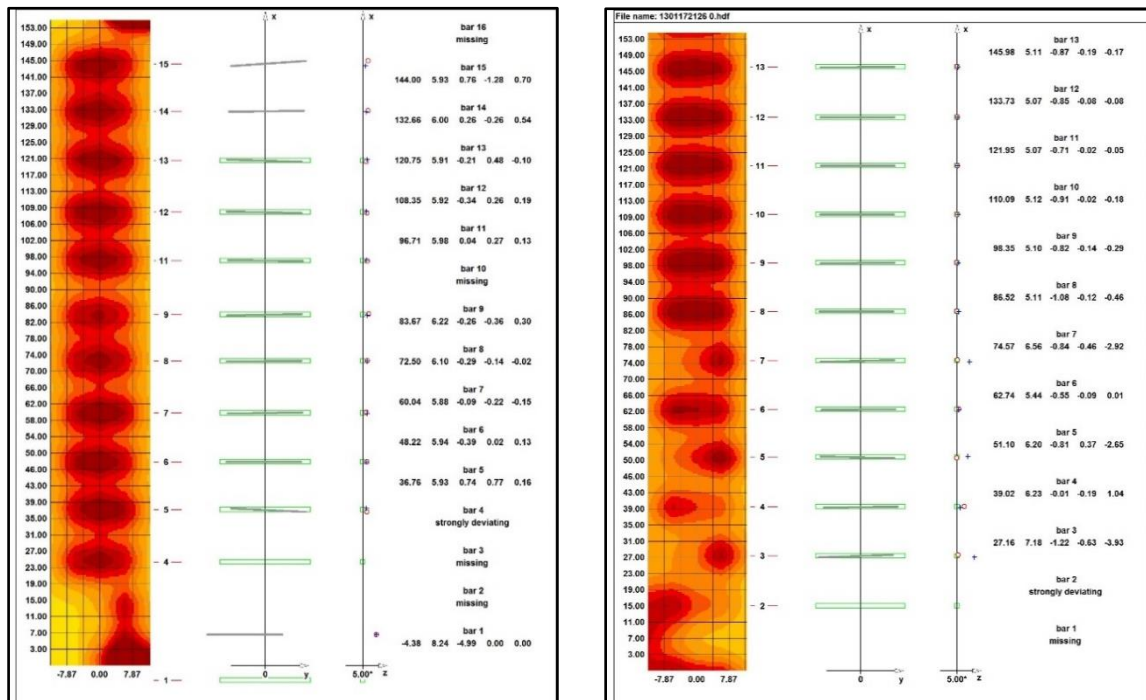
**Figure 4.1** Examples of joints excluded from analysis

Some of the joints in Norfolk project had dowel misalignments that could not be captured by typical misalignment categories, and thus these joints were not included in the data analysis task. Examples of two joints are presented in figure 4.1. From the signal intensity contour, it can be seen that some of the dowels in the joint are completely shifted and have lost their effectiveness. It is worthy to note that the joints in this figure had faulting values of 2 to 3 mm, which were among the highest faulting values observed on the Norfolk project. In spite of that, the

misalignment values reported by the MIT Scan-2 device does not capture the condition of the joint. Therefore, these joints have not been included in the analysis.

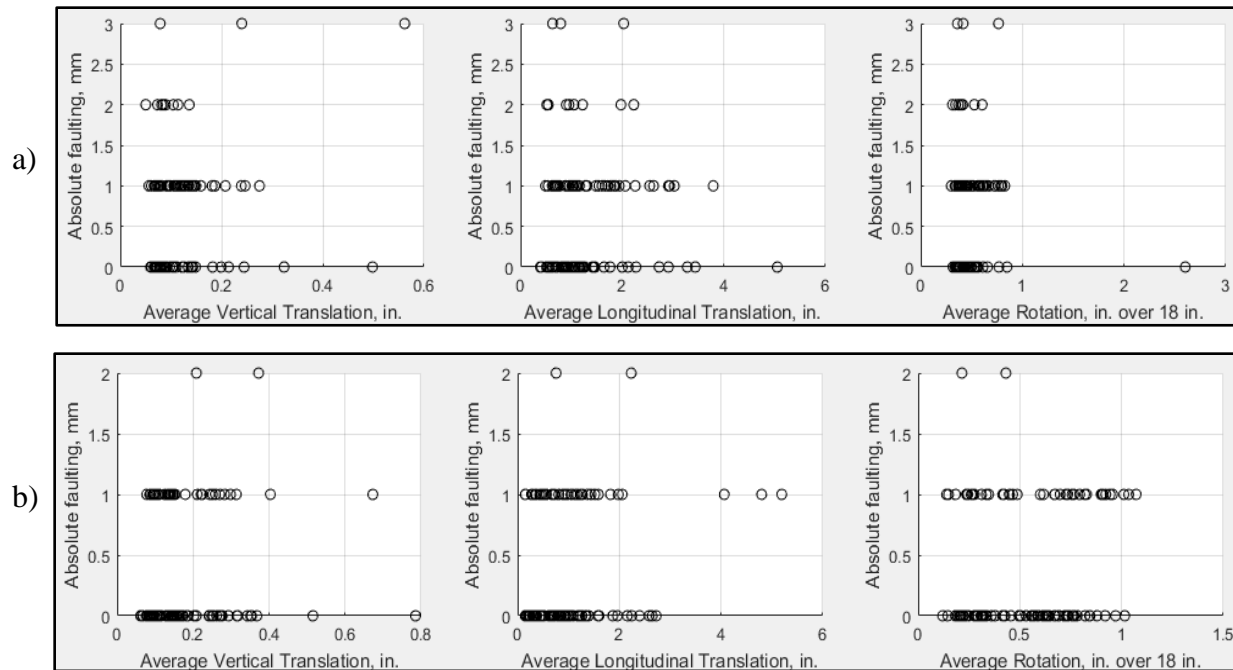
**Figure 4.2** Faulting as a function of average dowel misalignment for (a) Hooper and (b) Norfolk

In order to analyze the effect of longitudinal translation, vertical translation, and dowel rotation on faulting at joints, faulting-misalignment graphs were developed for Hooper and Norfolk projects. Figure 4.2 shows the faulting value of each joint as a function of the average misalignment value of the joint dowels. If there is a relation between faulting and the extent of misalignment observed in the field, a trend is expected in the graphs. However, no such trend is visible, and it can be seen that higher faulting values (>2mm) occur at all ranges of dowel misalignment, which means that the high value of faulting is likely caused by factors other than dowel misalignment.
