Synthesis of Repair Practices of Damaged Precast/Prestressed Concrete Girders

SPR-P1 (19) M090

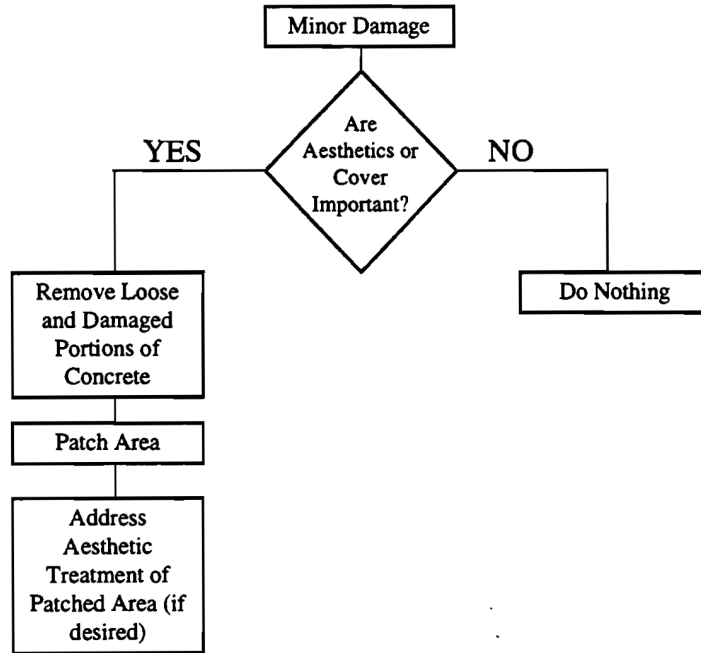
Figure 2: Minor damage step-by-step repair procedure, courtesy of Feldman et al., 1996

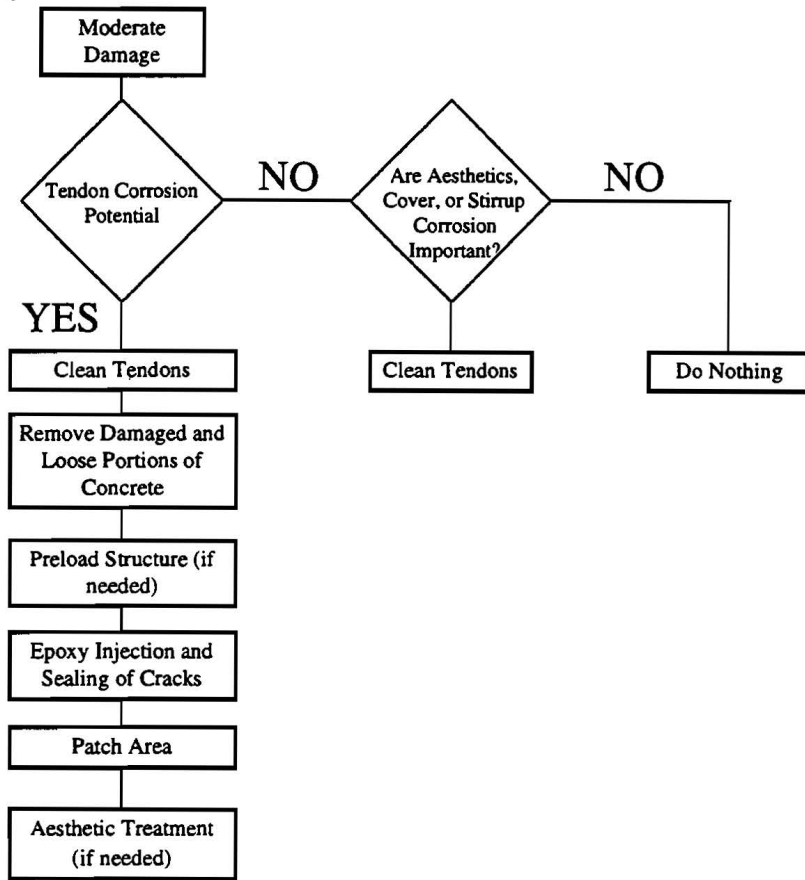
Figure 4: Moderate damage step-by-step repair procedure, courtesy of Feldman et al., 1996

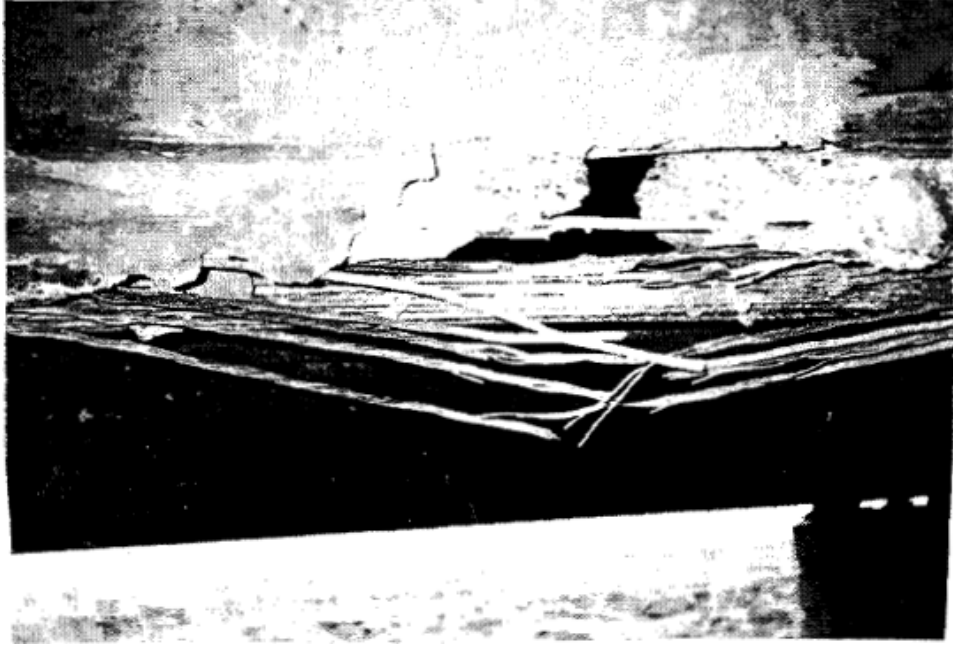
Figure 5: Severe damage, courtesy of Feldman et al., 1996

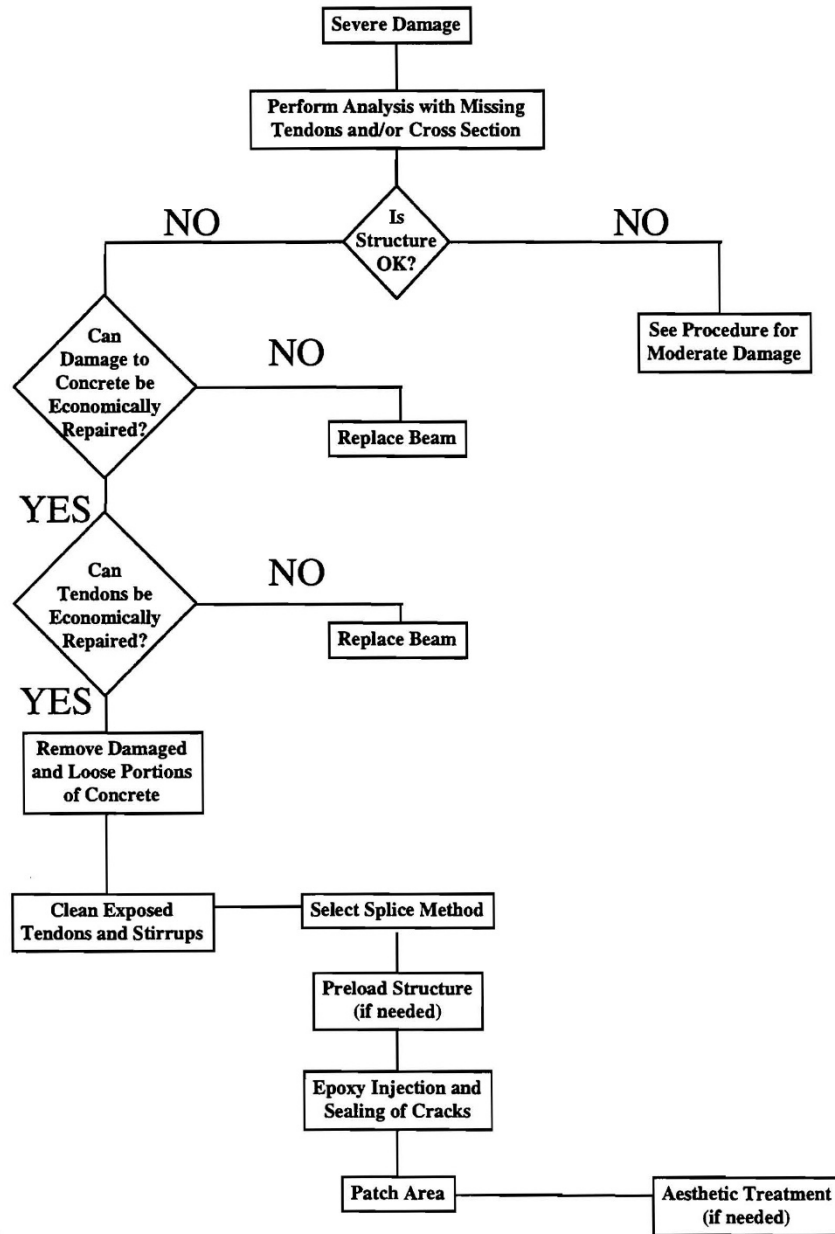
Figure 6: Severe damage step-by-step repair procedure, courtesy of Feldman et al., 1996

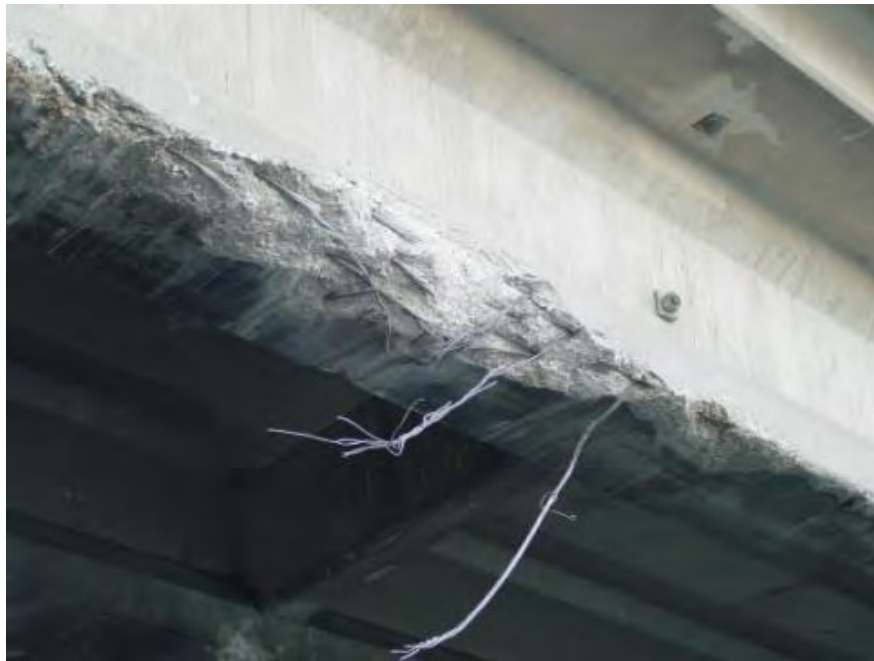
Figure 7: AASHTO I-girder; reportedly repaired, courtesy of Harries et al., 2012

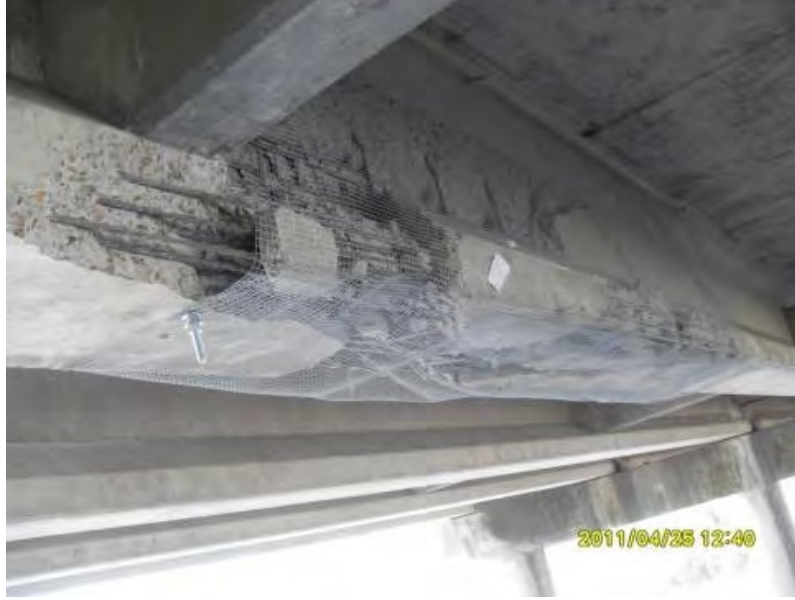
Figure 8: AASHTO I-girder; reportedly repaired, courtesy of Harries et al., 2012

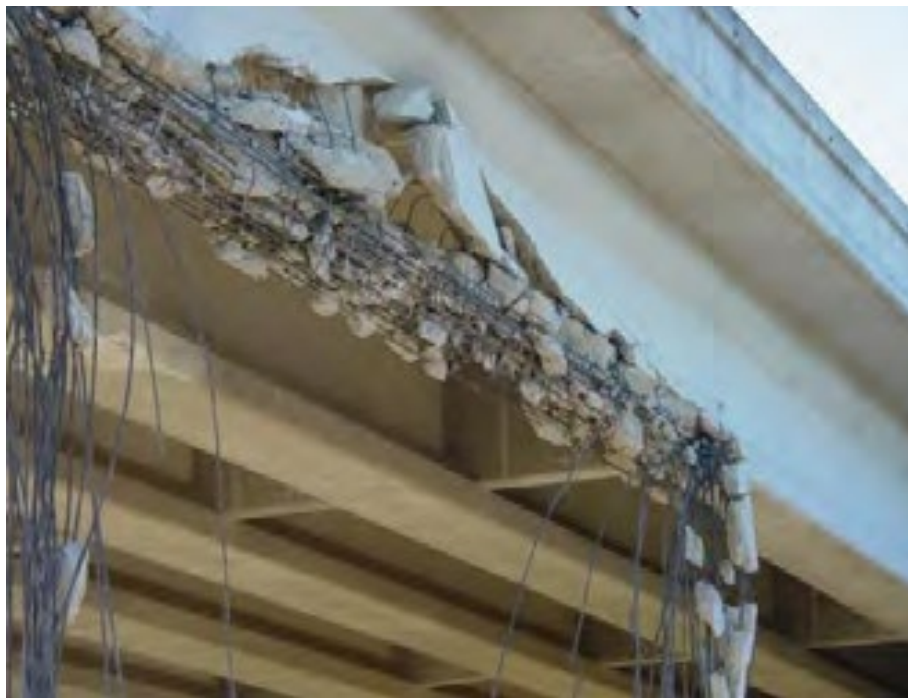
Figure 9: Exterior girder FM479 over Kerr Road, San Antonio TX. AASHTO I-girders; reported that the entire bridge was demolished and replaced, courtesy of Harries et al., 2012

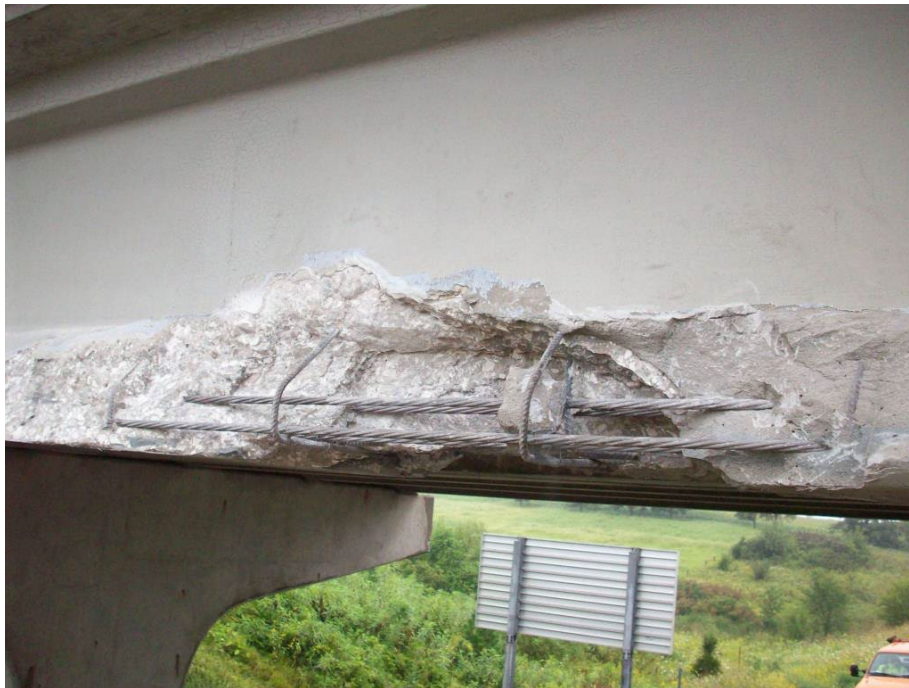
Figure 11: Bottom flange damage with mild reinforcing and prestressing strands intact, courtesy of Iowa DOT, 2014

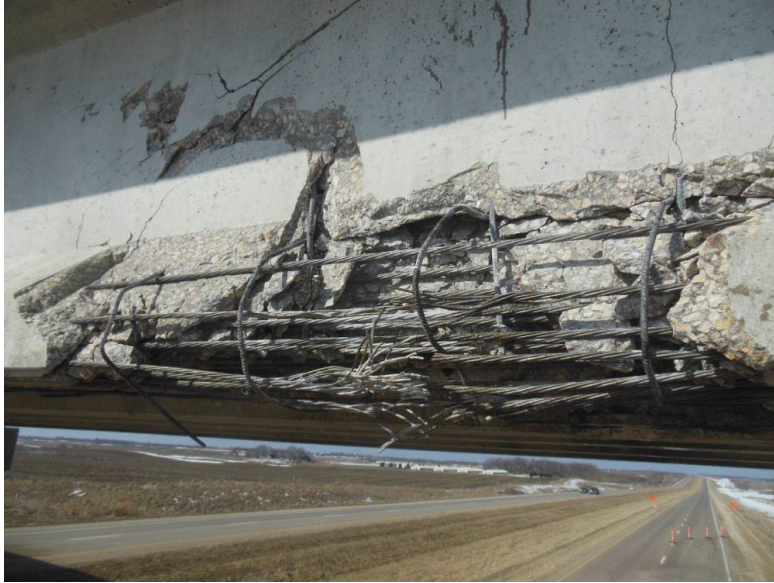
Figure 12: Heavy damage with web cracking and severed mild reinforcing and prestressing strands, courtesy of Iowa DOT, 2014

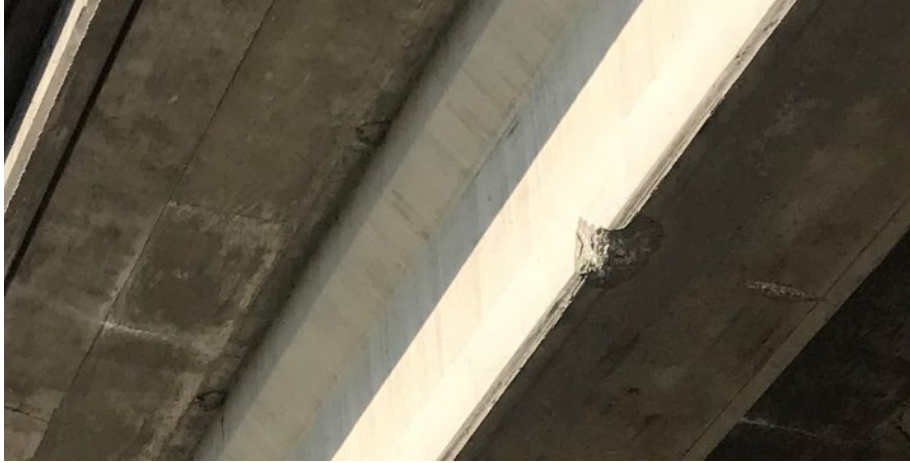
Figure 13: Minor damage, NDOT York Bridge East, courtesy of NDOT

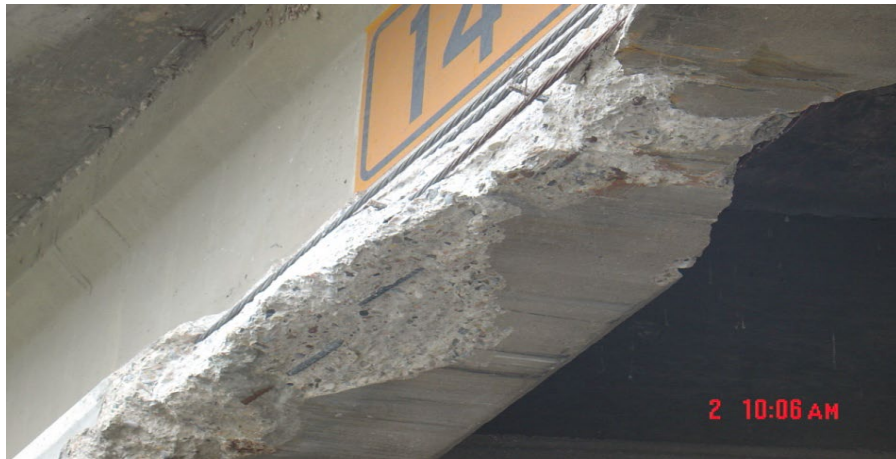
Figure 14: Moderate damage, exposed intact strands, courtesy of Pantelides et al., 2010

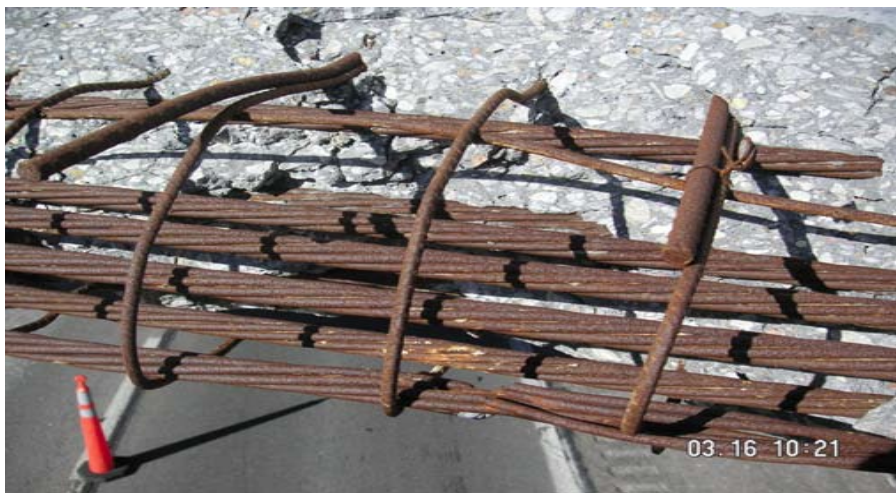
Figure 15: Severe I damage, one severed strand, NDOT Wood River Interchange Bridge Girder (A), courtesy of NDOT

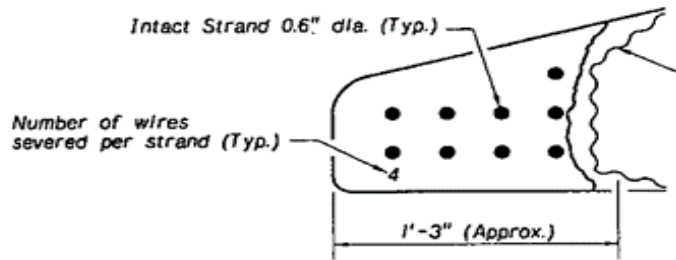
Figure 16: Severe I damage, one severed strand and loss of vertical camber, camber of +1 in. at undamaged girders and +0.06 in. at Girder (A), NDOT Wood River Interchange Bridge Girder (A), courtesy of NDOT

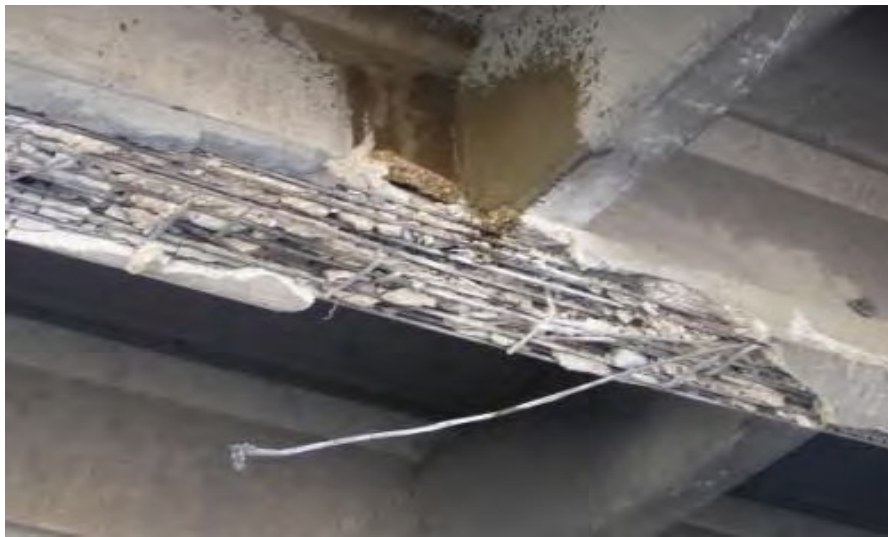
Figure 17: Severe I damage, one severed strand, courtesy of Harries et al., 2012

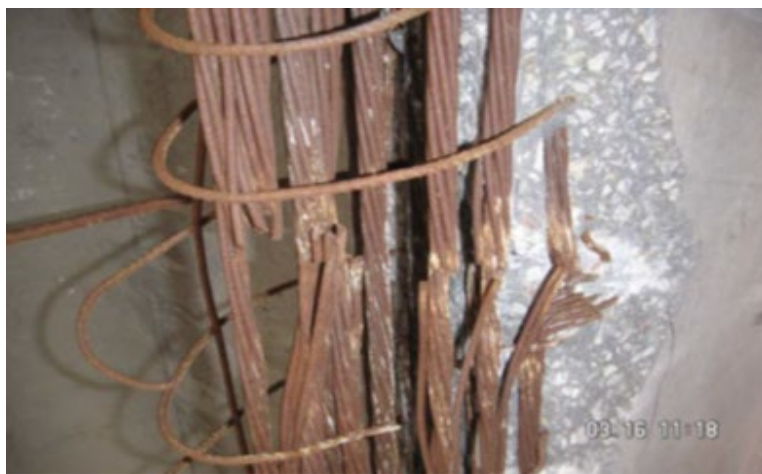
Figure 18: Severe II damage, five severed strands, NDOT Wood River Interchange Bridge Girder (E), courtesy of NDOT

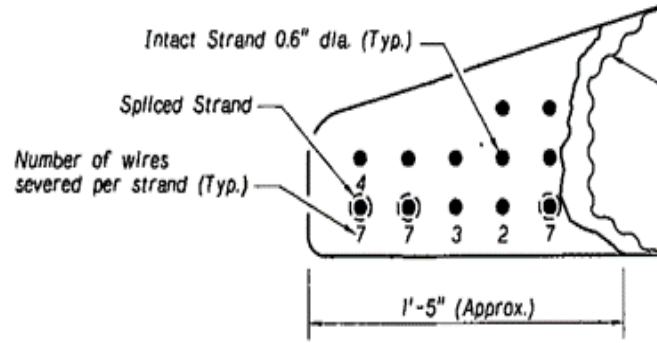
Figure 19: Severe II damage, five severed strands and vertical downward deflection, camber of +1 in. at undamaged girders and -0.48 in. at Girder (E), NDOT Wood River Interchange Bridge Girder (E), courtesy of NDOT

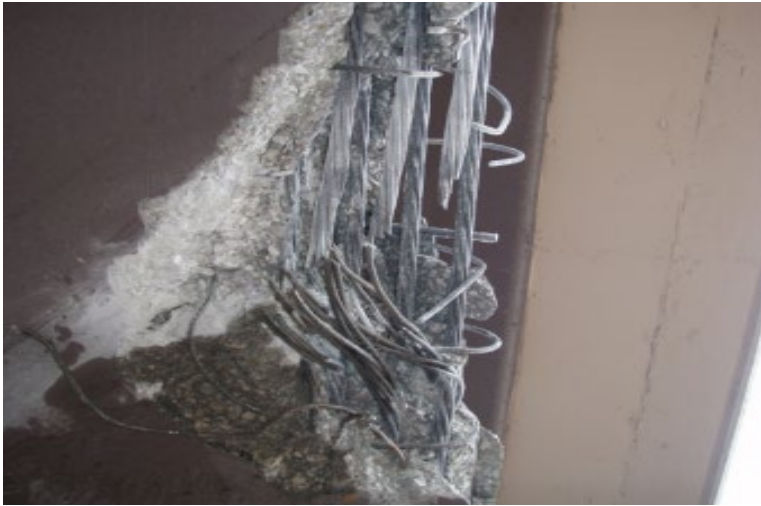
Figure 20: Severe II damage, three severed strands, NDOT Scottsbluff Gering Bypass Bridge, courtesy of NDOT

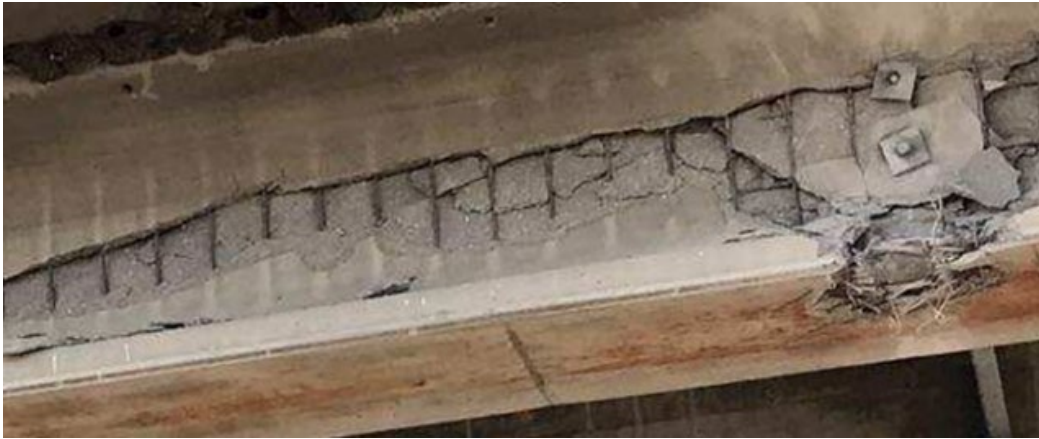
Figure 21: Severe III damage, several damaged strands, NDOT Schuyler Bridge, courtesy of NDOT

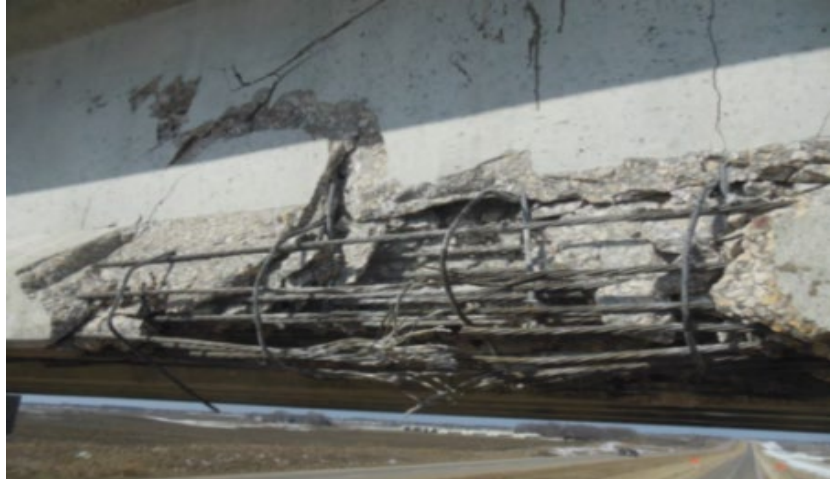
Figure 22: Severe III damage, several damaged strands, courtesy of Iowa DOT, 2014

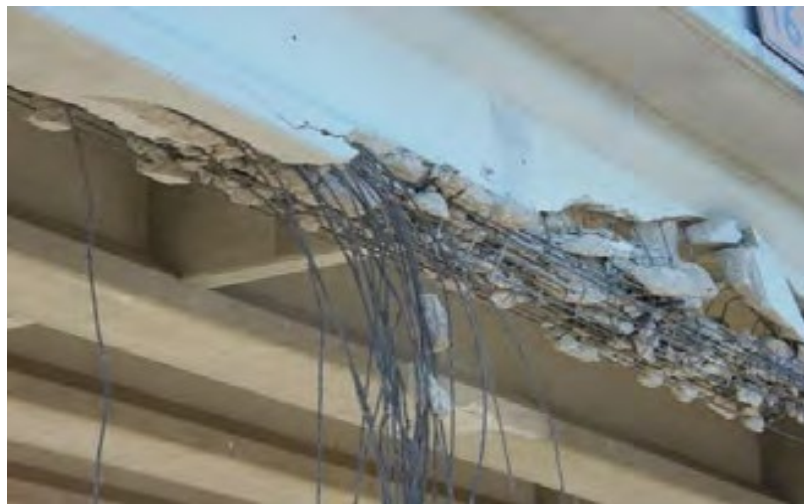
Figure 23: Severe III damage, several damaged strands, courtesy of Harries et al., 2012

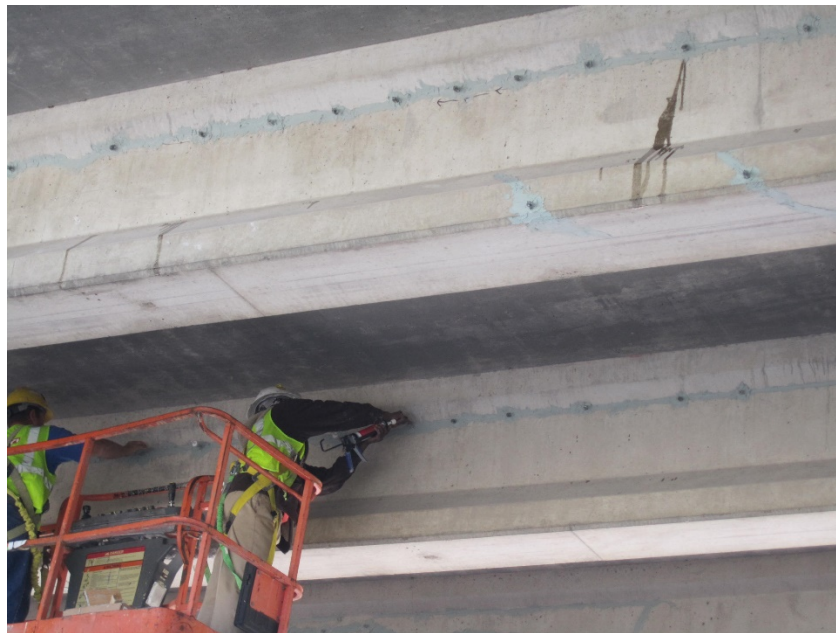
Figure 24: Epoxy injection process done in I-680 over US-75 Bridge, courtesy of NDOT

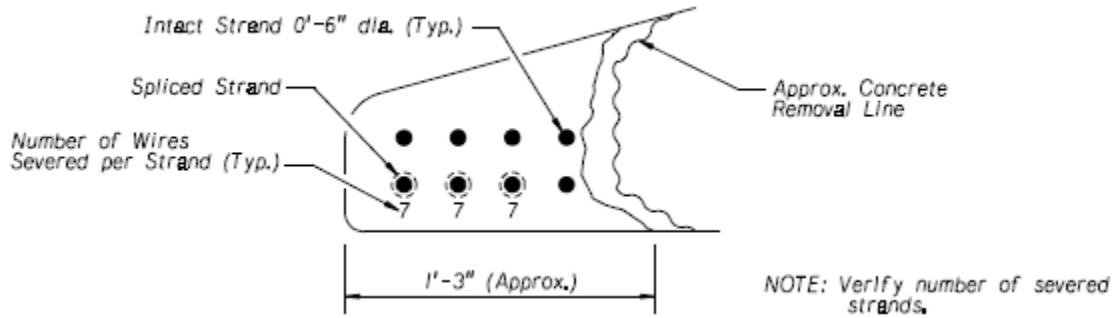
Figure 26: Patching performed after strand splicing to restore the concrete section, Scottsbluff Gering Bypass Bridge, courtesy of NDOT

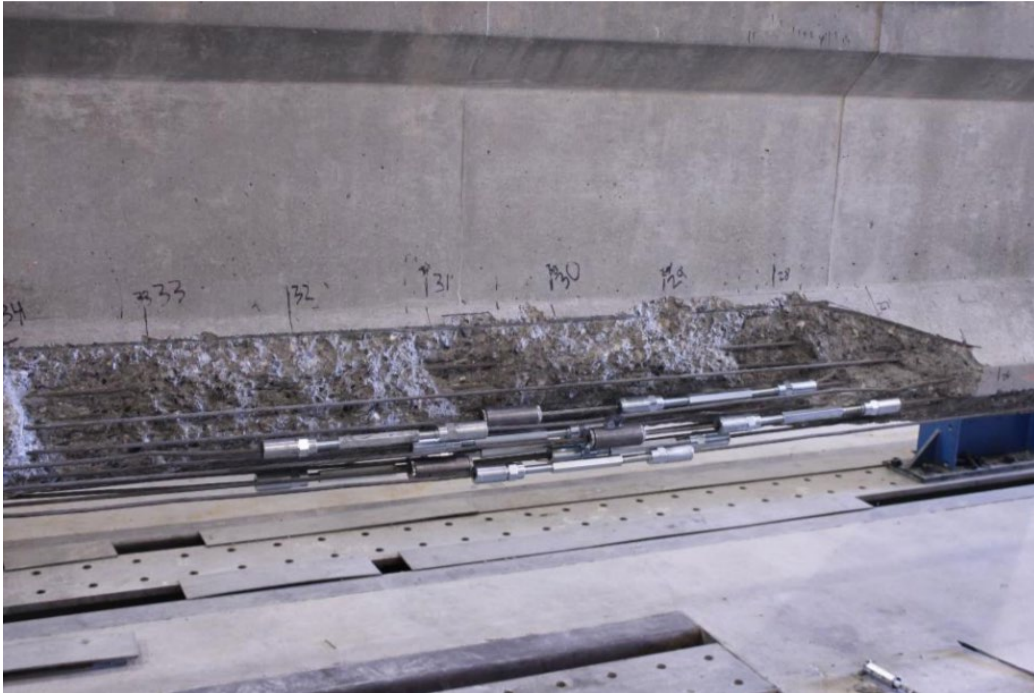
Figure 29: Strand splicing, courtesy of Jones, 2017

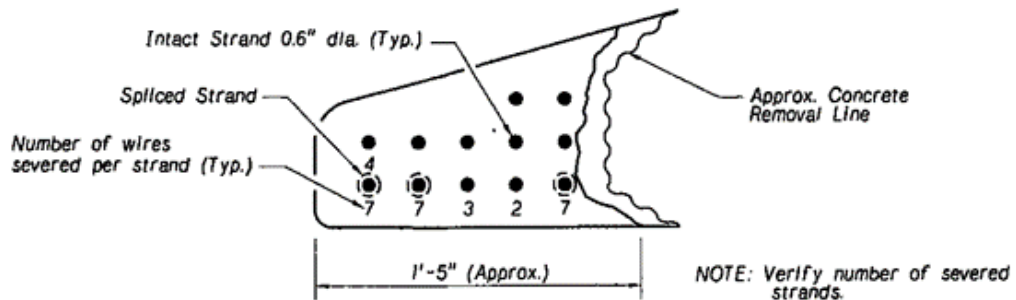
Figure 31: Spliced strands, Wood River Interchange Bridge, courtesy of NDOT

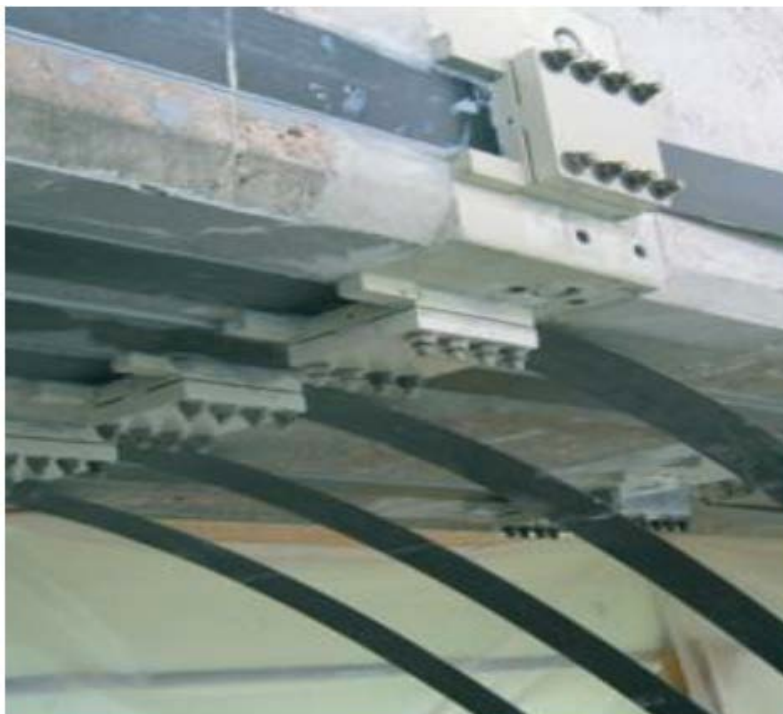
Figure 33: Sika carbostress system external CFRP post-tensioning, courtesy of Kasan, 2009

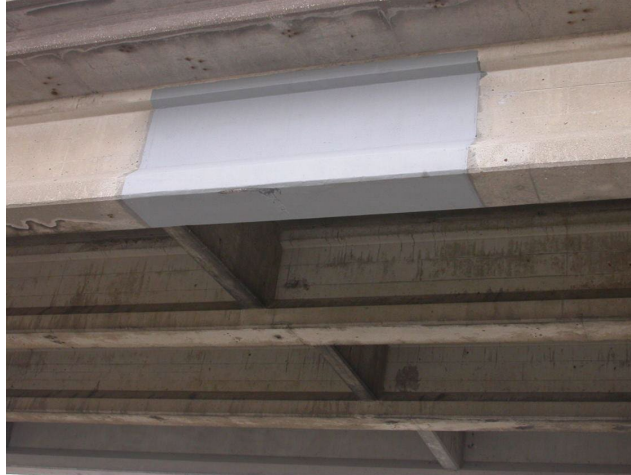
Figure 34: FRP Wrapped Repair, courtesy of Iowa Dot, 2014

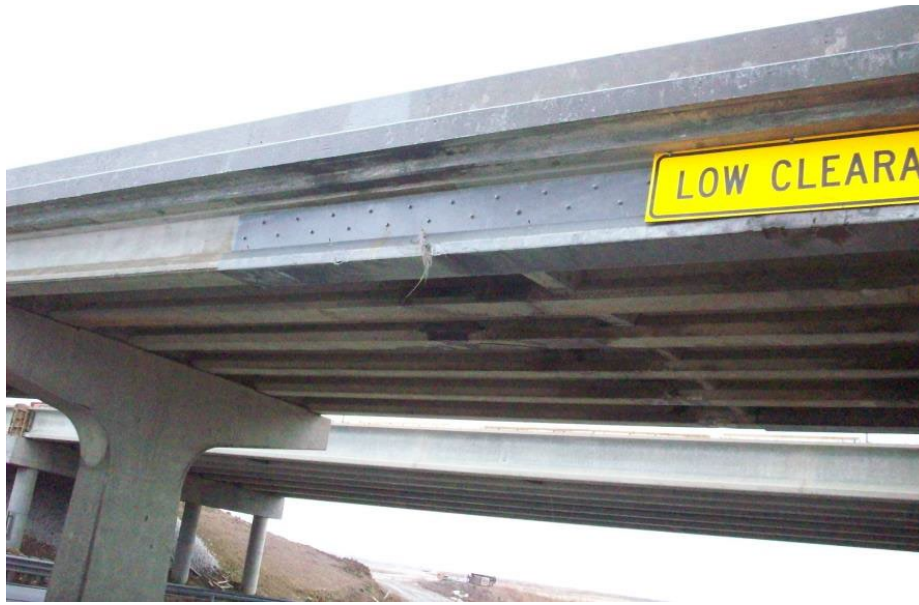
Figure 35: Grouted steel sleeve repair, courtesy of Iowa Dot, 2014

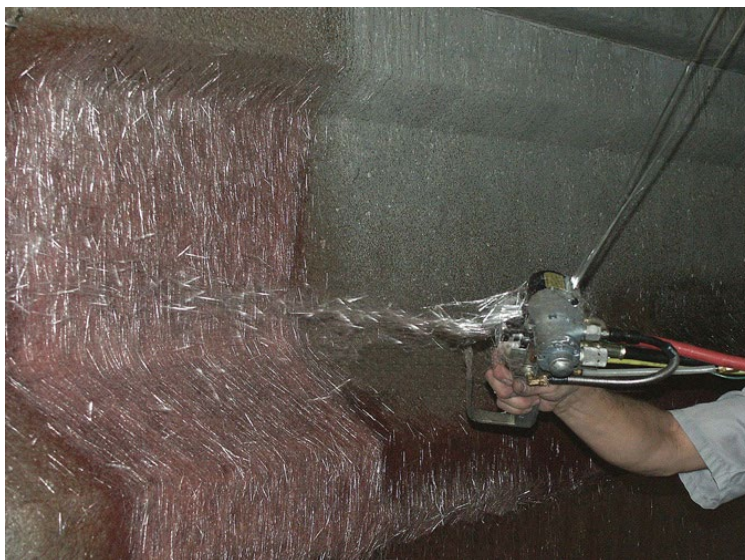
Figure 36: Sprayed GFRP technique, courtesy of Boyd et al, 2006

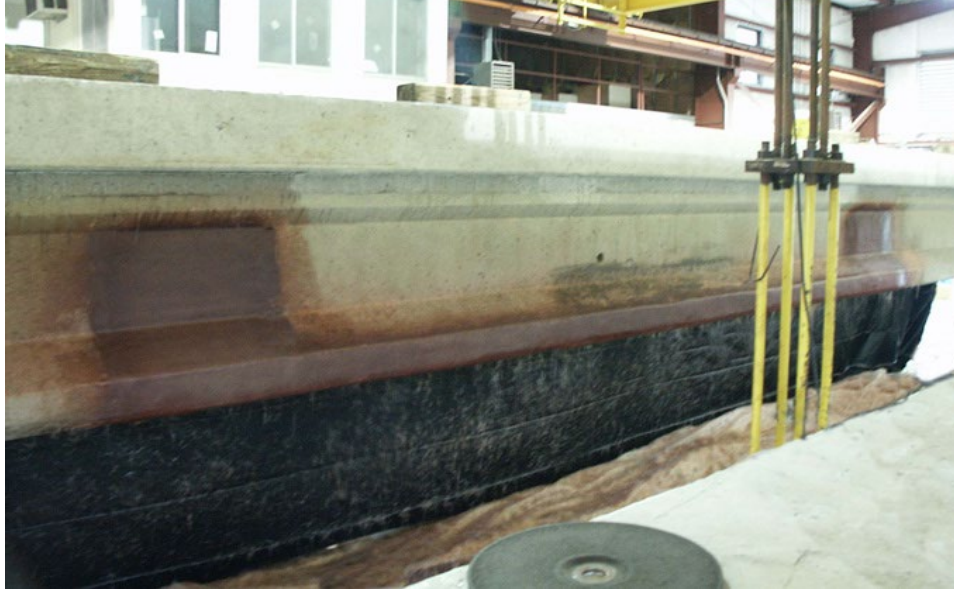
Figure 37: Repaired specimen, courtesy of Boyd et al, 2006

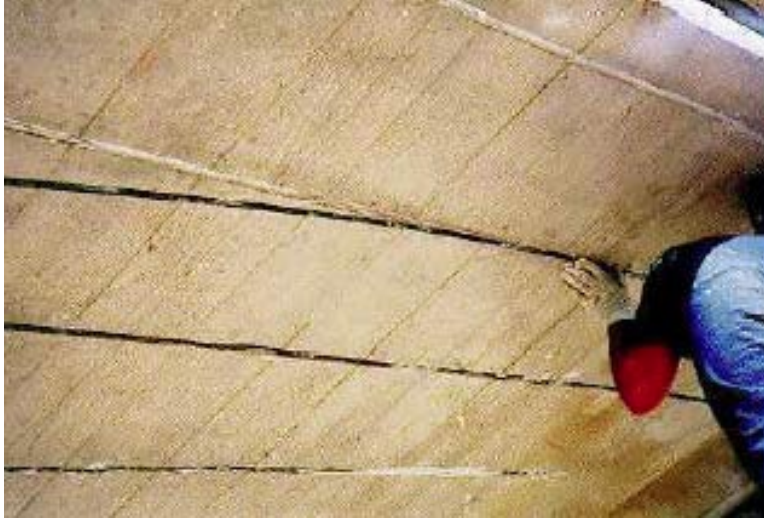
Figure 39: Use of near-surface mounted C-FRP in bridge decks, courtesy of Parretti et al 2004

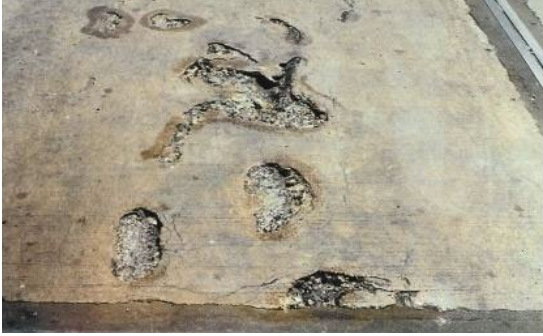
A: Concrete spalling

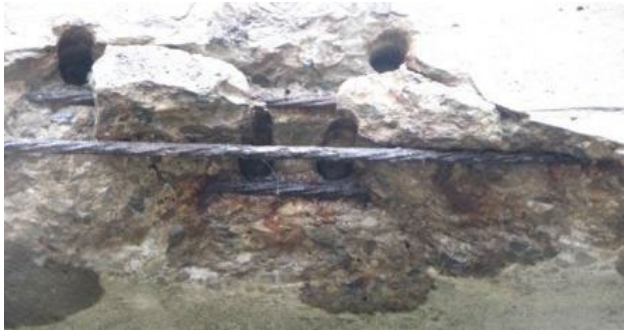
B: Exposed strands without corrosion

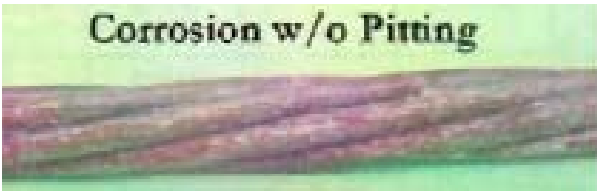
C: Corrosion without pitting

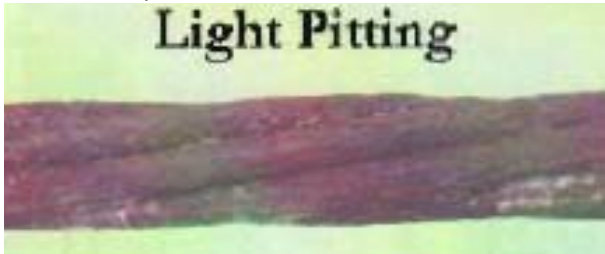
D: Corroded strand with light pitting

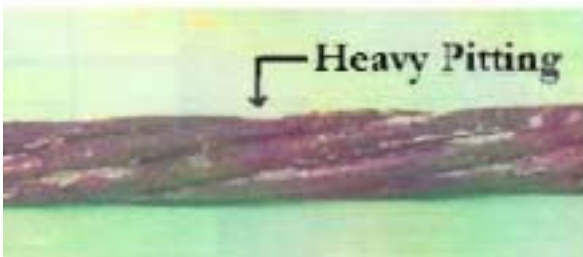
E: Corroded strand with heavy pitting

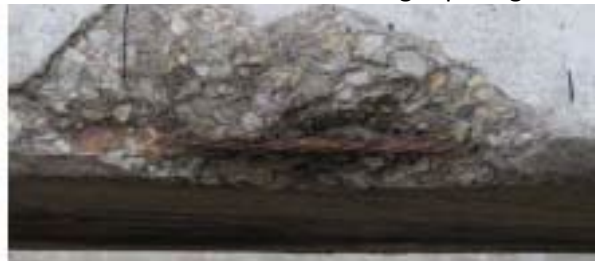
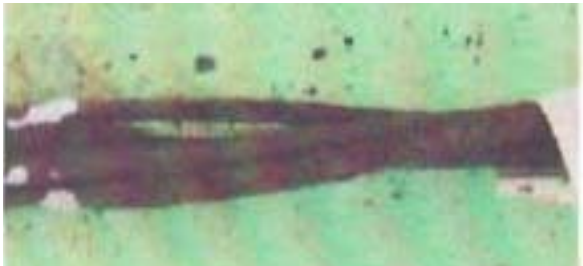
F: Partial loss of strand area

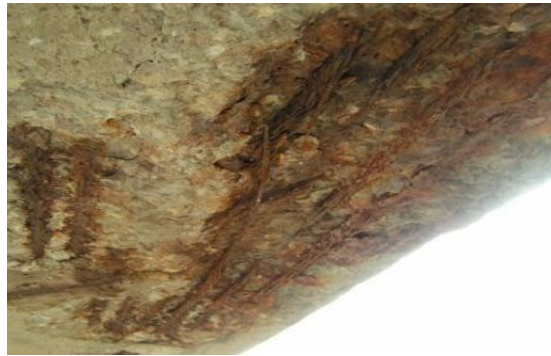
Figure 40: Continuum of corrosion damage, courtesy of Naito et al., 2006

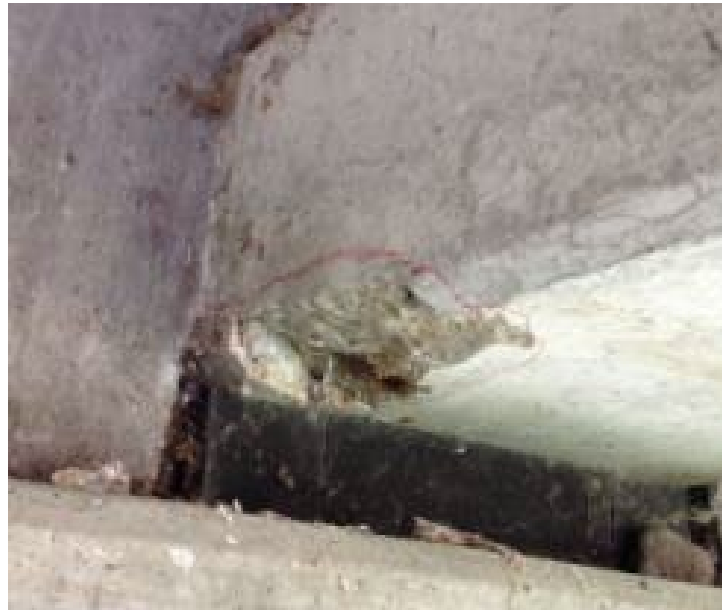
Figure 41: Condition State Poor, spalling on concrete bridge girder, courtesy of WisDOT, 2018

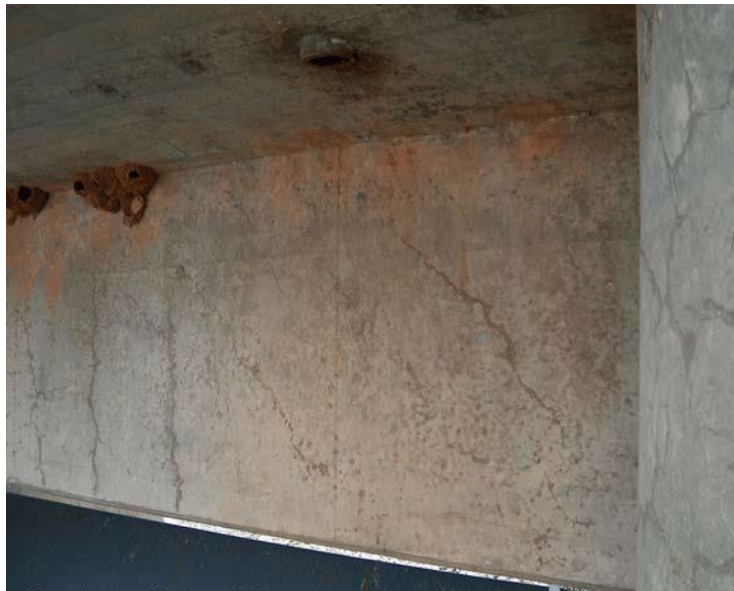
Figure 42: Condition State Fair, cracking on concrete bridge girder, courtesy of WisDOT, 2018

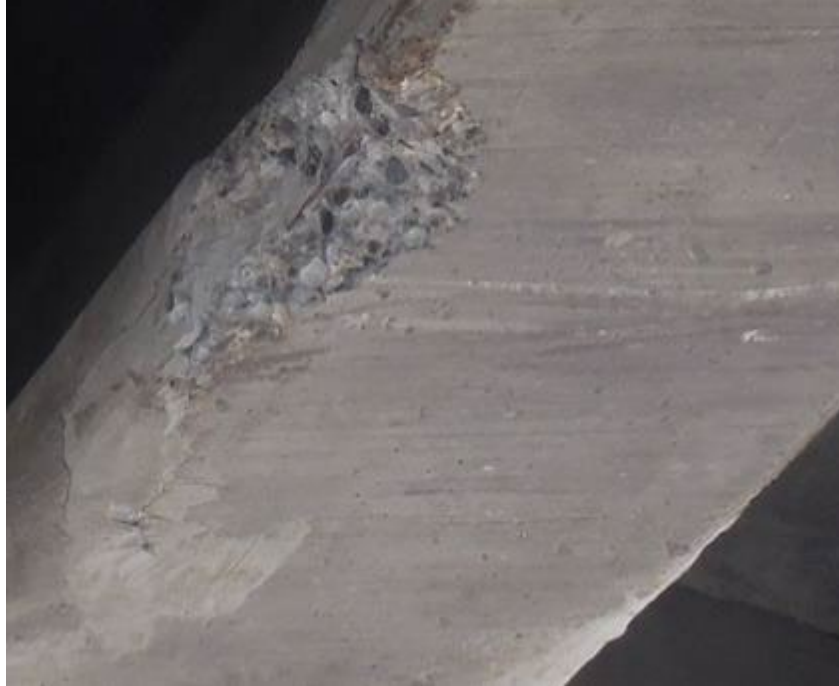
Figure 43: Condition State Fair, exposed strand on concrete bridge girder, courtesy of WisDOT, 2018

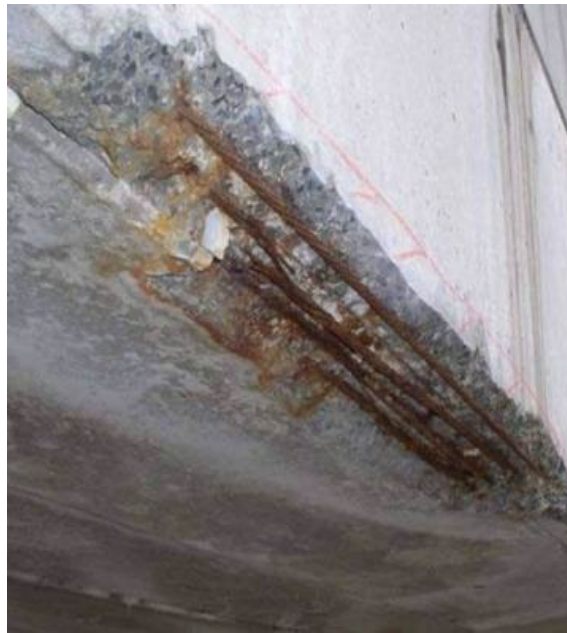
Figure 44: Condition State Poor, exposed strands on concrete bridge girder, courtesy of WisDOT, 2018

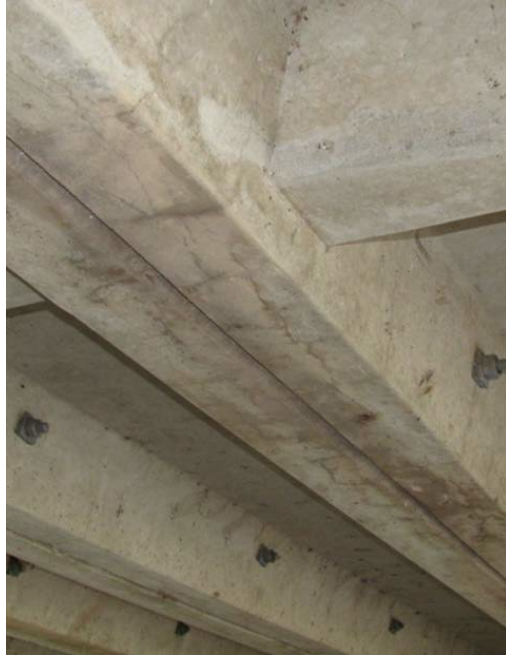
Figure 45: Condition State 2 cracking on precast concrete channel girders, courtesy of MnDOT, 2019

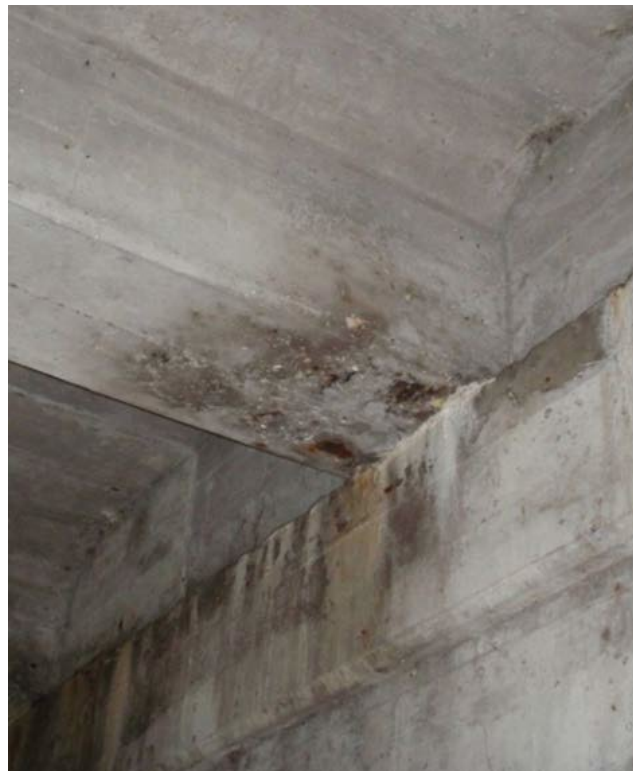
Figure 46: Condition State 3 water saturation, rust staining, and spalling on a cast-in-place concrete T-girder, courtesy of MnDOT, 2019

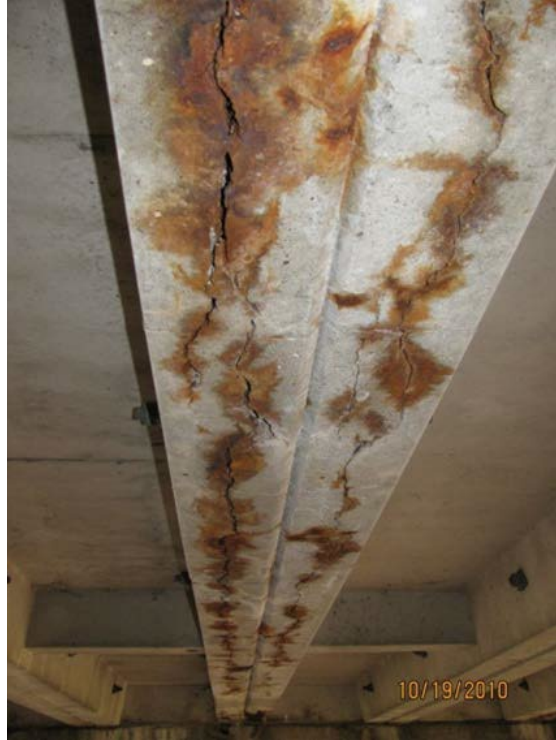
Figure 47: Condition State 3 cracking, delamination, and rust staining a precast concrete channel girder, courtesy of MnDOT, 2019

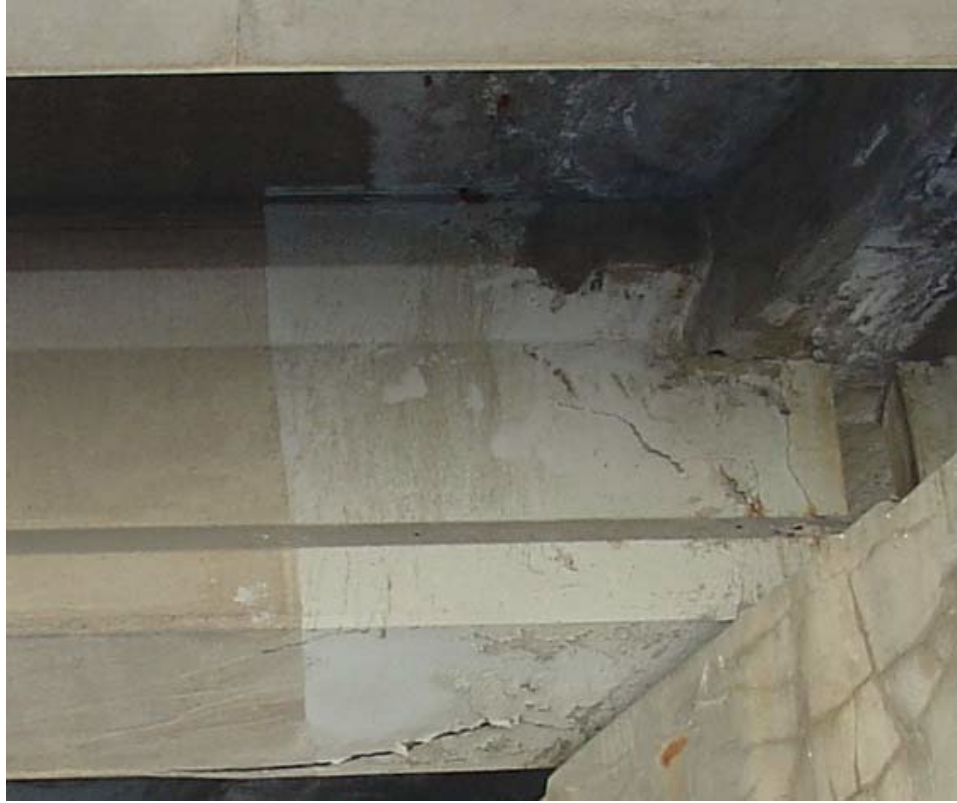
Figure 48: Severe class corrosion damage at girder end causing severe cracks, courtesy of Pantelides et al., 2010

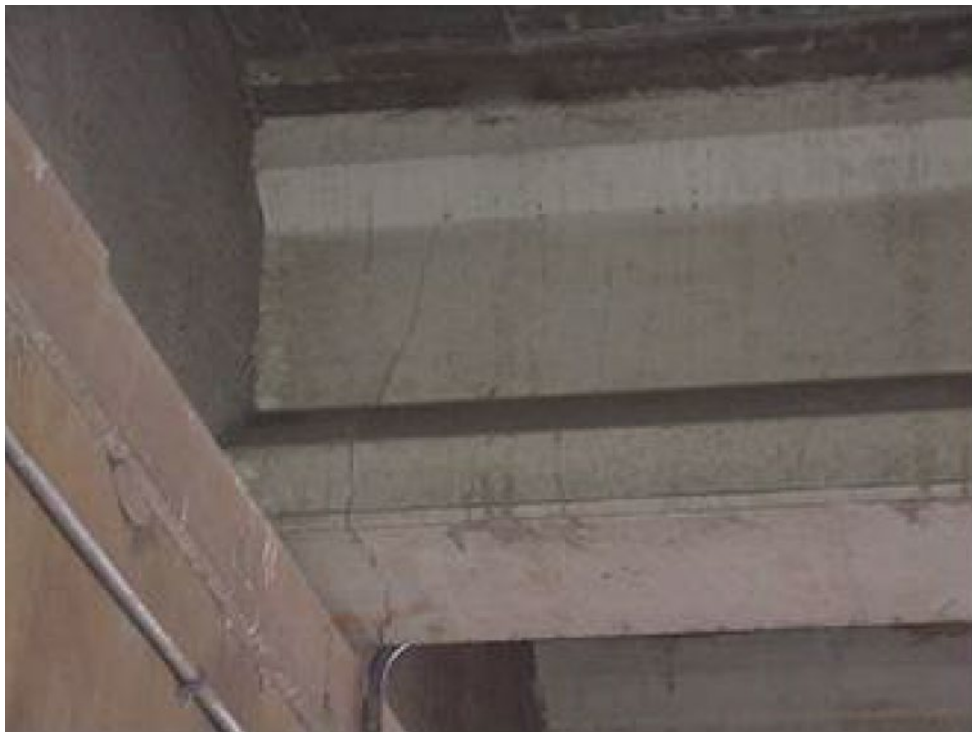
Figure 49: Severe class corrosion damage at girder end causing severe cracks, courtesy of Choo et al., 2013

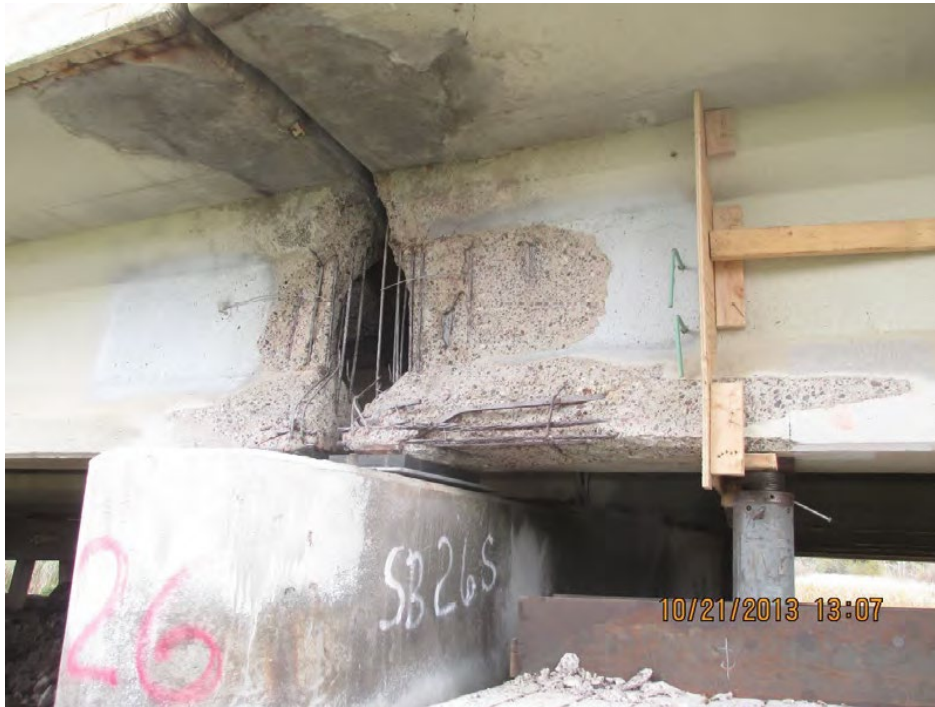
Figure 50: Severe class corrosion damage at girder end, MN/RC 2018-07 Report

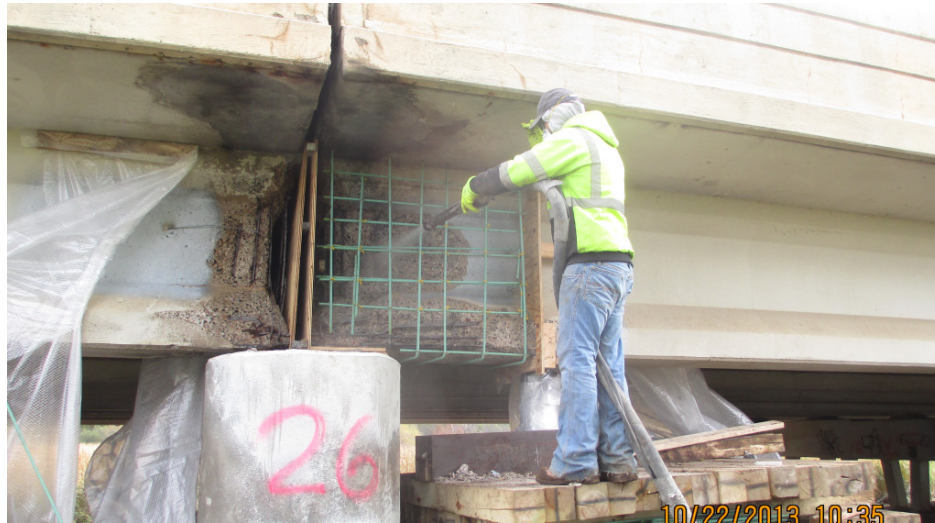
Figure 51: Shotcreting repair at girder end, MN/RC 2018-07 Report
