Synthesis of Repair Practices of Damaged Precast/Prestressed Concrete Girders

SPR-P1 (19) M090

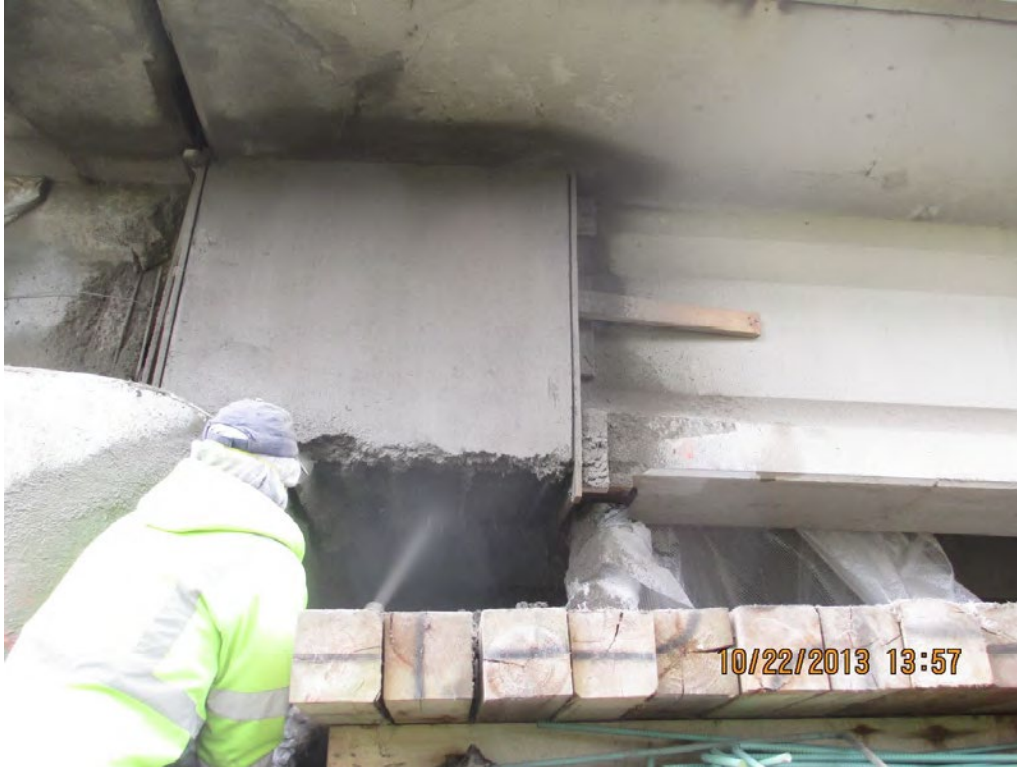
Figure 52: Shotcreting the bottom surface of the repair at girder end, MN/RC 2018-07 Report

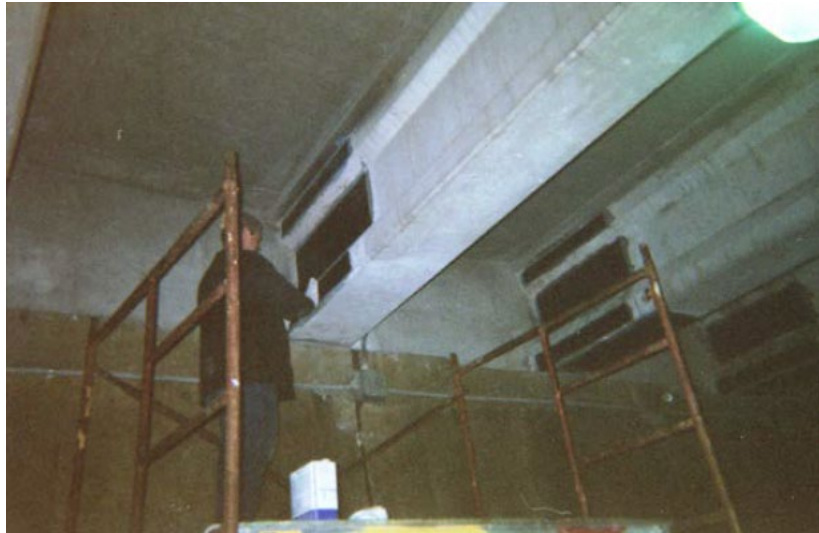
Figure 53: CFRP fabrics installation on I-65 expressway bridge girders, courtesy of Choo et al., 2013

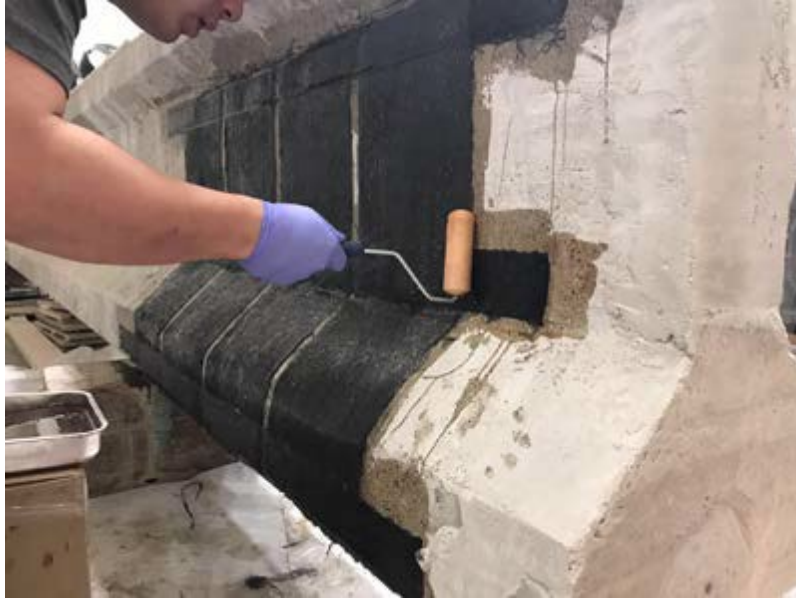
Figure 54: Applying shear CFRP to full-scale prestressed girder end, courtesy of Andrawes et al., 2018

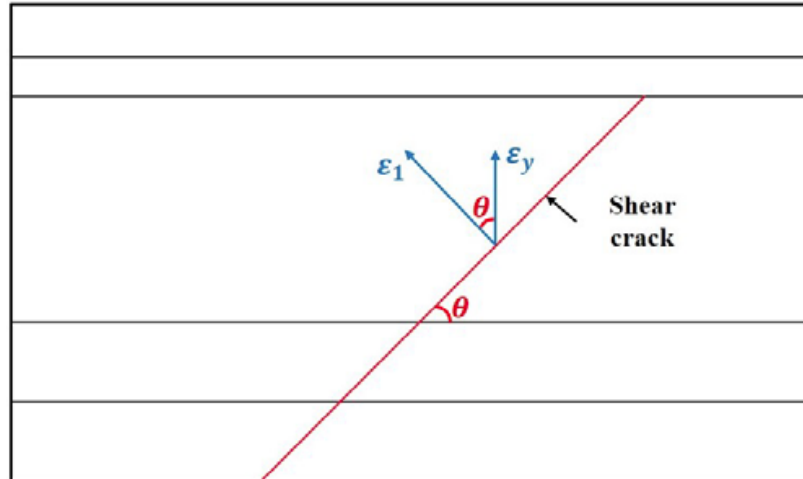
Figure 56: Principle strain direction, courtesy of Andrawes et al., 2018

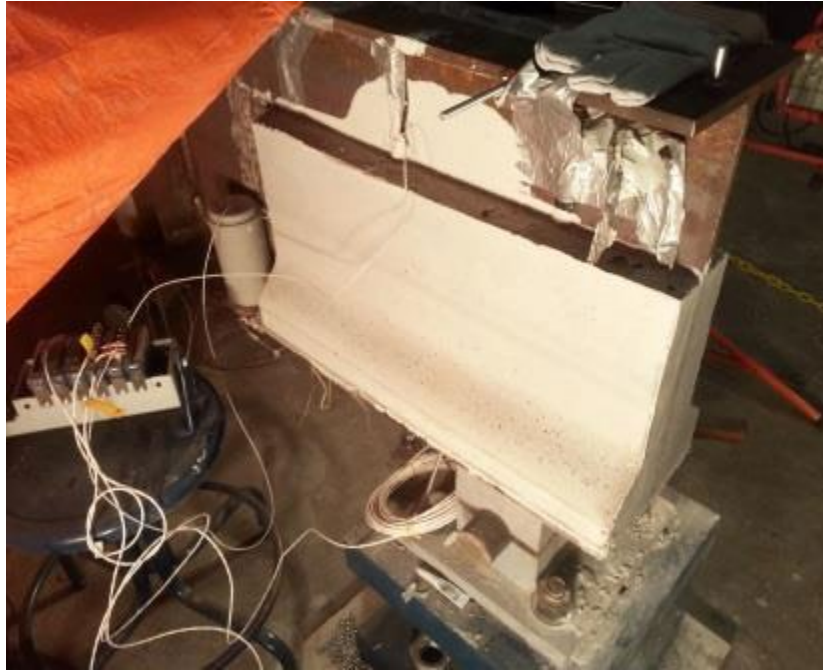
Figure 57: UHPC encasement at the repaired girder end zone, courtesy of Zmetra, 2015

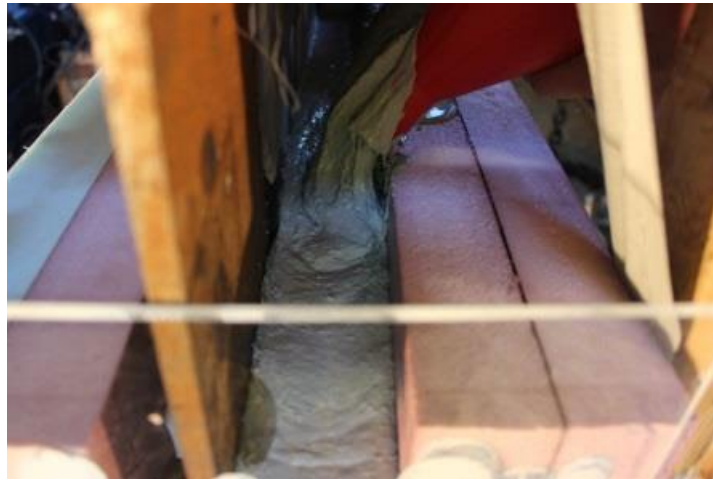
Figure 58: Casting UHPC at a steel girder end from the top of formwork, courtesy of Zmetra, 2015

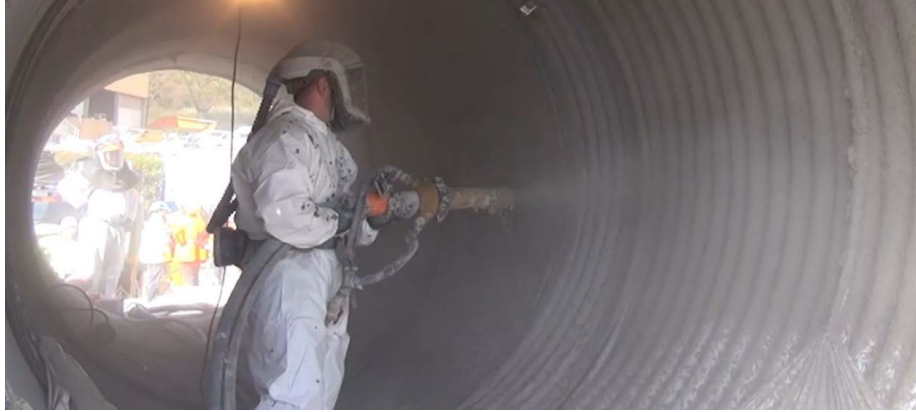
Figure 61: UHPC shotcrete to renovate a deteriorated metal culvert suffering from corrosion damage, obtained from Ductal website

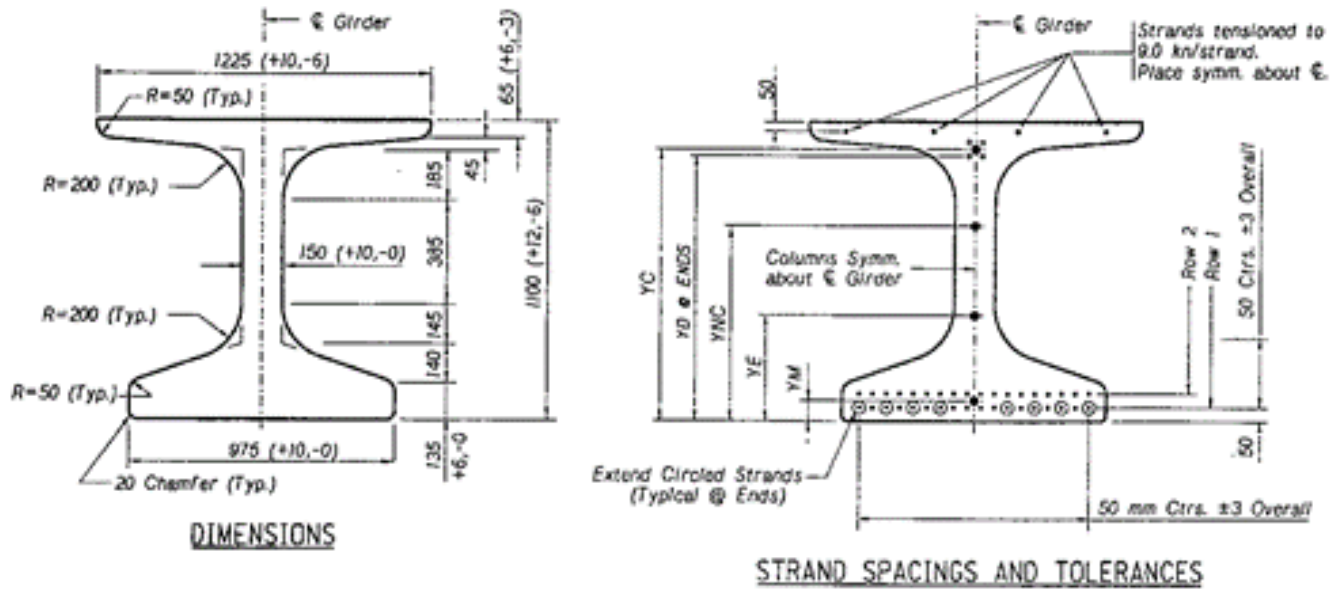
Figure 63: Girder dimensions and strand distribution, from the construction documents of 168th St. over West Dodge Road Bridge, courtesy of NDOT

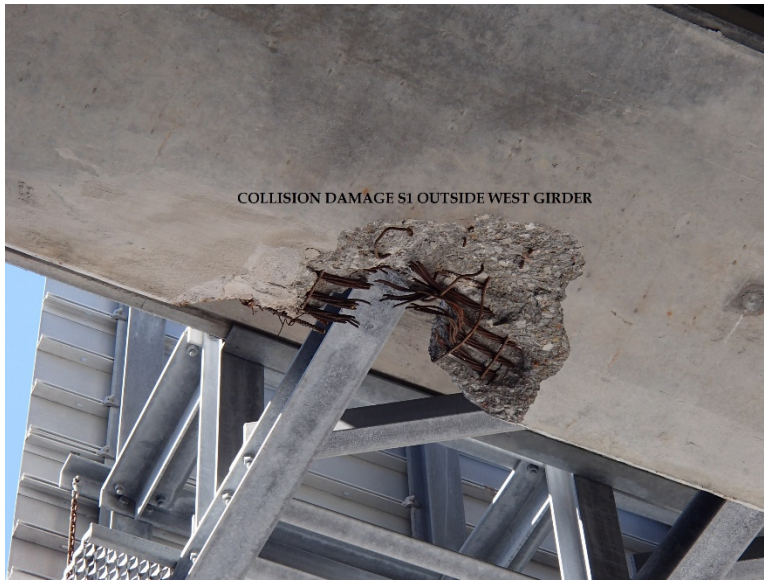
Figure 65: Level of damage, 168th St. over West Dodge Road Bridge, courtesy of NDOT

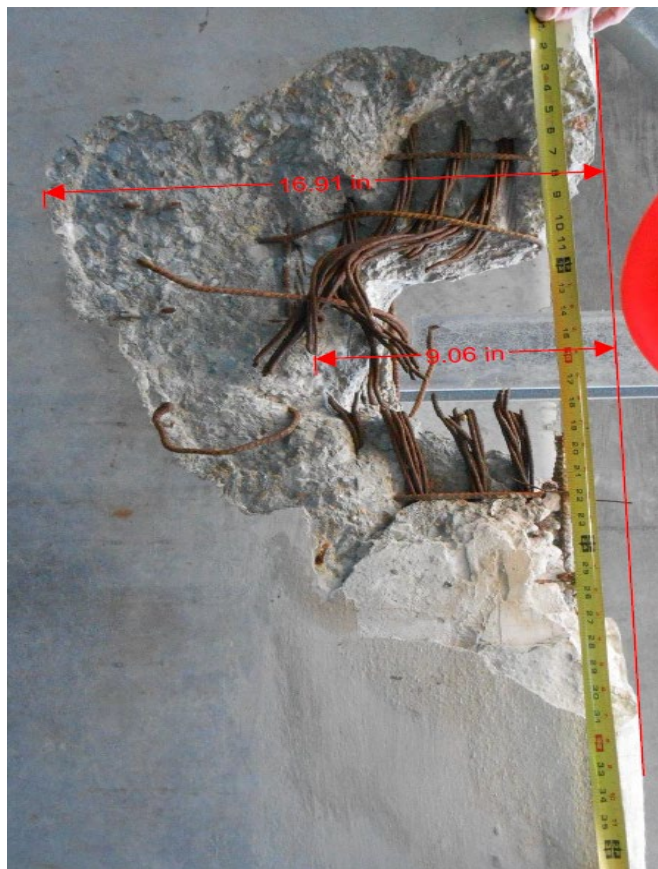
Figure 66: Level of damage, 168th St. over West Dodge Road Bridge, courtesy of NDOT

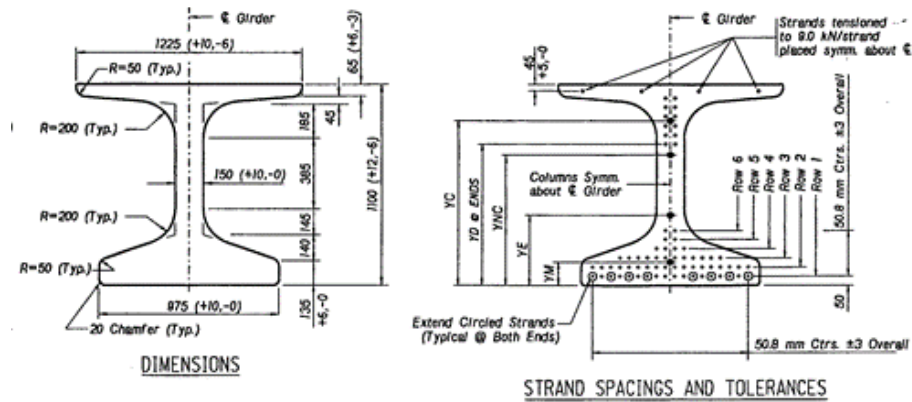
Figure 69: Girder dimensions and strand distribution, from the construction documents of Schuyler Bridge, courtesy of NDOT

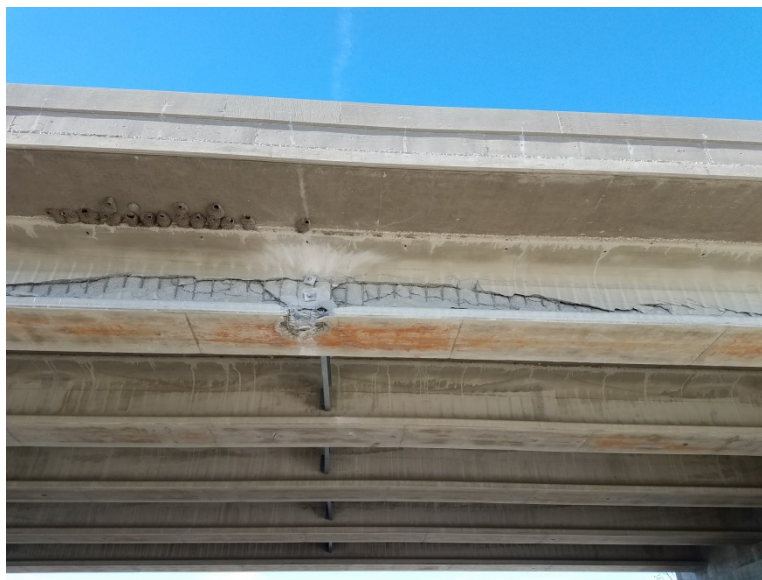
Figure 70: Level of damage, Schuyler Bridge, courtesy of NDOT

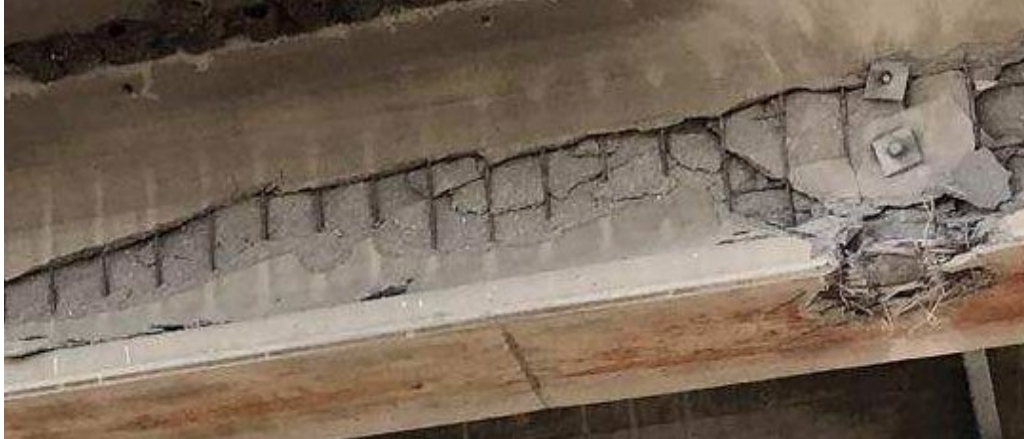
Figure 71: Level of damage, Schuyler Bridge, courtesy of NDOT

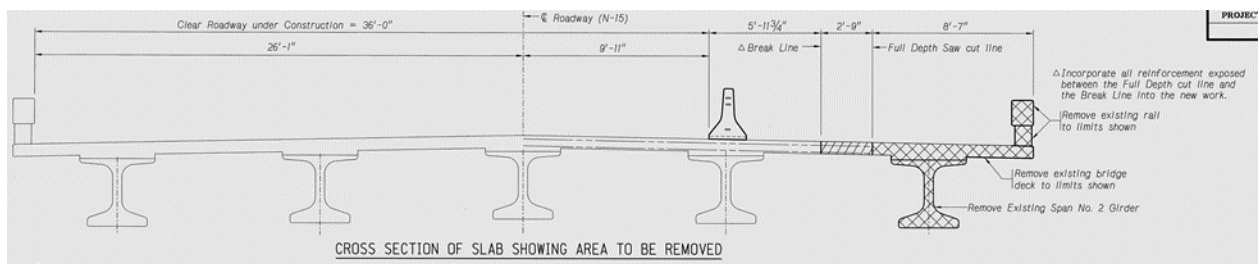
Figure 72: Girder replacement cross-section, from the replacement documents after the damage of Schuyler Bridge, courtesy of NDOT

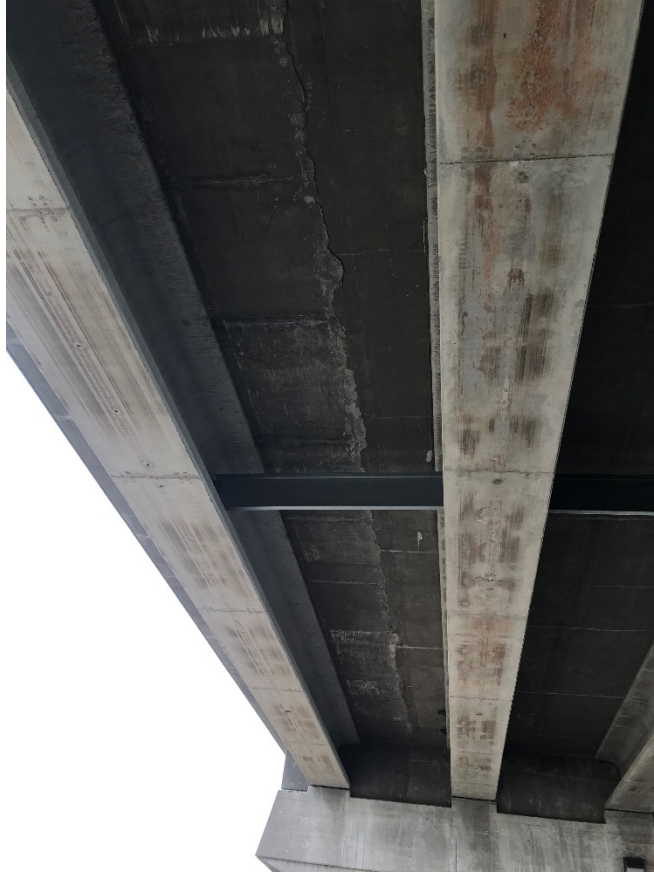
Figure 73: Replaced girder with no notable deficiencies, Schuyler Bridge, courtesy of NDOT

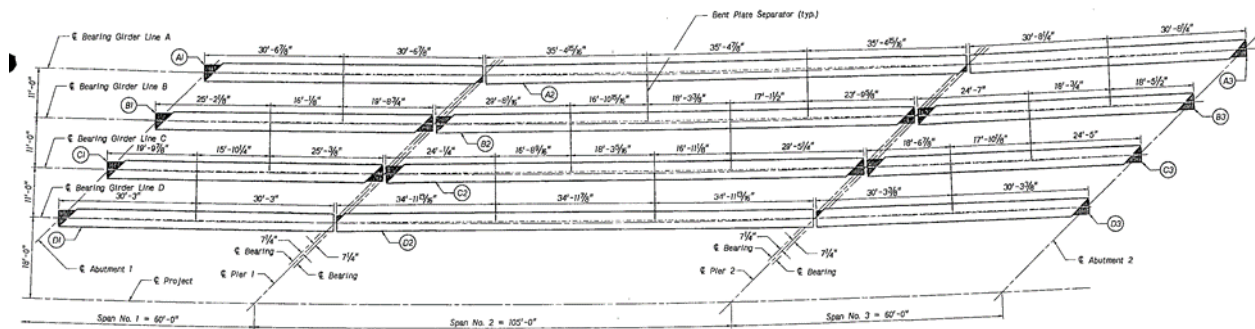
Figure 74: Plan view from the construction documents of Scottsbluff Gering Bypass bridge system, courtesy of NDOT

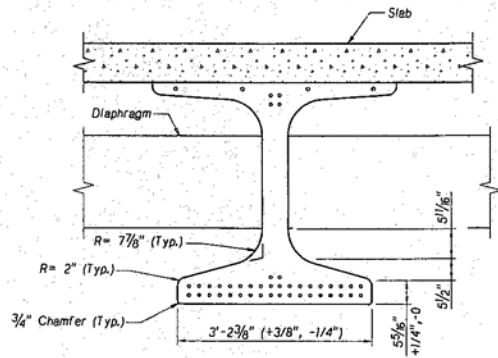
Figure 75: Girder reinforcement and strand distribution, from the construction documents of Scottsbluff Gering Bypass Bridge, courtesy of NDOT

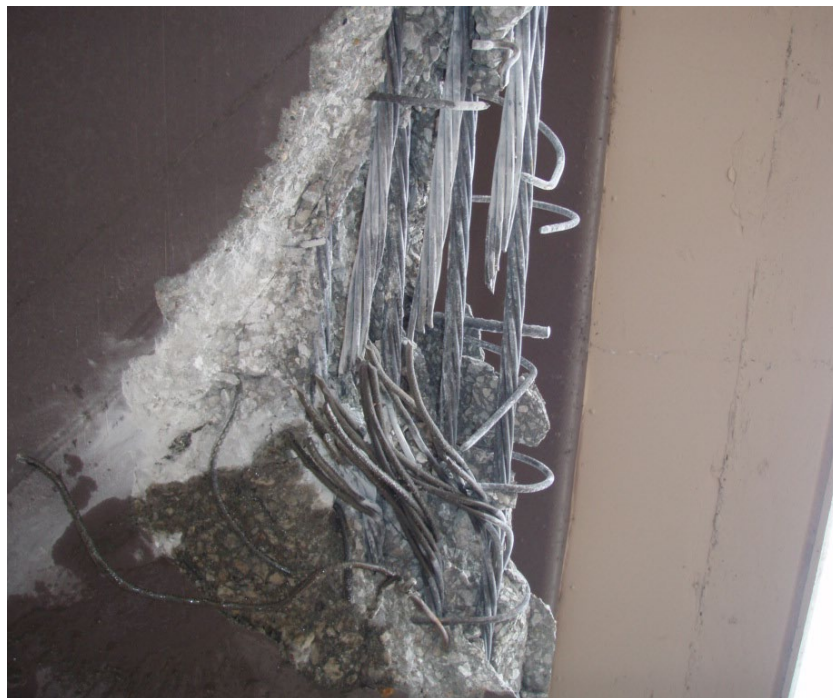
Figure 76: Level of damage, Scottsbluff Gering Bypass Bridge, courtesy of NDOT

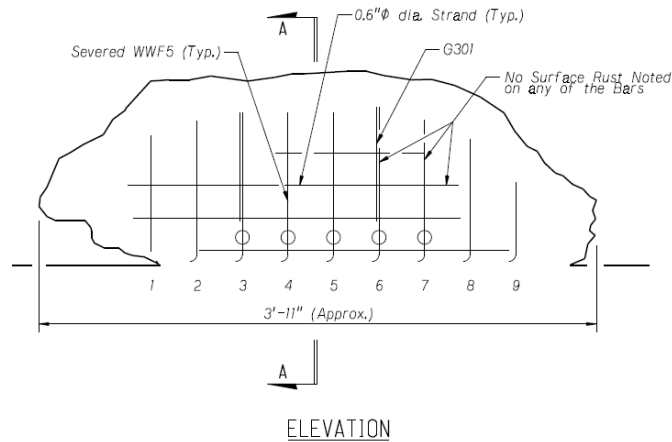
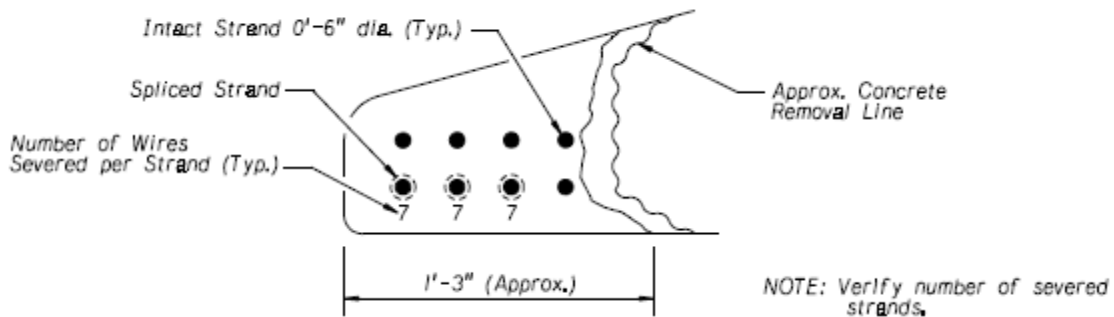
Figure 77: Severed strands and transverse reinforcement, from the repair documents of Scottsbluff Gering Bypass Bridge, courtesy of NDOT

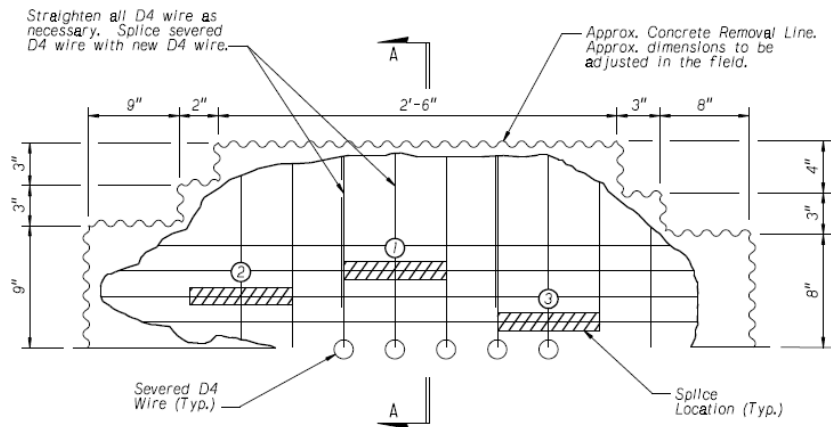
A2 PLAN VIEW (BOTTOM OF GIRDER)

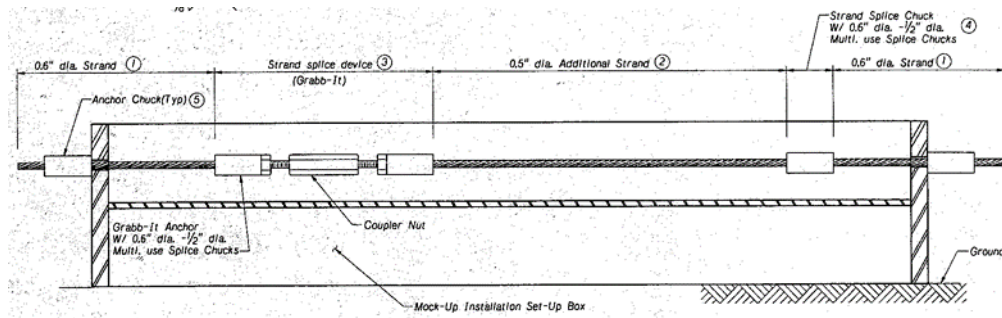
Figure 79: Mock-up installation before strand splicing, from the repair documents of Scottsbluff Gering Bypass Bridge, courtesy of NDOT

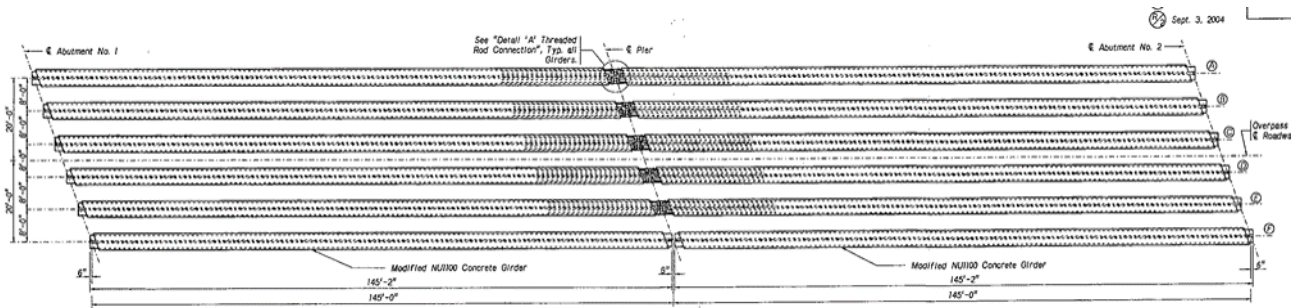
Figure 80: Plan view from the construction documents of Wood River Interchange bridge system, courtesy of NDOT

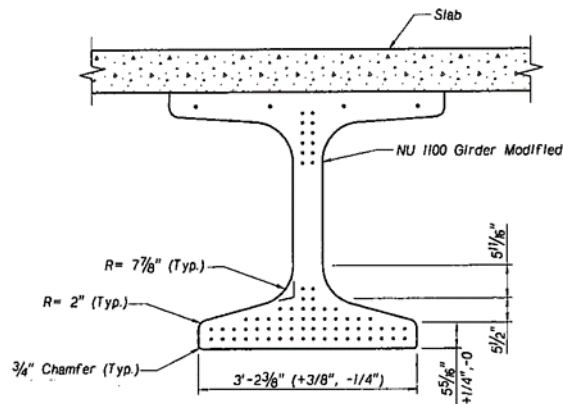
Figure 81: Girder reinforcement and strand distribution, from the construction documents of Wood River Interchange Bridge, courtesy of NDOT

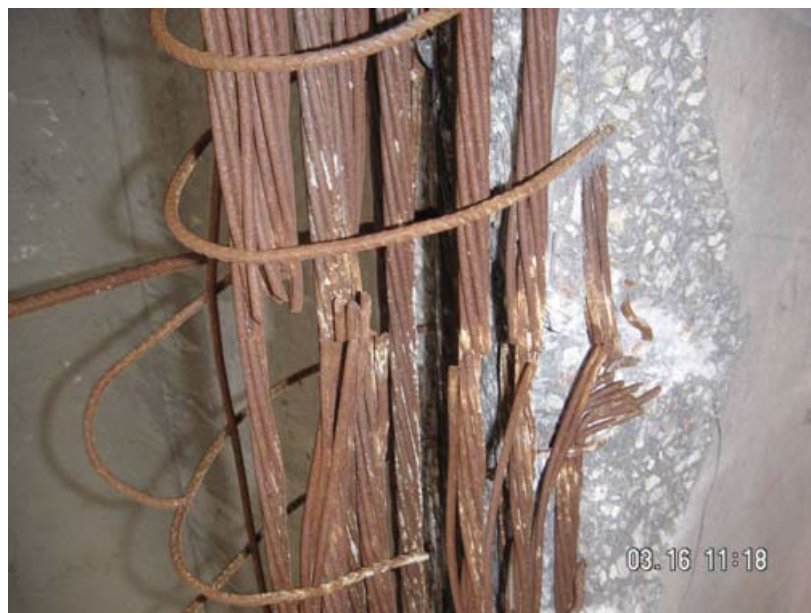
Figure 83: Girder (E) level of damage, Wood River Interchange Bridge, courtesy of NDOT

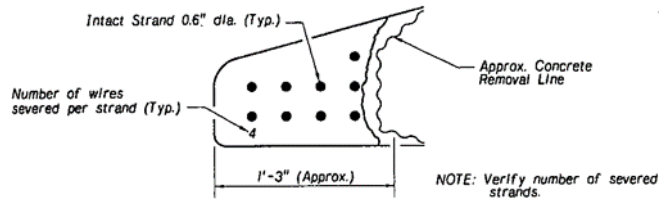
Figure 84: Severed strand in Girder A, from the repair documents of Wood River Interchange Bridge, courtesy of NDOT

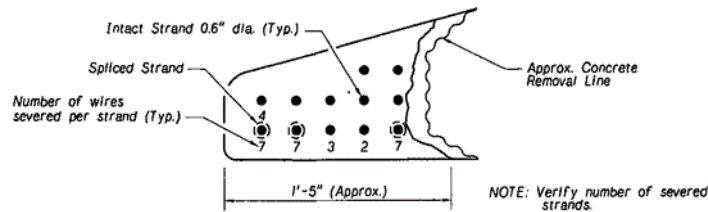
Figure 85: Severed strands in Girder E, from the repair documents of Wood River Interchange Bridge, courtesy of NDOT

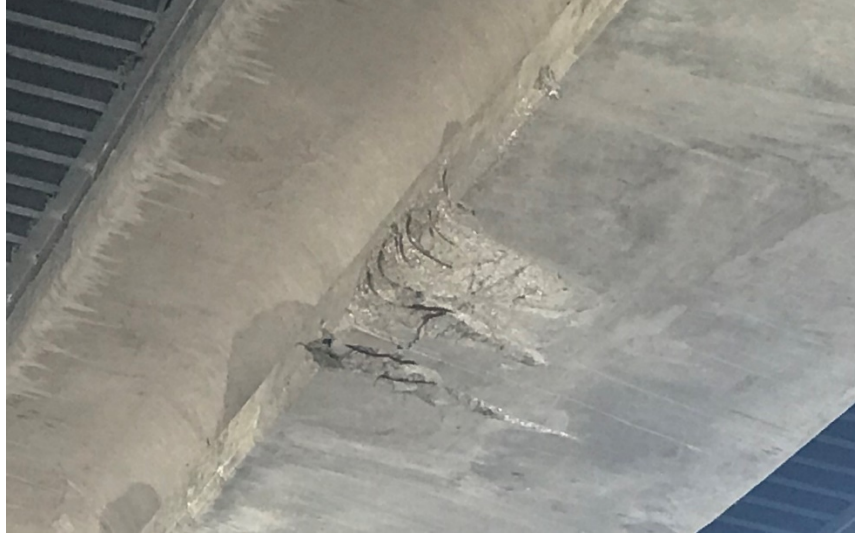
Figure 86: Damage at the patched area on Girder E, Wood River Interchange Bridge, courtesy of NDOT

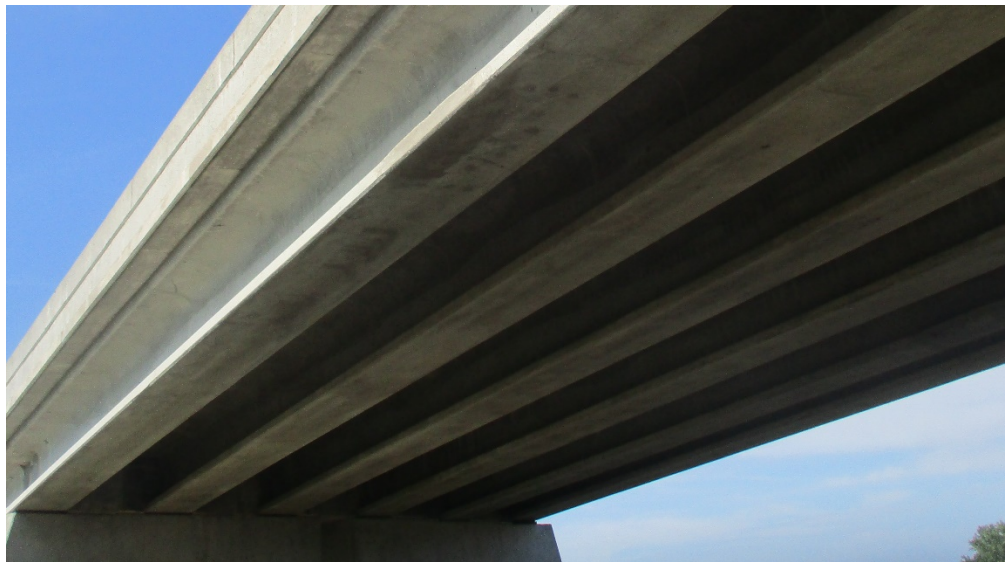
Figure 87: Patched area on Girder A, Wood River Interchange Bridge, courtesy of NDOT

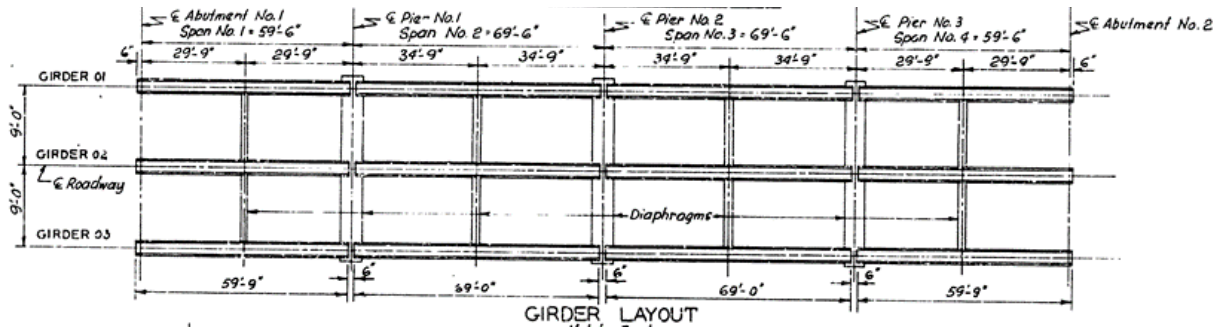
Figure 88: Plan view from the construction documents of York East bridge system, courtesy of NDOT

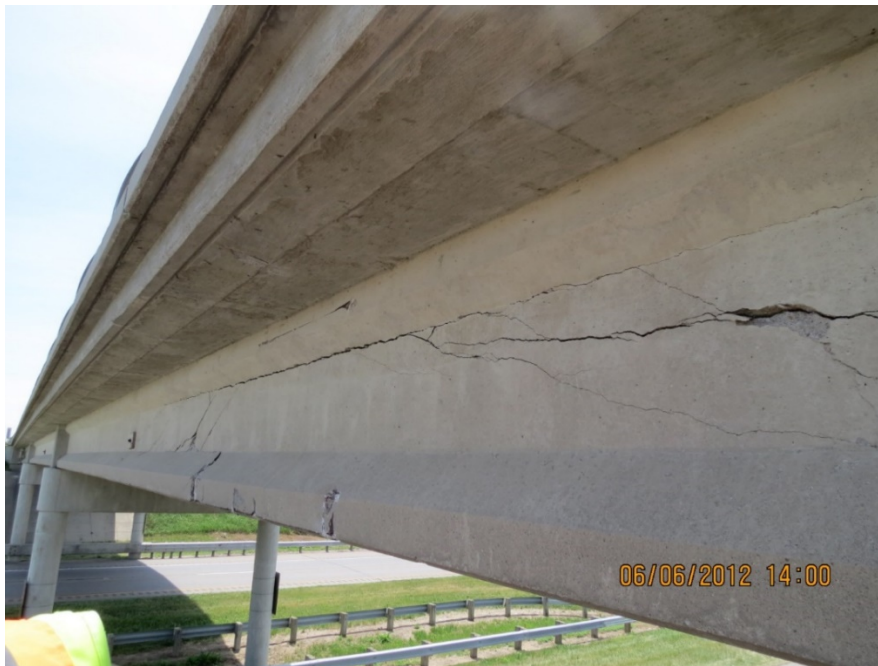
Figure 89: Level of damage, York East Bridge, courtesy of NDOT

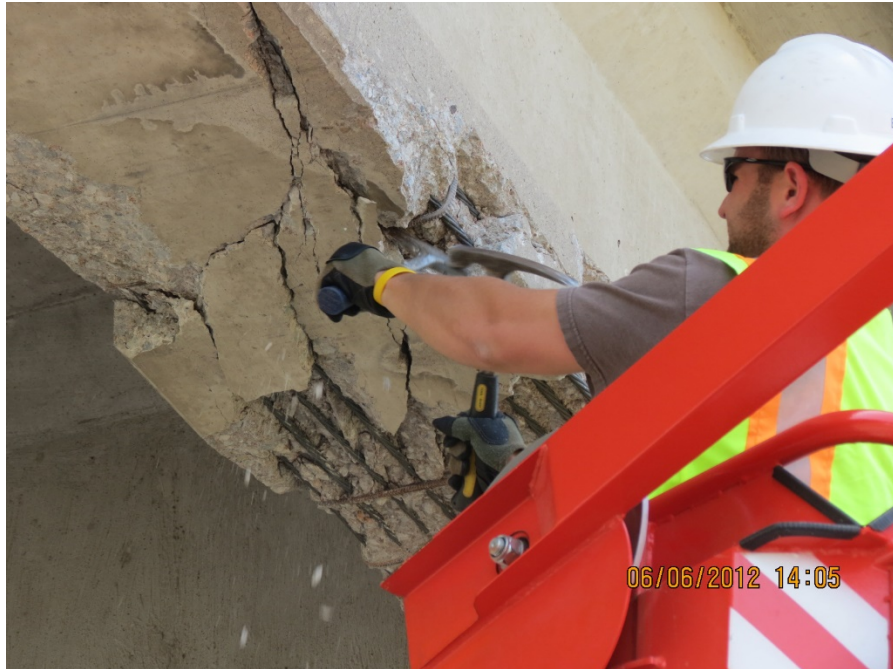
Figure 90: Removing all loose concrete immediately from the girder, York East Bridge, courtesy of NDOT

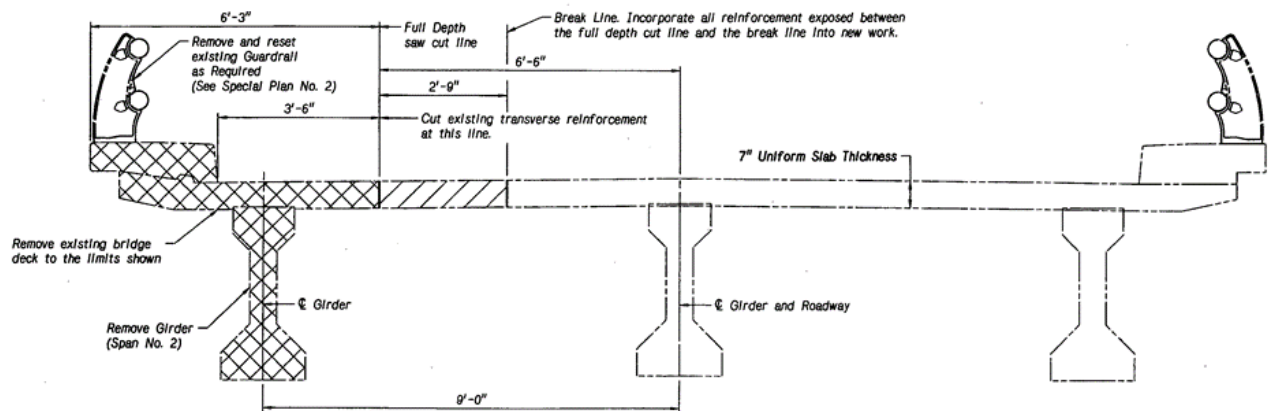
Figure 91: Girder replacement procedure, cross-section to be removed, from the replacement documents of York East Bridge, courtesy of NDOT

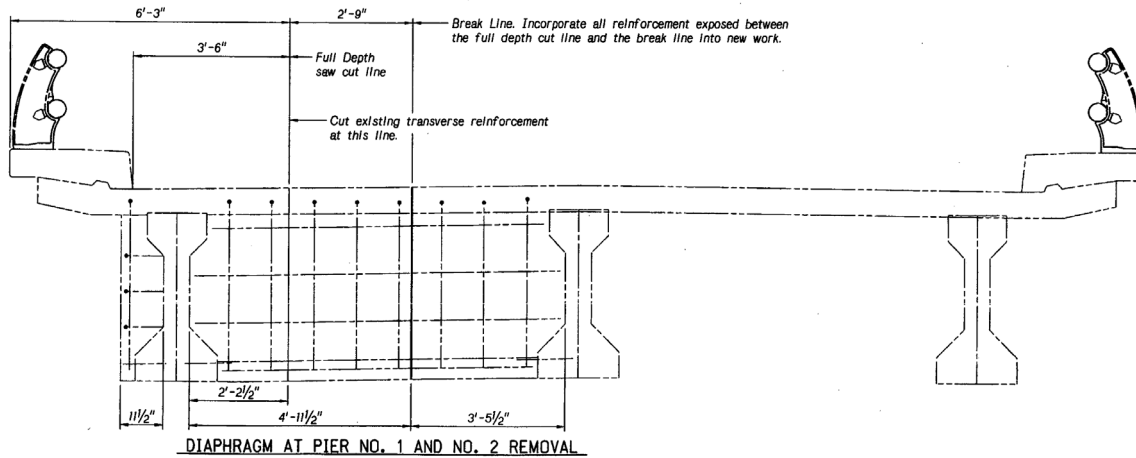
Figure 92: Girder replacement procedure, diaphragm section to be removed, from the replacement documents of York East Bridge, courtesy of NDOT

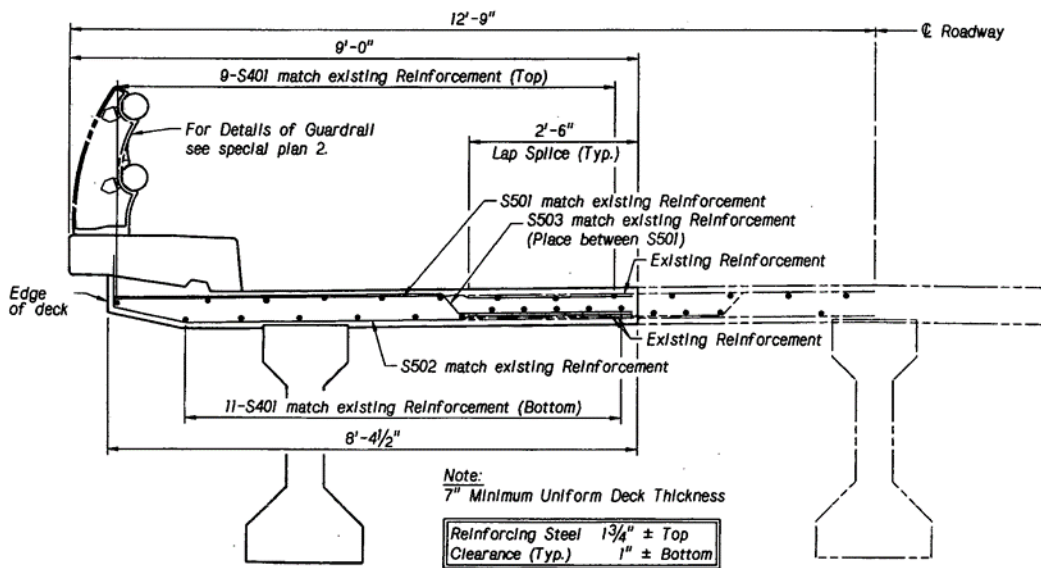
CROSS SECTION NEAR MIDSPAN

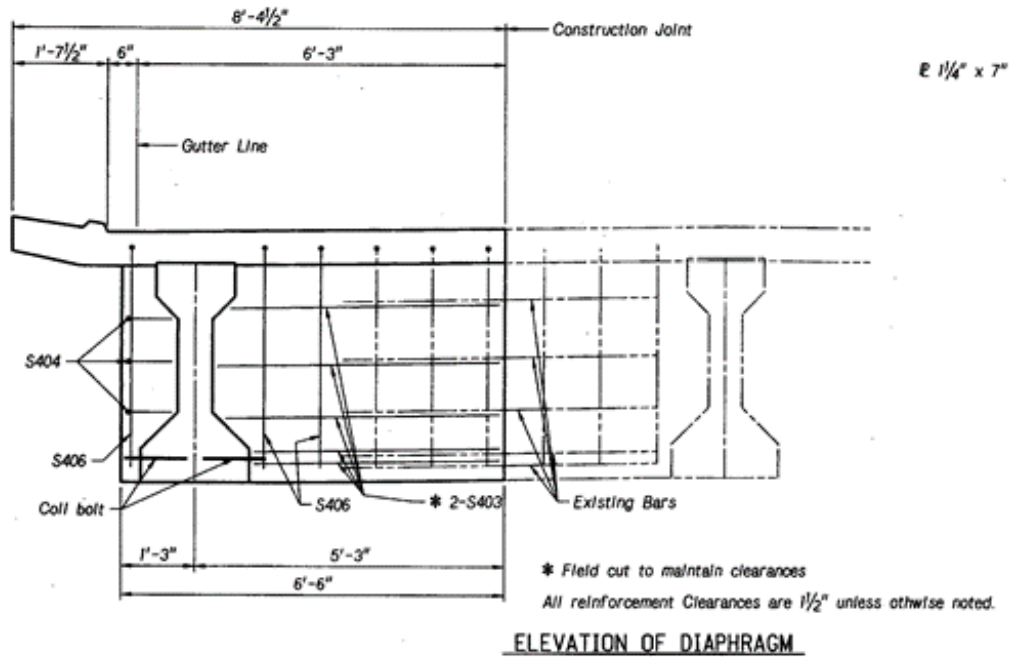
Figure 94: Girder replacement procedure, splicing diaphragm reinforcement, from the replacement documents of York East Bridge, courtesy of NDOT

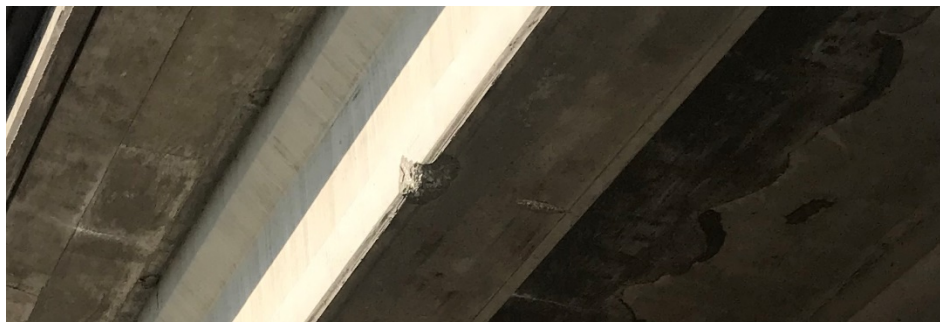
Figure 95: Impact damage at the replaced girder, York East Bridge, courtesy of NDOT

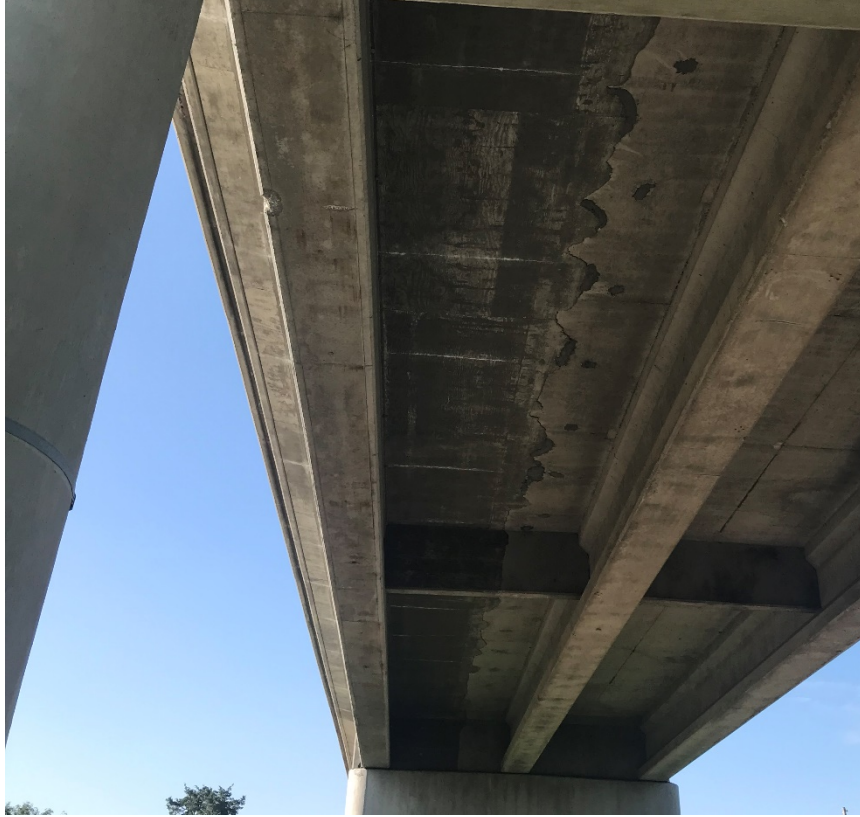
Figure 96: Replaced girder, York East Bridge, courtesy of NDOT

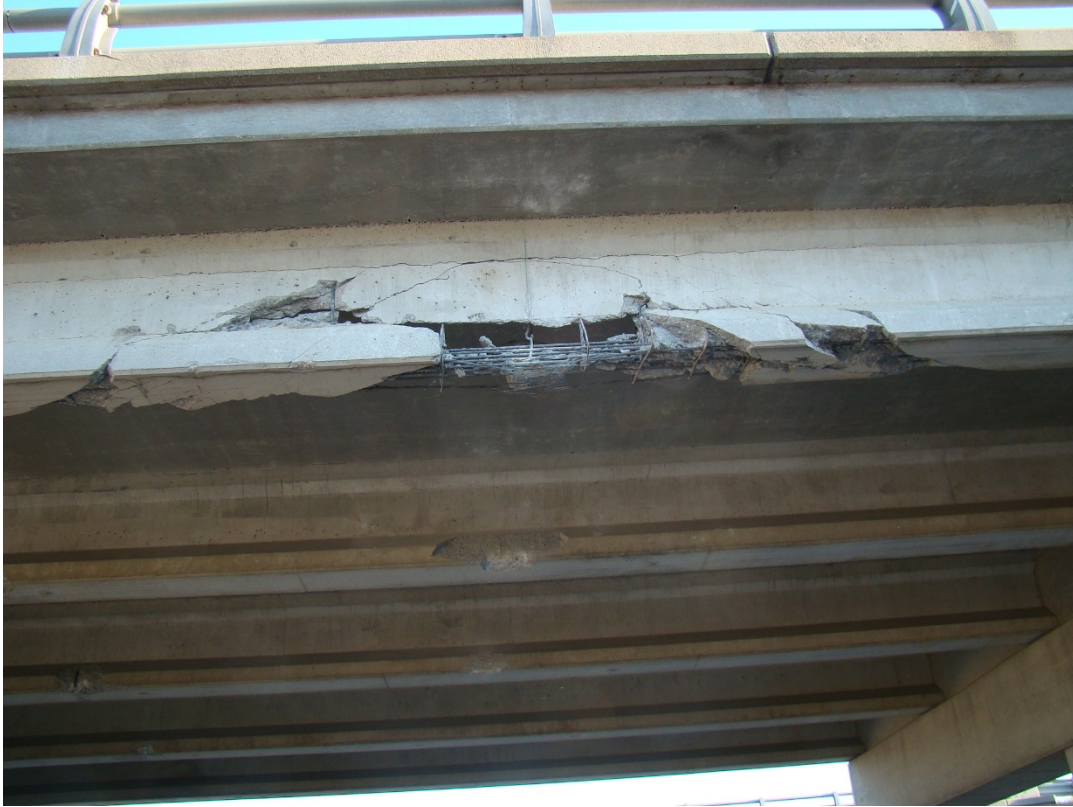
Figure 97: Level of damage, I-680 over US-75 Bridge, courtesy of NDOT

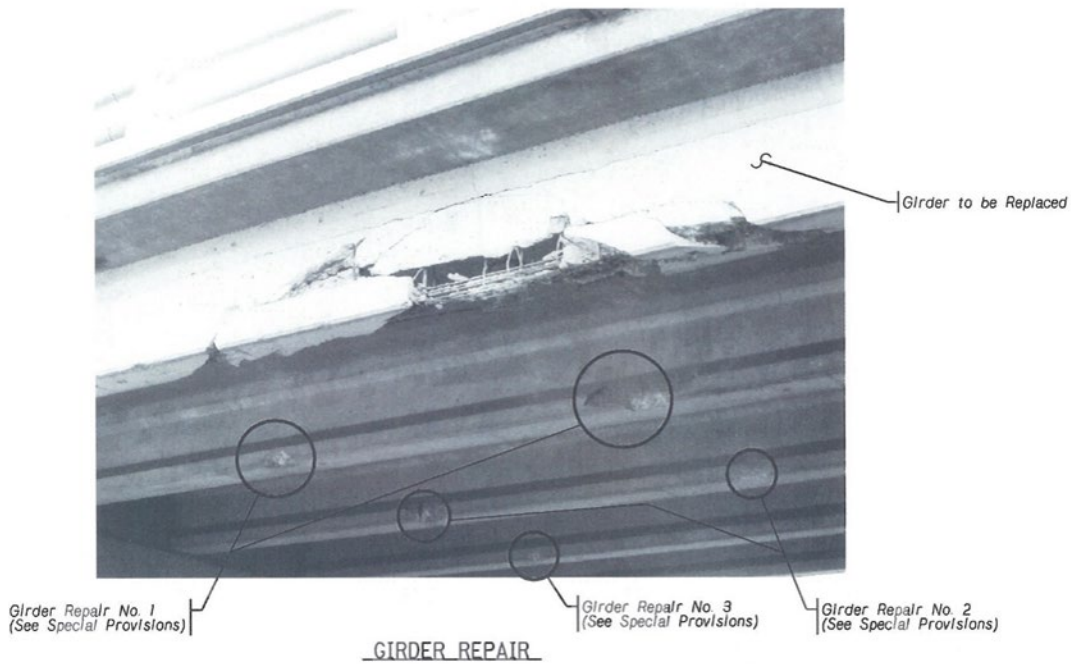
Figure 98: Girders to be repaired or replaced, from the repair documents of I-680 over US-75 Bridge, courtesy of NDOT

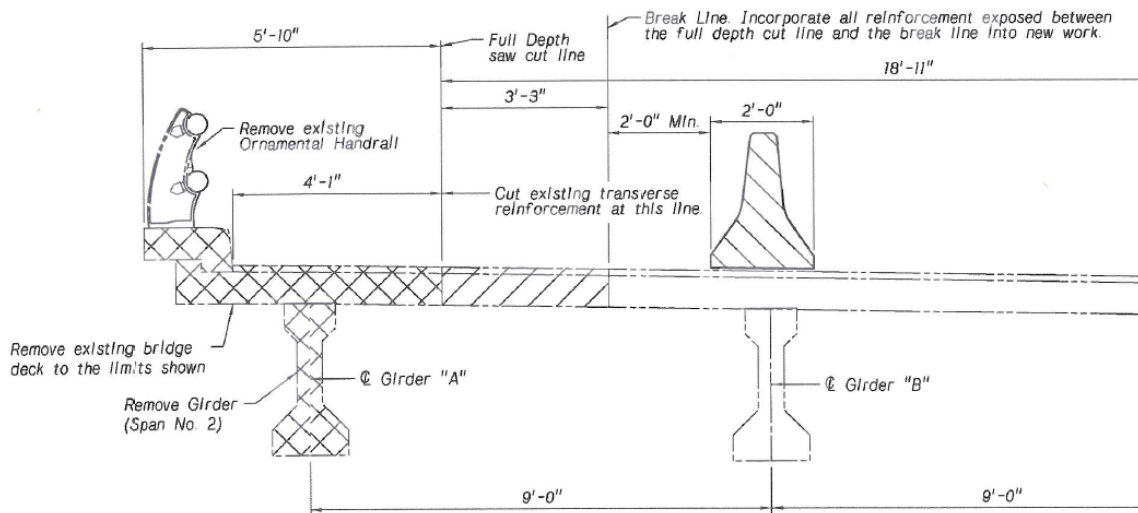
Figure 99: Girder replacement procedure, cross-section to be removed, from the repair documents of I-680 over US-75 Bridge, courtesy of NDOT

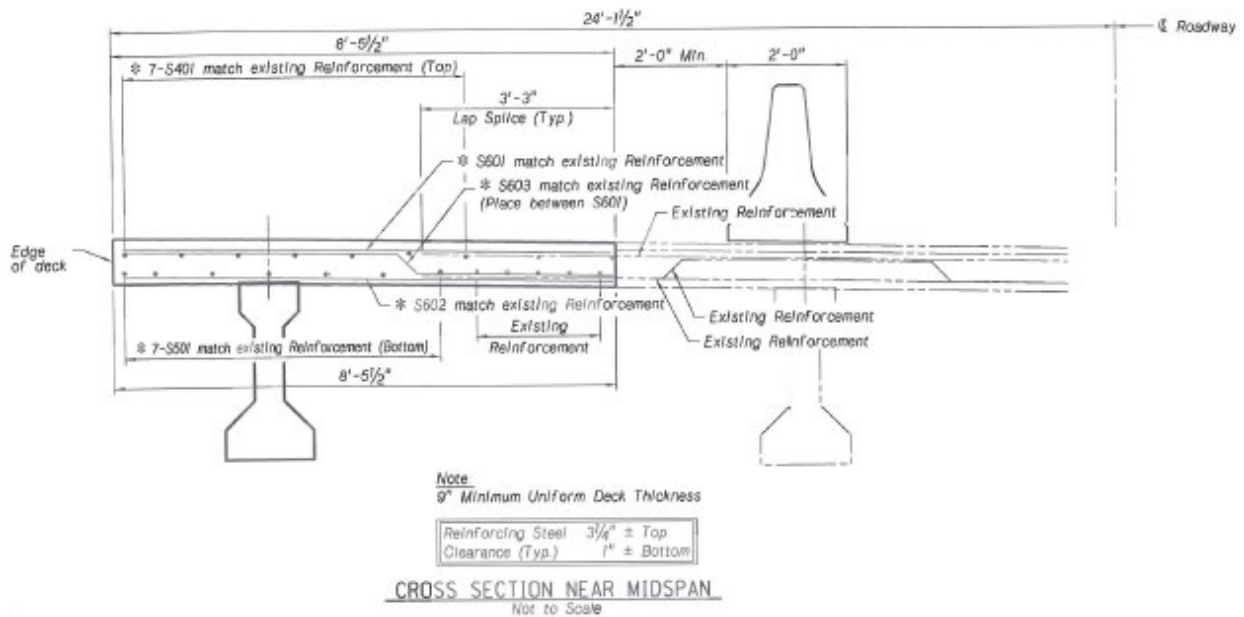
Figure 100: Girder replacement procedure, splicing deck reinforcement, from the repair documents of I-680 over US-75 Bridge, courtesy of NDOT

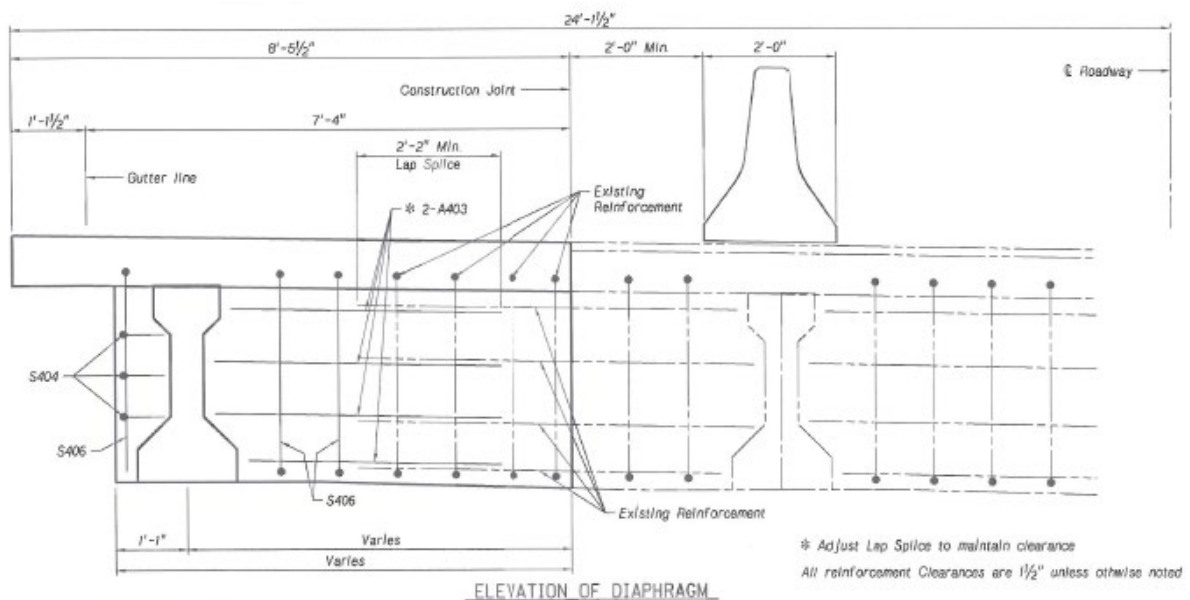
Figure 101: Girder replacement procedure, splicing diaphragm reinforcement, from the repair documents of I-680 over US-75 Bridge, courtesy of NDOT

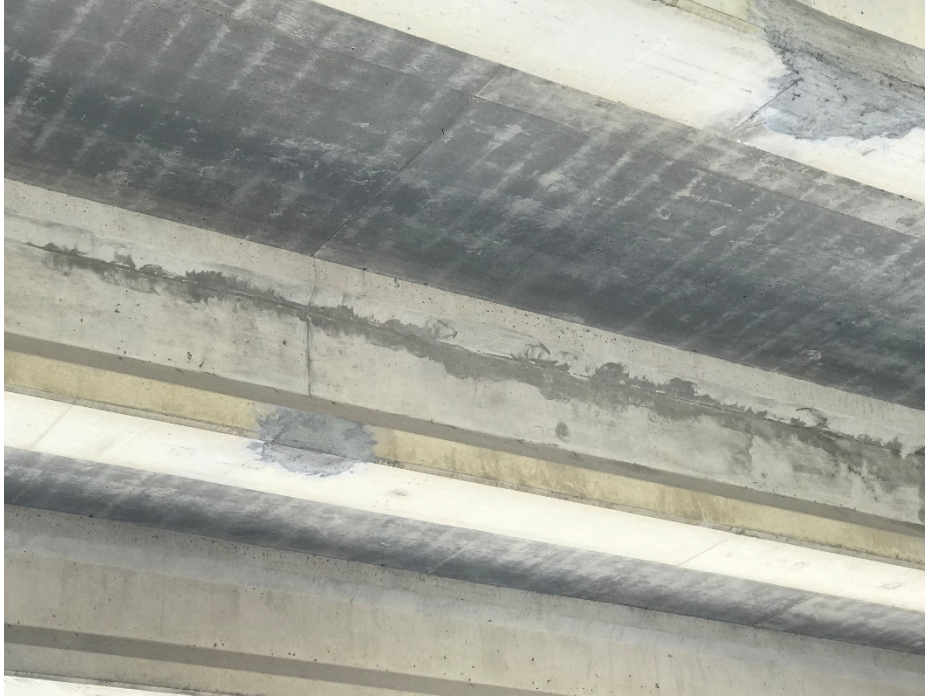
Figure 102: Girders with patching and epoxy injection works, I-680 over US-75 Bridge, courtesy of NDOT
