Synthesis of Repair Practices of Damaged Precast/Prestressed Concrete Girders

SPR-P1 (19) M090

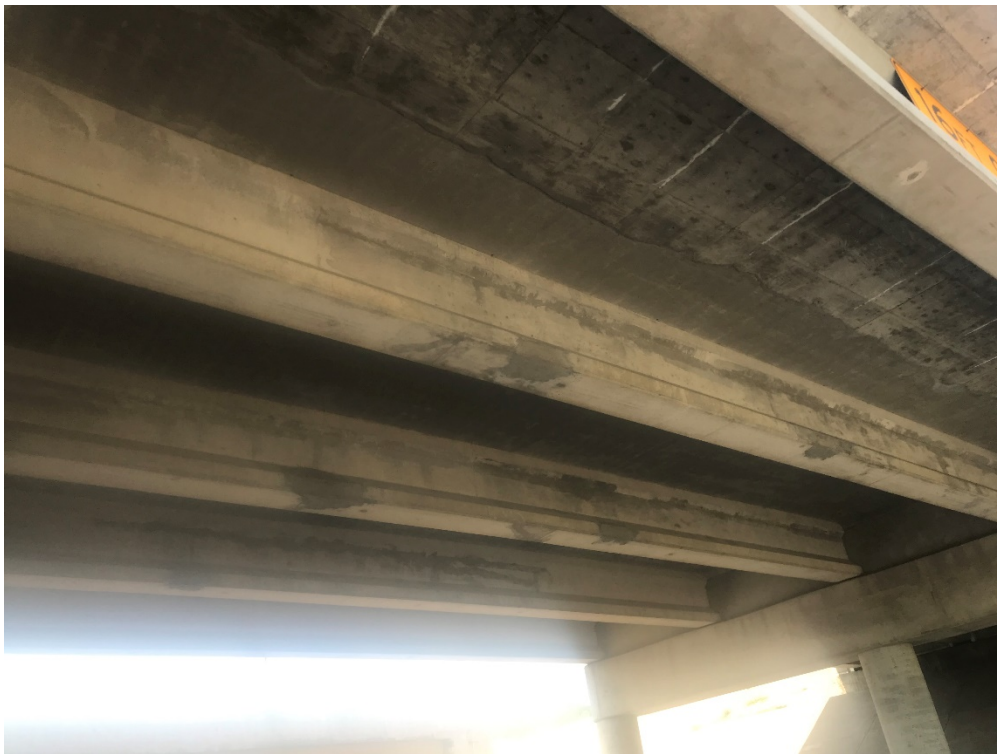
Figure 103: Replaced girder and girders with patching and epoxy injection works, I-680 over US-75 Bridge, courtesy of NDOT

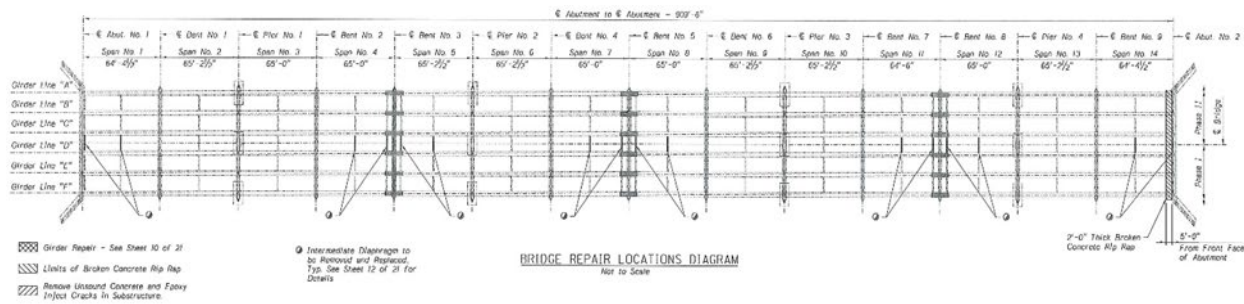
Figure 104: Girder spans and location of repair works, from the repair documents of Platte River Bridge East of Grand Island, courtesy of NDOT

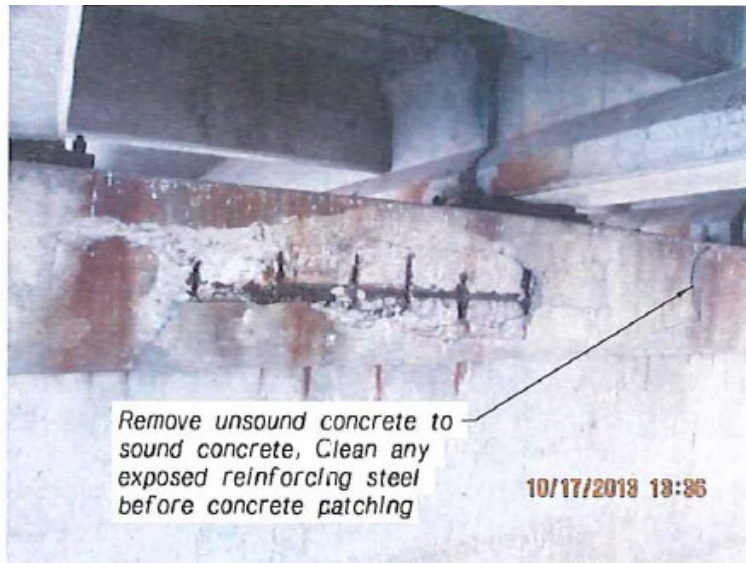
Figure 105: Corrosion damage at girder end and abutment, Platte River Bridge East of Grand Island, courtesy of NDOT

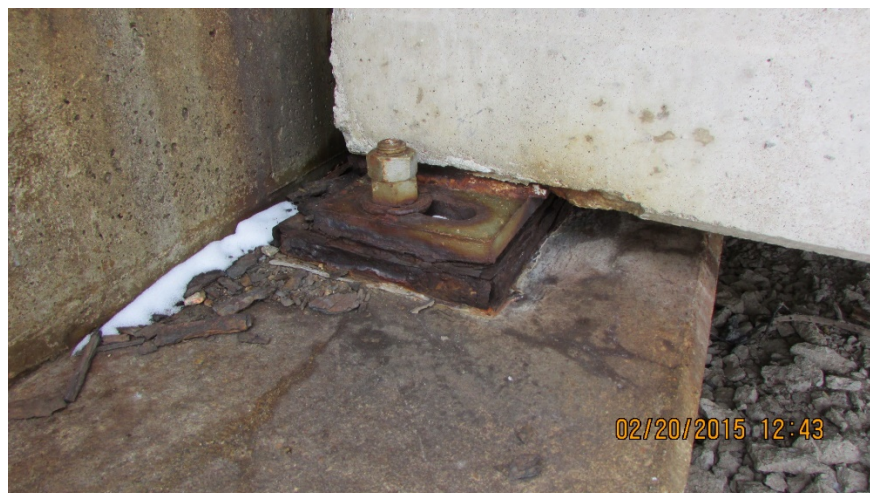
Figure 106: Corrosion damage at bearing assembly, Platte River Bridge East of Grand Island, courtesy of NDOT

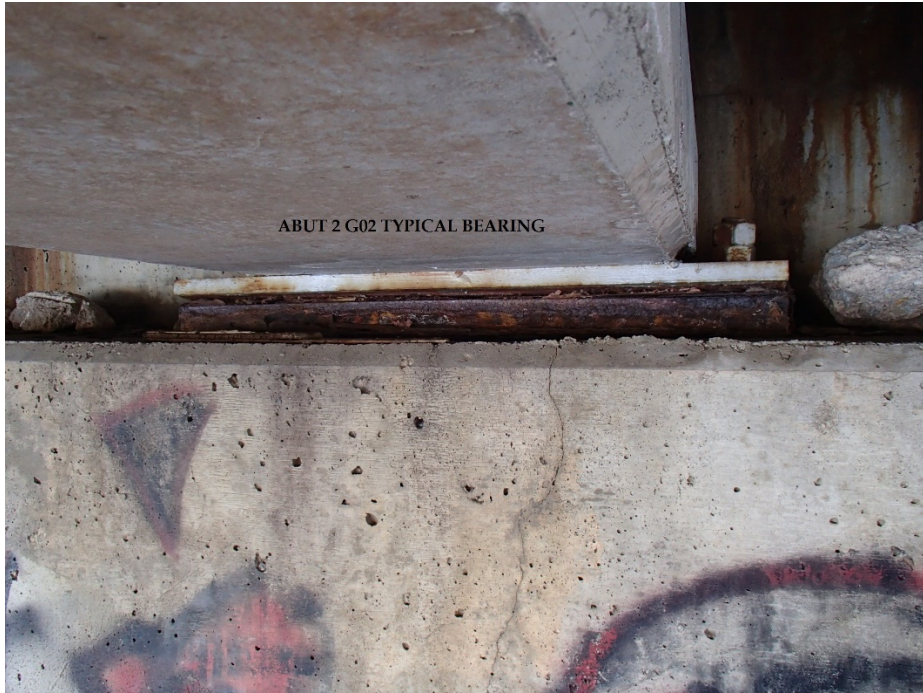
Figure 107: Corrosion damage at bearing assemble, Platte River Bridge East of Grand Island, courtesy of NDOT

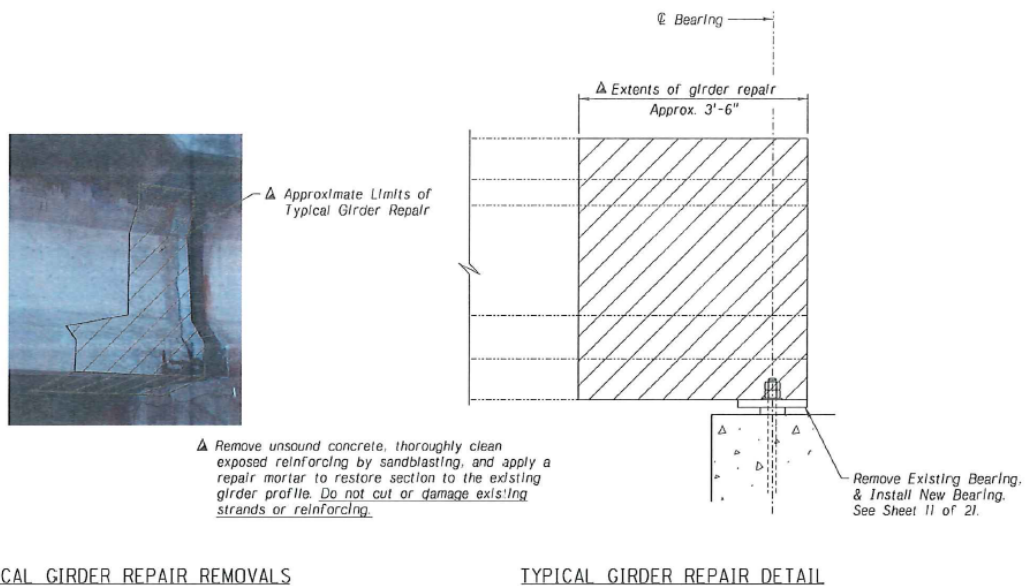
Figure 108: Removing loose materials and cleaning exposed reinforcement at girder end, from the repair documents of Platte River Bridge East of Grand Island, courtesy of NDOT

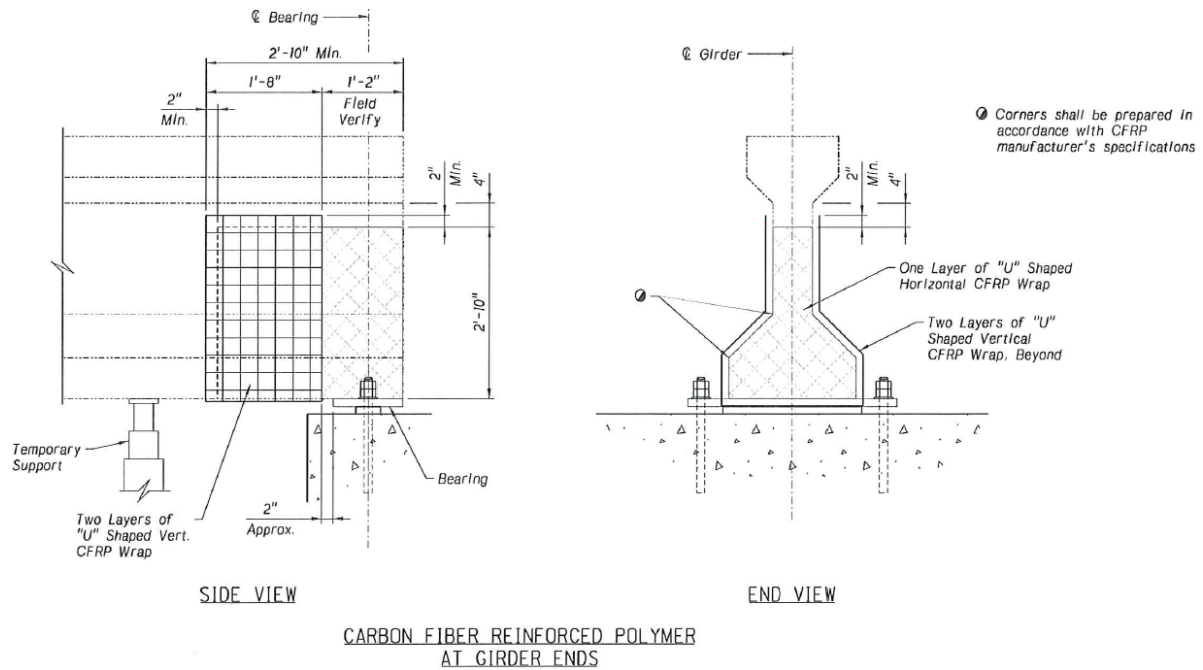
Figure 109: CFRP confinement for the patch at girder end, from the repair documents of Platte River Bridge East of Grand Island, courtesy of NDOT

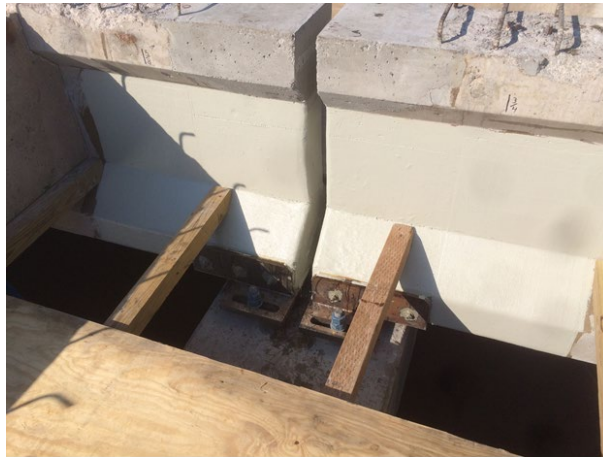
Figure 110: Girder end after CFRP confinement and bearing assemble replacement, Platte River Bridge East of Grand Island, courtesy of NDOT

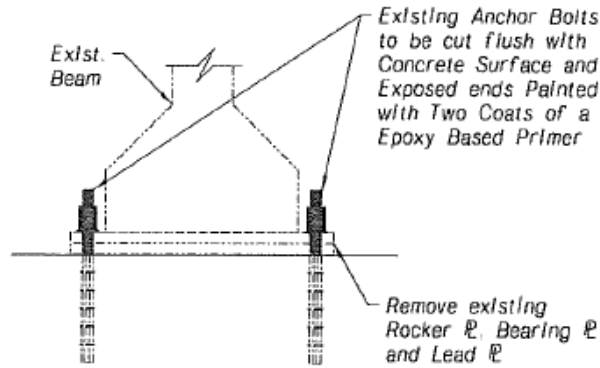
EXISTING BEARING ASSEMBLY REMOVAL DETAIL

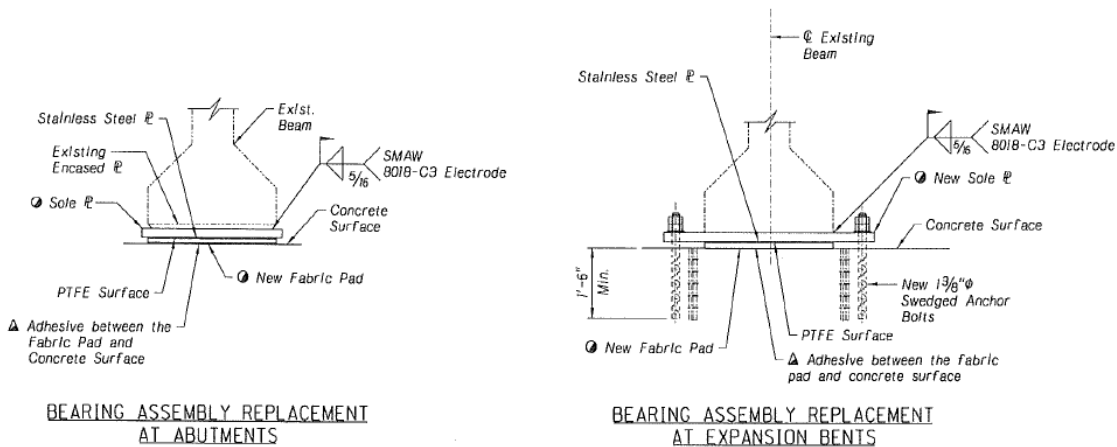
BEARING ASSEMBLY REPLACEMENT AT ABUTMENTS

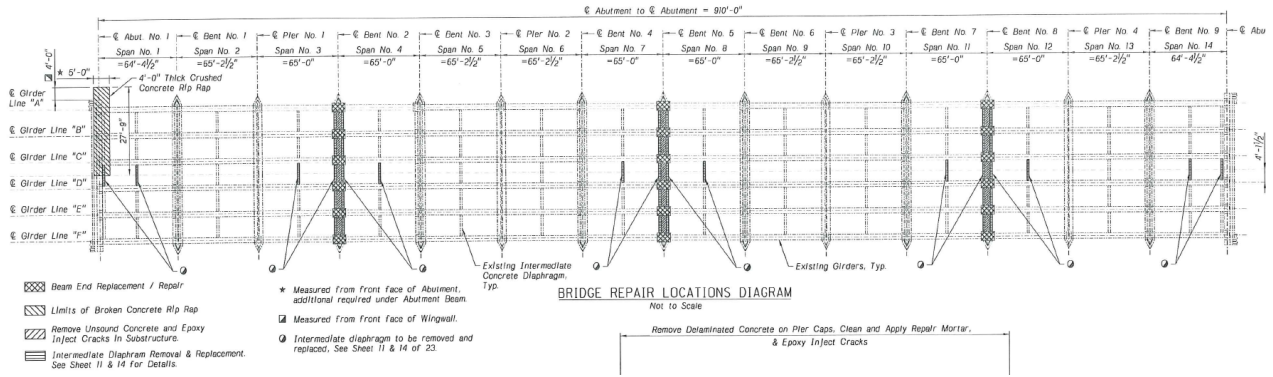
Figure 113: Girder spans and location of repair works, from the repair documents of Kearney South Platte River Bridge, courtesy of NDOT

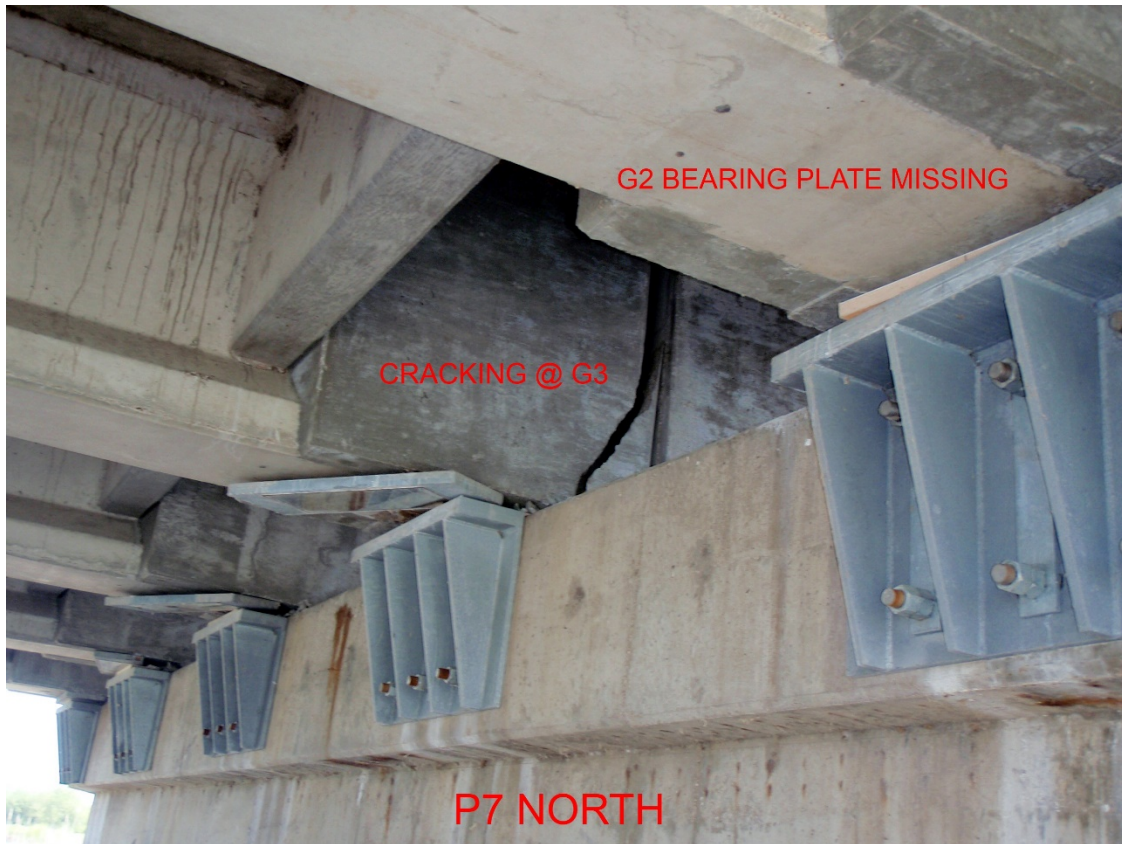
Figure 114: Damage at girder end, Kearney South Platte River Bridge, courtesy of NDOT

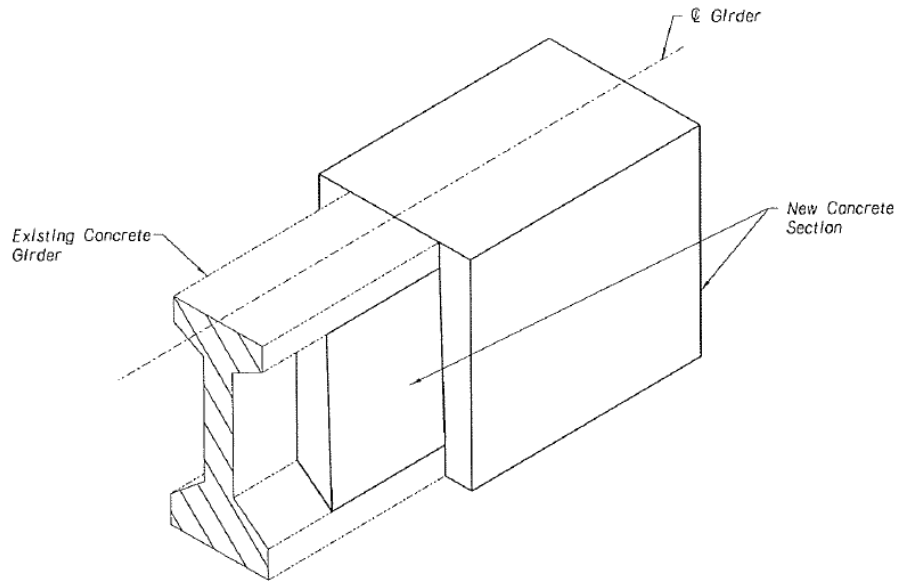
Figure 115: Isometric detail of girder end encasement on the 2015 repair works, from the repair documents of Kearney South Platte River Bridge, courtesy of NDOT

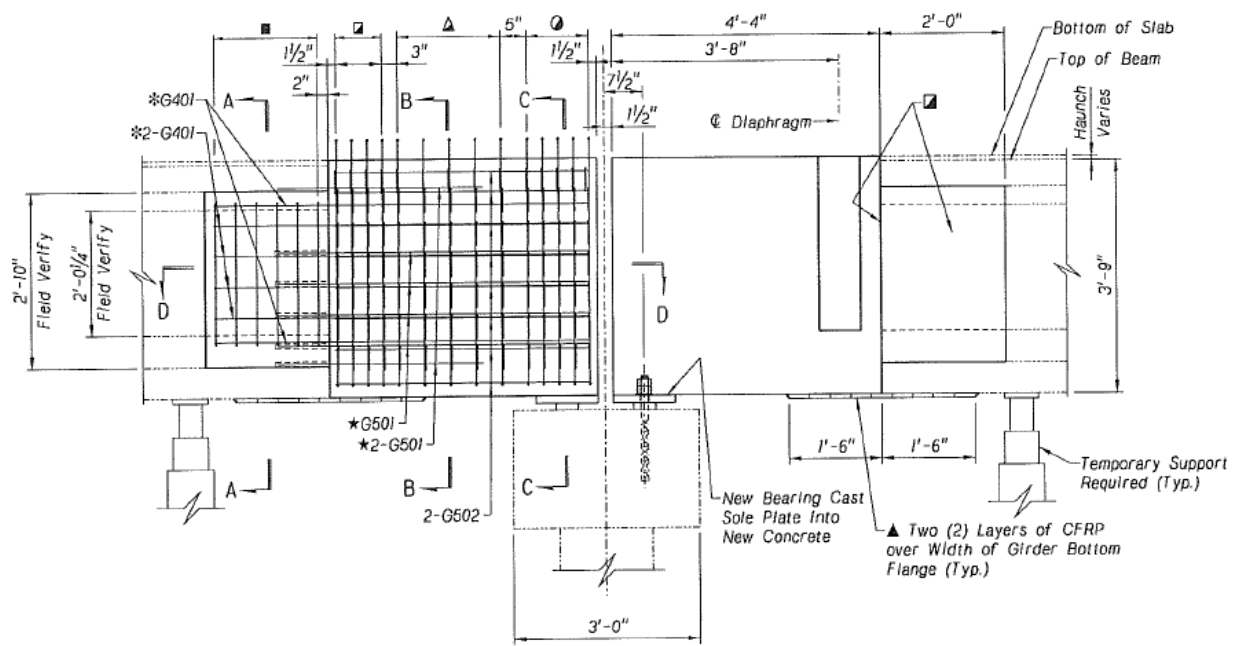
Figure 116: Detail of girder end encasement and CFRP layers on the 2015 repair works, from the repair documents of Kearney South Platte River Bridge, courtesy of NDOT

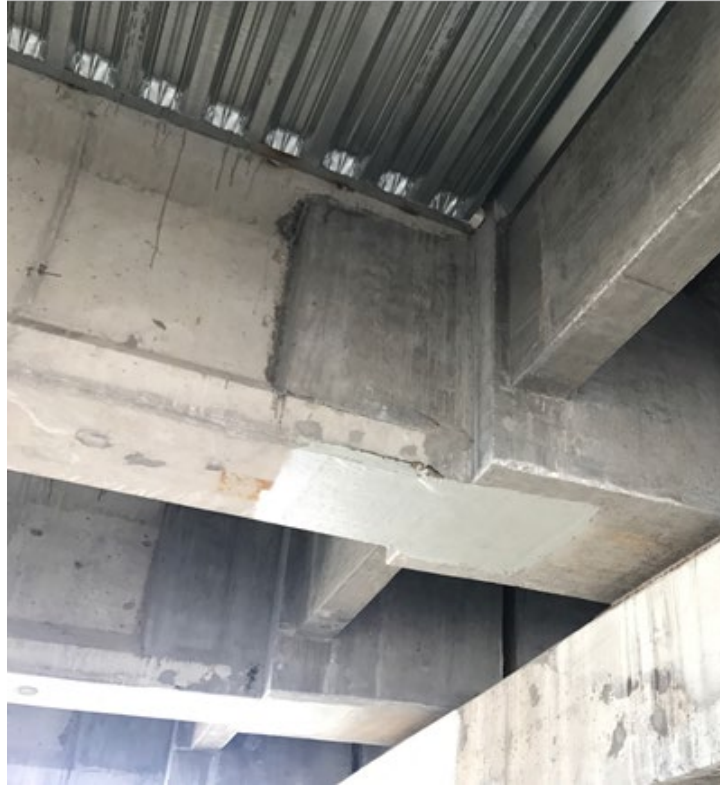
Figure 117: Girder end encasement and CFRP layers, Kearney South Platte River Bridge, courtesy of NDOT

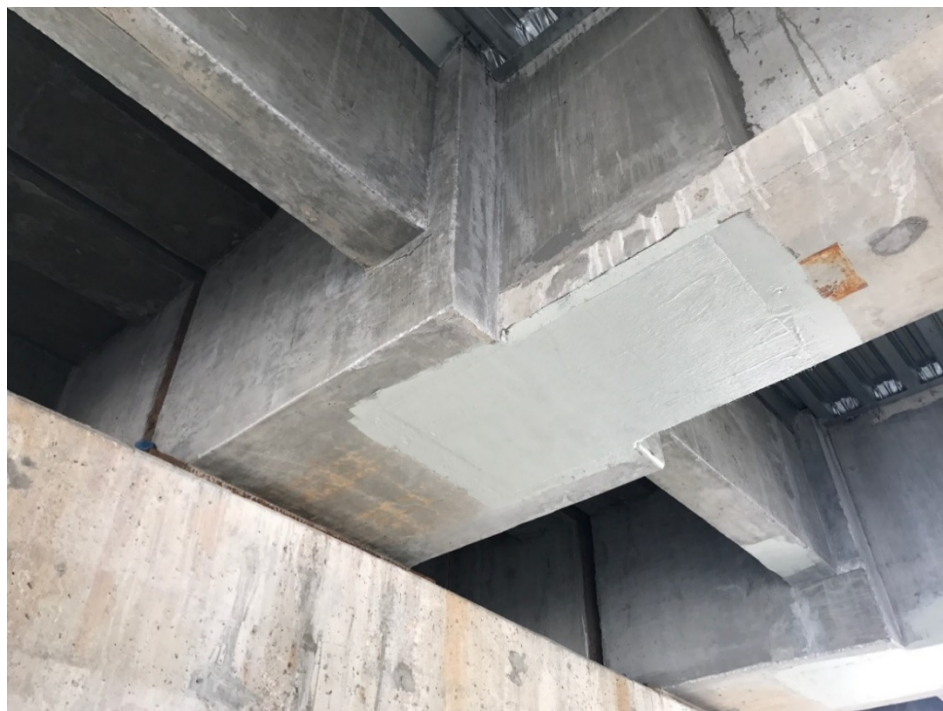
Figure 118: Girder end encasement and CFRP layers, visible crack at the diaphragm, Kearney South Platte River Bridge, courtesy of NDOT

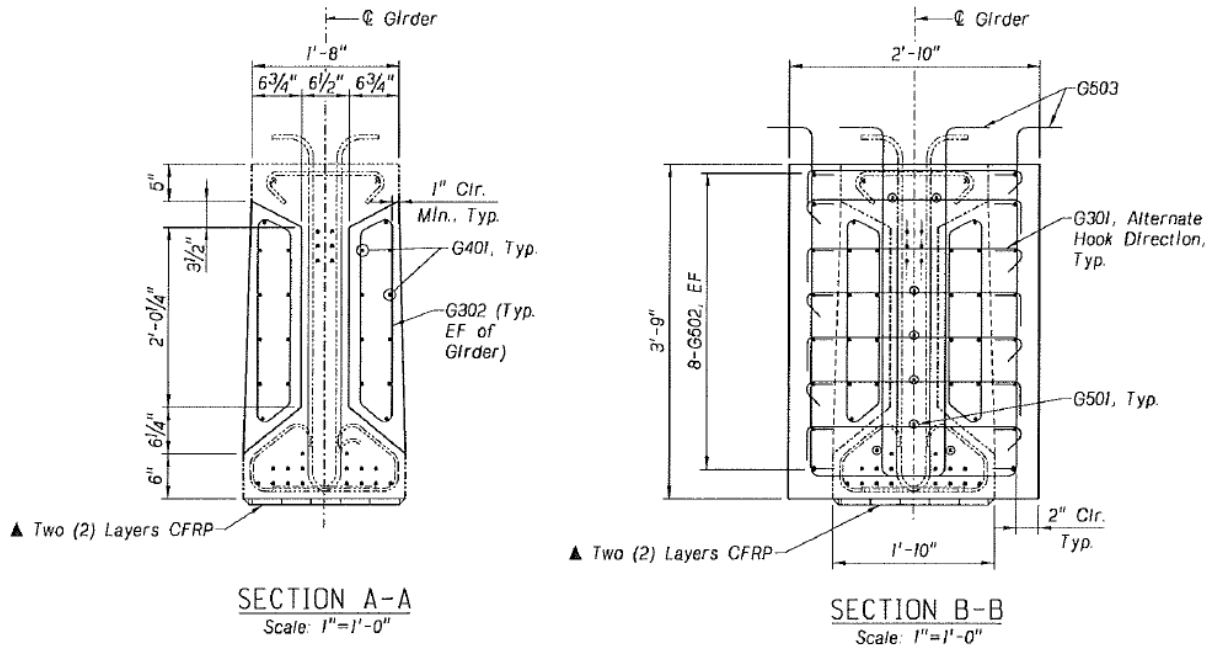
Figure 119: Detail of girder end encasement reinforcement and CFRP layers, from the repair documents of Kearney South Platte River Bridge, courtesy of NDOT

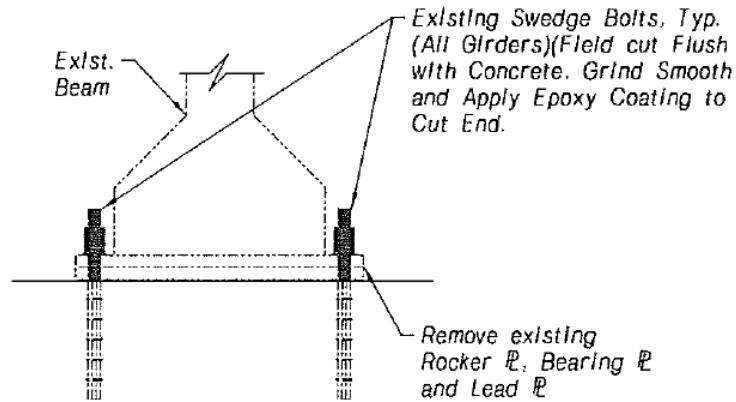
Figure 120: Detail of bearing assemble removal, from the repair documents of Kearney South Platte River Bridge, courtesy of NDOT

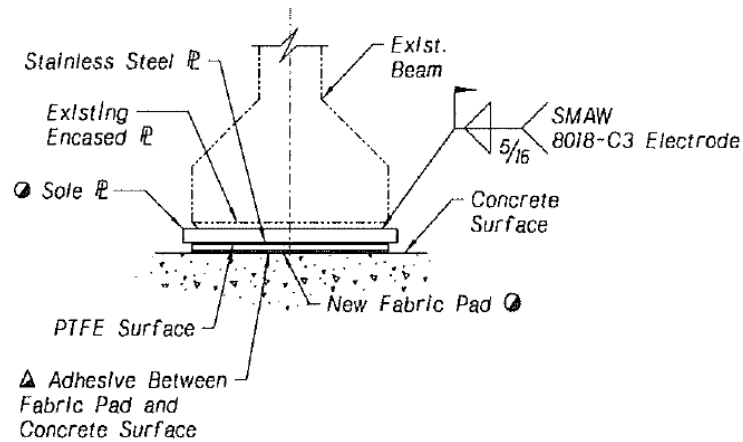
Figure 121: Detail of bearing assemble replacement, from the repair documents of Kearney South Platte River Bridge, courtesy of NDOT

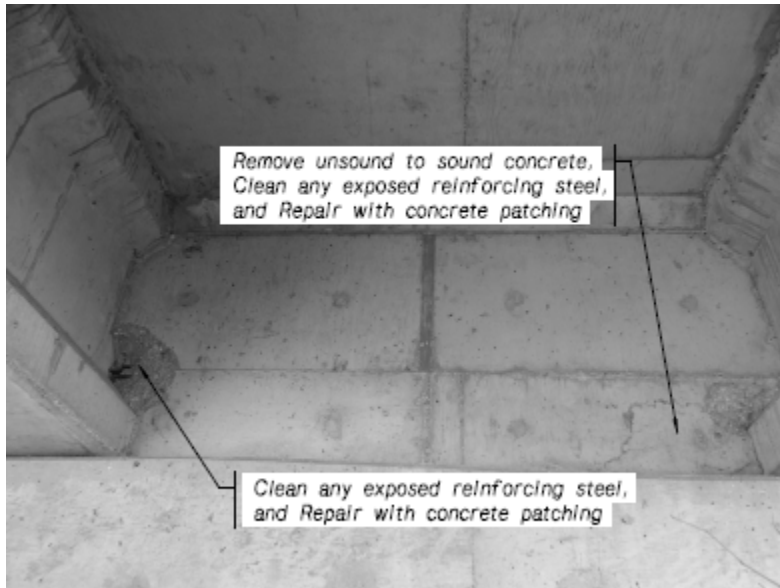
Figure 122: Damage at girder ends and diaphragm, Platte River South Bridge, courtesy of NDOT

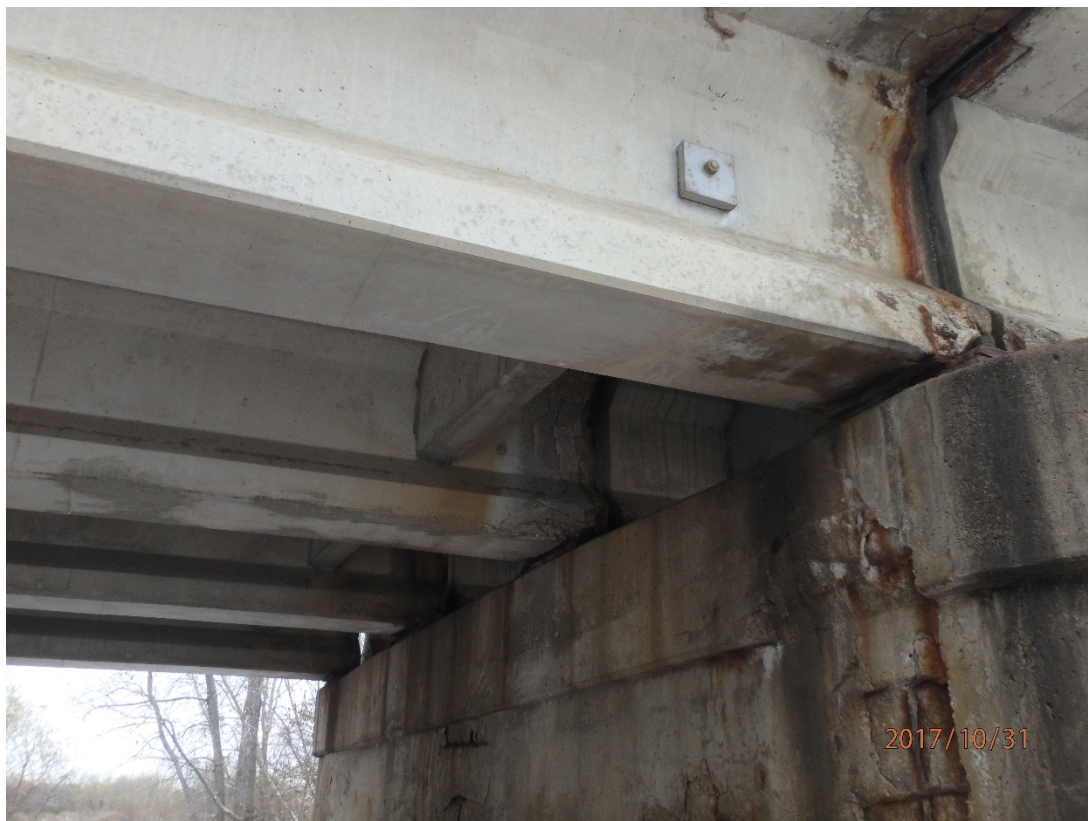
Figure 123: Damage at girder ends, Platte River South Bridge, courtesy of NDOT

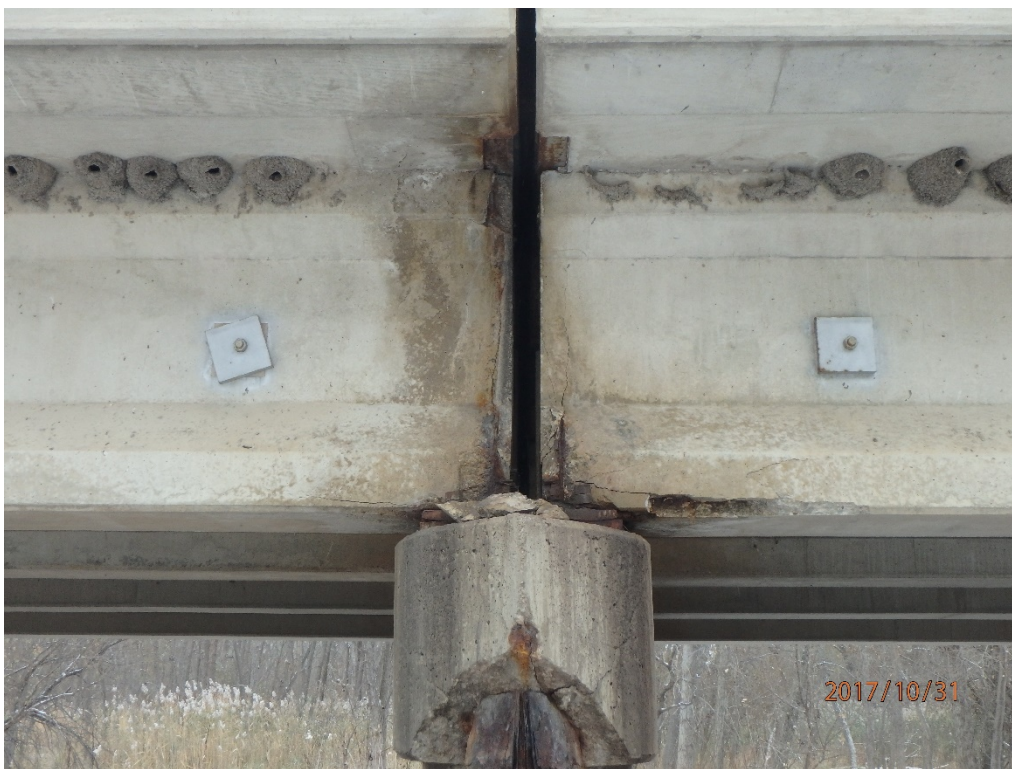
Figure 125: Damage at girder ends, Platte River South Bridge, courtesy of NDOT

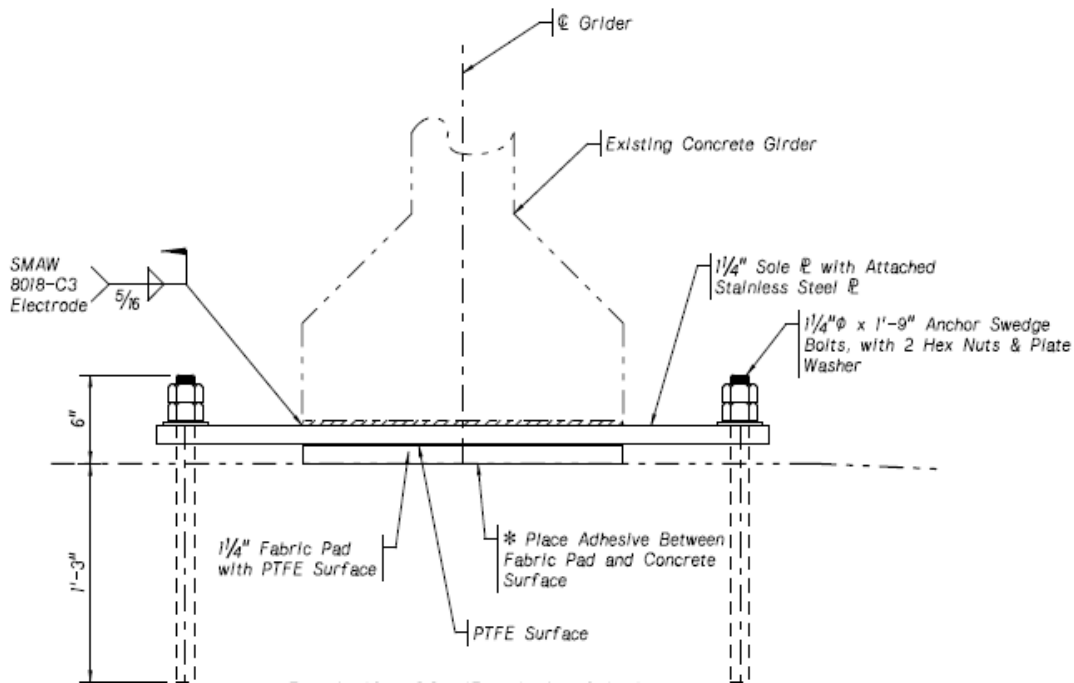
Figure 128: Bearing assemble replacement detail, from the repair documents of Platte River South Bridge, courtesy of NDOT

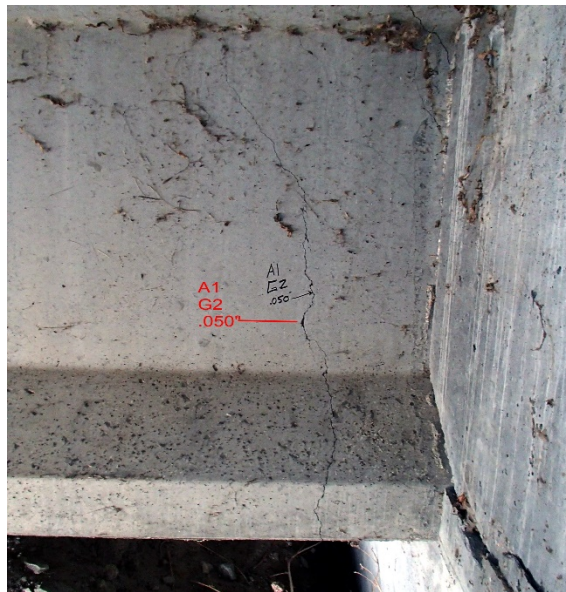
Figure 130: Cracking at girder end, Alma South Bridge, courtesy of NDOT

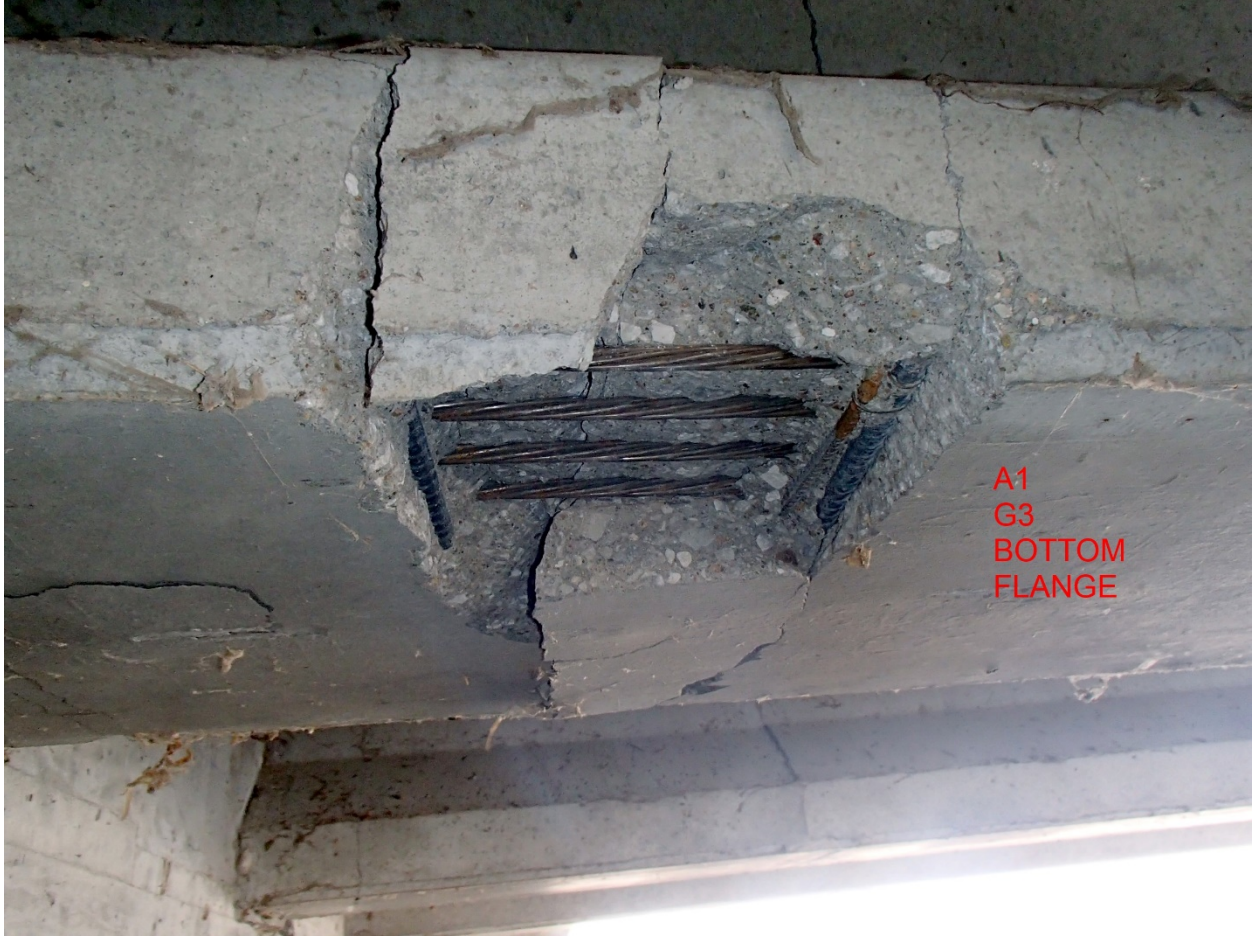
Figure 131: Exposed strands at bottom flange, Alma South Bridge, courtesy of NDOT

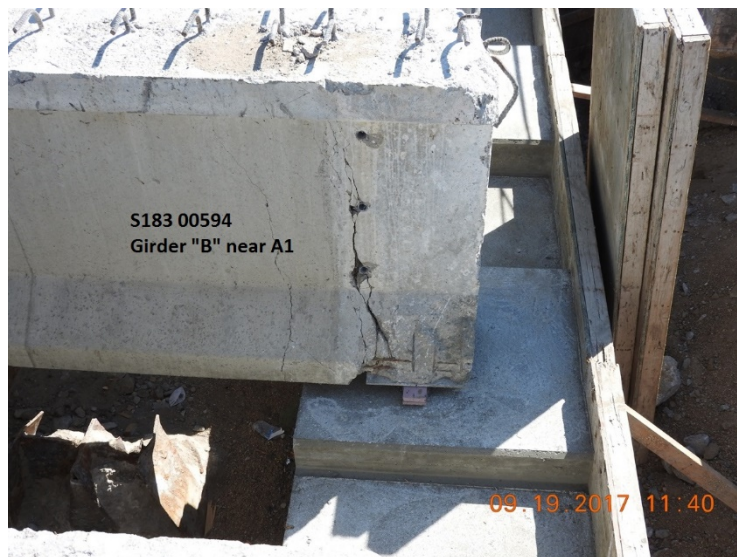
Figure 132: Heavy cracking at girder end, Alma South Bridge, courtesy of NDOT

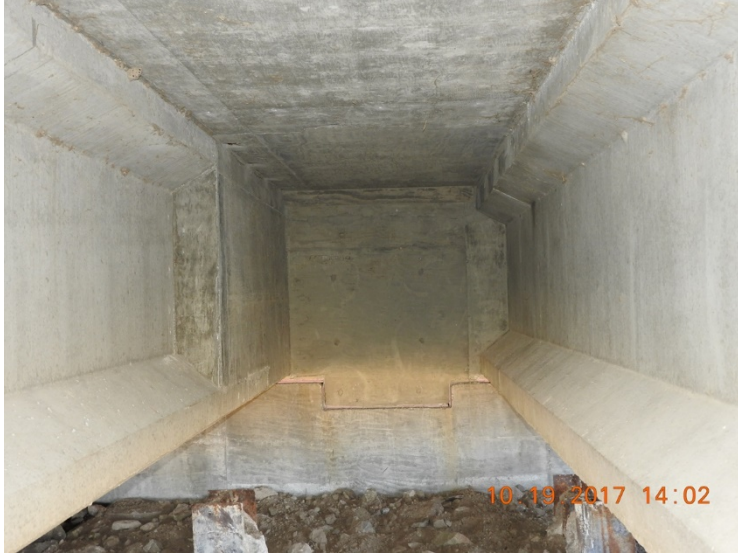
Figure 133: Repaired girder end with a concrete encasement, Alma South Bridge, courtesy of
NDOT

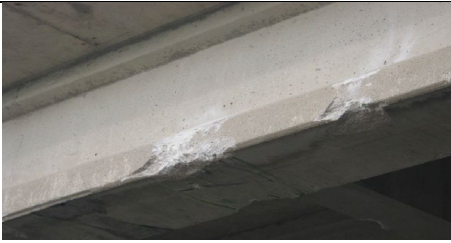
Figure 1: Minor damage, bottom flange spalling, Iowa DOT, 2014

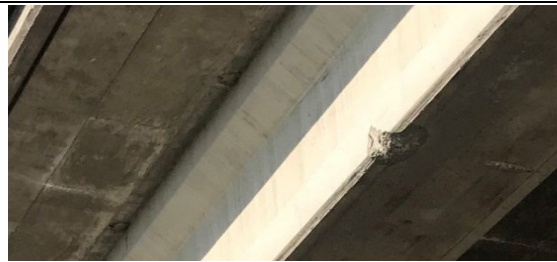
Figure 2: Minor damage, NDOT York Bridge East

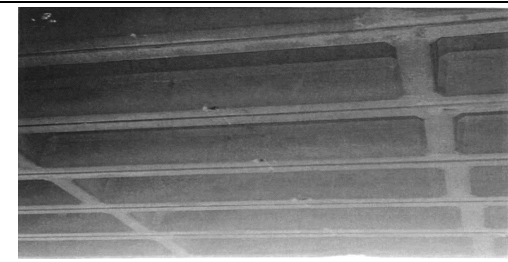
Figure 3: Minor damage, bottom flange cracks, Feldman et al., 1996

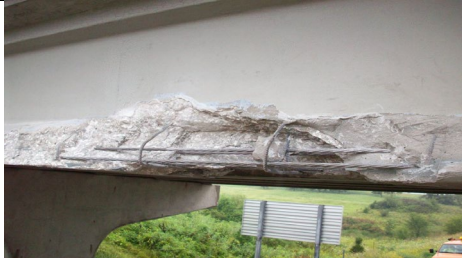
Figure 4: Moderate damage, exposed intact strands, Iowa DOT, 2014

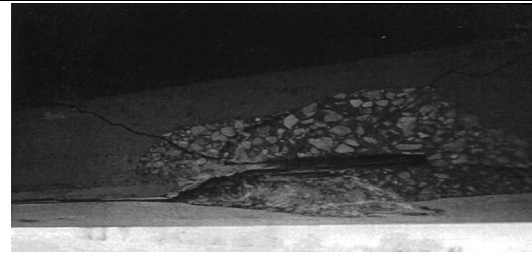
Figure 5: Moderate damage, exposed intact strands, Feldman et al., 1996

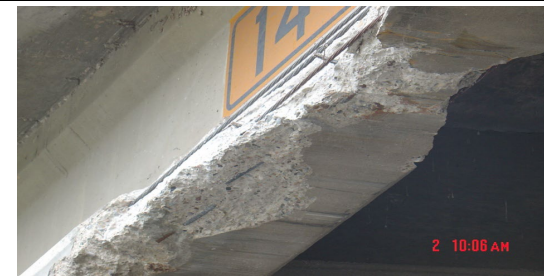
Figure 6: Moderate damage, exposed intact strands, Pantelides et al., 2010

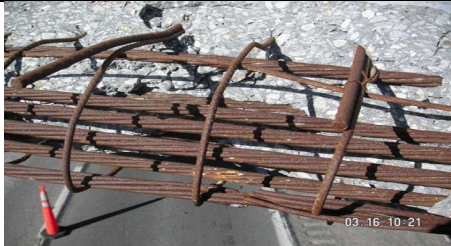
Figure 7: Severe I damage, one severed strand, NDOT Wood River Interchange Bridge Girder (A)

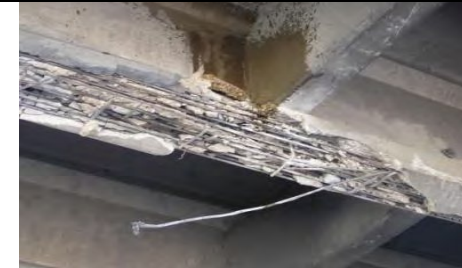
Figure 9: Severe I damage, one severed strand, Harries et al., 2012

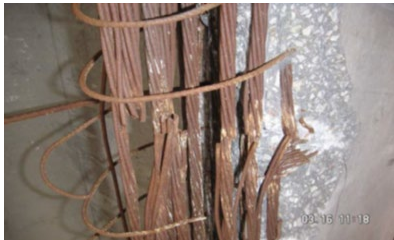
Figure 10: Severe II damage, five severed strands, NDOT Wood River Interchange Bridge Girder (E)

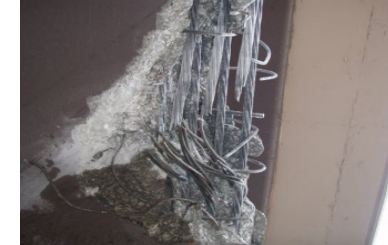
Figure 12: Severe II damage, three severed strands, NDOT Scottsbluff Gering Bypass Bridge

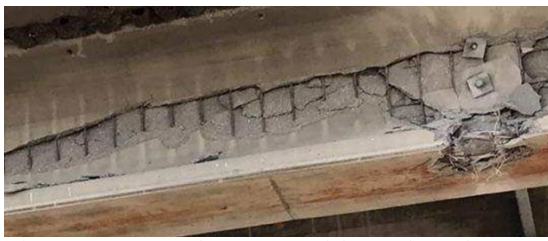
Figure 13: Severe III damage, several damaged strands, NDOT Schuyler Bridge

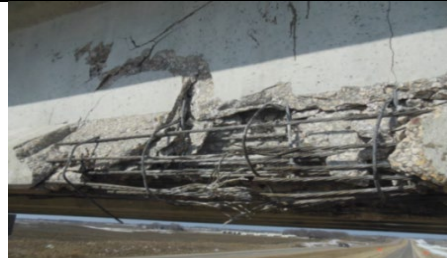
Figure 14: Severe III damage, several damaged strands, Iowa DOT, 2014

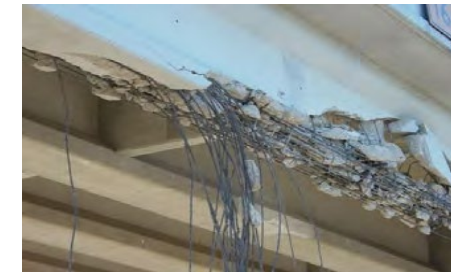
Figure 15: Severe III damage, several damaged strands, Harries et al., 2012

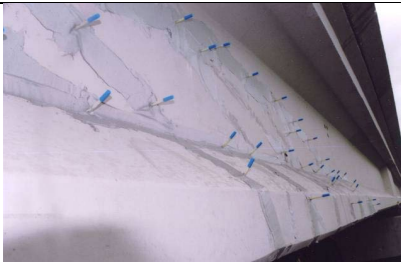
Figure 16: Epoxy injection ports, AIT, 2005

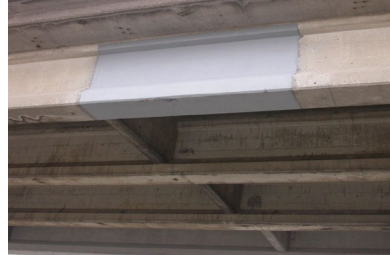
Figure 23: FRP Wrapped Repair, Iowa Dot, 2014

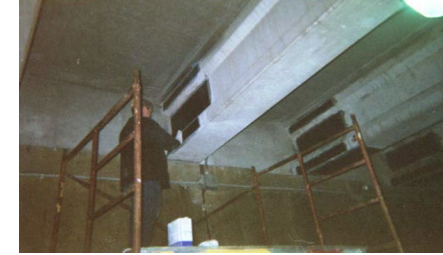
Figure 24: CFRP fabrics installation, Choo et al., 2013

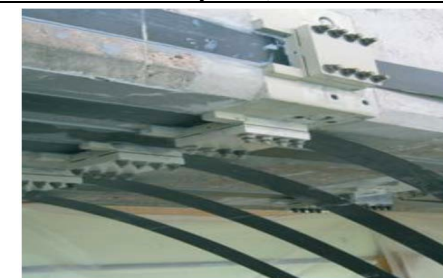
Figure 30: Sika carbon stress system external CFRP post-tensioning, Kasan, 2009

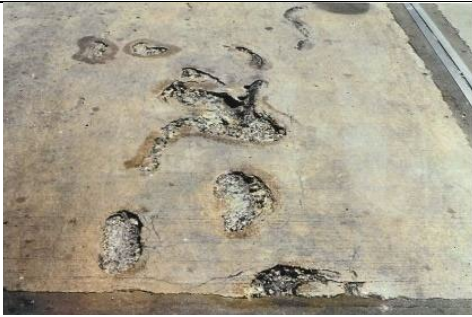
Figure 1: Minor damage, surface spalling with no exposed reinforcement, Naito et al., 2006

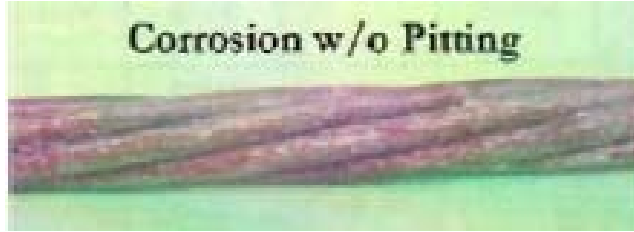
Figure 2: Moderate damage, exposed strands having corrosion without pitting, Naito et al., 2006

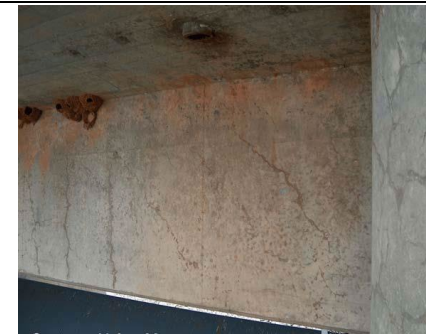
Figure 3: Moderate damage, hairline cracks, WisDOT, 2018

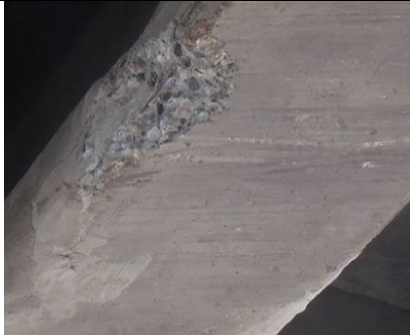
Figure 4: Moderate damage, one exposed strand on concrete bridge girder, WisDOT, 2018

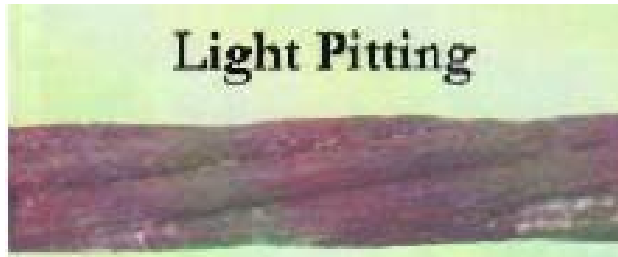
Figure 5: Extensive damage, exposed strands having corrosion with light pitting, Naito et al., 2006

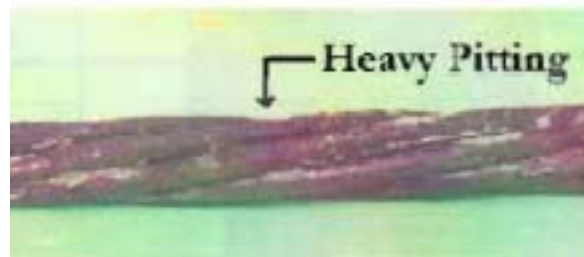
Figure 8: Severe damage, exposed strands having corrosion with heavy pitting, Naito et al., 2006

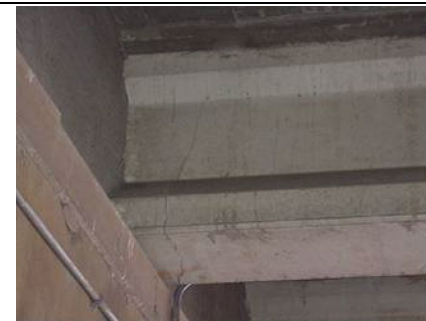
Figure 9: Severe damage, severe cracks, Choo et al., 2013

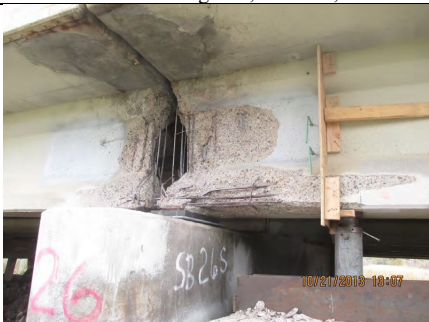
Figure 10: Severe damage, exposed strands > 15 %, MN/RC 2018-07 Report

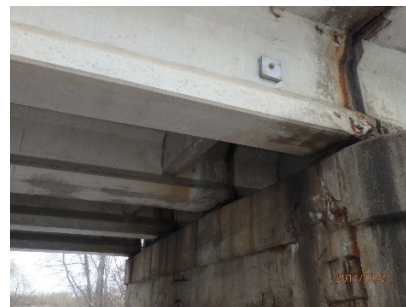
Figure 11: Severe damage, exposed strands, NDOT Platte River South Bridge

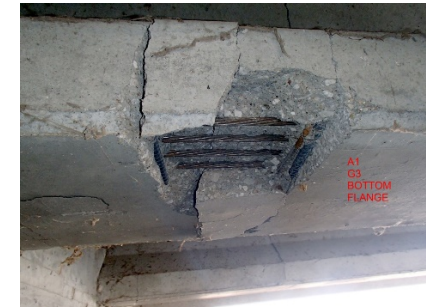
Figure 12: Severe damage, exposed strands, severe cracks or fractures, NDOT Alma South Bridge

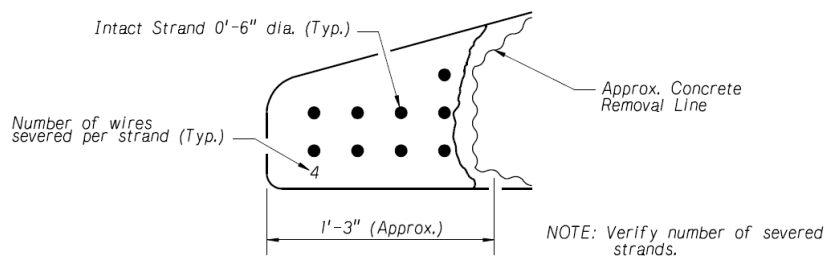
Location of damaged strand
