Report SPR-P1(17) M075

# Development and Implementation of a Moving Nondestructive Evaluation Platform for Bridge Deck Inspection

Department of Civil Engineering, University of Nebraska-Lincoln

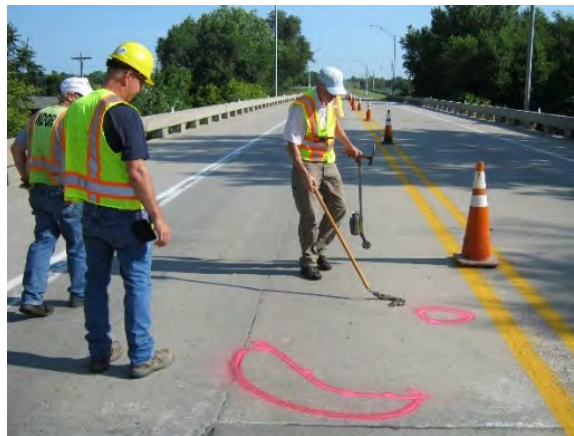
**Fig. 1.1.** State of the practice chain drag inspection on a bridge deck on which the locations of delaminations are marked using a handheld paint sprayer

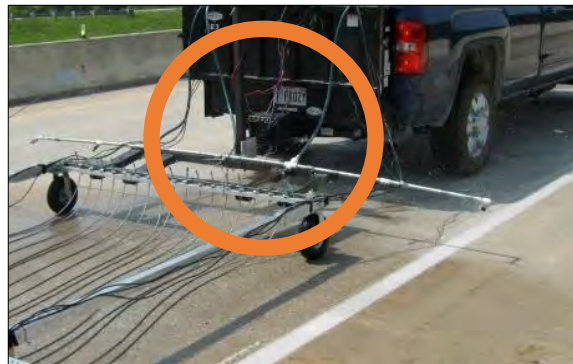
**Fig. 1.4.** (a) Originally proposed NDE platform to efficiently and easily collect NDE technology data during scanning. (b) Deployment of constructed NDE platform during scanning of a bridge on the Homestead Expressway in Nebraska during the 2018 scanning tour

This project provided a mobile platform design to allow Nebraska Department of Transportation (NDOT) to efficiently evaluate the condition of concrete bridge decks and improve maintenance and rehabilitation results. As shown in **Figure 1.4** , the proposed platform

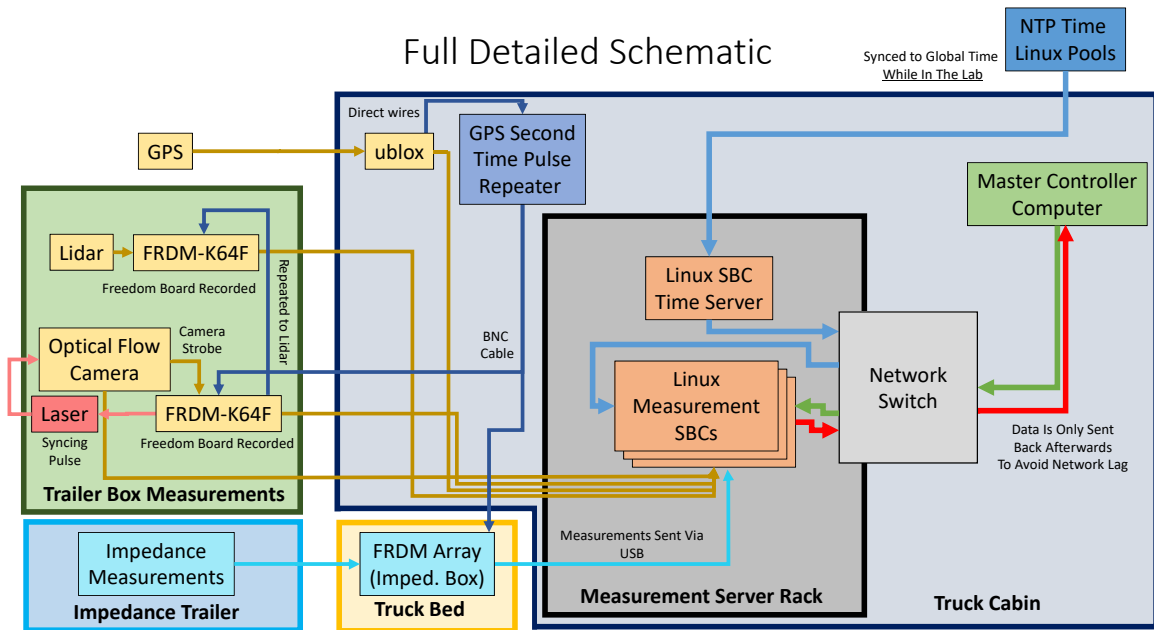
**Fig. 2.1.** Schematic of the data collection framework for the VEI scanner, with VEI, GPS, LiDAR, and camera measurements being recorded on different SBCs during scanning.

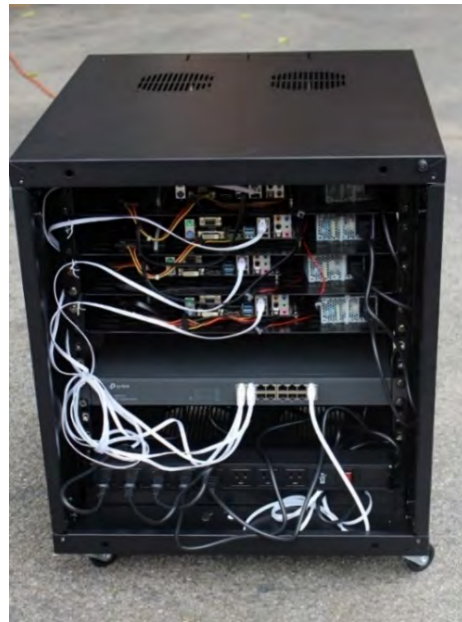
**Fig. 2.2.** Modular data collection system in which the SBCs are placed at the top of the rack, the network switch is in the middle of the rack, and power distribution and batteries are at the bottom of the rack

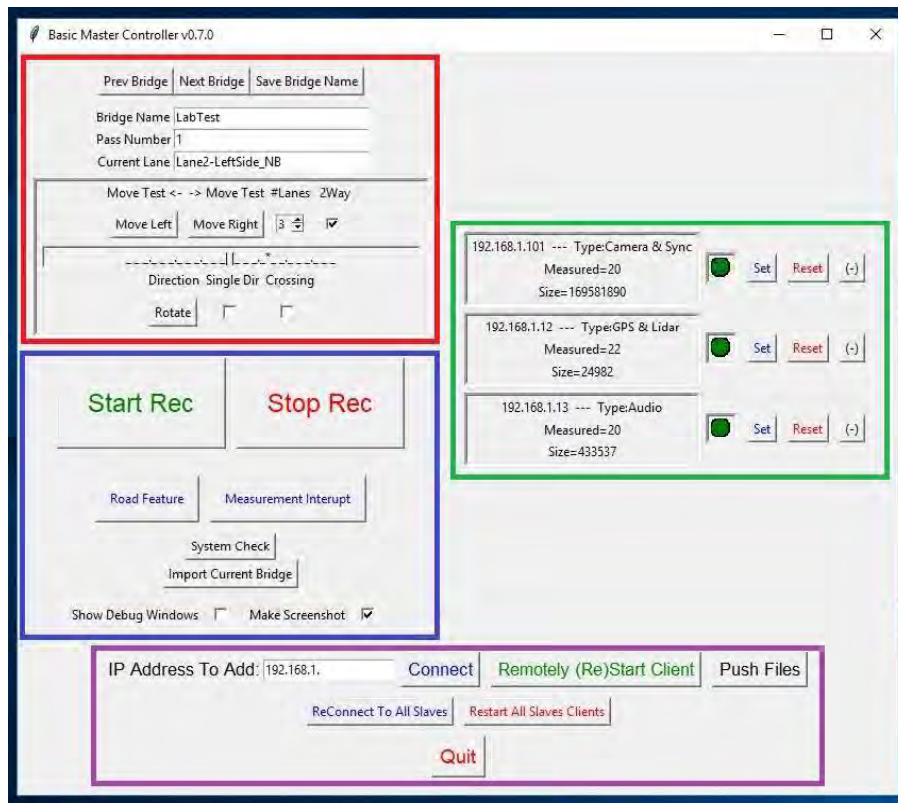
**Fig. 2.4.** Master controller software interface

The data collection section which controls the overall **Start** and **Stop** commands for recording data is shown in blue color box. There are also blue timestamp buttons to record some sort of measurement interrupt or feature on the road that is wished to be noted. These are recorded only within the timestamp section of each slave computer. The **System Check** button performs a 3 second recording on all systems and will automatically import the data for inspection within the “Imported Data” folder created. The **Import Current Bridge** button will attempt to import all the data from all computers for the bridge currently at the Bridge Name section at the top for the current day.

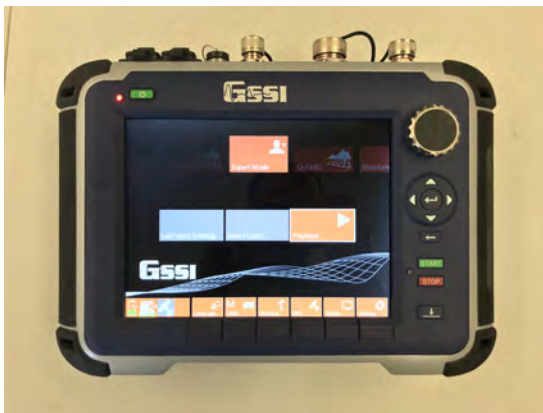
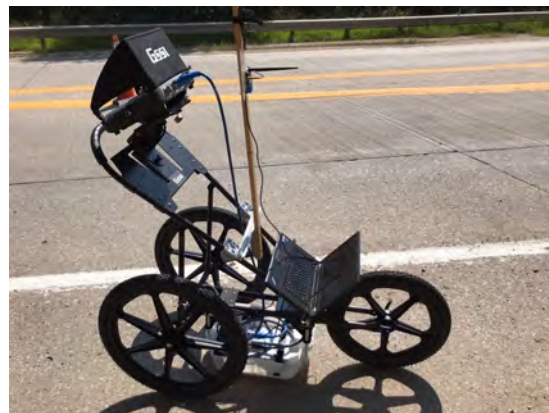
(a) GSSI SIR-4000 computer

(b) GPR system on a survey cart

A survey cart, shown in the **Figure 3.2**, is used in ground-coupled GPR survey. Since the survey is at a walking speed, traffic control is needed. The center frequency of the antenna determines the maximum penetration depth of EM wave and the vertical resolution of the B-scan image. Increasing the frequency will improve the image resolution at the cost of decreasing the penetration depth. In most bridge deck surveys, ground-coupled antennas with a center frequency of 1.5 GHz provides sufficient penetration depth and adequate resolution. The time range determines the total time that GPR records the reflections from the subsurface. The proper time range can be determined by the expected penetration depth and velocity information.

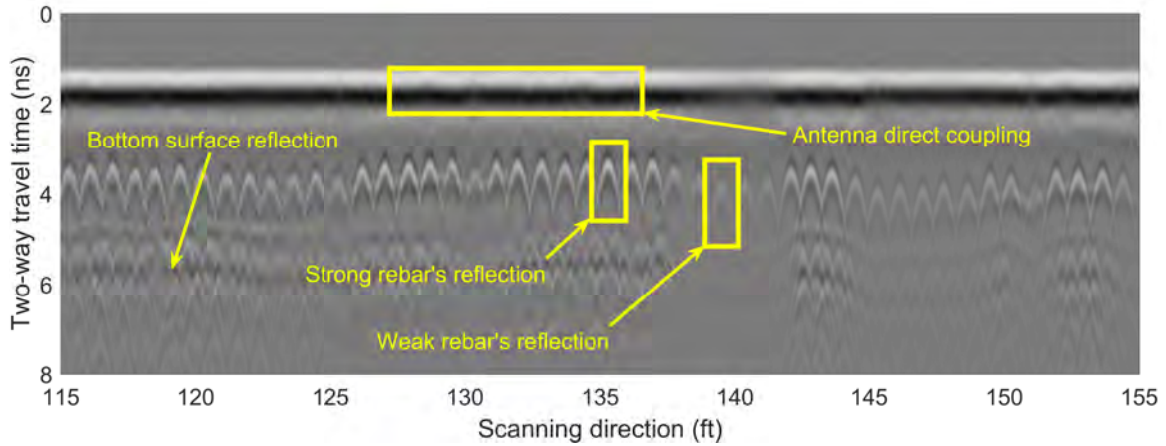
**Fig. 3.3.** GPR B-scan image

**Figure 3.3** shows a GPR B-scan images recorded over a bridge deck with 8 ns time range in the vertical scale. As highlighted in the **Figure 3.3**, direct coupling, rebar reflection, and bottom of the bridge deck are the main features that can be visually identified in the image.

The conventional way to analyze the B-scan is through comparison of depth-corrected amplitudes of rebar reflections. Concrete deterioration and rebar corrosion will decrease the GPR amplitude and increase the attenuation. The UNL research team recently proposed a complete procedure for GPR data processing to address the issues in the current GPR analysis methods. These improvements include accurate zero offset, migration of rebar reflections, amplitude correction based on actual rebar depth, and accurate wave velocity, etc. Details can be found in recently published research reports and publications [23, 24]. With the new GPR analysis algorithm, we are able to extract three additional maps from GPR data, direct-coupling amplitude, wave velocity and cover thickness maps.

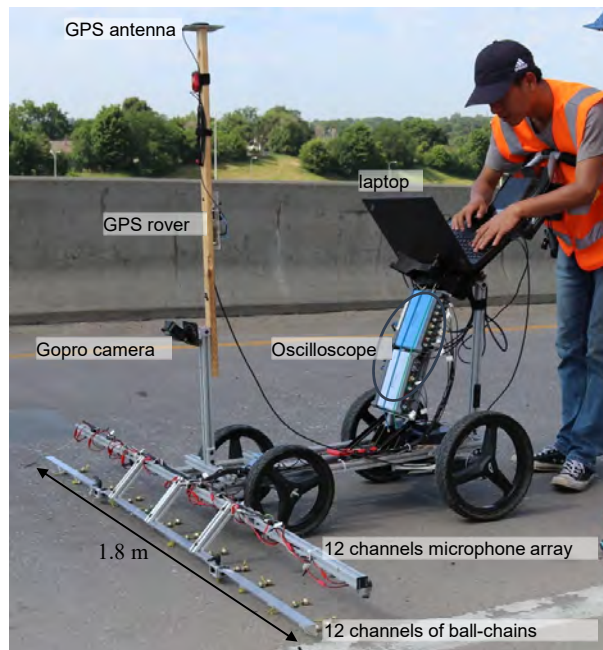
**Fig. 3.4.** 12-channel acoustic scanning cart

The scanning cart can scan a bridge deck in a normal walking speed ( about 4 ft/s). With the scanning frame width of 6-ft, the system can scan an area of 24 ft<sup>2</sup>/s. The longitudinal spatial resolution depends on the scanning speed. At a walking speed, this system will give a spatial resolution of 1-2 inch. The testing speed effect is discussed in detail in a previous study by the authors [17].

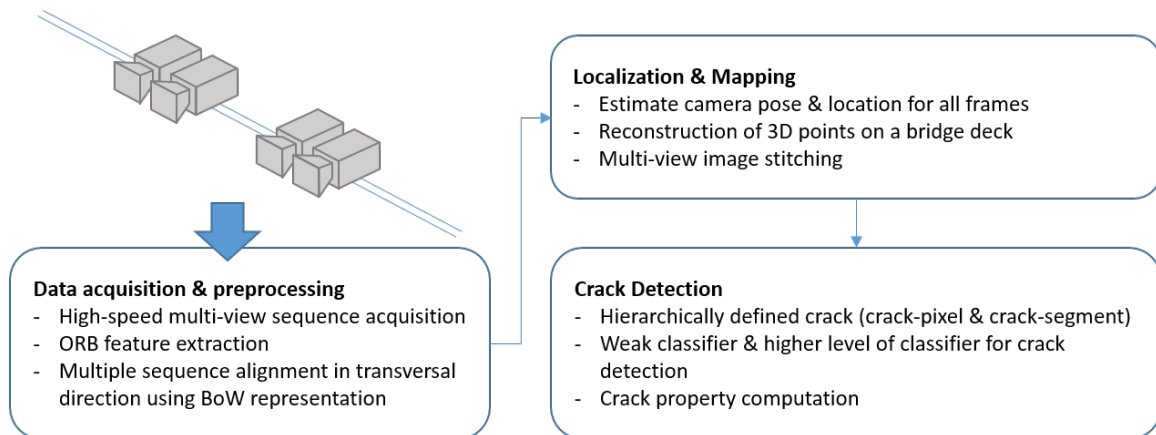
**Fig. 3.6.** Overall process of the proposed system

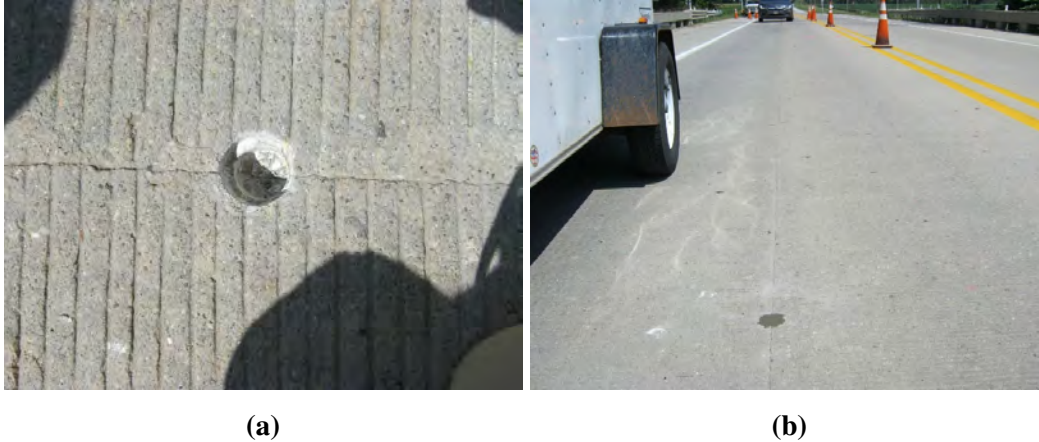
**Fig. 4.2.** Photographs of a hole made for chloride sampling (a) and the patched hole (b) after sampling was complete.

the depth interval from 0 to 1 in., while the second sample represented the depth interval from 1 to 2 in. After removal, the samples were returned to Brigham Young University for laboratory analysis. Photographs of the hole and patched hole for the low impedance location of Bridge Deck 1 (S006 29351) are found in **Figure 4.2**.

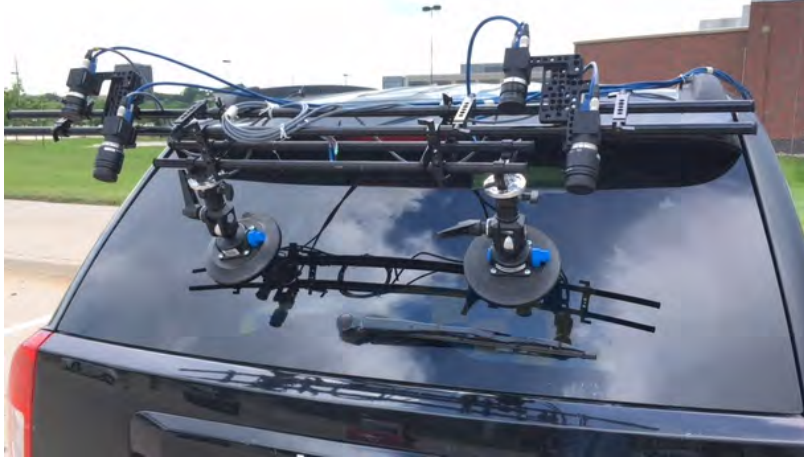
**Fig. 4.3.** Multi-view Camera System mounted on a Road Vehicle

We used multiple optical sensors attached to a road vehicle for data acquisition as shown in **Figure 4.3**. Two types of optical sensors (cameras) were used where one serves for localization and the other for crack detection purpose. For image-based localization, two large field-of-view cameras were used to cover a wide surface (bridge deck) area and to compensate the relative pose changes through performing stereo reconstruction of 3D points on the bridge deck in real-scale. The other two cameras were used for crack detection and have a longer focal length to capture the surface of bridge deck with high resolution images (provides two-times finer resolution than the other pair of cameras).

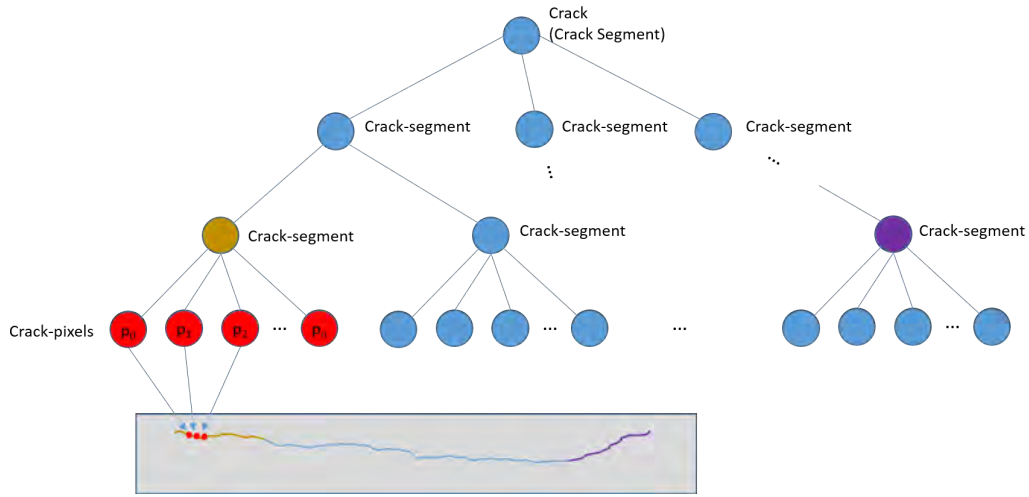
**Fig. 4.7.** Hierarchy of crack pixels and crack-segments

In order to detect cracks from images, we have defined a crack hierarchy using crack-pixels and crack-segments as shown in **Figure 4.7**. The crack-pixel is the basic unit of the crack within an image. A crack-pixel has low intensity value and has a dominant orientation.

Many of the previous research studies assumed that a crack has low intensity and the local shape can be approximated by a line segment. Our definition of a crack element is stricter considering the dominating characteristics of the pixels (low-intensity and a dominant local orientation) but more flexible (less strict) for the shape of the crack. By the definition of a crack-pixel and a crack-segment, each crack is represented by a tree structure as shown in **Figure 4.7**. The nodes of the tree are crack-segments and the leaf nodes have crack-pixels as shown in **Figure 4.7**.

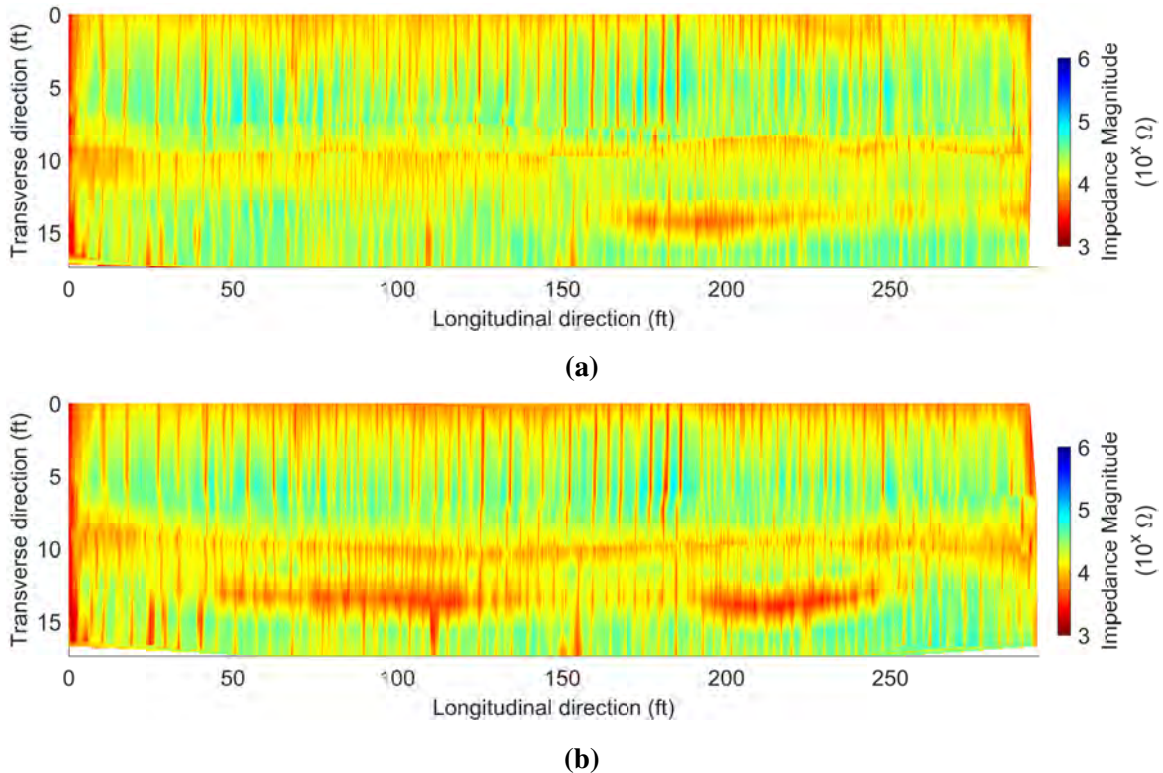
**Fig. 4.11.** VEI map of Bridge Deck S006 29351 generated from the first pass (a) and second pass (b) (Not to scale).

From the data shown in **Figure 4.11**, soaking during subsequent scanning passes did not appear to significantly change the results between passes. For this bridge deck, the low-impedance chloride concentration sampling location was positioned at a longitudinal distance of 212 ft and a transverse distance of 15 ft, while the high-impedance chloride concentration sampling location was positioned at a longitudinal distance of 162 ft and a transverse distance of 9 ft. The results of the chloride concentration testing are shown in **Table 4.1** at the end of this chapter.
