# Dowel Basket Assemblies Tie Wire: Material & Research Field Performance Investigation

Nebraska Department of Roads

**Research Project Title:**  
Dowel Basket Assembly Tie Wire:  
Materials & Research Field Performance  
Investigation

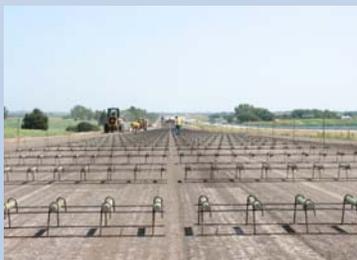
Figure 1. Dowel Movement During Placement

The red arrow shown is the dowel bar translation movement during concrete placement. Figure 1.

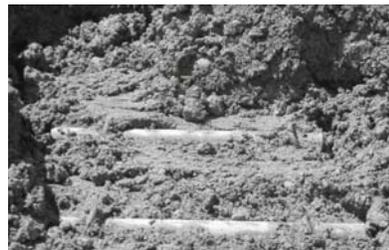
Figure 2. Dowel misalignment

The measured translation movement from the original dowel bar assembly was 1 1/2 inches as shown in Figure 3 and 4.

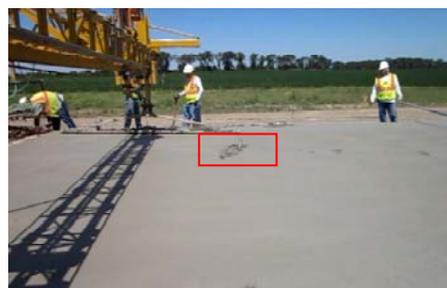
Figure 5.

Figure 5 shows the possible result of the dowel bar translation movement as the paver passes. This figure shows the dowel bar vertically aligned from the surface of the pavement.

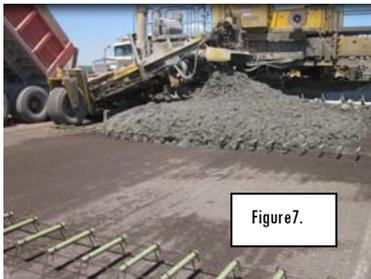
1. Shipping wires were not cut (Figure 6).
2. Measure the translational movement of the dowel bars and spray paint on the dowel bar basket assembly to visualize the movement during concrete placement (Figure 7 and 8).
3. Identified location of uncut wire assembly for future for field monitoring (Figure 9).

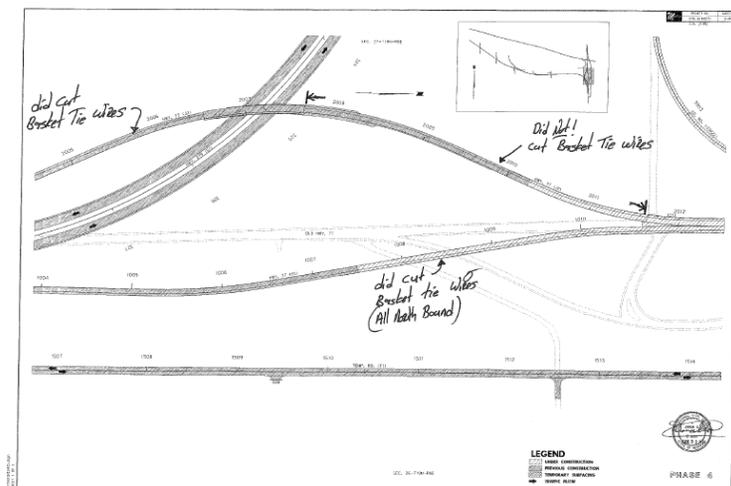
Figure 10. Hooper Experimental Section Built in 2007

In 2007, the Department of Roads experimented with a section of pavement in District 2 on the Hooper East & West project. For the last 5 years the M&R Portland Cement Concrete Pavement Research and Development Section has been monitoring a section built with uncut dowel bar basket assemblies, as shown in Figure 10.

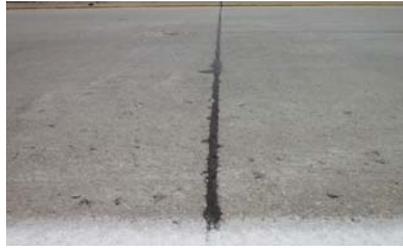
Figure 11. Transverse Joint- 2012 Field performance

After 5 years of monitoring on the Hooper East & West project, the field performance of the uncut dowel bar assembly has shown no signs of distress at the transverse joints, as shown in Figure 11. Therefore, the field performance has shown the impact of not cutting the wires is negligible. In fact, this result in smoother pavement, as well as dowel that are better aligned, which strengthen dowel baskets.<sup>3</sup>

The transverse joint performance with uncut dowel bar assemblies and the observations of the translation movement as the paver passes has led the M&R to recommend leaving dowel bar basket assemblies tie wires uncut.
