**Research**

Penetrating Sealers Evaluation on Portland Cement Concrete with Supplemental Cementitious Materials

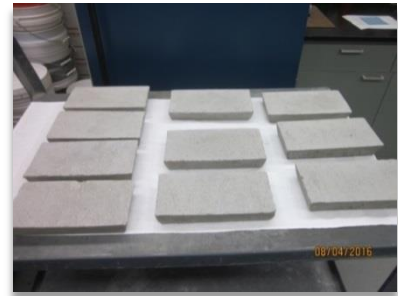
*Figure 1 Concrete Blocks for Laboratory Testing*

Concrete blocks were made for the laboratory testing using typical 47B concrete mix design. Each block was 6x12 inches on the surface. All of the blocks cured for 14 days then dried for 14 days. Due to complications, testing was unable to begin for a month after the block dried. The blocks that were treated are shown in Figure 1.

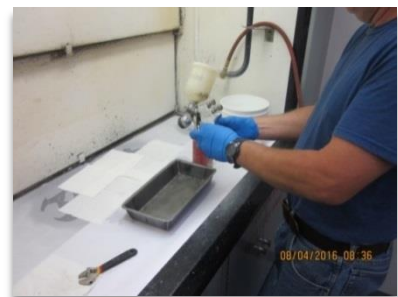
*Figure 2 Handheld Sprayer for Sealer Application to Blocks*

The sealers were applied to the concrete block surfaces using a handheld sprayer. All sealers were applied at the minimum application rate, according to each manufacturer's specifications. Between each application, the sprayer was cleaned with 100% ethanol to remove any residual sealer left in the reservoir or nozzle. The handheld sprayer used is shown in Figure 2.

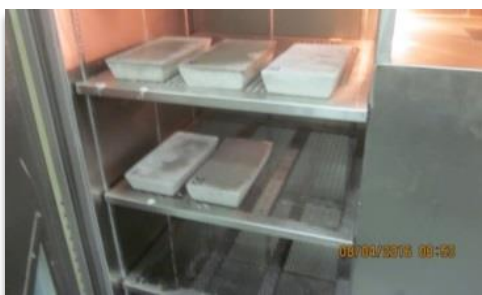
*Figure 3 Cold Chamber for Laboratory Testing*

Two chambers were used to create two extreme environmental conditions for the laboratory testing of blocks. The chambers have the capability of maintaining set temperatures and humidity. The first chamber was set to 50°F with 90% humidity, referred to as the "Cold Chamber" shown in Figure 3. The second chamber was set to 90°F with 50% humidity, referred to as the "Hot Chamber" shown in Figure 4.

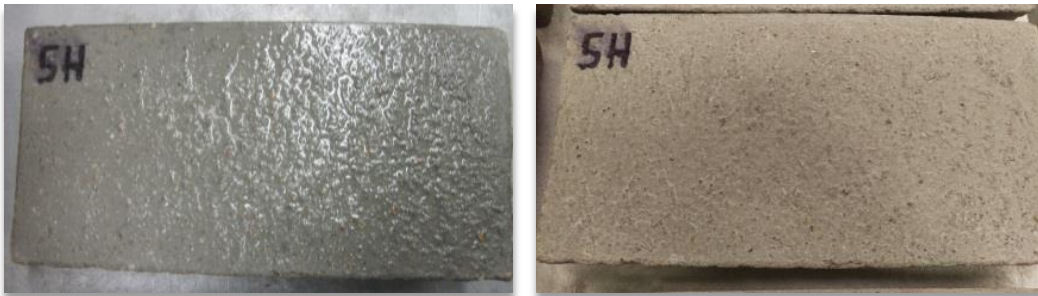
Figure 5 Contrast of a Wet and Dry Concrete Block

During testing, it was observed that the wet and dry surfaces were visually different. This can be seen by the contrast of the wet and dry concrete block of Sealer 5 shown in Figure 5. The results of the drying-time testing are shown in Figure 6.

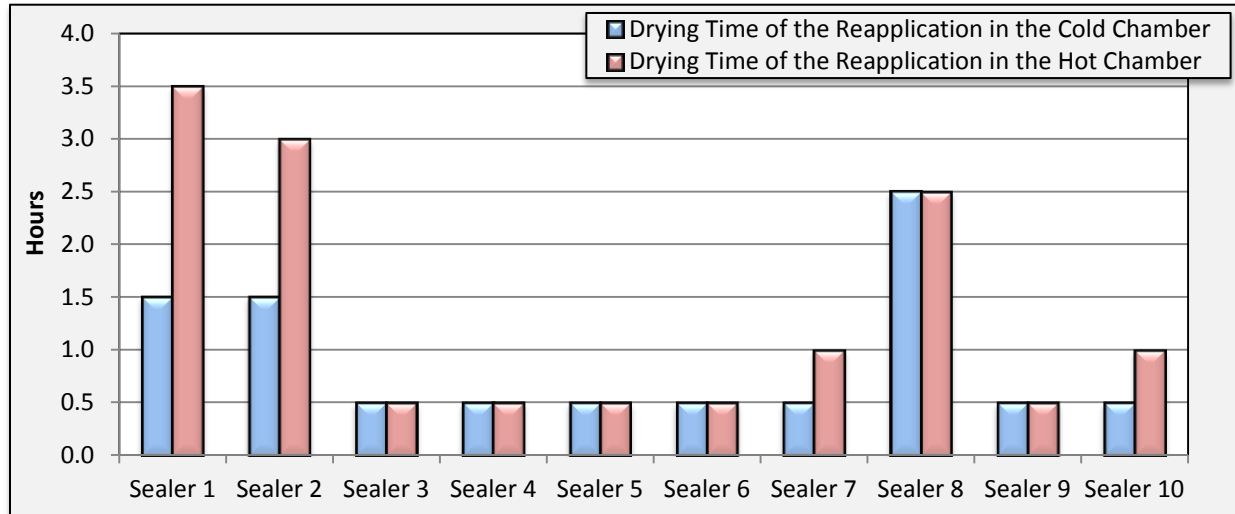
Figure 7 Results of the Laboratory Reapplication Drying Time

For this test, one-half of each core from the first drying-time test had the same sealer applied at the same rate. Each block was then placed into the same chamber and the drying time was measured again. The results can be viewed in Figure 7.

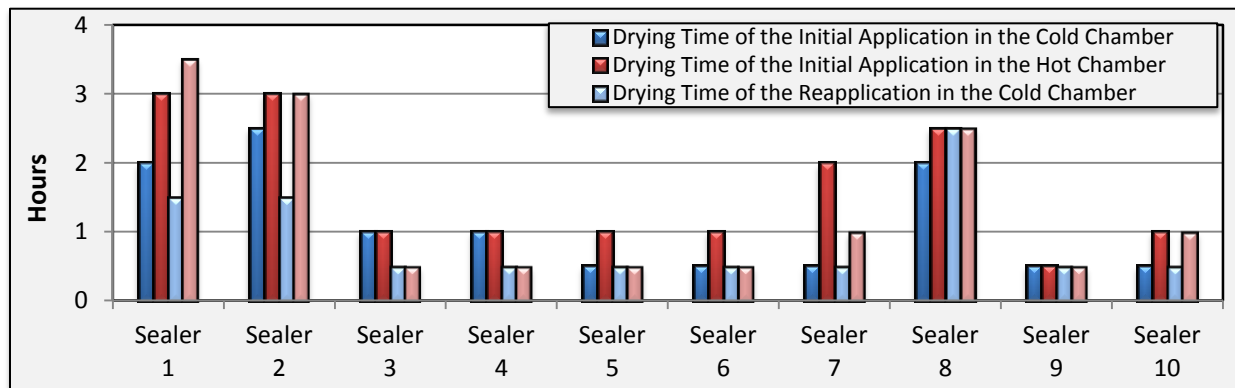
Figure 8 Relationship between the Drying Times of the Initial Application and the Reapplication

A comparison of the laboratory drying-time tests is shown in Figure 8. All the results together provided three relationships of note.

1. The drying times in the cold chamber were less than the corresponding application in the hot chamber.
2. The drying times for the initial application were greater than the corresponding reapplication chamber.
3. There were only small differences in drying times between the initial application and reapplication, leading to the conclusion that the reapplication of a sealer was not hindered by previous applications of the same sealer.

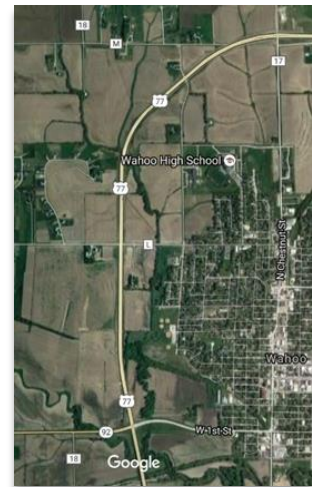
Figure 9 Field Testing Location (Google, 2016)

For the field investigation it was decided that testing would be completed near Wahoo, NE on US 77-US 92 (Co Rd M), shown in Figure 9. This location was chosen because it was recently completed, is multilane and the concrete contained SCMs.

Throughout the day of Monday, September 16, 2016, the sealers were applied to test sections on US 77. The test sections started south of the intersection of US 77 and Hwy 17 and ended north of the intersection of US 77 and Hwy 92.

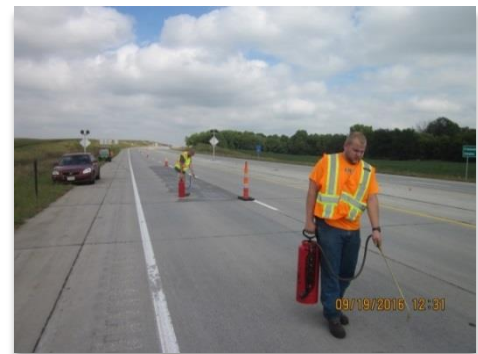
Figure 10 Sealer Application with Handheld Sprayers

Sealers were applied with handheld sprayers at the minimum application rate recommended by each manufacturer. The application can be seen in Figure 10.

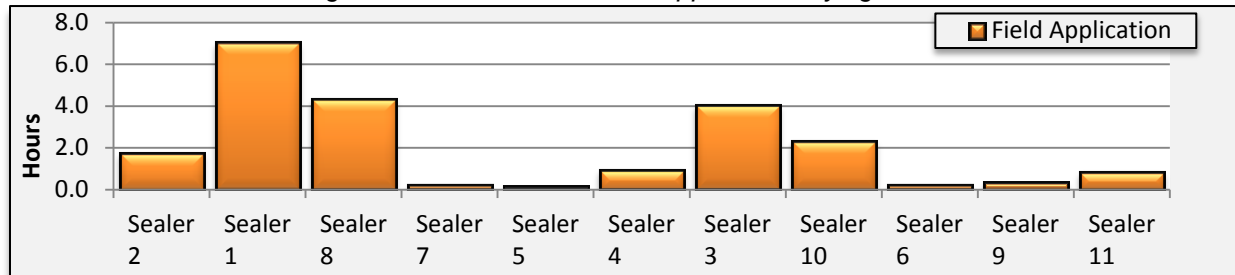
Figure 11 Results of the Field Application Drying Time

As each sealer was applied, the drying time was recorded. Dryness was assessed the same as it was done for the laboratory blocks by the pressing of white matte printer paper with no pick up. The dryness of each application was also easily observed visually; the drying time results are shown in Figure 11.

The drying time for the sealers varied greatly. Sealers 4, 5, 6, 7, 9, and 11 dried quickly, in an hour or less. Sealers 1, 3, 8 and 10 dried slowly, in two hours or more. Sealer 1 was still somewhat wet even after 7 hours.

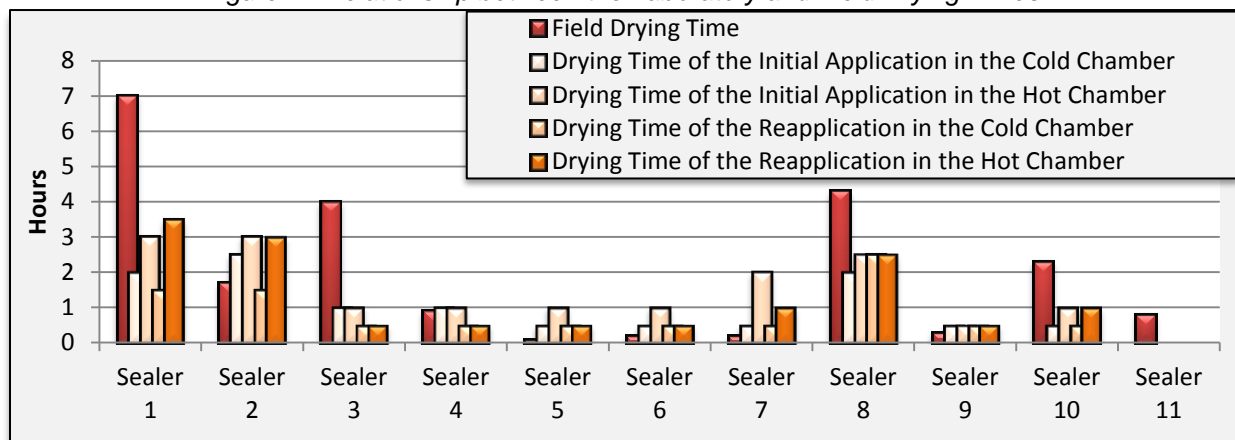
Figure 12 Relationship between the Laboratory and Field Drying Times

A comparison of the laboratory and field drying time testing results is shown in Figure 12. There was some correlation as well as divergence between the laboratory and field drying times.

In general, the sealers maintained the same relationships in the field as in the laboratory, such that the slow drying sealers in the laboratory were slow drying in the field, and fast drying sealers in the laboratory were fast drying in the field.

The divergence between test results was the magnitude in drying time. Sealer 1 required three hours in the lab, but greater than seven hours in the field. The same relationship was seen for Sealers 3, 8, and 10.

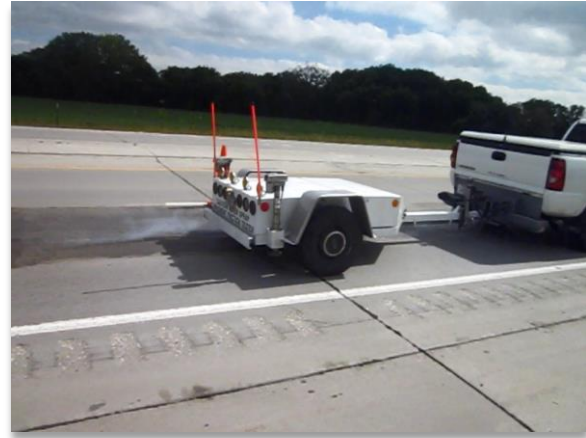
*Figure 13 Determining of Skid Resistance with a Locked-Wheel Skid Tester*

The skid resistance was found as the force required on the test tire to create a skid divided by the load on the test tire; the resulting value is the skid number ( $SN$ ). The baseline before sealer application was recorded as ( $SN_I$ ). All measurements after sealer treatment were recorded as ( $SN_T$ ). Figure 13 shows the active measurement of skid resistance using the locked-wheel skid tester.

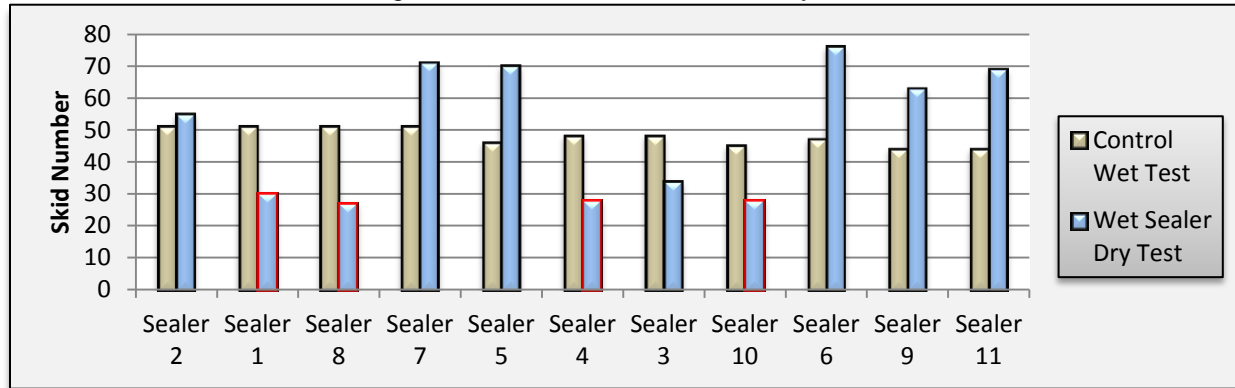
Figure 14 Control and Wet Sealer Dry Test

To see if skid resistance was reduced when there is wet sealer on the pavement, the research team tested without water immediately after the sealer was applied. The control section was conducted with a wet locked-wheel skid test prior to the application of the sealers. The results are shown in Figure 14.

The SN results of the “Control Wet Test” varied from 51 to 44. The SN results of the “Wet Sealer Dry Test” varied from 76 to 27.

Sealers 5, 6, 7, 9, and 11 had SN values well above the control values; these sealers also dried quickly, which leads the team to believe that the highest values are probably due to the sealer being mostly dry by the time testing was completed.

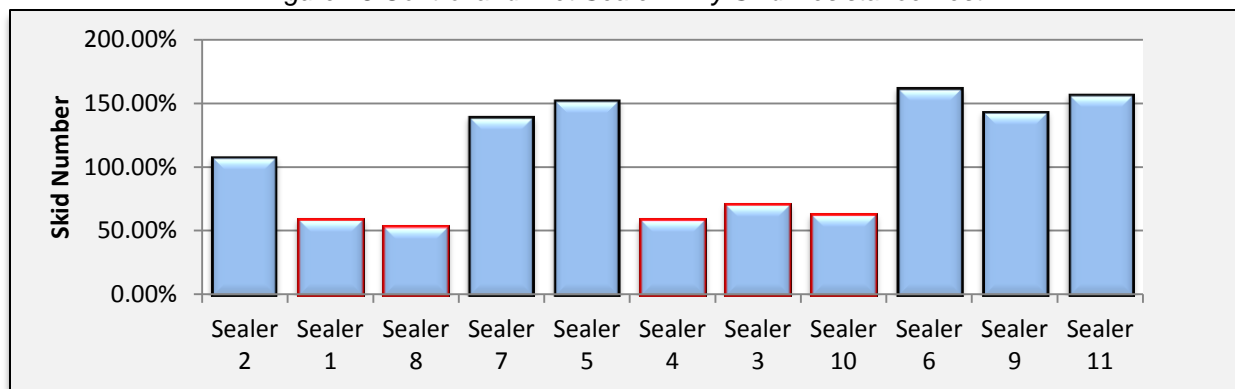
Figure 15 Control and Wet Sealer - Dry Skid Resistance Test

Highlighted in red are the sealers that had significant reductions in skid resistance: Sealers 1, 3, 4, 8, and 10.

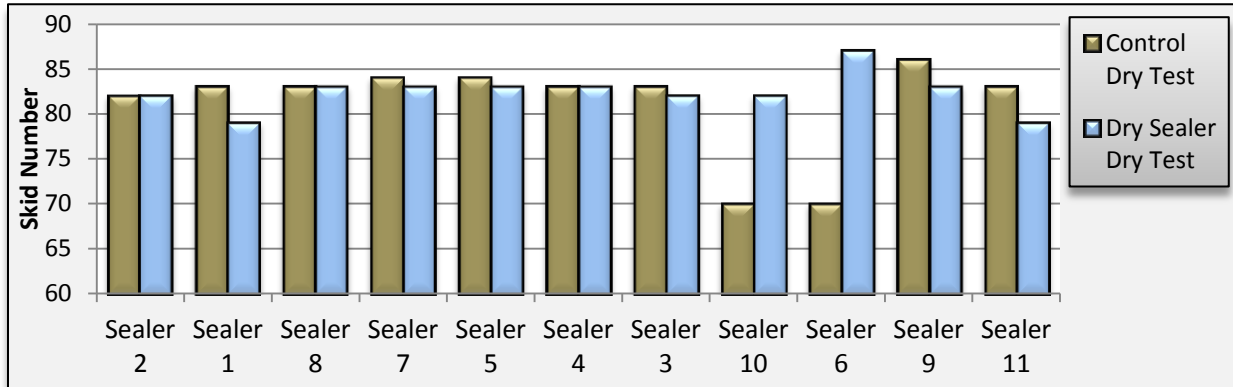
Figure 16 Control and Sealer Dry Test

The control skid results varied from SN 85 to 70. The results of the “wet” skid resistance testing results varied in SN from 85 to 75. All values were well above SN value of 32. The skid resistance percentage is shown in Figure 17.

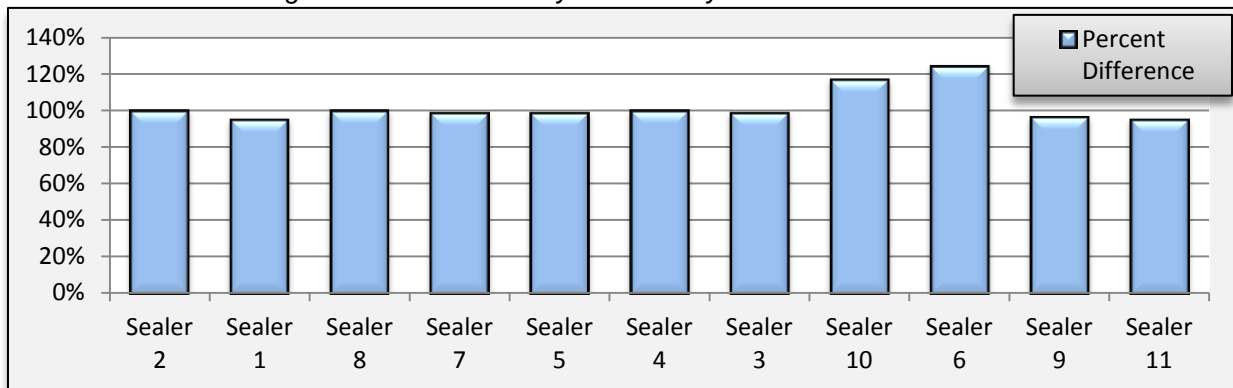
Figure 17 Control and Dry Sealer - Dry Skid Resistance Test

Under dry conditions, there was no significant reduction in skid resistance between treated and untreated pavements. The percent change in skid resistance remained near 100% for all sections.

It is, therefore, safe to conclude that the skid resistance is not reduced by sealer application when the pavement is dry.

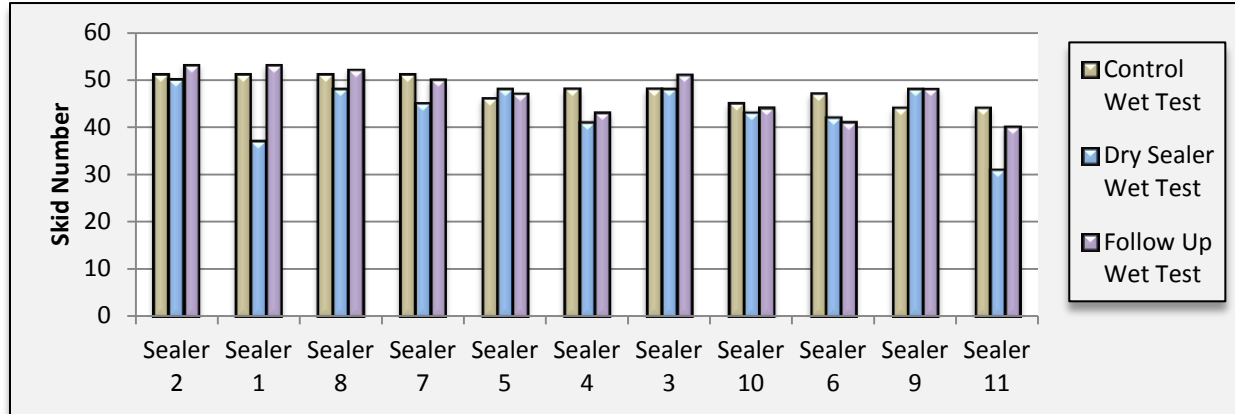
Figure 18 Control and Dry Sealer - Wet Test

The results of the “Control Wet Test” varied in SN from 51 to 44. The results of the “Dry Sealer Wet Test” varied in SN from 50 to 31. The results of the “Follow Up Wet Test” varied in SN from 53 to 40. All values were above a SN value of 32.

The value of 31 for Sealer 11 was the only one for concern, but the SN increased back up to 40 one week later, so this seemed to be either an experimental variance or an artifact of Sealer 11 itself. The skid resistance percentage is shown in Figure 19.

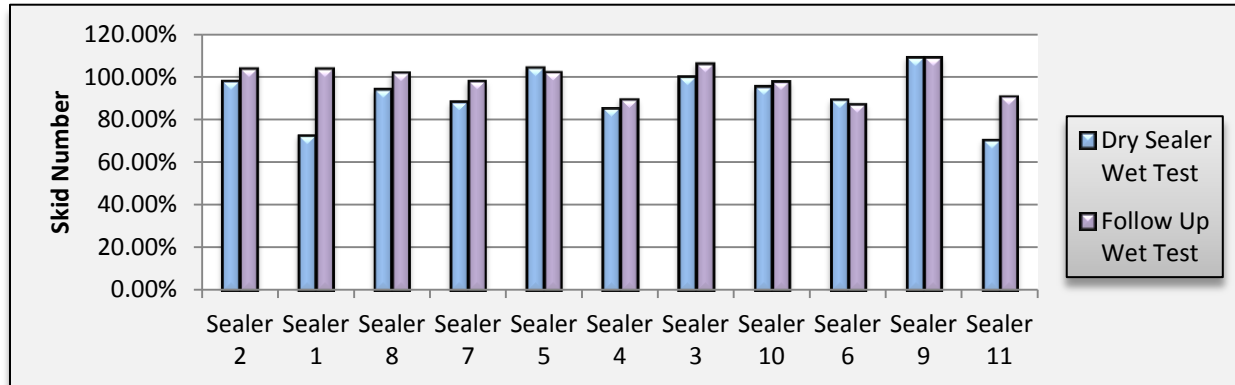
Figure 19 Control and Dry Sealer- Wet Skid Resistance Test

Under wet conditions, there was no significant reduction in skid resistance one week after the sealer application. However, there was some significant reduction in skid resistance the same day of testing. Sealers 1 and 11 had SN values at 72% and 75%, highlighted in red in Figure 19. Sealer 1 can probably be explained as being due to the sealer not being fully dry that day of testing, while Sealer 11 can probably be explained as being due to the nature of the active ingredient. Sealer 11 uses hygroscopic crystals to prevent the ingress of water; it is speculated that this may have caused the reduction in SN.

Since all test sections had SN values one week after application similar to the control values, the team concludes that the skid resistance is not reduced by sealer application.

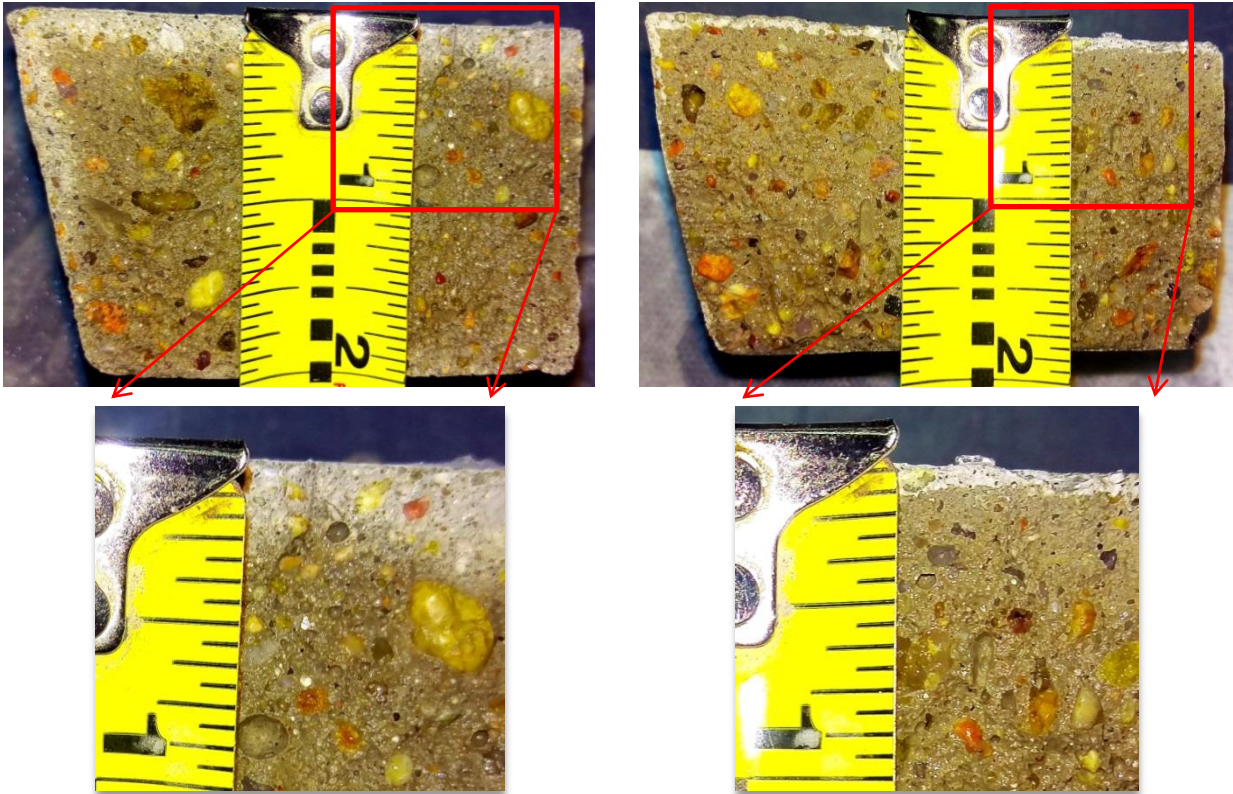
Figure 20 Contrast of a Deep and Shallow Water Repulsive Layer

The concrete blocks were split from top to bottom and then water was applied to the split surface. The resulting observation can be seen in Figure 20. Figure 20 shows a contrast between a deep and shallow water repulsive layer that is observed as the area that is lightly shaded, compared to the darker concrete below it. The deep layer on the left with a large area near the surface that is lightly shaded and the shallow layer on the right has the thin band that is very light.

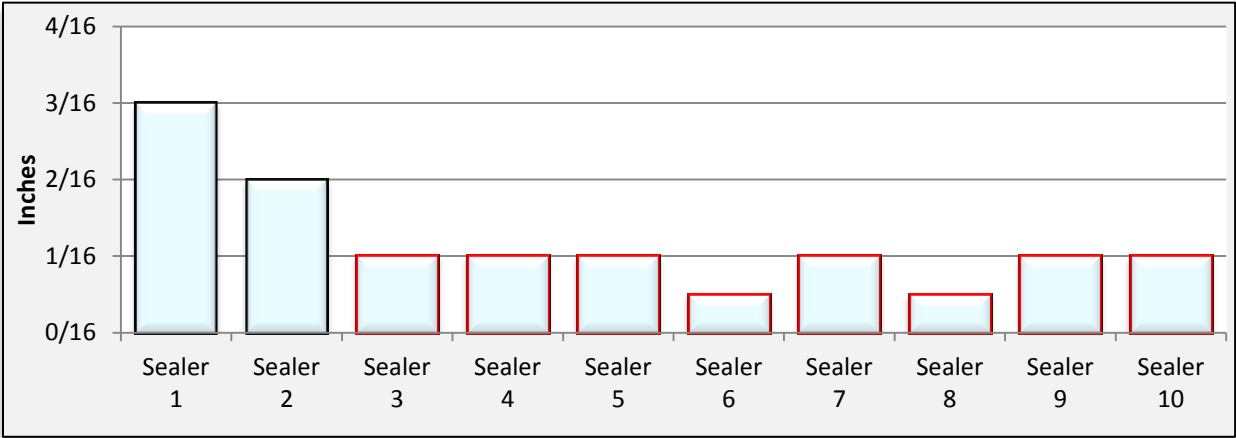
Figure 21 Depth of Penetration in Hot Chamber Laboratory Blocks

Examination of the laboratory blocks found that all of them had an obvious layer at the surface of the concrete that prevented the penetration of water. The depths of penetration in the hot chamber blocks can be seen in Figure 21. Only the results of the hot chamber block are shown because the cold chamber laboratory blocks tested had penetration depths similar to the hot chamber.

This test found that Sealers 1 and 2 were the only ones to have a depth of penetration greater than 1/16<sup>th</sup> of an inch.

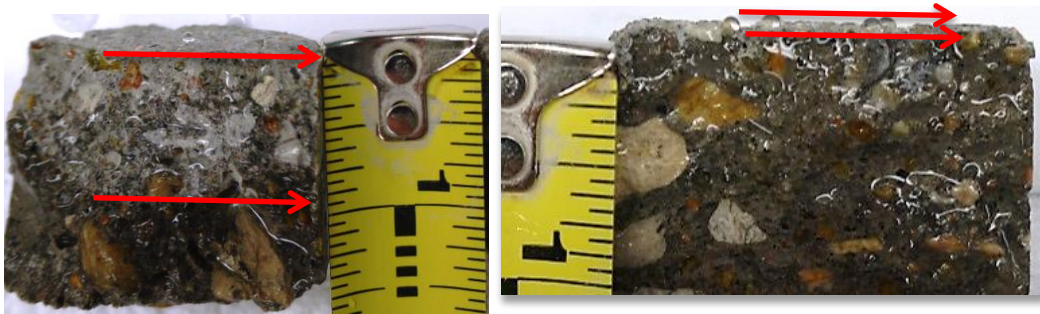
Figure 22 Contrast of a Good and Poor Depth of Penetration in a Split Core by the Visual Method

A contrast between a good and poor depth of penetration can be seen in Figure 22. The good depth of penetration can be seen in the image on the left, while the poor depth of penetration can be seen in the image on the right.

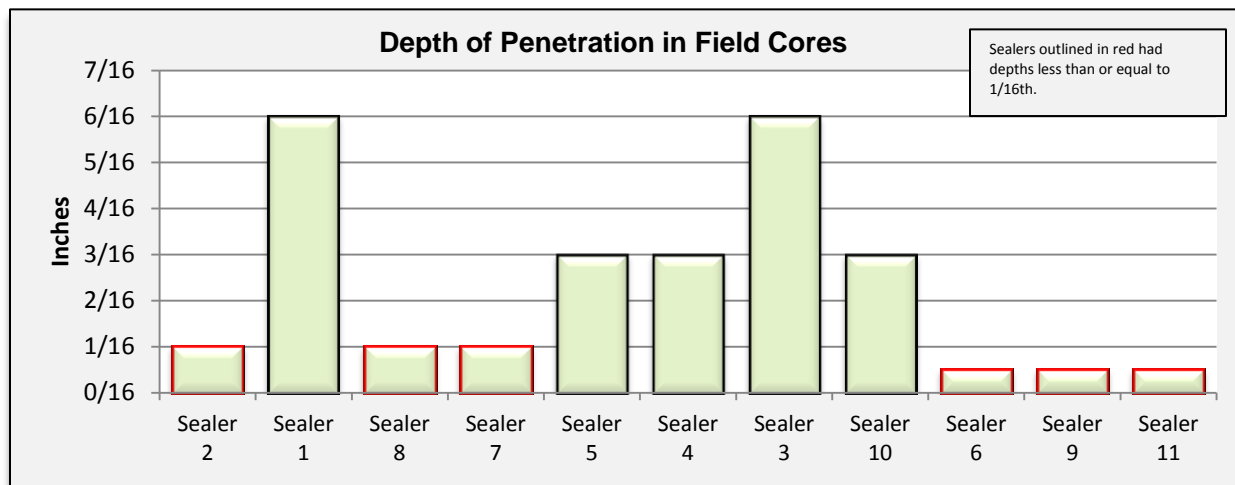
Figure 23 Depth of Penetration in Field Cores

The results of the depth of penetration in the field core can be seen in Figure 23 below.

Cores from Sealers 1, 5, 4, 3, and 10 were found to have sealer penetration depths greater than  $1/16^{\text{th}}$  of an inch, while Sealers 2, 8, 7, 6, 9, and 11 had sealer penetration depth less than or equal to  $1/16^{\text{th}}$  of an inch.

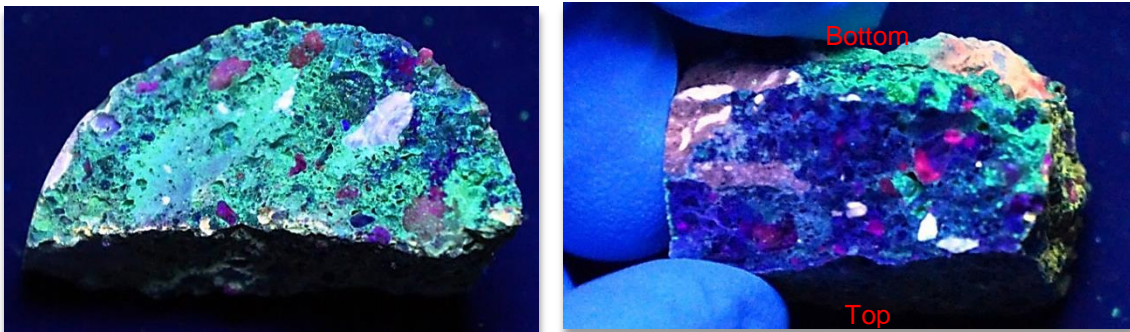
*Figure 24 Contrast of a Protected and Unprotected Split Core by the Dye Method*

Some of the cores from the water application to field cores did not show a water-repelling layer adequately, either a very narrow band, or an inconsistent repelling depth. As a follow-up, five sealers had a dye test method completed. The method involves soaking the cores in a water based fluorescent dye for four days, drying, splitting, and viewing under an ultraviolet light. By using a water-based dye, the areas of concrete that are not protected by the sealer can be highlighted. Figure 24 contrasts cores without and with sealer protection.

The image on the left shows a core that did not prevent the ingress of the water-based dye while the image on the right shows a core that prevented the ingress of the water-based dye at the surface (bottom) of the core.

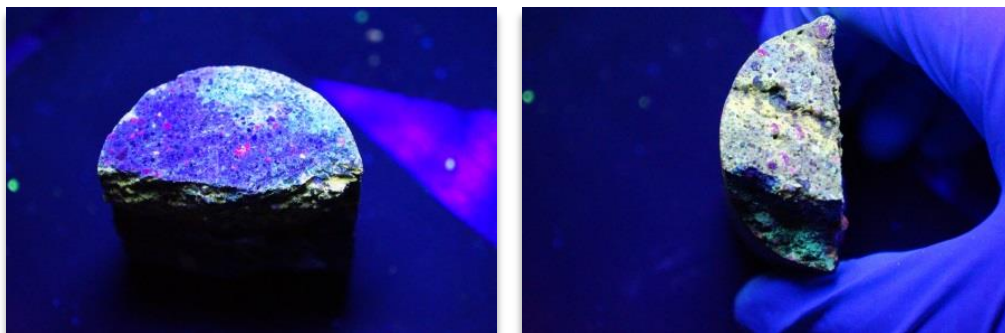
*Figure 25 Contrast of a Protected and Unprotected Core Surface by the Dye Method*

The dye method found that all five of the sealers tested did show a layer of protection provided by the sealer. Sealers 5, 8, 9, and 10 also protected the surface of the core, while Sealer 11 did not. This was attributed to the differences in sealer technologies, as Sealers 5, 8, 9, and 10 are silane-based and Sealer 11 uses hygroscopic crystals. This contrast can be seen below in Figure 25.

The core surface in the left image of Figure 25 is protected by the sealer as it is seen to be mostly blue, reflecting the UV light. The core surface in the right image of Figure 25 is not protected by the sealer as it is seen to be mostly yellow, showing the UV light being absorbed by the dye fluorescing yellow.

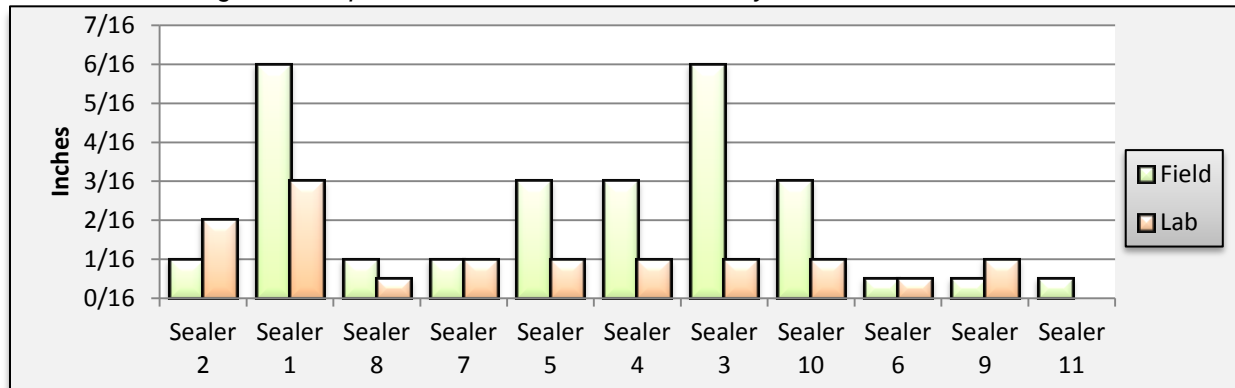
Figure 26 Depth of Penetration in the Laboratory Blocks and Field Cores

There was some correlation between the lab and field results, shown in Figure 26.

The depth of penetration was greater in the field cores than in the laboratory blocks and a general relationship can be seen between the shallow and deep sealers.

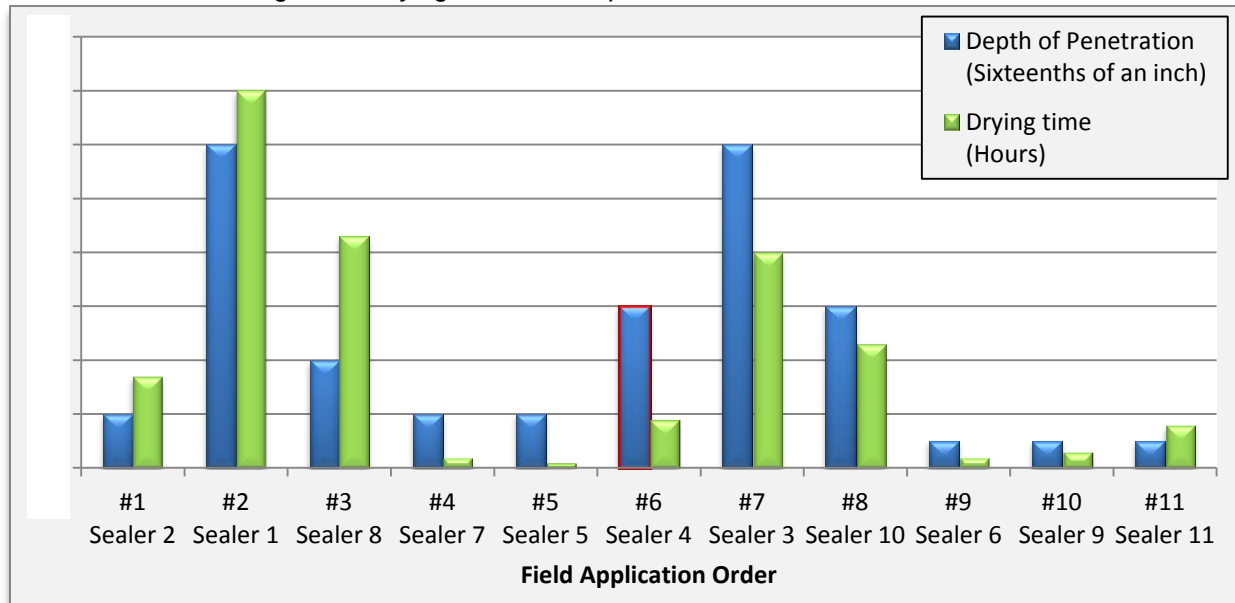
Figure 27 Drying Time and Depth of Penetration in Field Cores

Overall, there appears to be a direct relationship between the drying time and the depth of penetration. Fast-drying sealers had moderate shallow penetration and slow-drying sealers had the deepest penetration.

Sealer 8 had a moderate drying time and penetration; Sealers 5 and 4 had fast drying times and some penetration. The section that took longest to dry had the greatest depth of penetration.

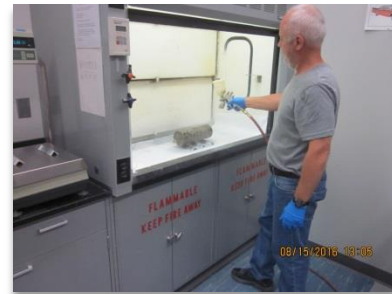
Figure 28 Sealer Application to Concrete Cores Using a Handheld Sprayer

Except for the untreated control core 12, each core had sealer applied to the entire surface with a handheld sprayer, as shown in Figure 28. Initially, the research team tried to meet the minimum recommended coverage on the core for Sealer 1. Due to the round shape of the core, the sealer would run off after slightly greater than half of the minimum recommended coverage had been applied. To maintain consistency among cores, the sealers were applied at half of the minimum recommended coverage.

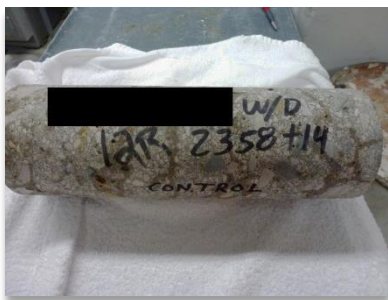
Figure 29 Untreated Control Core After the Wet and Dry Test

The results of this investigation were promising. The untreated control core in Figure 29 shows lots of cracks and dark-shaded lines indicative of small cracks associated with ASR. The sealed core in Figure 30 shows little-to-no cracking, even though the aggregate is reactive. This means that the sealer minimized the deleterious effects of ASR. The results are shown in Table 6.

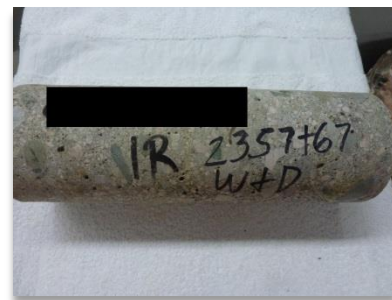
Figure 30 Sealer Treated Core After the Wet and Dry Test

Review of all the cores found that Sealers 2,1,8,4,3,10, and 9 did not show any cracking or moisture penetration.
