Effect of Penetrating Concrete Sealers on Pavement Marking

Completion Date (May 2025)

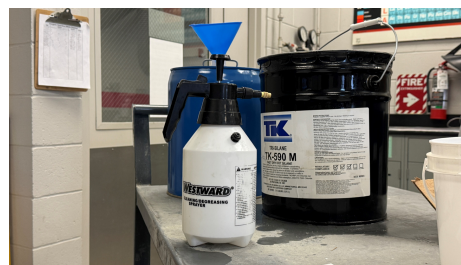
Figure 1: This image shows the two different sealers used, with TK-590 in the black and BHN in the blue. The white container is a standard sprayer used to spray sealer onto concrete beams in the lab.

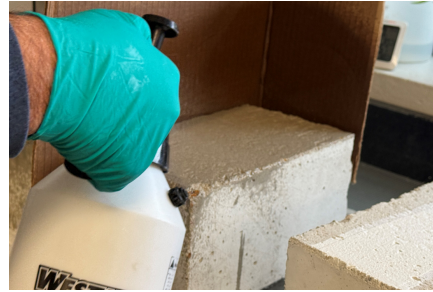
Figure 3: This image illustrates the application of sealer onto the slabs.

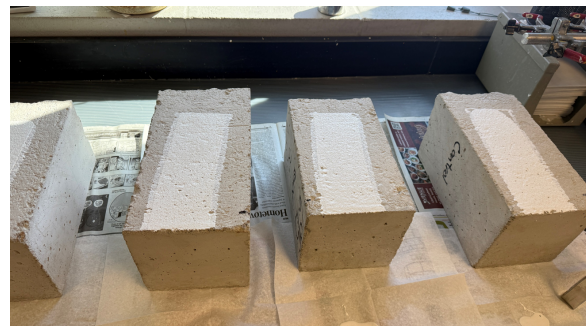
Figure 4: Concrete beams BHN-P, BHN-S, and Control are shown (from left to right) once all paint and sealer was applied.

The concrete beams are shown in Figure 4 and Figure 5 after the paint had dried. Overall, the paint was applied uniformly across the concrete beams; however, the Control and BHN-S samples had uneven coverage in the upper right-hand corners. This resulted in exposed areas of concrete, which is important consideration when evaluating paint adhesion.

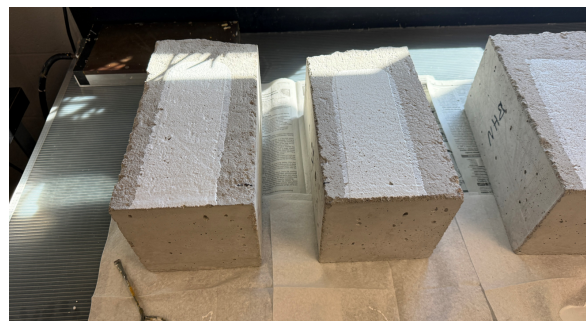
Figure 5: Concrete beams TK-P and TK-S are shown (from right to left) once all paint and sealer was applied.

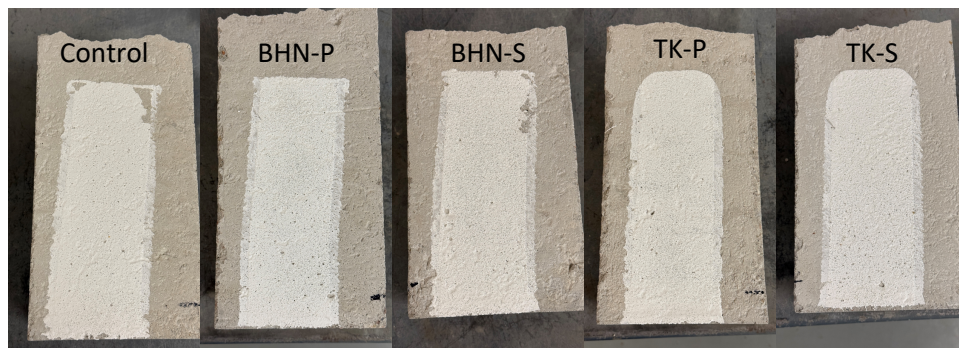
Figure 6: This image shows the 5 different concrete beams post scraping. While both Control and BHN-S had areas without paint, this was a paint application issue, not a paint adhesion issue. The paint was not applied at those locations.

The painted section on each beam was scraped, shown below in Figure 6. Based on this testing, the PCC Engineer determined that the paint adhered to the surface in all configurations. This conclusion was drawn through a qualitative assessment by comparing each sealer-paint sample to the control.
