**Report SPR-P1(17) M061**

**Final Report**  
26-1121-4036-001

## **Nebraska Specific Slope Design Manual**

# Nebraska Specific Slope Design Manual

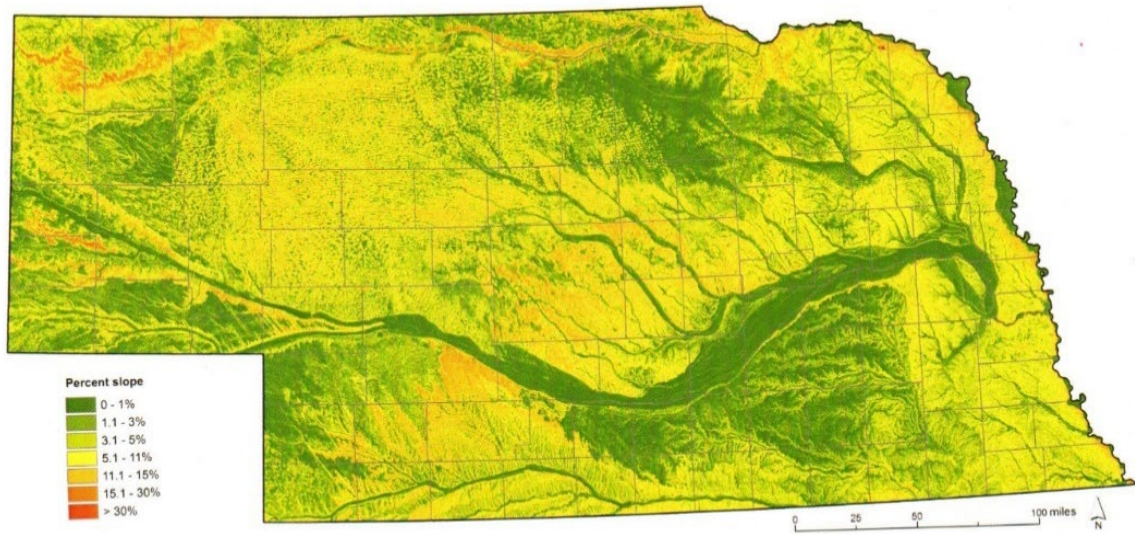
**Figure 1.4** Surface topographic slope (After Eversoll, 2013)

With all the geological conditions discussed earlier, the slopes may not fail if the slope angles are gentle enough. Figure 1.4 shows the surface slope in percentile. The slopes along the Niobrara River, Missouri River, and small tributary rivers to the Platte River appear high. The combination of steep slope, Loess, and rainfall may create conditions susceptible to landslides in these areas.

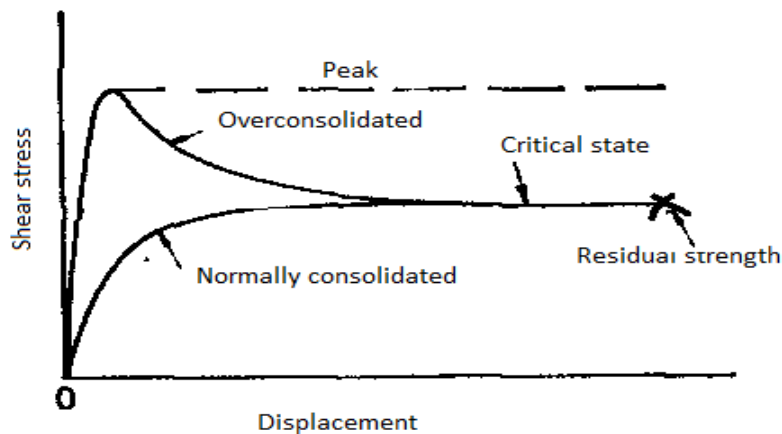
**Figure 2.1** Shear test result on clayey soils under drained condition (Skempton 1970)

The behavior of overconsolidated soils is different from that of normally consolidated soils. For undrained conditions, overconsolidated soils tend to develop negative excess pore pressure and result in high shear strength, while the behavior of normally consolidated soils is opposite and results in lower shear strength as depicted in Figure 2.1.

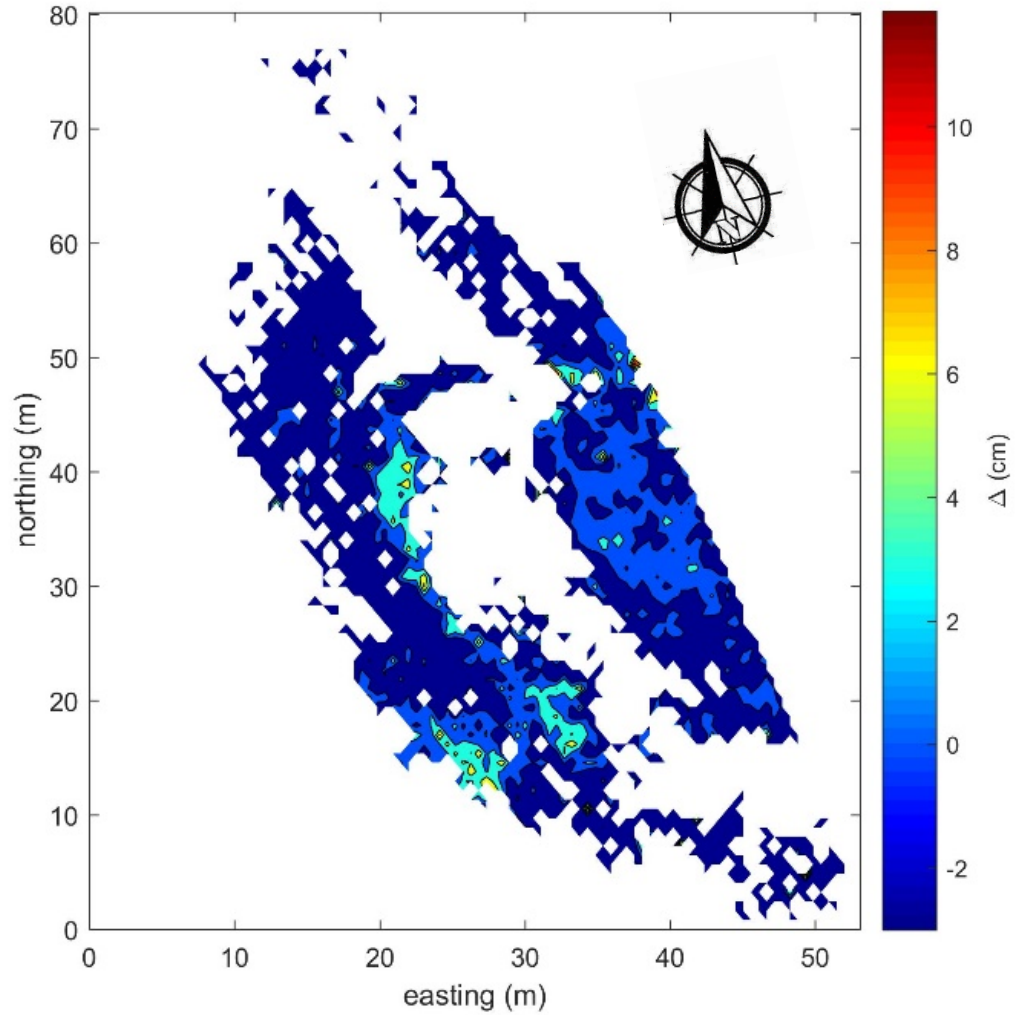
**Figure 2.3** UAS (Unmanned Aerial System; a.k.a. Drone) based deformation profile for slope at I-180/Superior St. (Note: High deformation along the newly formed crack is pronounced with bright green color, Courtesy of Dr. Richard Wood.)

In addition, UAS based deformation surveying system showed comparable deformation profile to that from total station based surveying result. UAS, however, Figure 2.3 shows the deformation around the newly developed cracks, which is in the range of 0.02 ft/month.

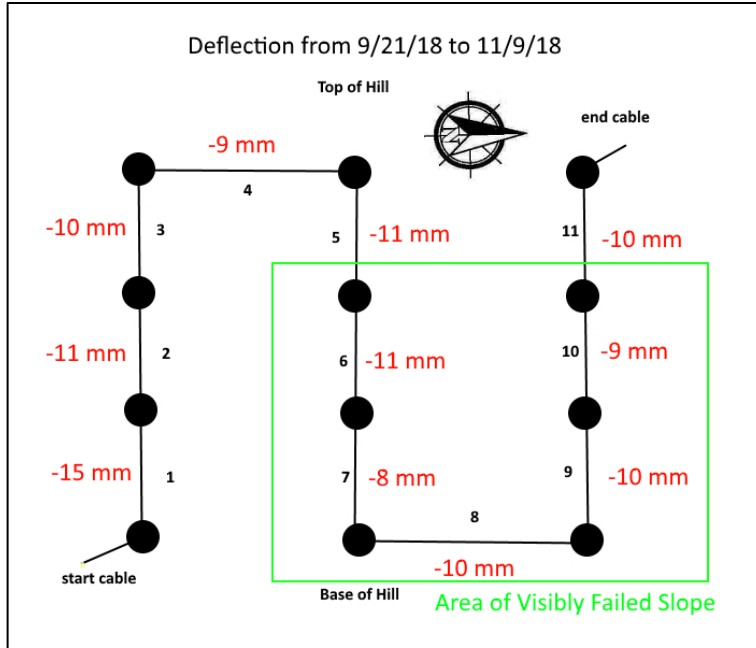
**Figure 2.4.a** Fiber optic based DSS (Distributed Strain Sensing) result for slope at I-180/Superior St. (Note: Left is South side.)

Fiber optic cable based DSS system showed relative movement between anchoring points installed in the slope as a grid pattern. This DSS results were expected to show sections that initiate the movement and other sections that follow the failed sections. Figure 2.4.a shows the deflection between Sept. 21<sup>st</sup>, 2018 and Nov. 9<sup>th</sup>, 2018. Each section showed a negative deflection, which represents a lowering of strain, convergence of posts, and shortening of cable sections. During this time period, the deflection of each section was close to 0.7mm/month (0.02 ft/month), with the greatest magnitude of deflection shown in section 1.0 mm/month (0.03 ft/month). It agreed with

surveying and UAS results. Figure 2.4.b shows the deflection between Jan. 17<sup>th</sup>, 2019 and Apr. 17<sup>th</sup>, 2019. Notice the area outlined in green, which is the area of slope that had visibly failed prior to beginning data readings. During this time period, the deflections of most of the sections were around 17 mm/month (0.6 ft/month), except for the vertical sections on the area of visibly failed slope: Sections 6, 7, 9, and 10. These sections had deflections of around 33 mm/month (0.11 ft/month) which is about twice the magnitude of deflection as the other sections. This may indicate that the bottom of the hill (sections 6, 7, 9, and 10) is the critical section that initiated the progressive slope failure. Comparable surveying and UAS based deformation measurement could not be conducted due either to the damage to the surveying pegs or unfavorable weather condition.

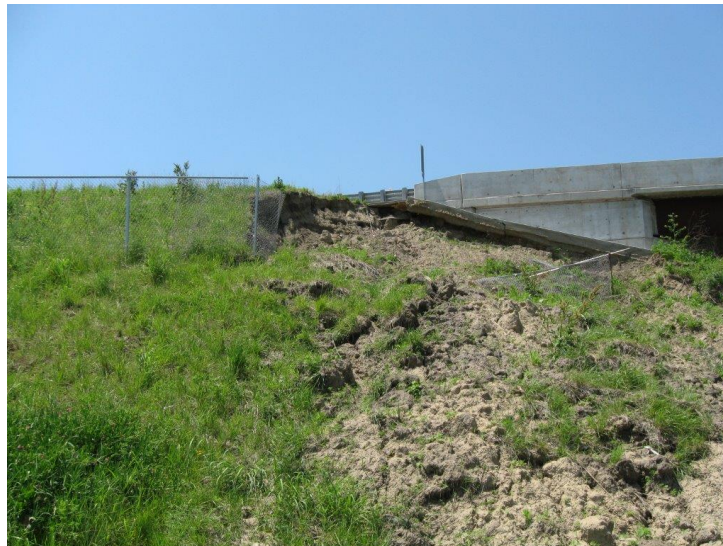
**Figure 3.2** US-75, Mudslide (NDOR, 2015)

layer of fine silty sand that is subject to fail during rainy seasons. The height of the selected slope cross section is at 39.56 ft with a slope angle of approximately 23 degrees. Scene of failure is shown in Figure 3.2.

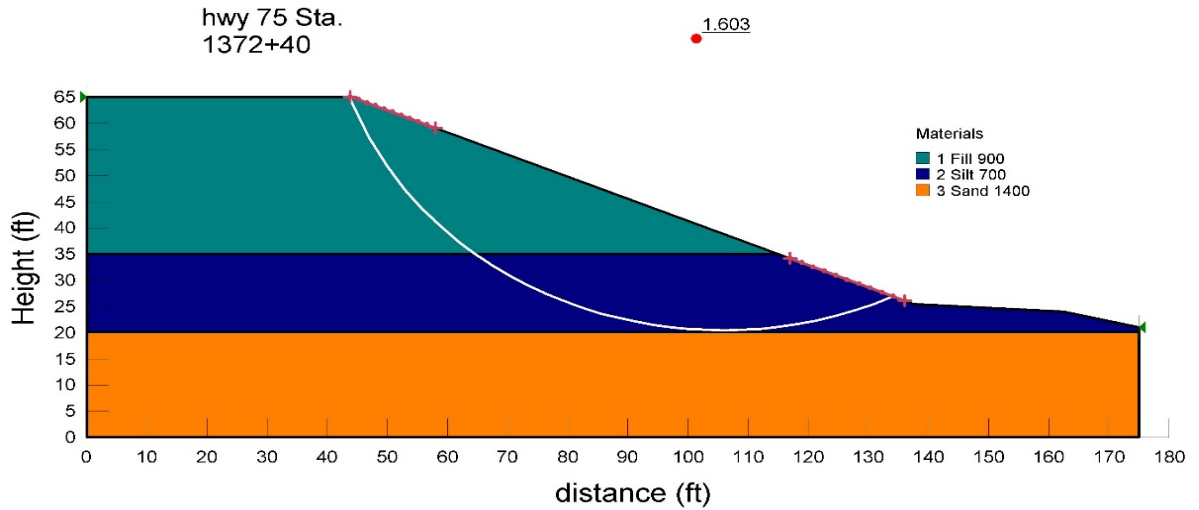
**Figure 3.3** US-75, Mudslide

Figure 3.3 shows the modeled slope based on design soil parameters, from which a factor of safety of 1.603 was obtained. This is an acceptable factor of safety, indicating a stable slope. In this case, the potential slip surface with the lowest factor of safety started at nearly the top edge of the slope, and after passing through the silt layer, it ended at approximately the toe of the slope.

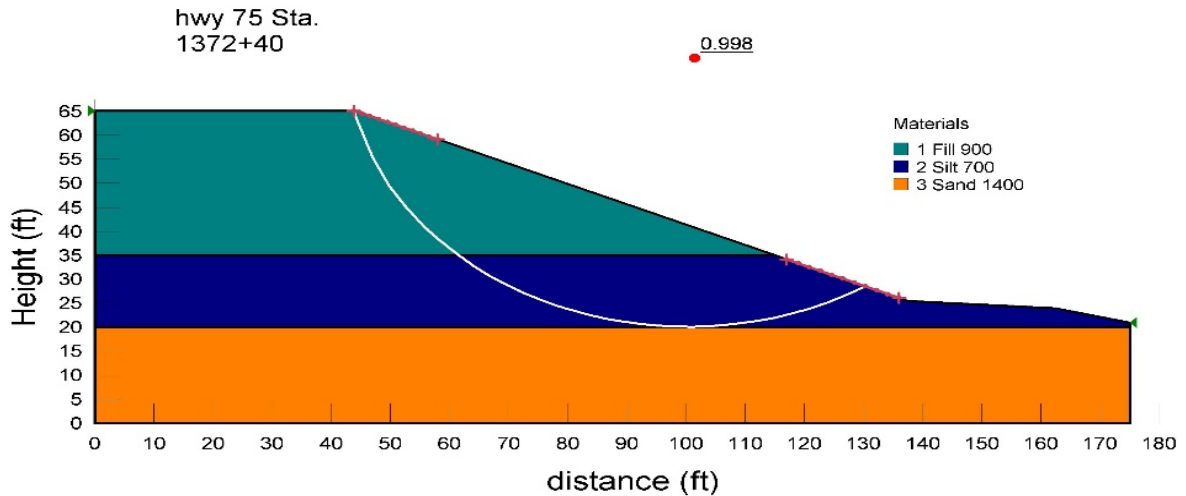
**Figure 3.4** US-75, Mudslide, back calculated result

For back analysis, the internal friction angle of the soil at failure was assumed to be equal to zero considering that the soils are mostly cohesive. Using a trial and error method, the shear strength of the soil was evaluated to reach FS=1. Figure 3.4 depicts the back calculated slip surface and factor of safety. The slip surface location remained unchanged in comparison to Figure 3.3, but resulted in a factor of safety of unity.

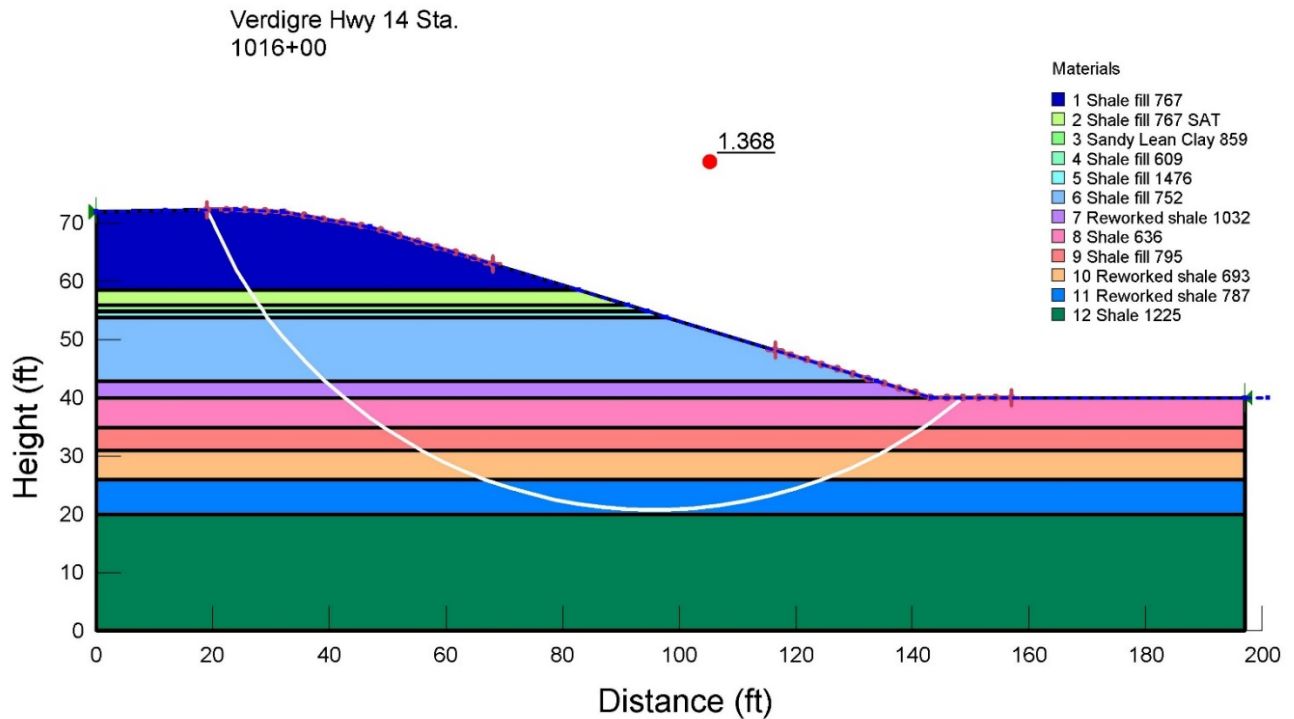
**Figure 3.6** Factor of safety calculated for Verdigre slope (Highway 14)

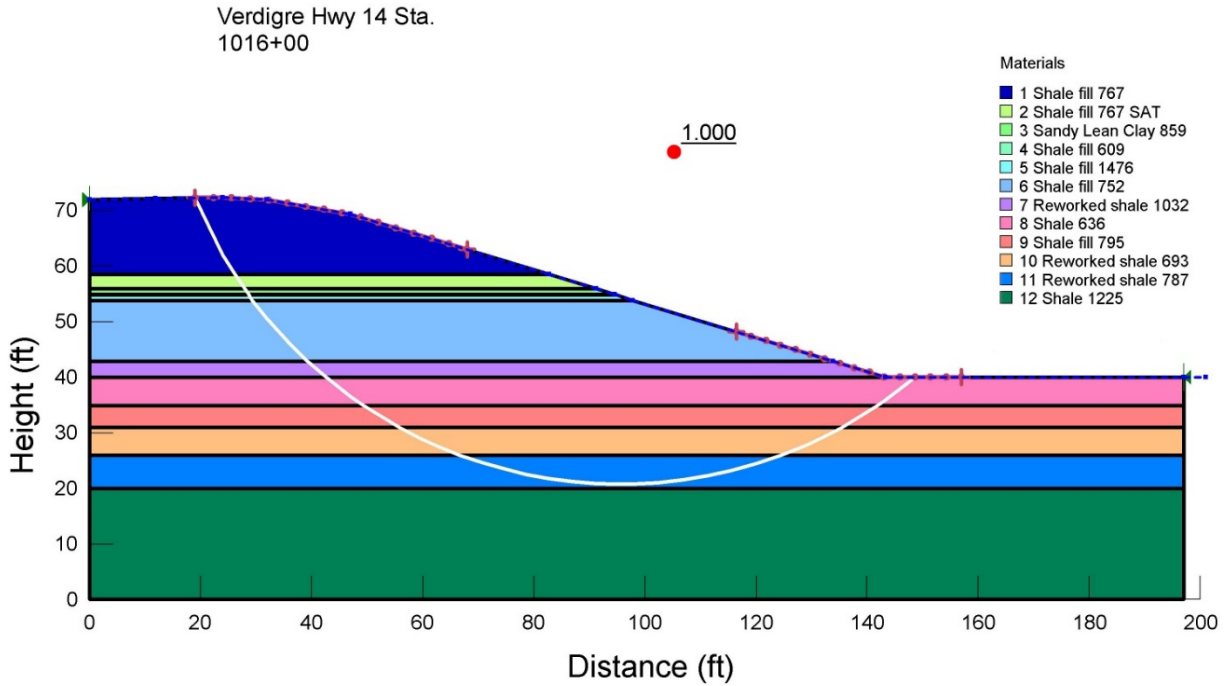
**Figure 3.7** Factor of safety from back analysis for Verdigre slope (Highway 14)

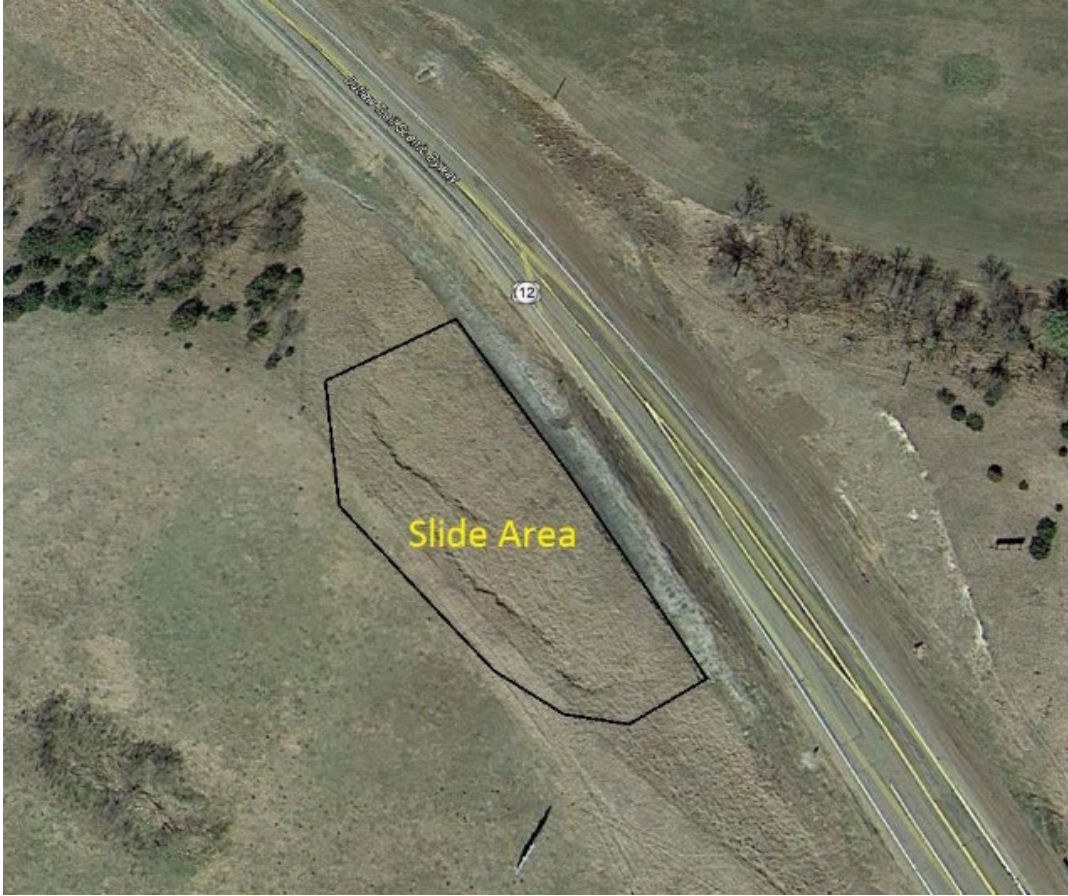
**Figure 3.11** Cracks on the top of the Spencer slope, (NDOR 2015).

As shown in Figure 3.11, the failure of the slide is indicated by two large longitudinal cracks near the top of the slope. This area contains both shale and loess, both of which are easy to fail in the presence of water. The bore log data showed two weathered and two un-weathered layers of stiff shales. Undisturbed samples were tested in the laboratory using direct shear tests. The shear tests of the samples did not show a well-defined shear surface. They rather showed intrusion of different colored materials into the sample and occasional cracks.

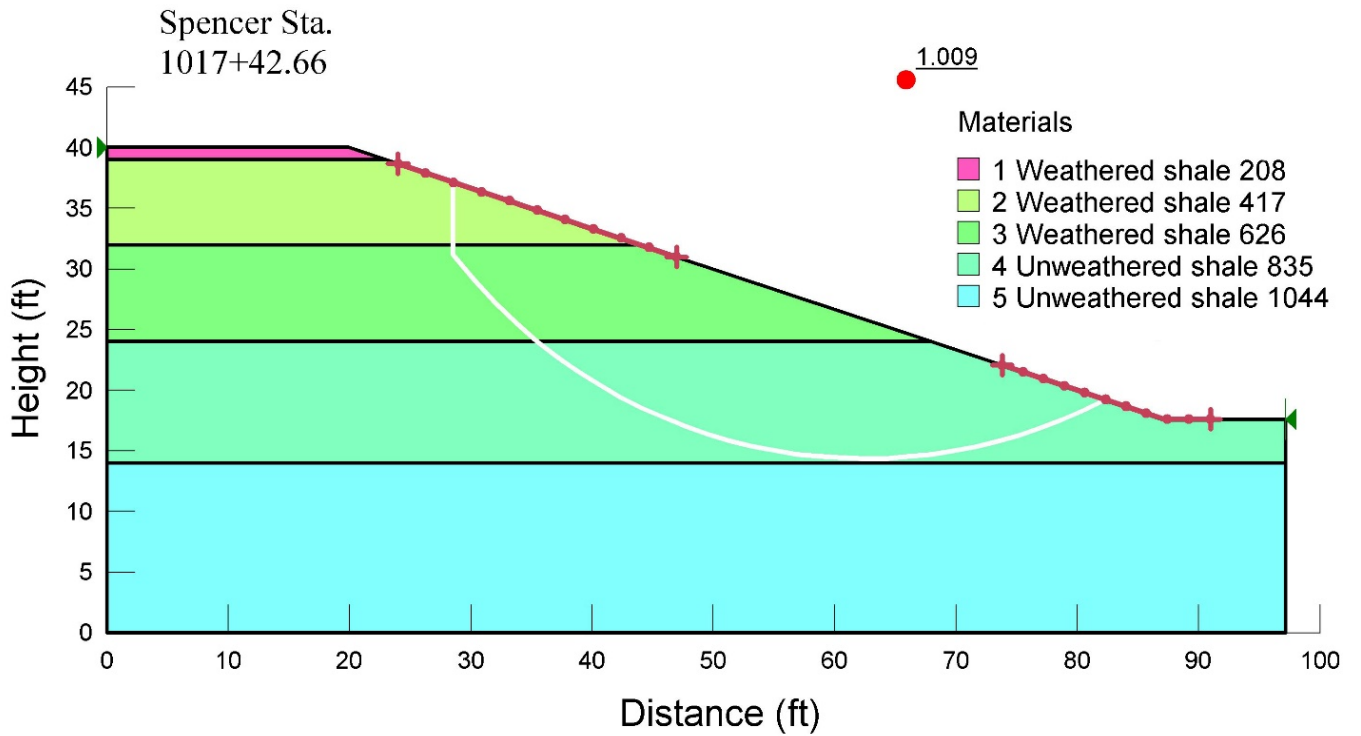
**Figure 3.13** Factor of safety from back analysis for Spencer slide

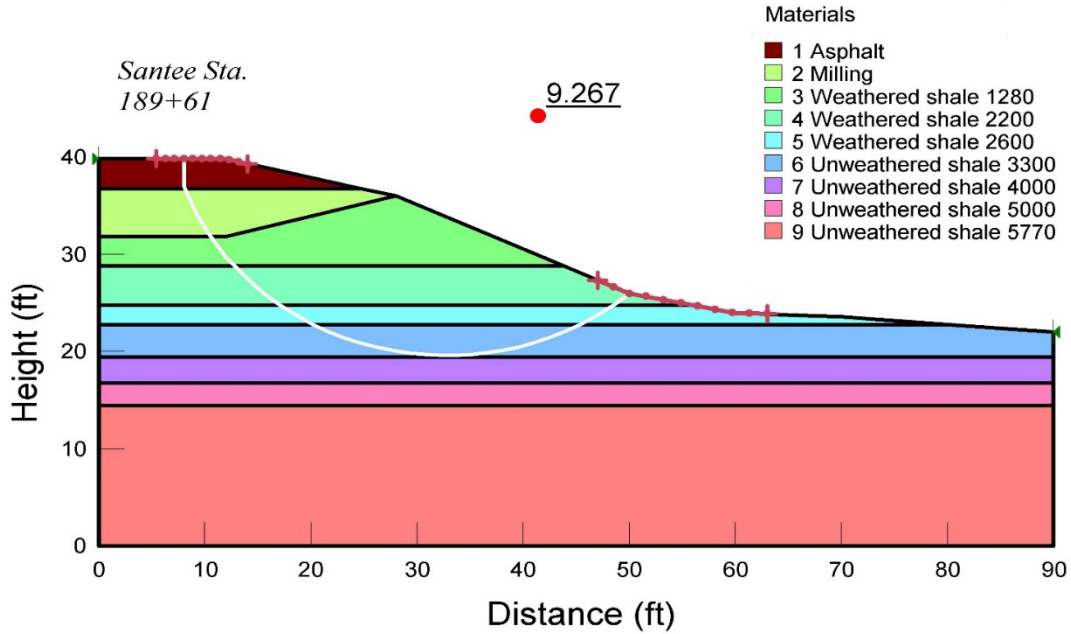
Figure 3.15 Factor of safety calculated for Santee slide

As illustrated in Figure 3.15, the initial factor of safety (9.267) for this project turned out to be quite high. The failure occurred along a slip surface that passed through weathered shales.

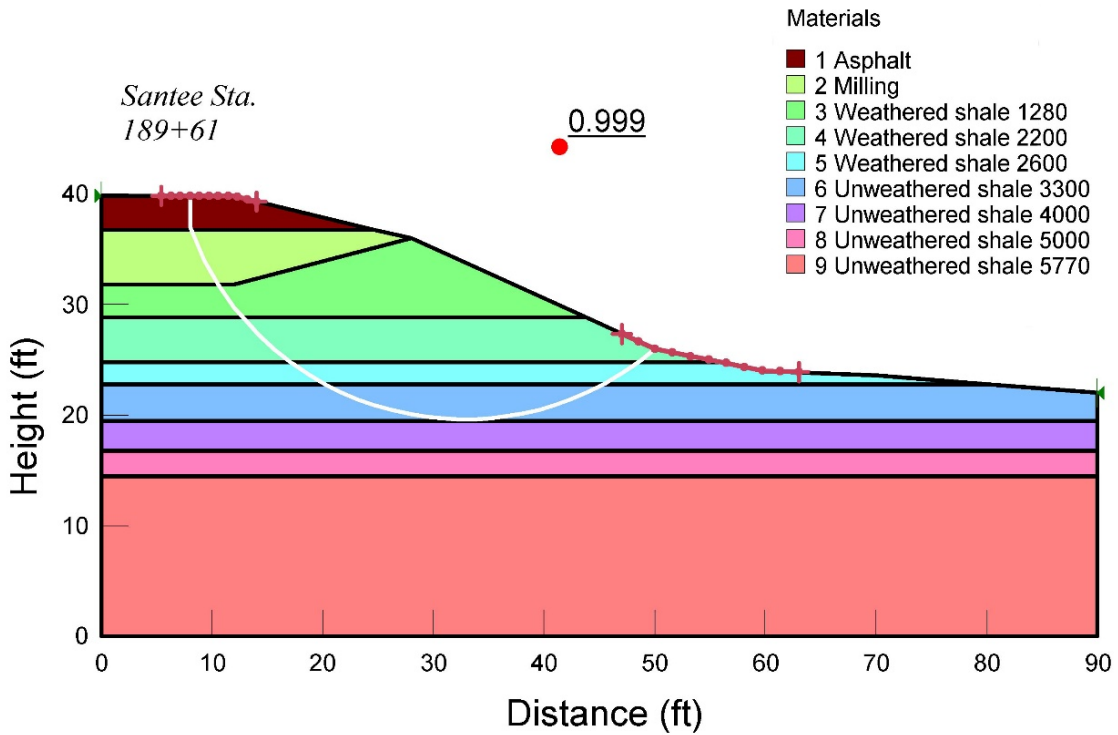
Figure 3.16 Factor of safety from back analysis for Santee slide

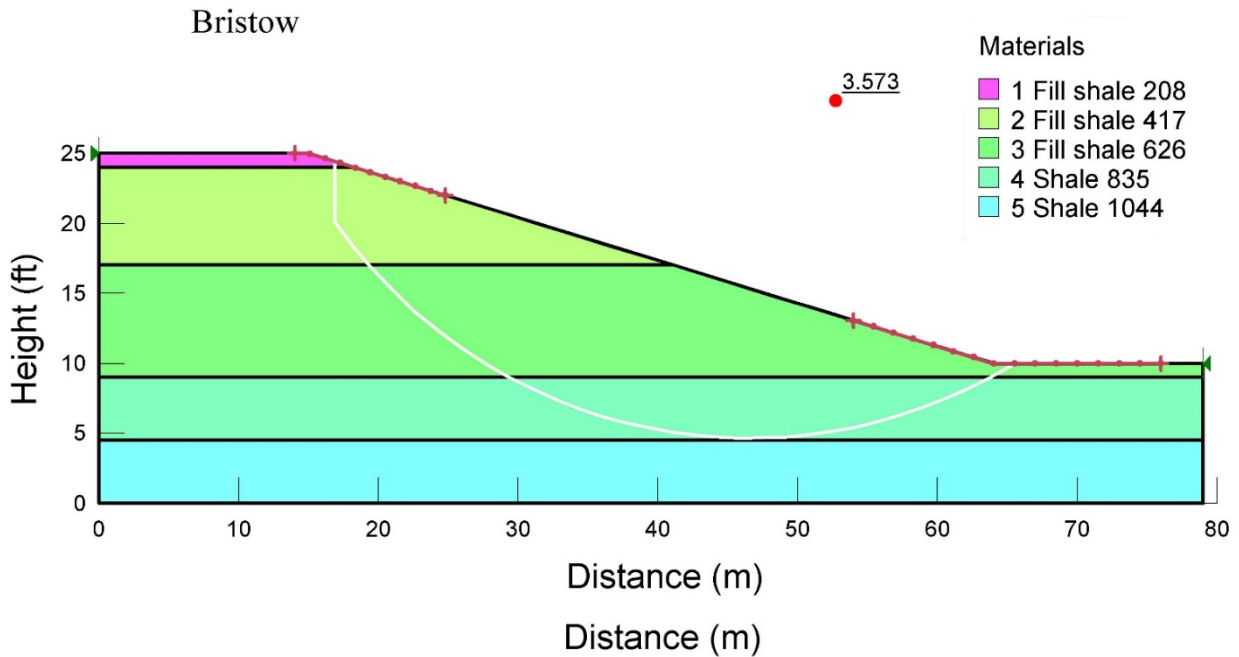
**Figure 3.18** Factor of safety calculated for Bristow Slide

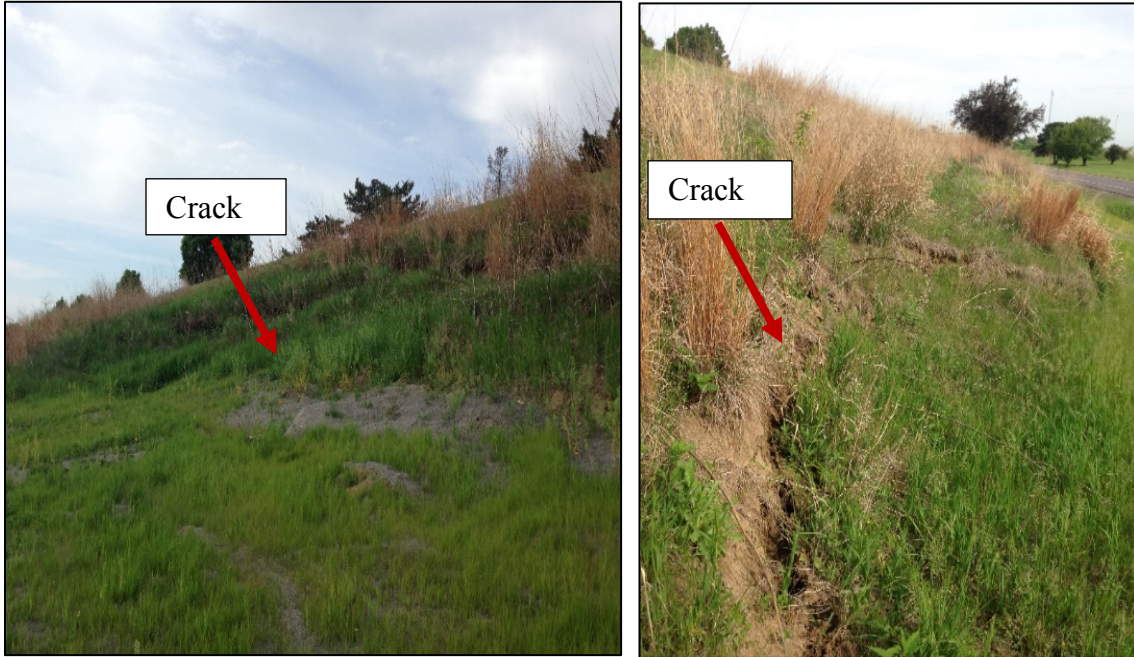
**Figure 4.1** Failed slope at I-180 and Superior Street (2017)

Three different sites were selected for sampling. The first boring log was drilled in a failed slope located at I-180 and Superior St. in Lincoln, NE. The slope was a cut slope on highway I-180. Site visitation was conducted on the slope to have a better understanding of the geometry of the slope (Figure 4.1). It seemed that there was a rotational movement in this slope, which started from the top and ended at the toe. Furthermore, several longitudinal cracks were observed around the top of the slope. The samples were taken from the top of the slide to have a close enough soil stratigraphy similar to that of the failed slope. The dominant formation of this area is usually a layer of Peoria loess overlaid on the glacial till formation. Information regarding the slope's material is discussed in the next sections.

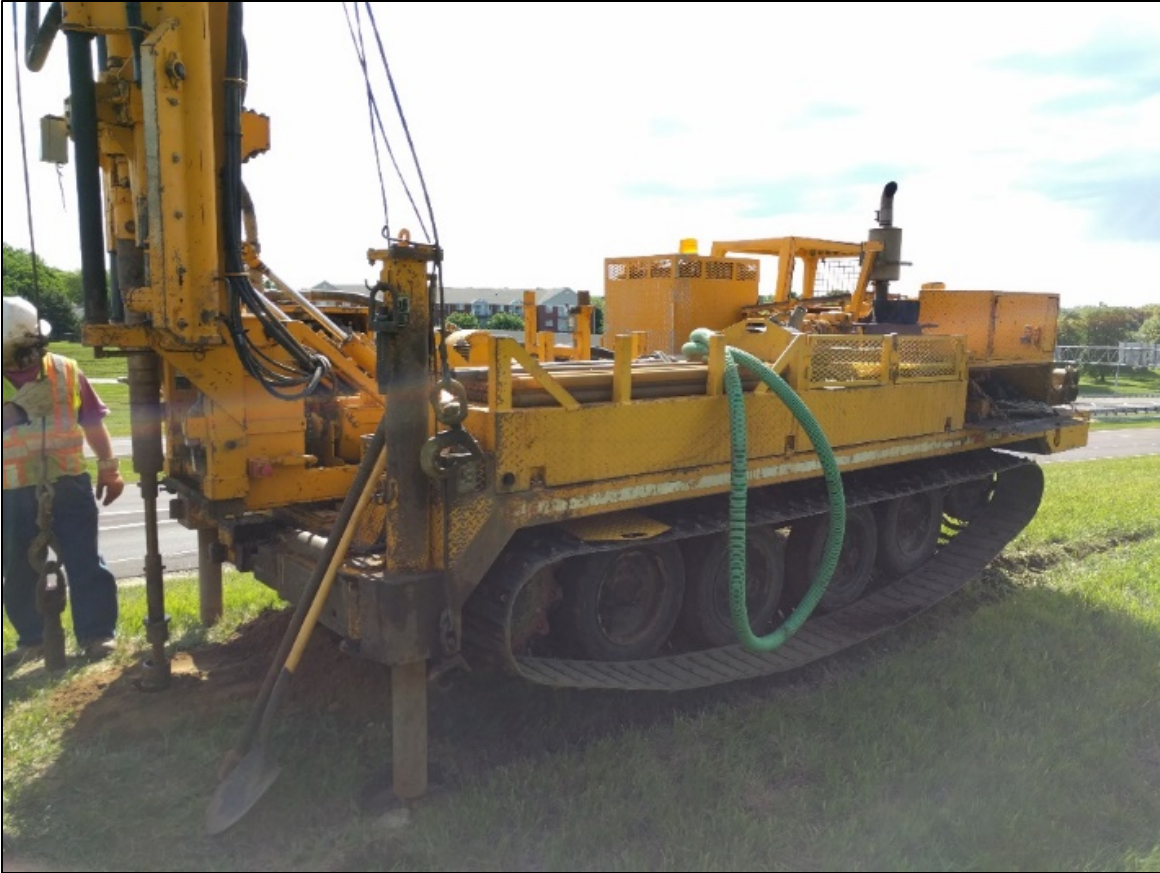
**Figure 4.2** Drilling equipment (I-180 and Superior St.)

Drilling and sampling were performed by the Nebraska Department of Transportation using hollow steam augurs and Shelby tubes (Figure 4.2). After reaching the desired depth, the Shelby tubes were used for taking undisturbed samples.

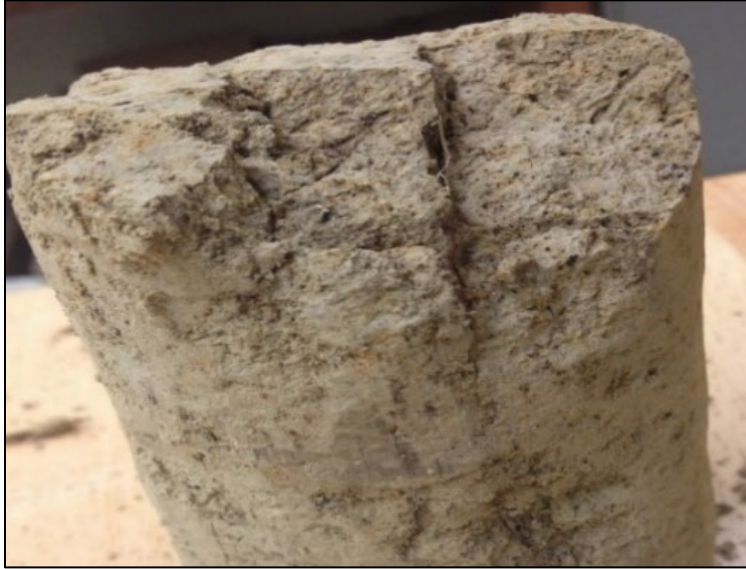
**Figure 4.3** Cracks and fissures inside the Shelby tube (IS-2.5) from shallow depth (I-180 and Superior St.)

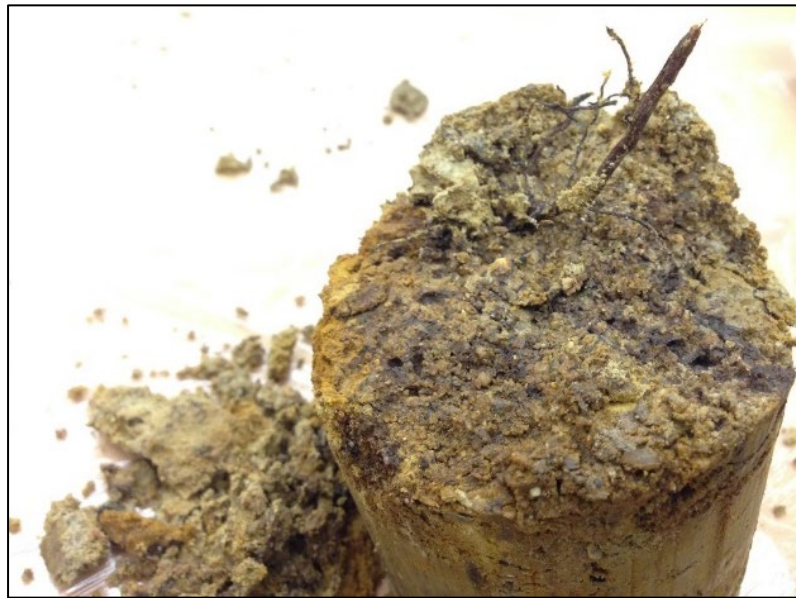
**Figure 4.4** Non-uniformity and cracks in Sample IS-14.5 (I-180 and Superior St.)

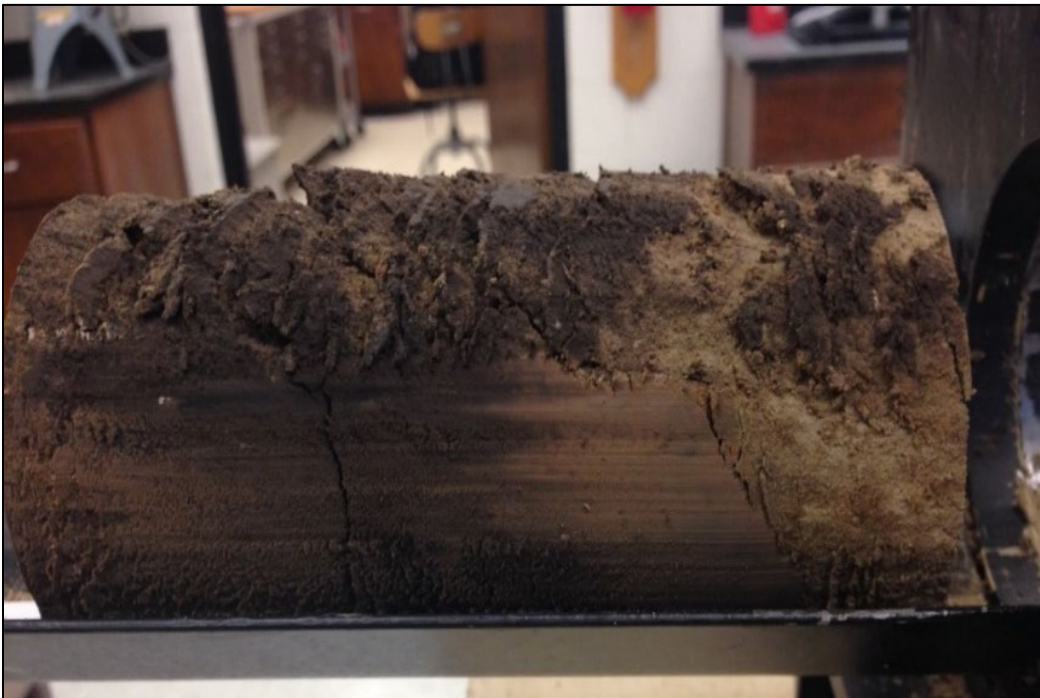
**Figure 4.5** Cracks on sample NL-14.5

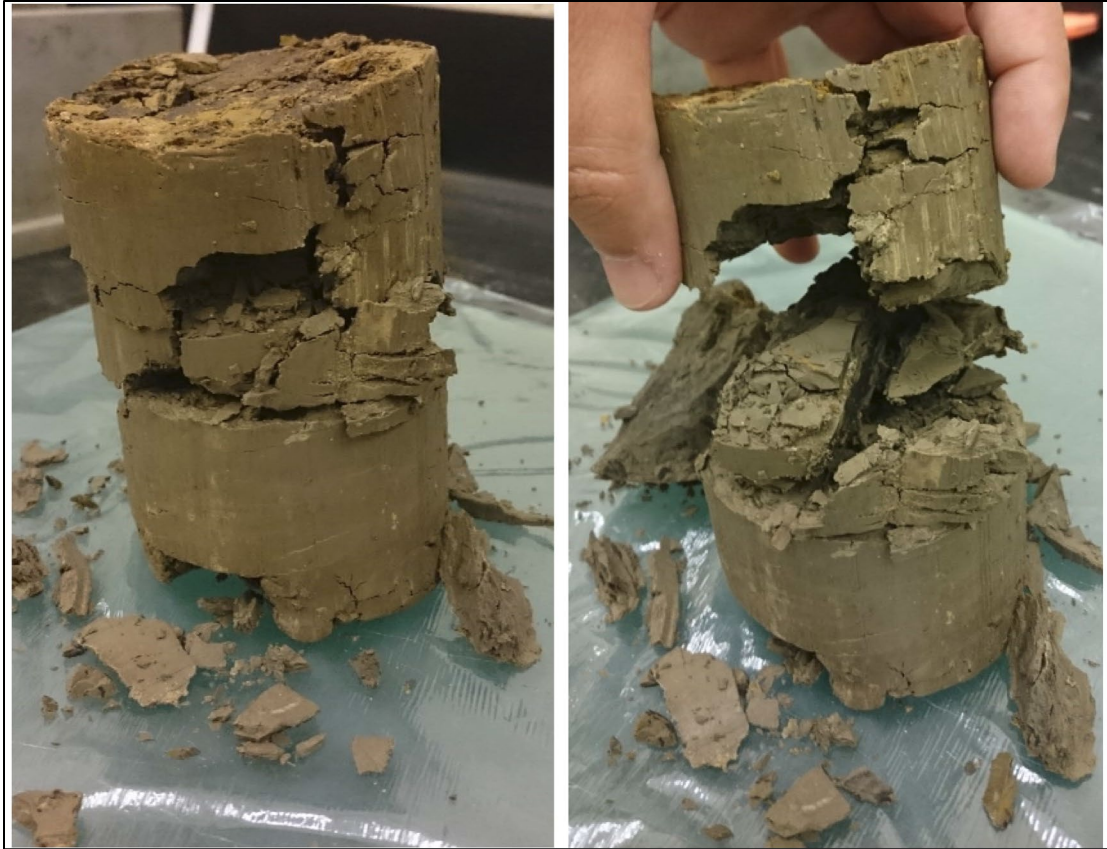
**Figure 4.6** Cracks and fissures on samples from Spencer slope

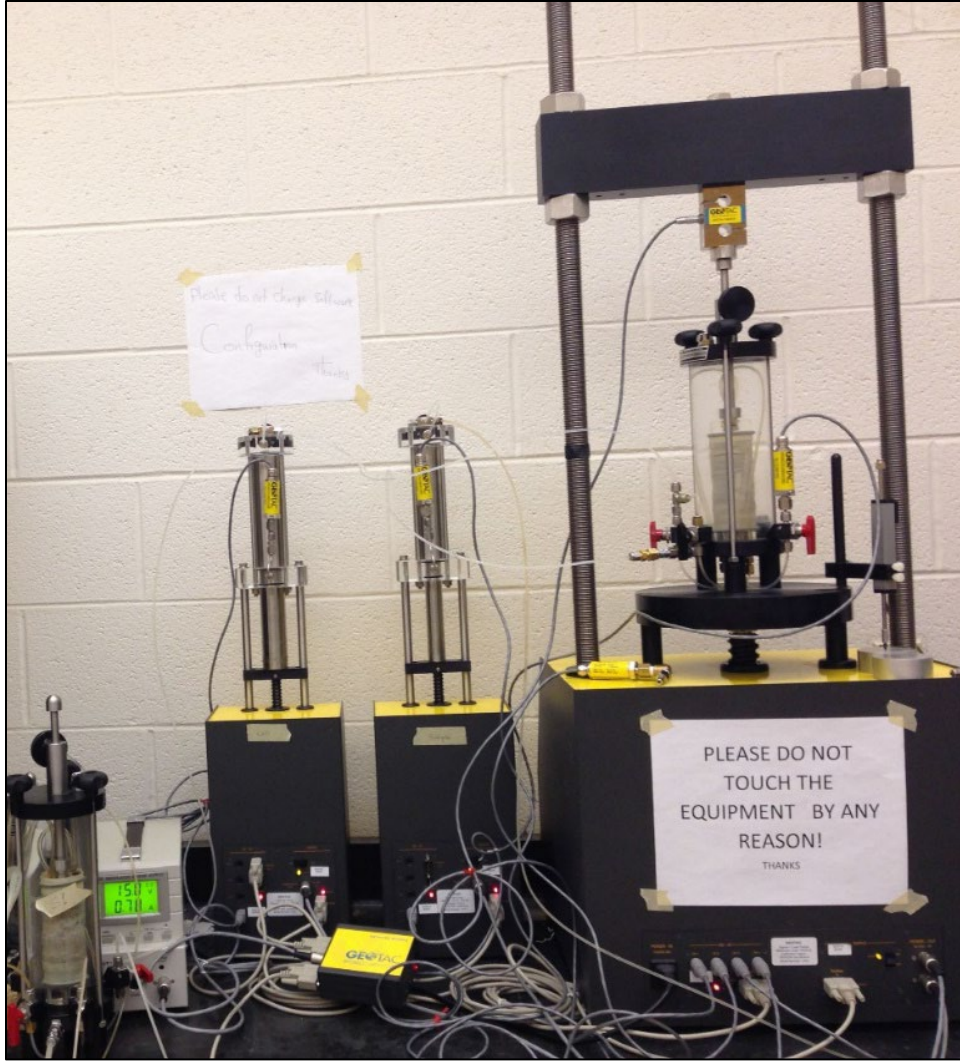
**Figure 4.7** GeoTac automated triaxial apparatus

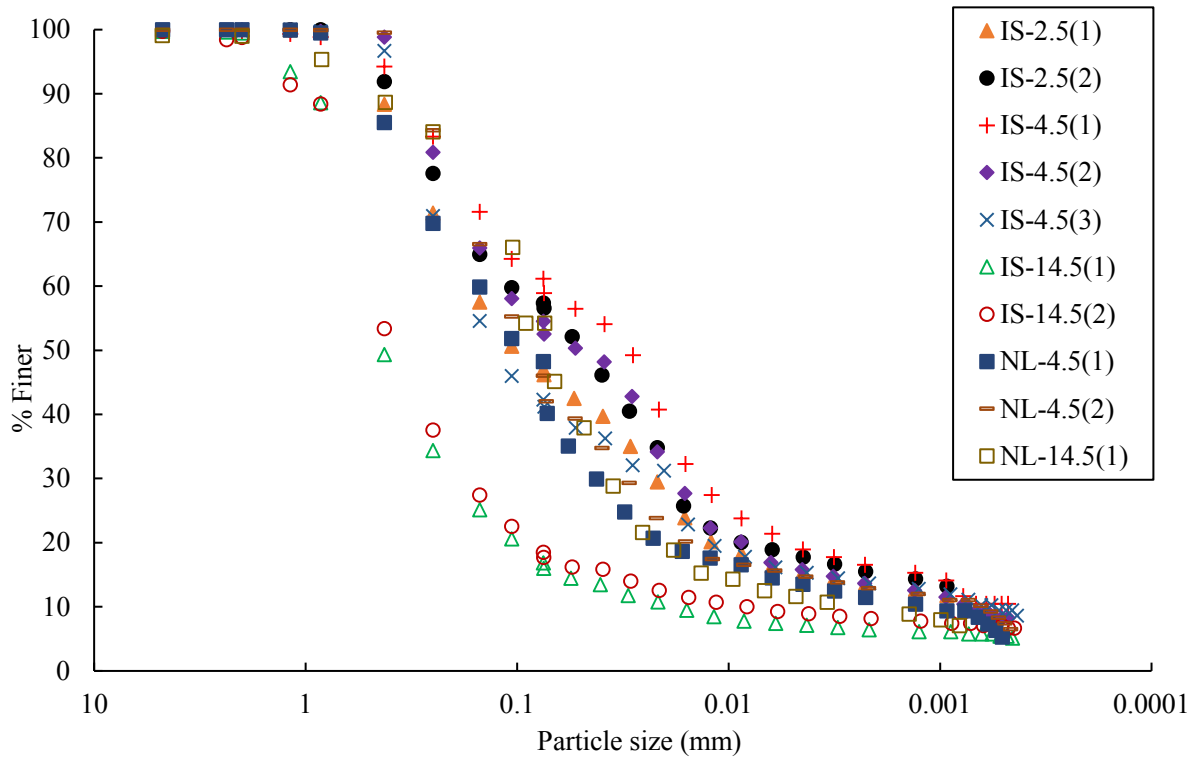
**Figure 5.1** Gradation of samples from I-180 and Superior St., and North-Loup failed slopes

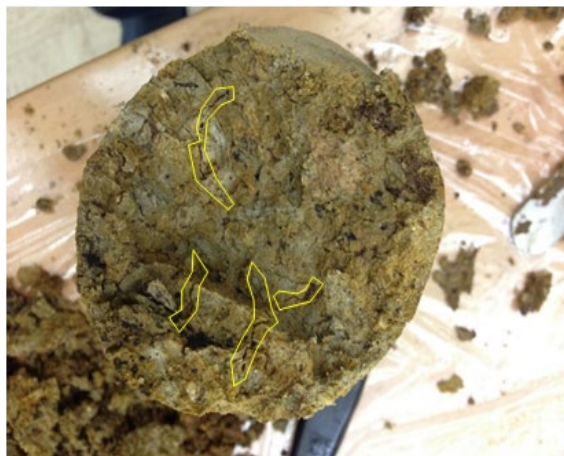
**Figure 5.4** Cracks and fissures inside of the sample from IS-14.5 (I-180 and Superior St.)

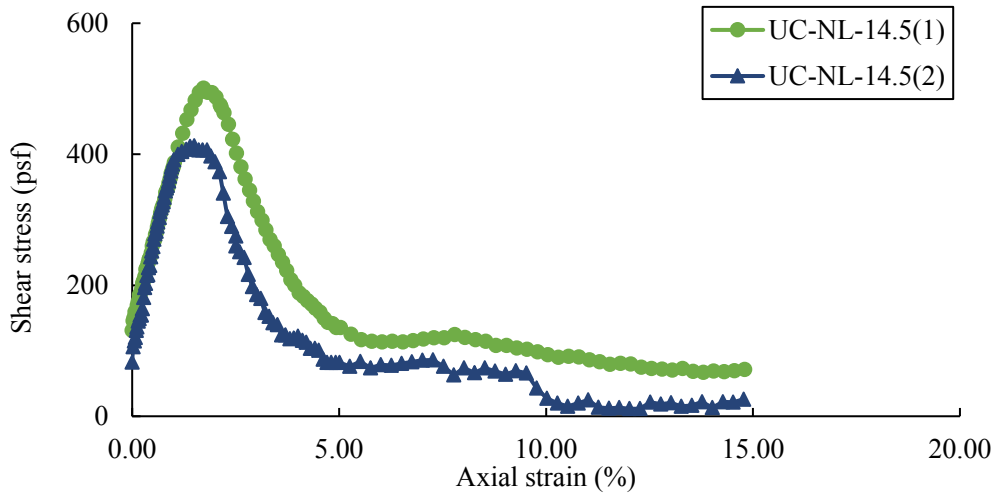
**Figure 5.8** Peak and residual shear strength from unconfined compression test on NL-14.5 (North-Loup)

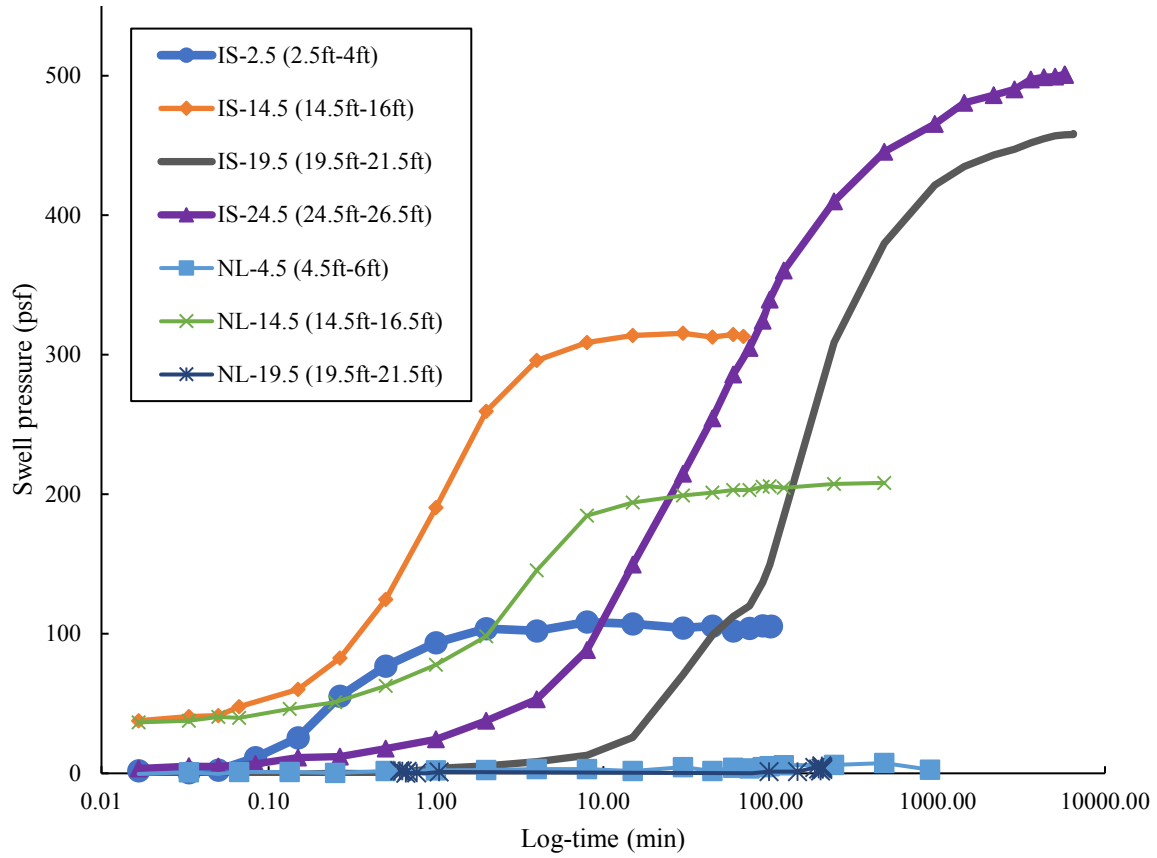
**Figure 5.9** Swell pressure results for I-180 and Superior St. (IS) and North-Loup (NL)

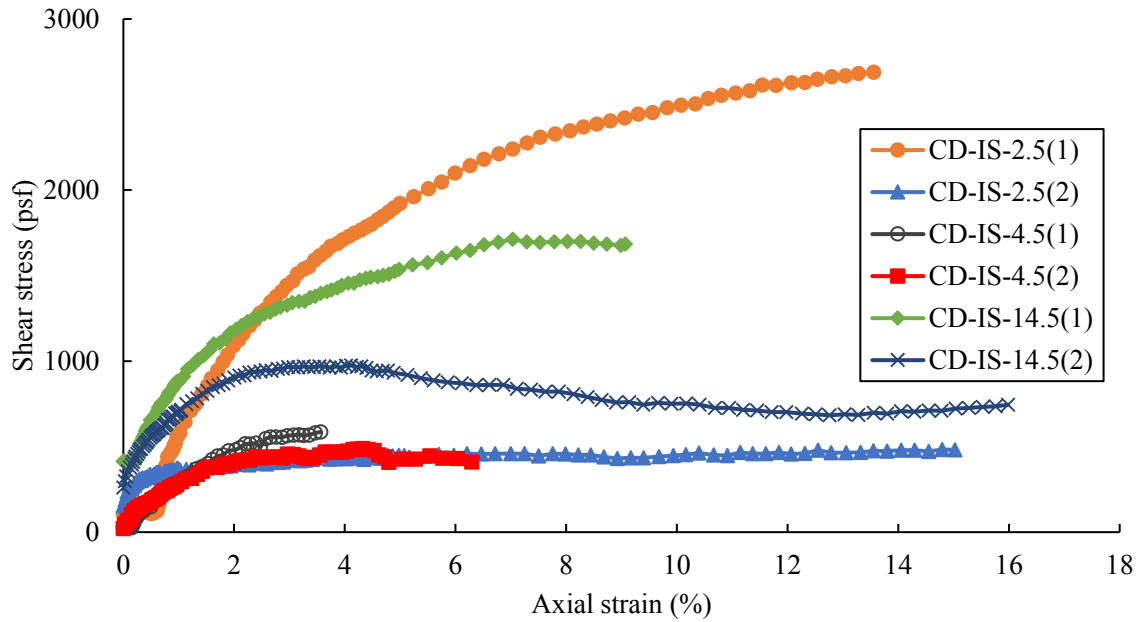
**Figure 5.12** Consolidated drained stress-strain curves for I-180 and Superior St.

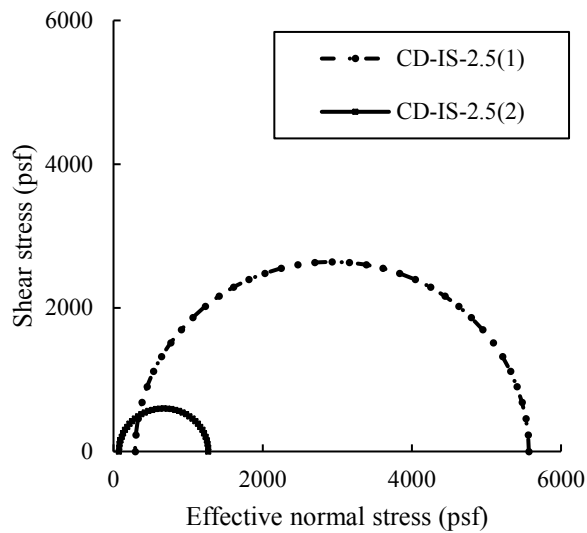
**Figure 5.13** Consolidated drained effective stress Mohr's circle of samples from IS-2.5 (I-180 and Superior St.)

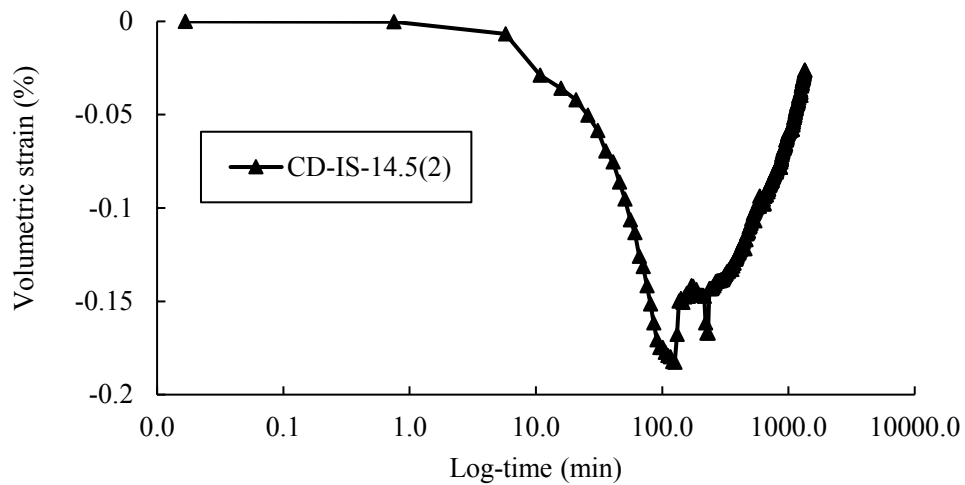
**Figure 5.20** The swelling of the sample IS-14.5 (glacial till formation) at low effective stress
