**Report SPR-P1(17) M061**

**Final Report**  
26-1121-4036-001

## **Nebraska Specific Slope Design Manual**

# Nebraska Specific Slope Design Manual

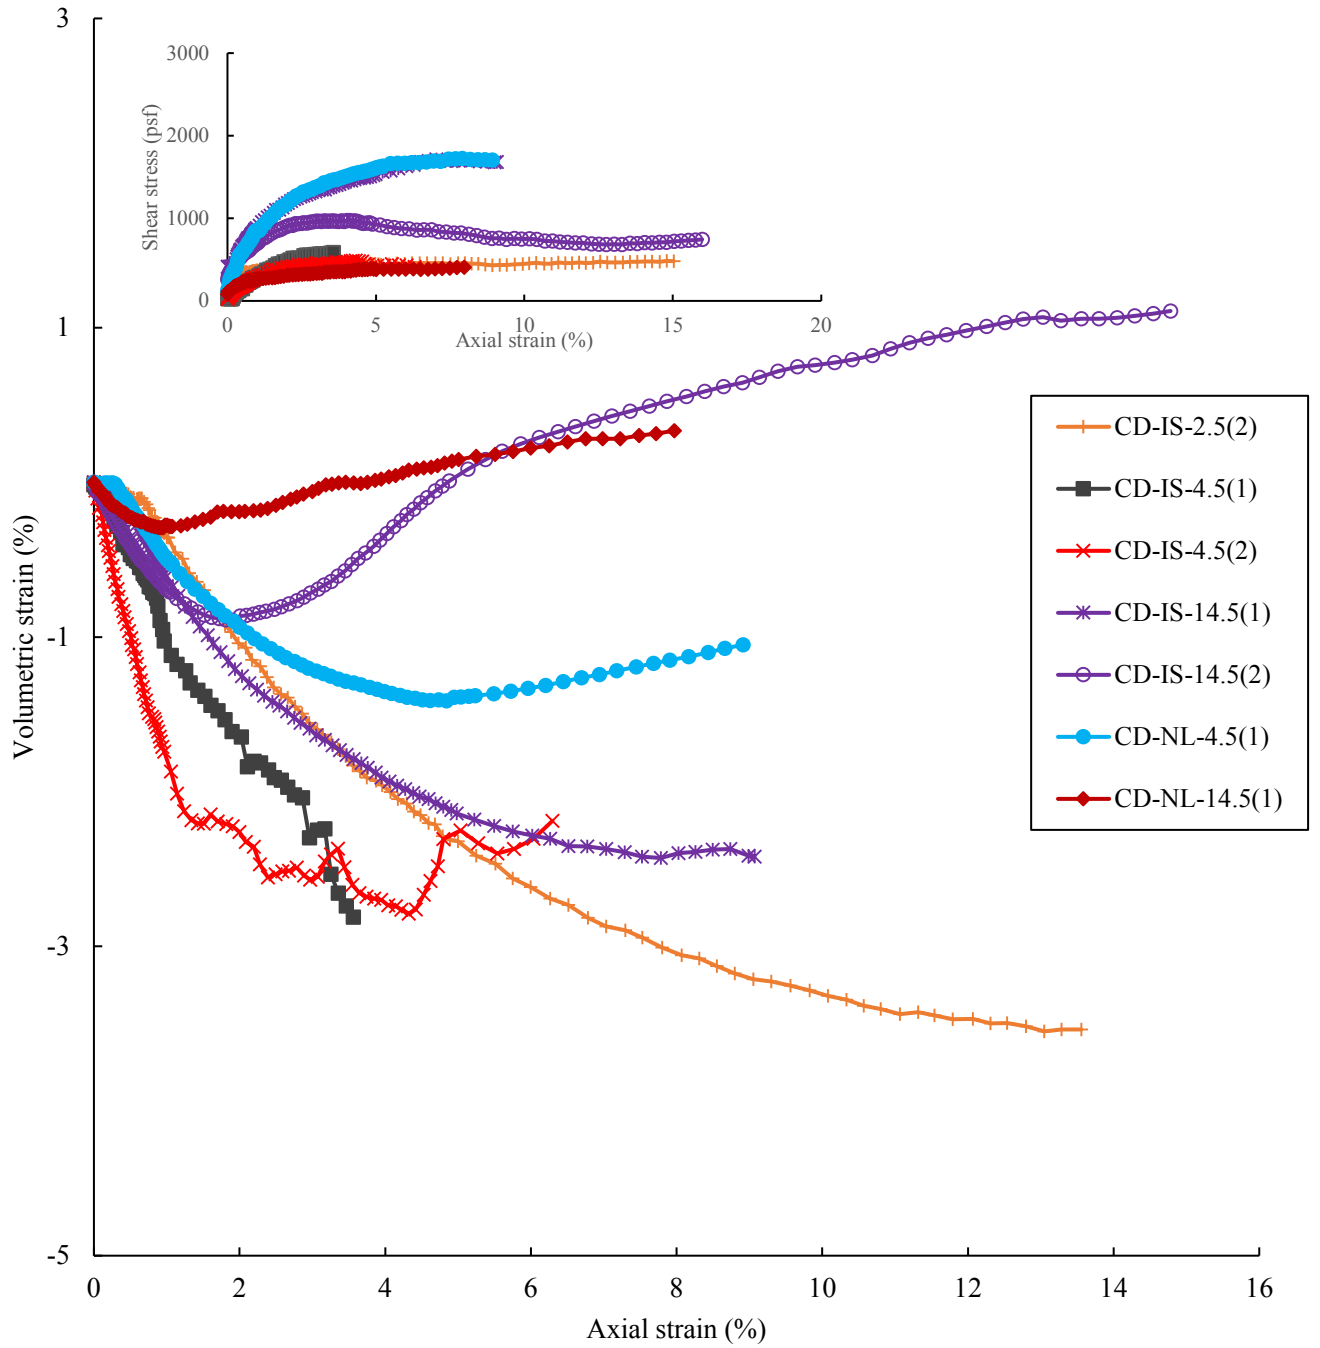
**Figure 5.23** Volume change behavior during triaxial drained shearing stage (the legend of inset is similar to the main Figure)

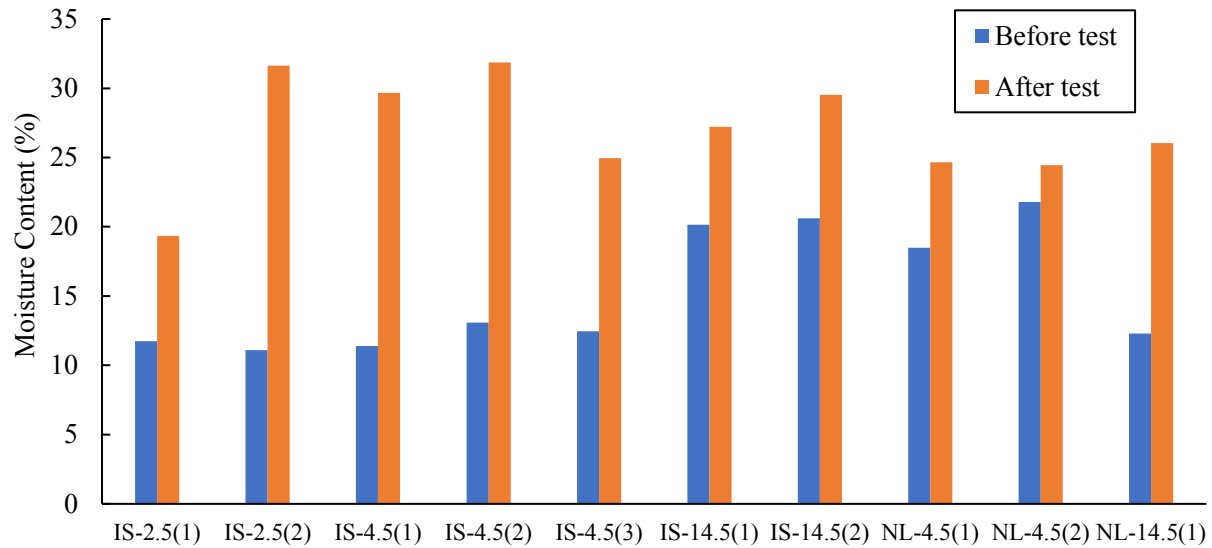
**Figure 5.24** Comparison of water content of samples before and after triaxial tests

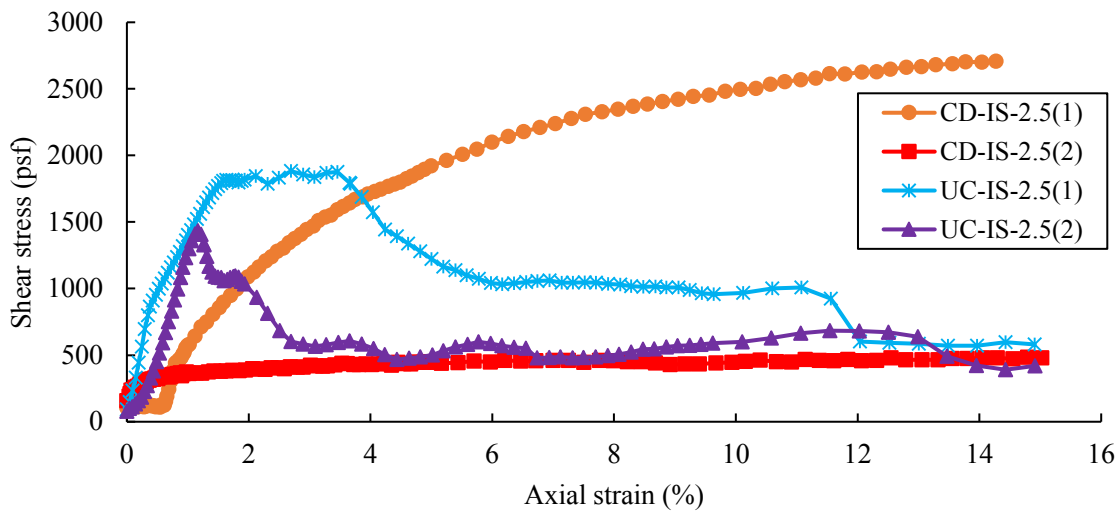
**Figure 5.25** Comparison between results of unconfined compressive shear strength and triaxial drained test on loess material at shallow depth (I-180 and Superior St.)

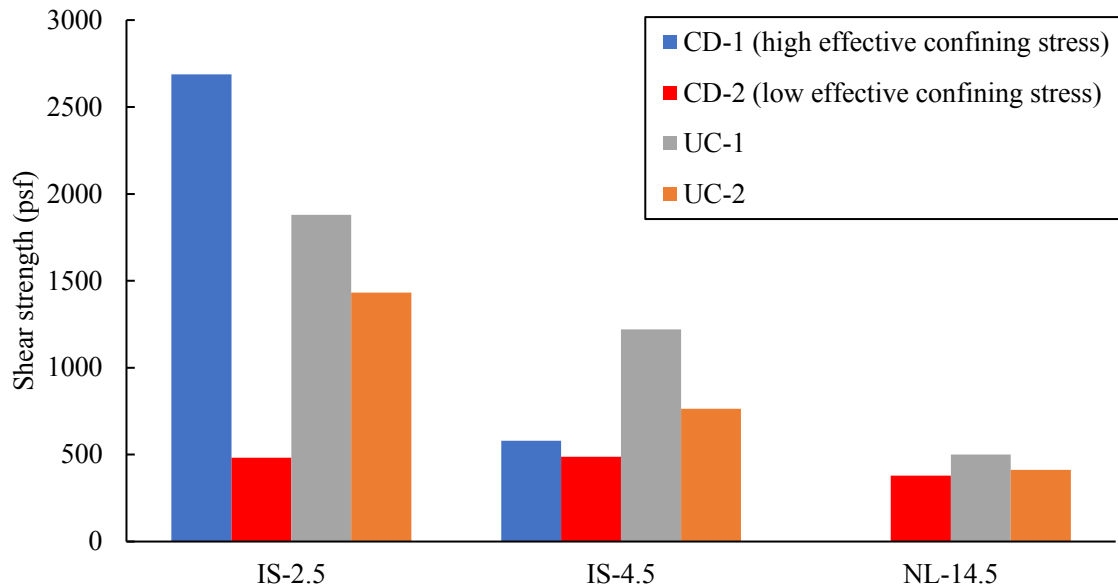
**Figure 5.29** Comparison between the peak unconfined shear strength (UC) and drained shear strength (CD) of overconsolidated clayey soils from I-180 and superior St. (S) and North-Loup (R)

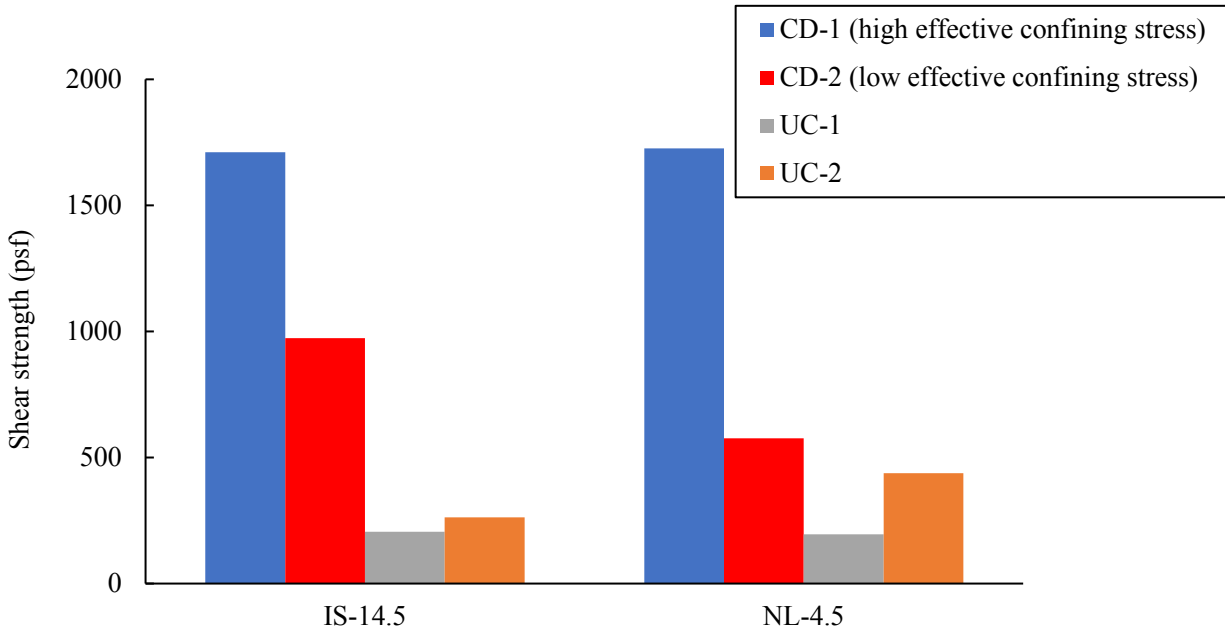
**Figure 5.30** Comparison between the peak unconfined shear strength (UC) and drained shear strength (CD) of overconsolidated sandy soils from I-180 and superior St. (S) and North-Loup (R)

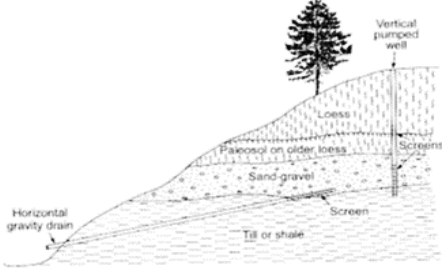
<p><u>Pros:</u> Will reduce water buildup that is often the cause of slope failure.</p> <p><u>Cons:</u> The drainage pipe can clog if proper screens aren't applied.</p>	<p>Probably effective depending on conditions.</p> <p>Improperly designed and maintained wells may collect water and can be a source of problems</p>
Surface water control  (Eversoll, 2013)	<p>This refers to more than one method of collecting surface water (such as from rain) and controlling its runoff. The idea is to collect the water and direct it away from the potential slip plane.</p>

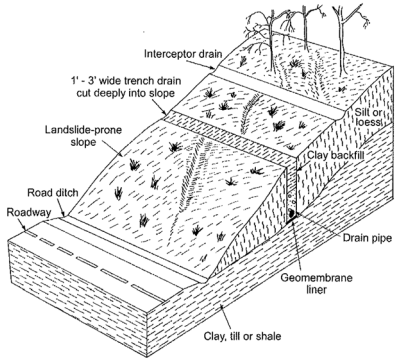
<p><u>Pros:</u> Directing water away from a slope will decrease the percent of precipitation that the slope will absorb.</p> <p><u>Cons:</u> While reducing the amount of infiltration that occurs due to rain would be an effective solution, it is a major challenge to effectively divert rainfall away from a slope.</p>	Not very effective, because controlling surface water is difficult.

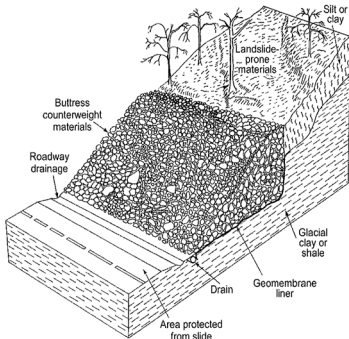
<p><u>Pros:</u> This can increase strength both by applying resisting force at the toe or increasing soil strength along the shear failure plan.</p> <p><u>Cons:</u> May not be possible due to geometry, cost, or space limitations.</p>	Probably effective, depending on the amount of room available for construction.
<p>Gabions</p> <p>(Highland, 2008; Eversoll, 2013)</p>	<p>Large cages filled with ~10-20cm size rock that are stacked against a slope.</p>

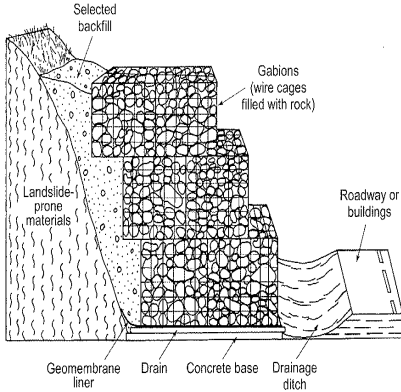
<p><u>Pros:</u> Reinforcement material itself is simple and permeable. Result in lots of friction to resist failure.</p> <p><u>Cons:</u> Will require counterforts if placed on clayey soil (structural and drainage purposes). Price can be high and construction can take a long time.</p>	<p>Not very effective, very costly and time consuming.</p> <p>Flexible structure.</p> <p>Can be expensive.</p>

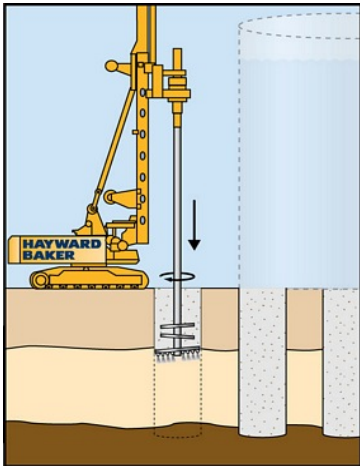
<p>Pros: Existing soils are used as the "aggregate" to mix into the cement, so no additional materials (other than the cement itself) are needed. Works well for soft cohesive soils.</p> <p>Cons: Depending on the chemical used to produce the cementation, the cement can wash away after years of rain.</p>	<p>Probably effective, depending on the situation.</p> <p>Most grouting techniques are good for high permeable soils or for non-freezing temperature condition.</p> <p>Not very good for Nebraska soils.</p>

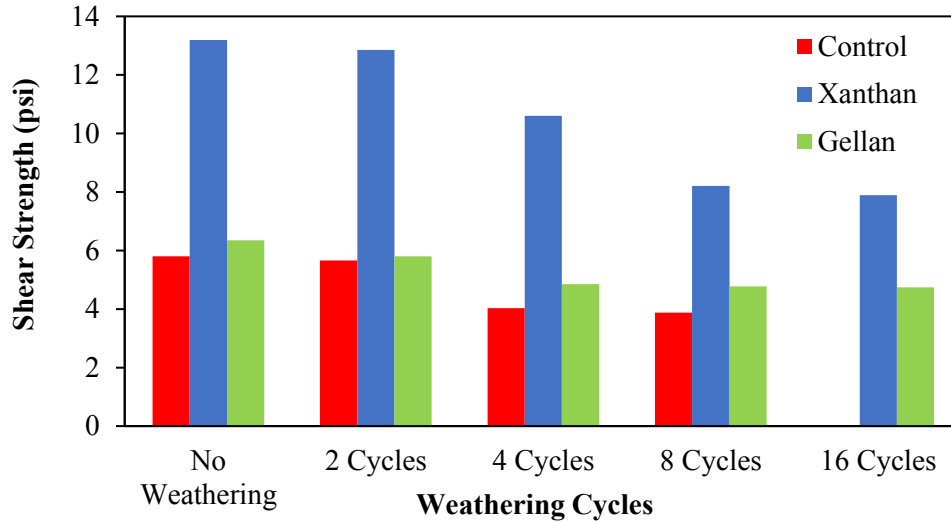
**Figure 6.1** Weathering induced strength reduction of glacial tills for treated samples and untreated samples (wet-dry condition) (Note: Control samples are untreated samples)

fortified with Xanthan, they will maintain the initial natural strength, even after an extended period of weathering cycles.

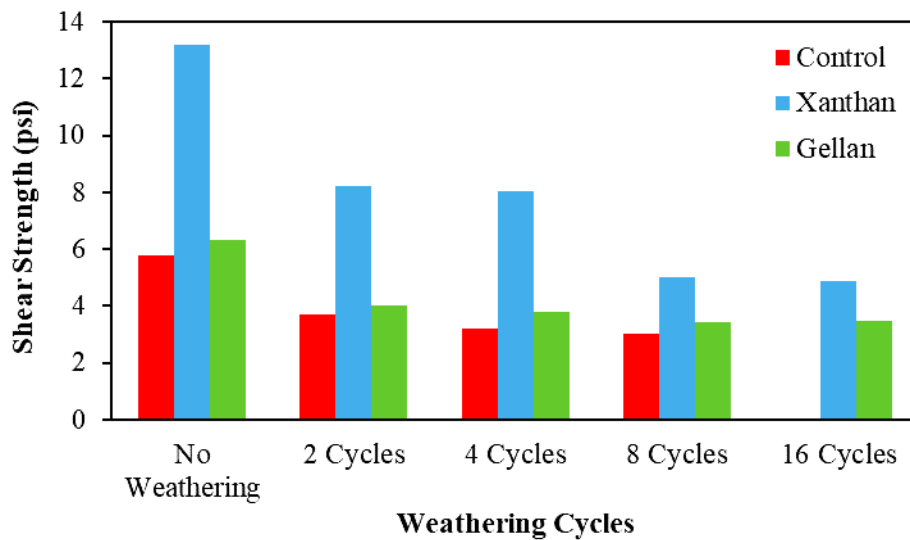
**Figure 6.2** Weathering induced strength reduction of glacial tills for treated samples and untreated samples (wet-freeze-dry condition) (Note: Control samples are untreated samples)

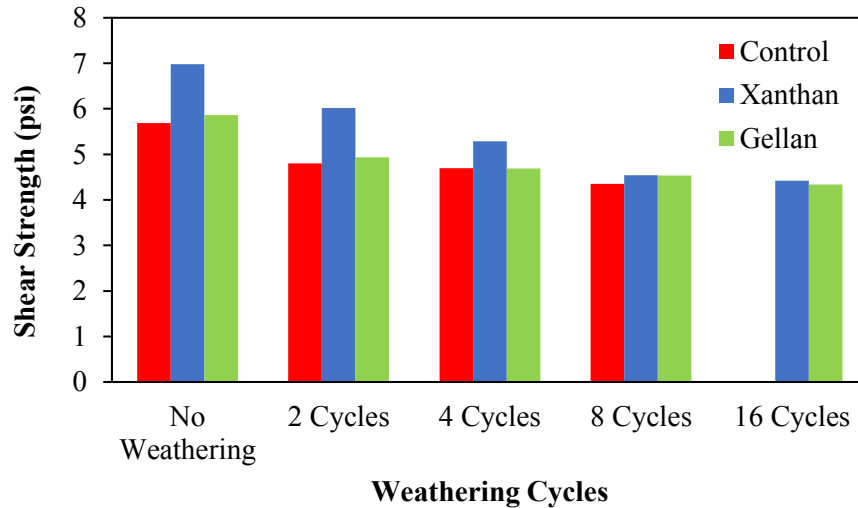
**Figure 6.3** Weathering induced strength reduction of remoulded shale for treated samples and untreated samples (wet-dry condition) (Note: Control samples are untreated samples)

The results showed consistent results to those for glacial tills.

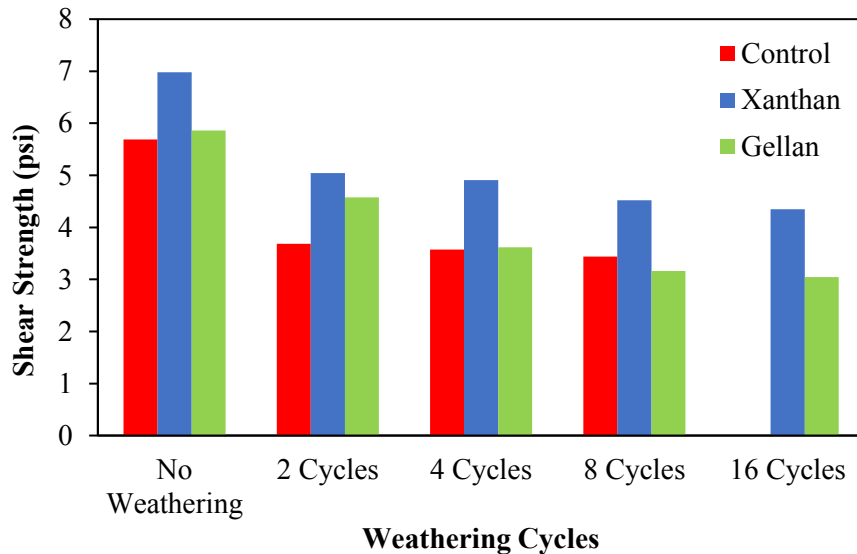
**Figure 6.4** Weathering induced strength reduction of remoulded shale for treated samples and untreated samples (wet-freeze dry condition) (Note: Control samples are untreated samples)

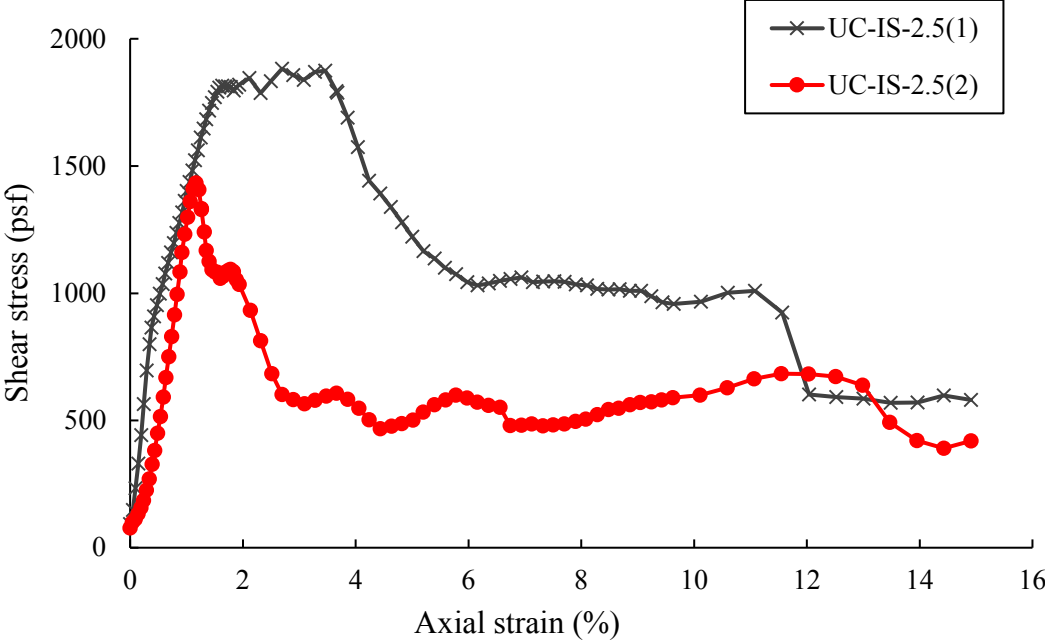
Figure A.1 Unconfined compressive test, I-180 and Superior St. (2.5 ft-4 ft)

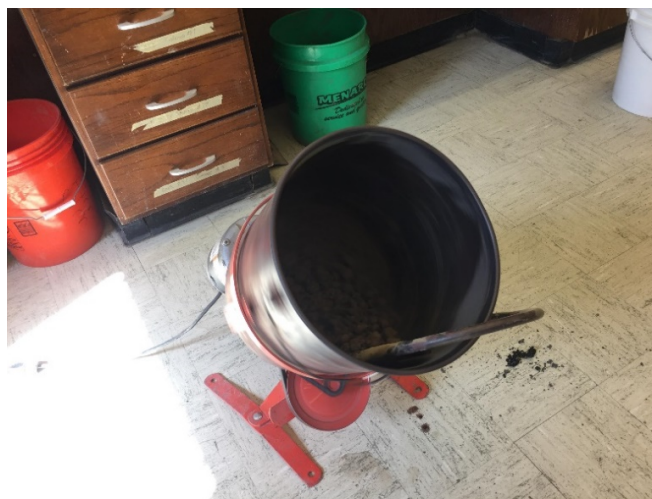
**Figure D.1** mixing soil with biopolymers and water

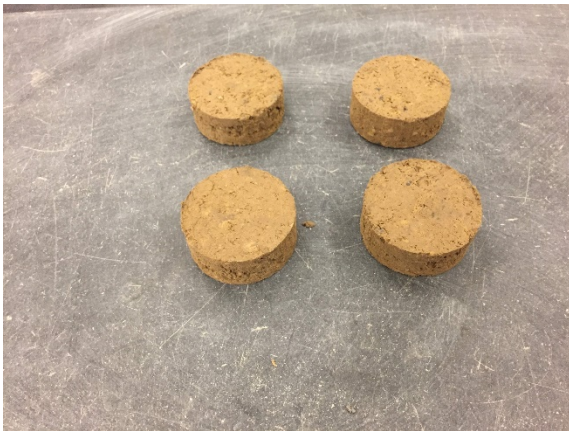
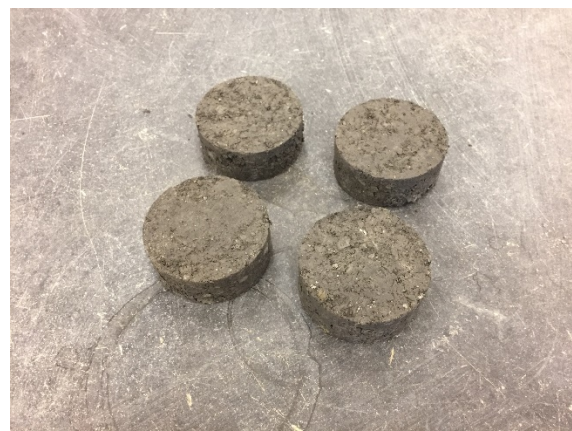
**Figure D.5** Compacted samples after cutting and trimming

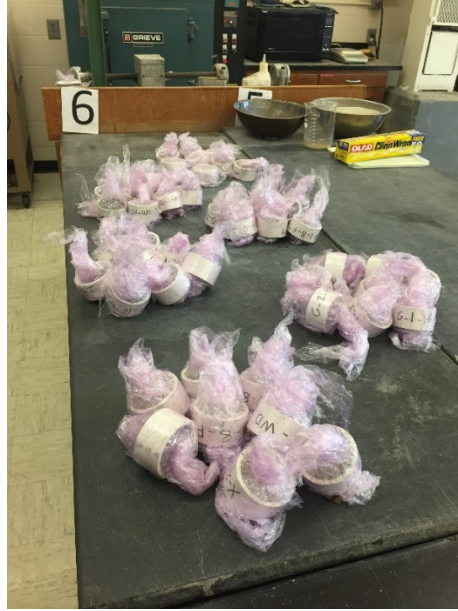
**Figure D.6** Curing stabilized soil samples

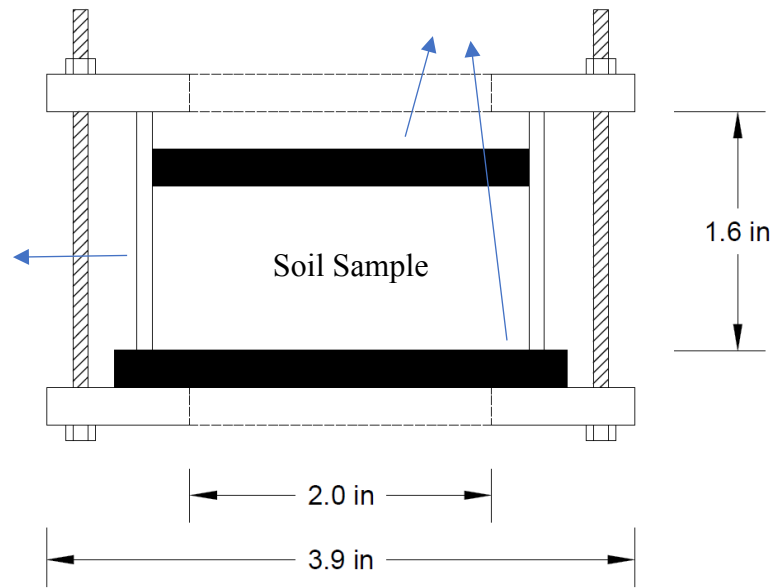
**Figure D.7** The fixture used for weathering soil samples

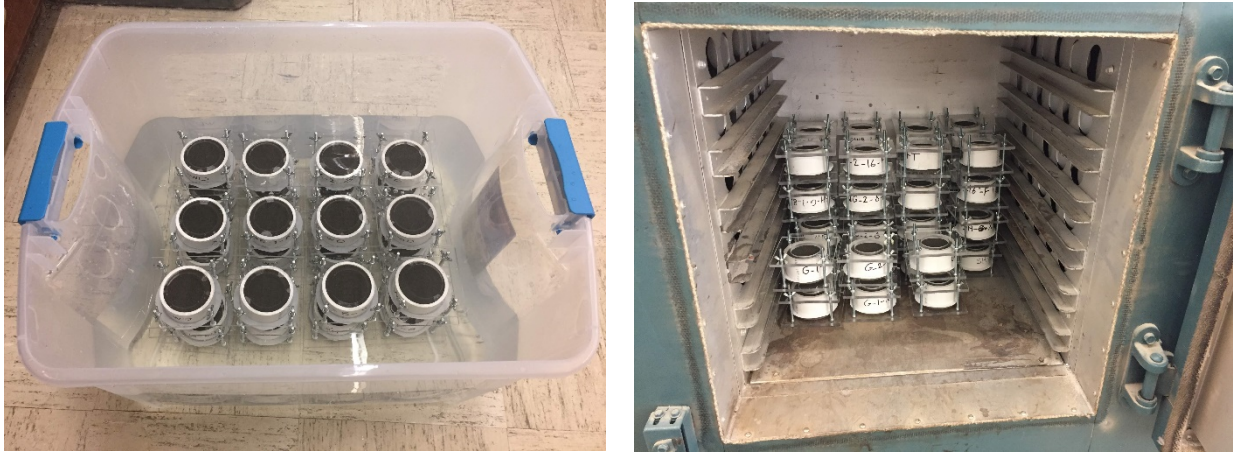
**Figure D.10** Water bath and oven used for weathering soil samples

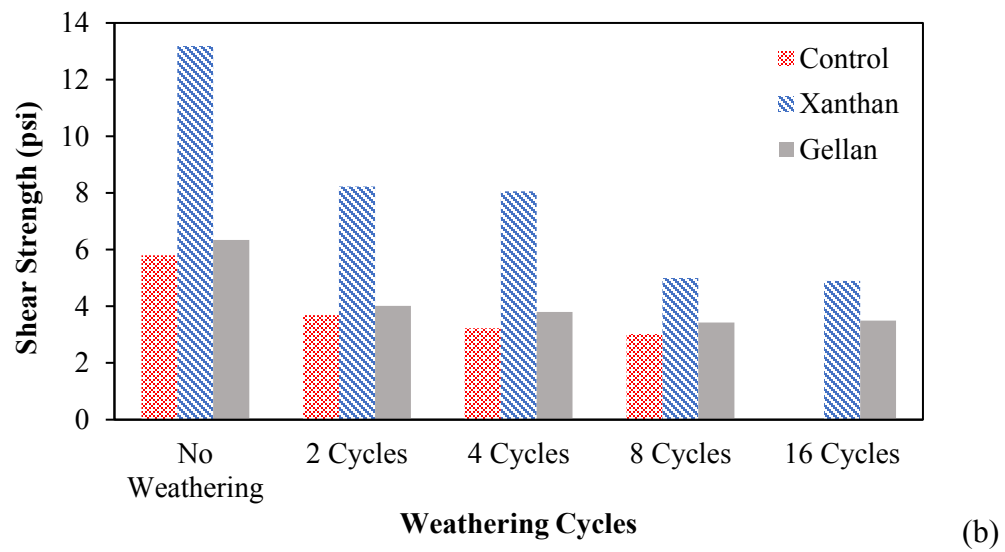
**Figure D.12** Direct shear test results for glacial till (a) wet-dry condition (b) wet-freeze-dry condition

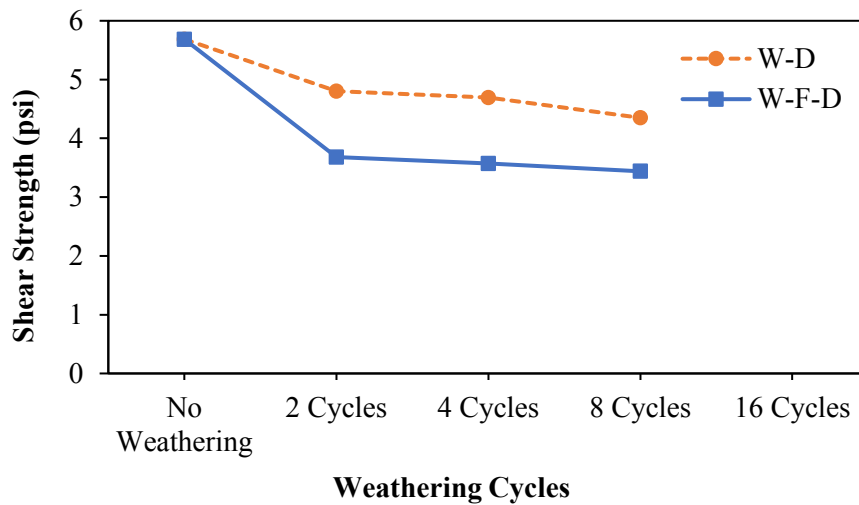
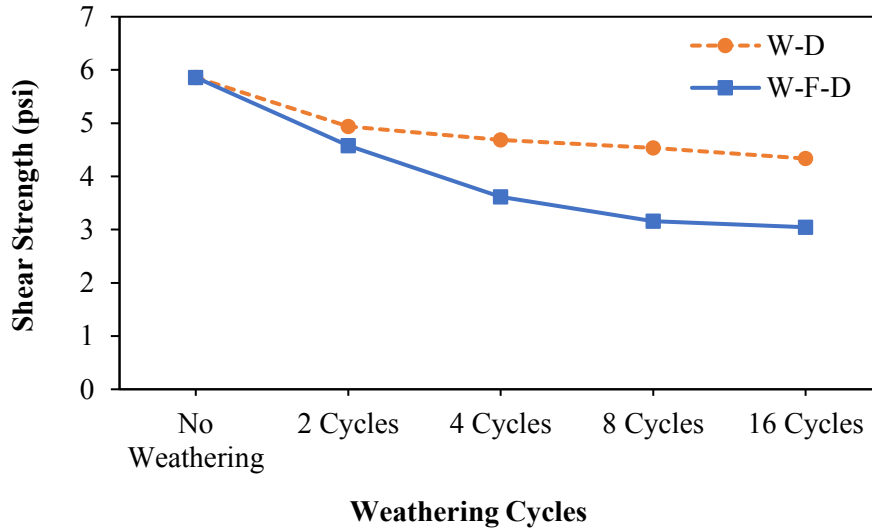
**Figure D.13** Direct shear test results for shale (a): control samples (b) Xanthan-stabilized samples (c) Gellan-stabilized samples

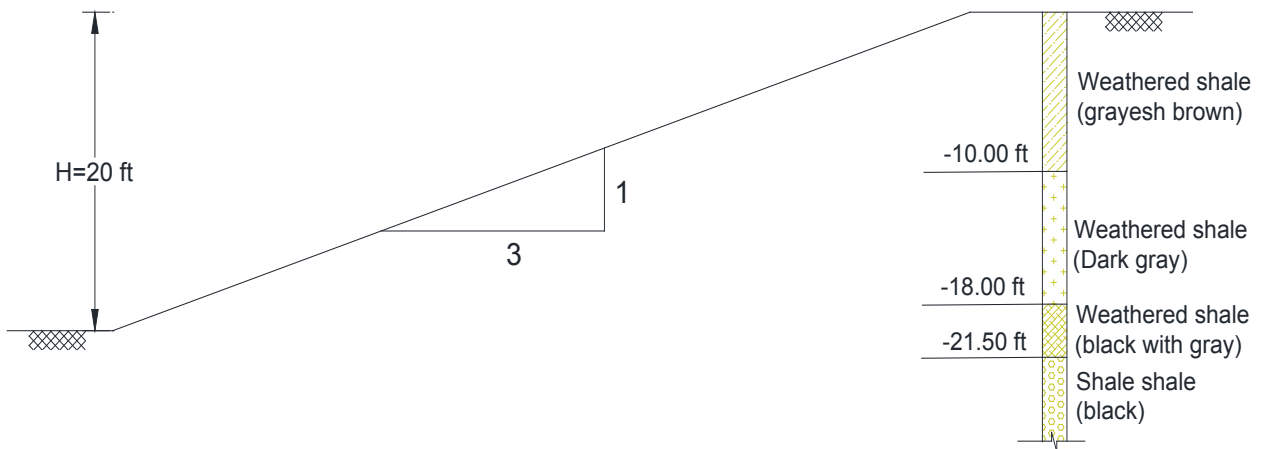
**Figure E.1** Hypothetical cut slope along with soil stratification

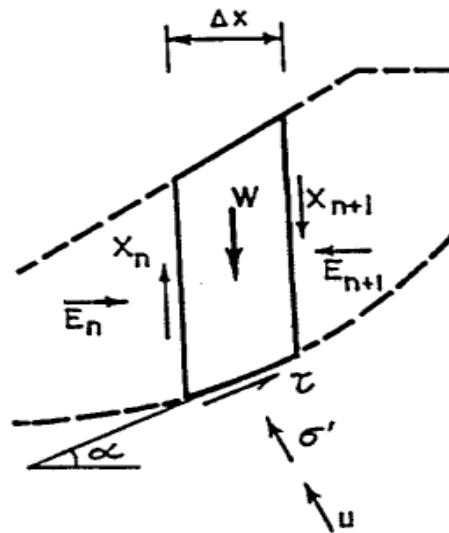
**Figure E.2** Forces and stresses acting on a single slice

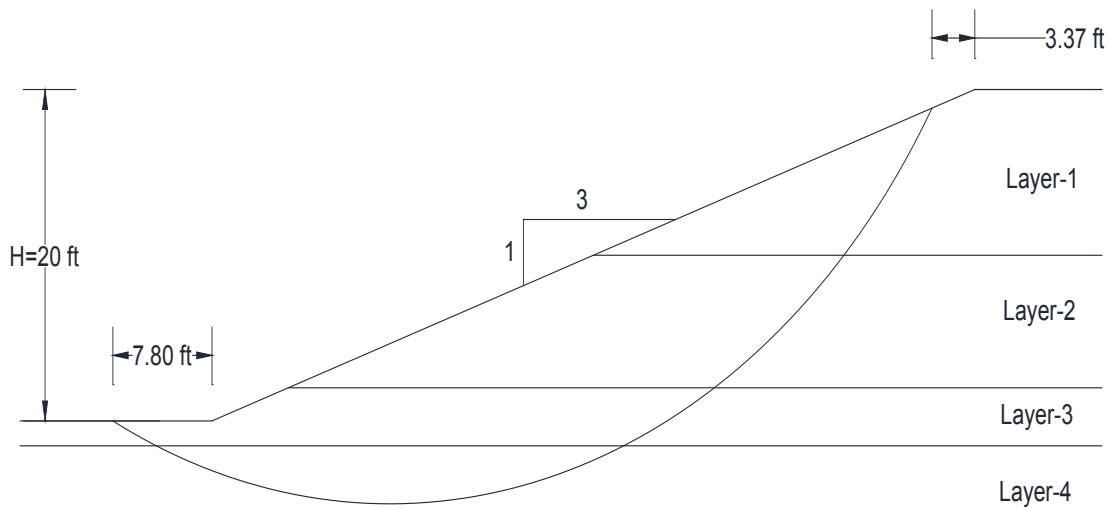
**Figure E.3** Critical slip surface

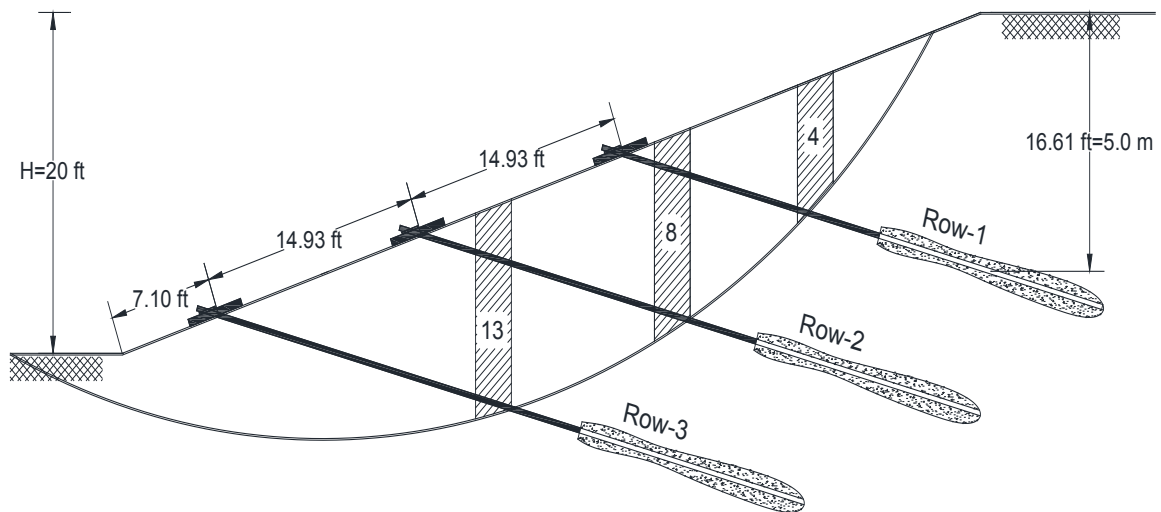
**Figure E.9** Anchor configuration for Trial-3 (final)

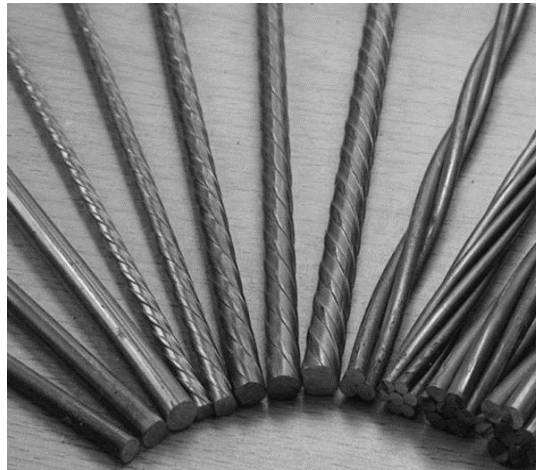
**Figure E.10** Tendons for ground anchors: plain bars, threaded bars, strands from left to right
