Appendix O

Biological Assessment and Habitat Connectivity Analysis

Project: Minatare to US-385

Project Number: NH-26-1(172); Control Number: 51521

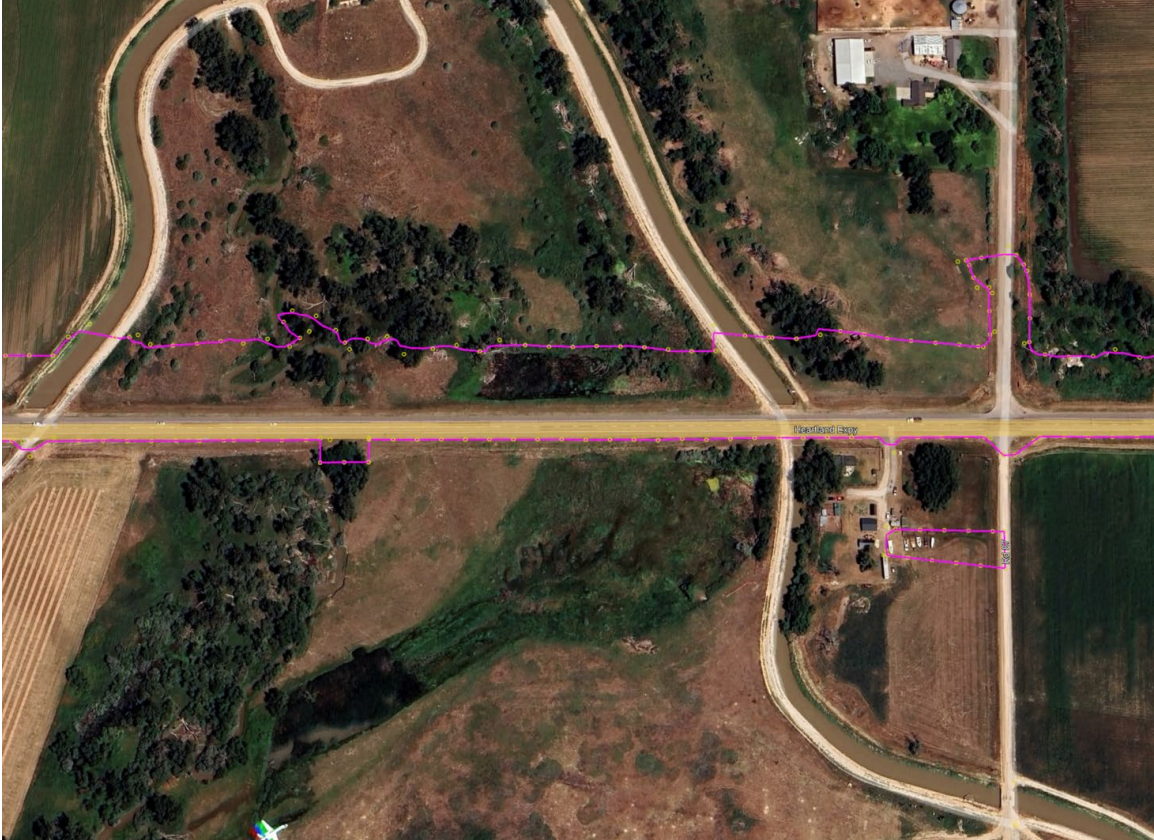
Figure 3. Location of suitable habitat for northern long-eared bat and tri-colored bat at Red Willow Creek with limits of Construction.

The only area of potential habitat for NLEB and TCB would be near Red Willow Creek from MM 5.87 to MM 6.17 (**Figure 3**). Just North of the alignment at this location, the wooded corridor along Red Willow Creek disappears as Red Willow Creek transitions into arid escarpments. To the south of the alignment, Red Willow Creek has moderate to low connectivity to the North Platte River Wooded Riparian Corridor. The heavier forested corridors that best support NLEB and TCB foraging and roosting are located to the south of the project alignment. Further, it should be noted that Red Willow Creek is classified as an intermittent channel, which indicates that it is dry for part of the year. This could pose challenges to both northern long-eared bats and tri-colored bats, as they both require access to water. Therefore, the only location of suitable habitat for NLEB and TCB along the alignment is at Red Willow Creek. Further, this is the only area where the NGPC identifies as within the range of NLEB on the project alignment.

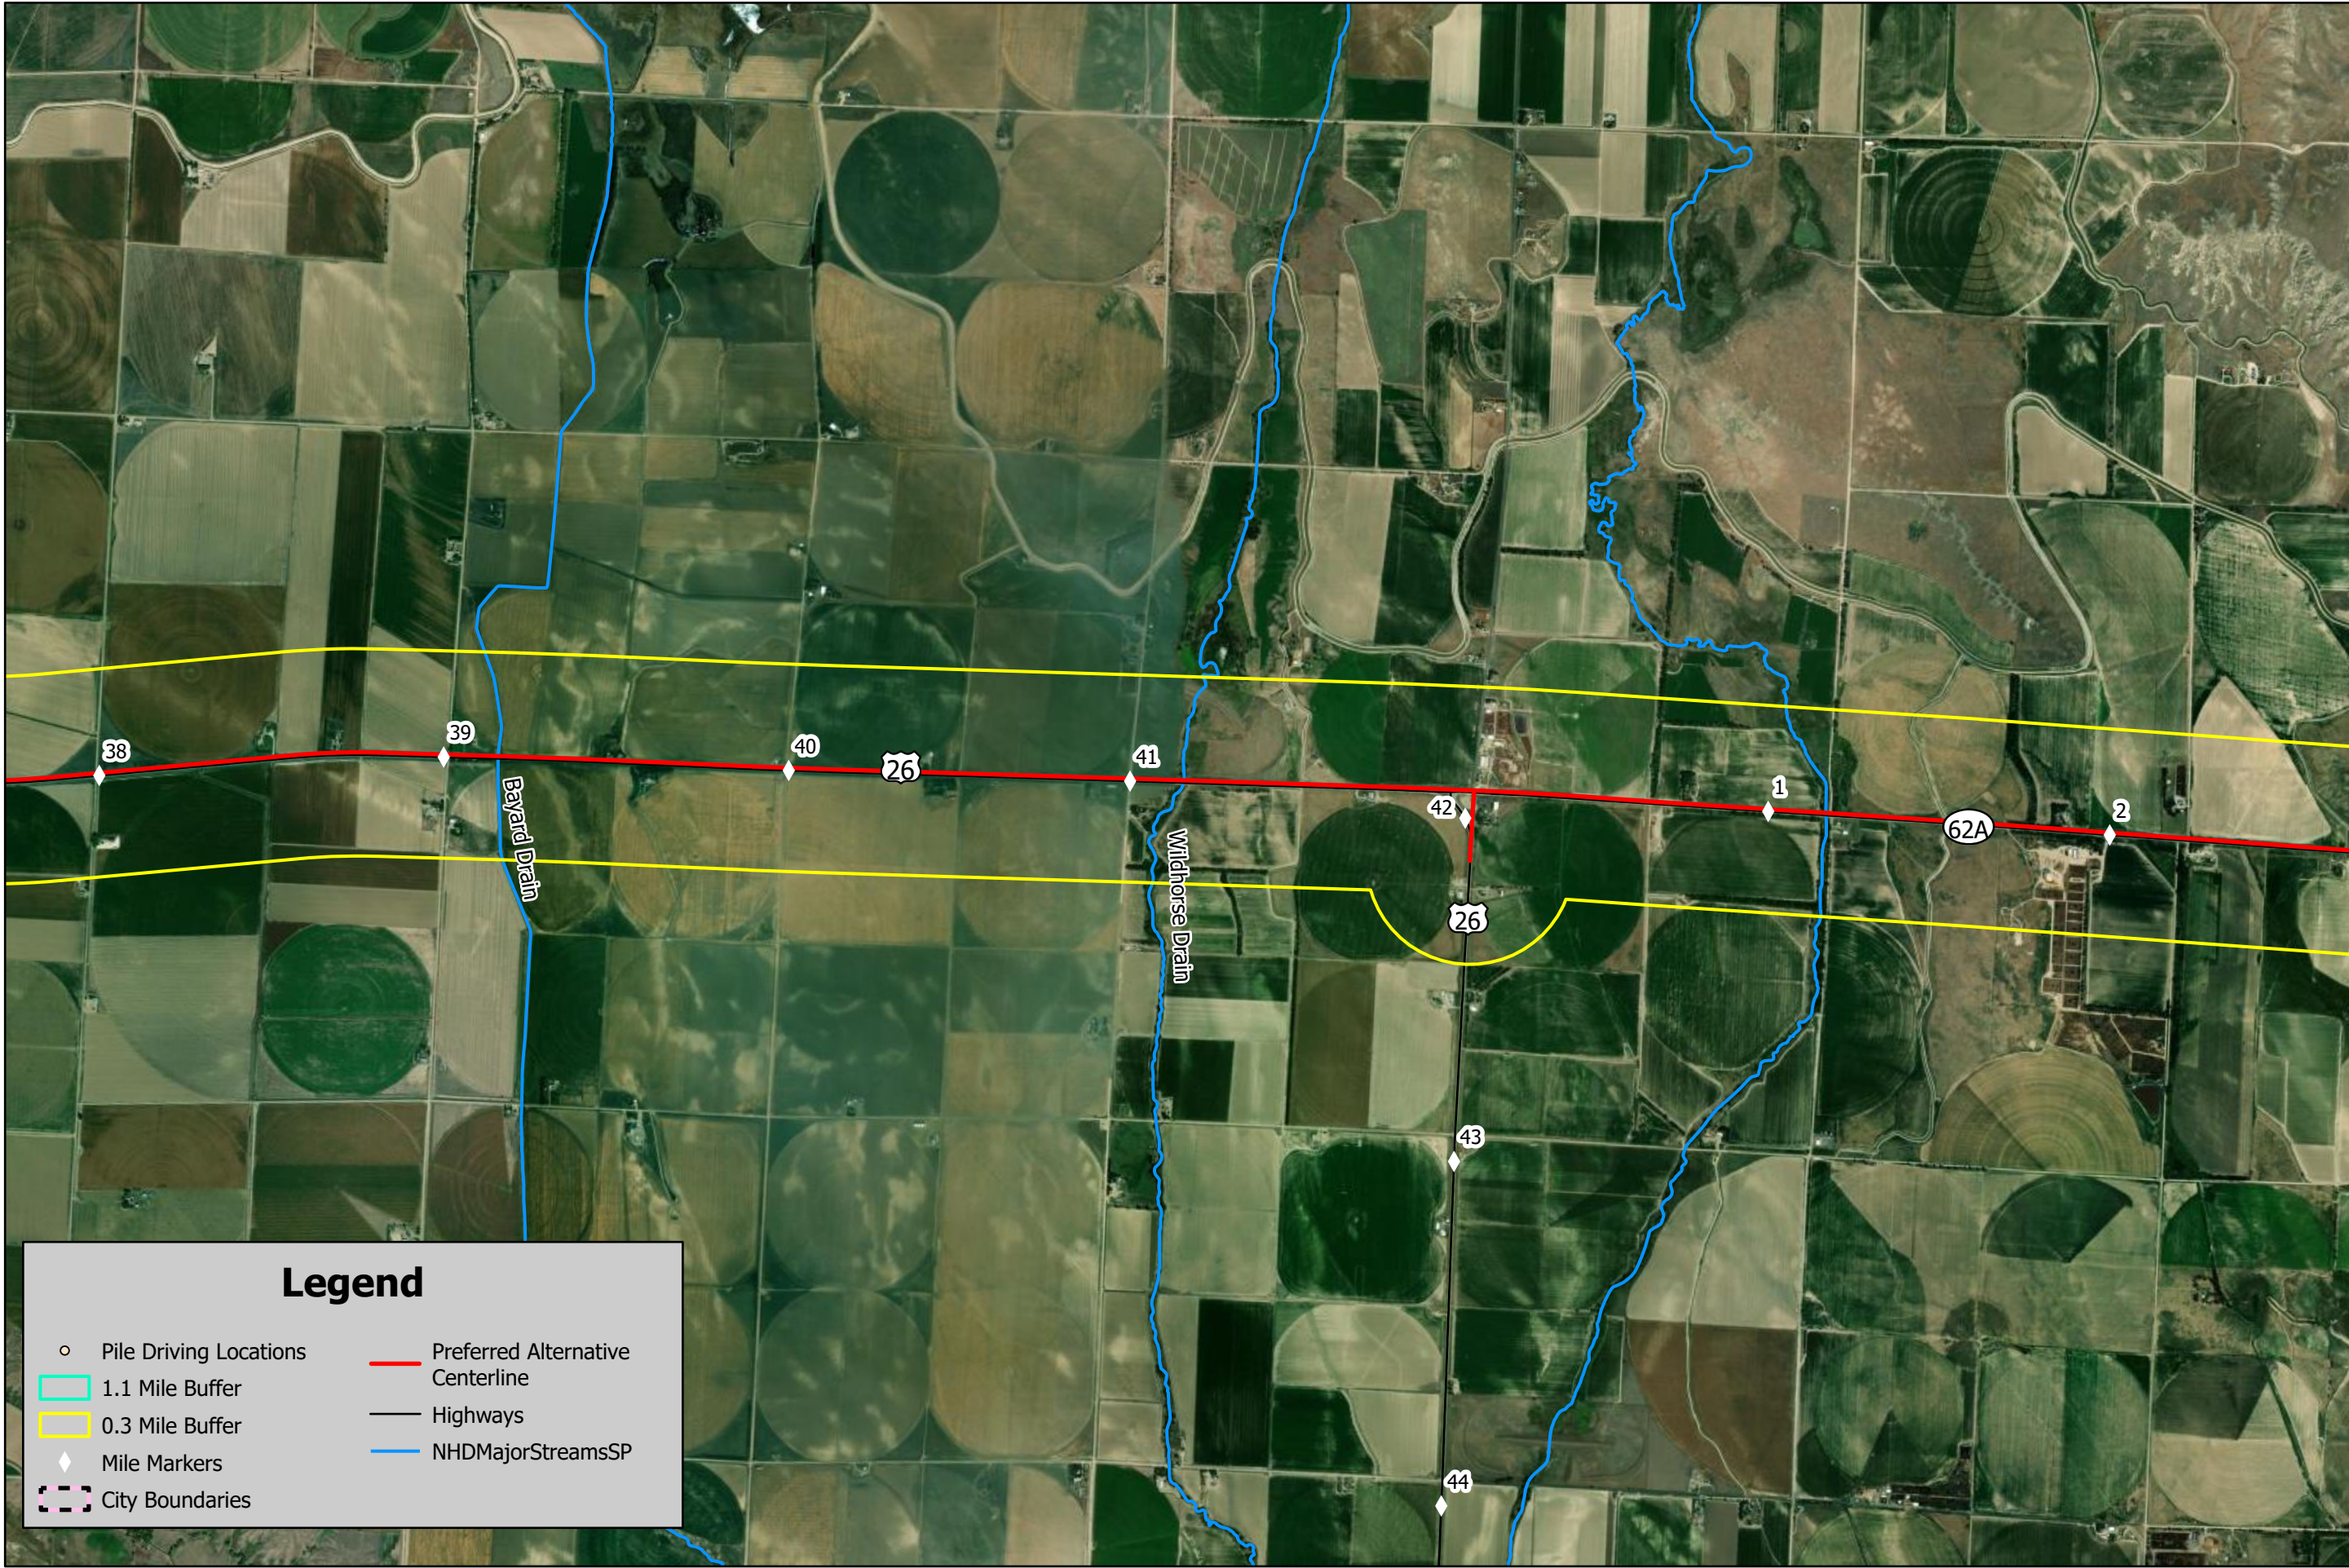
Minutare - US 385
 Scotts Bluff and Morrill County, Nebraska

- Pile Driving Locations
- 1.1 Mile Buffer
- 0.3 Mile Buffer
- ◆ Mile Markers
- ▭ City Boundaries
- Preferred Alternative Centerline
- Highways
- NHDMajorStreamsSP

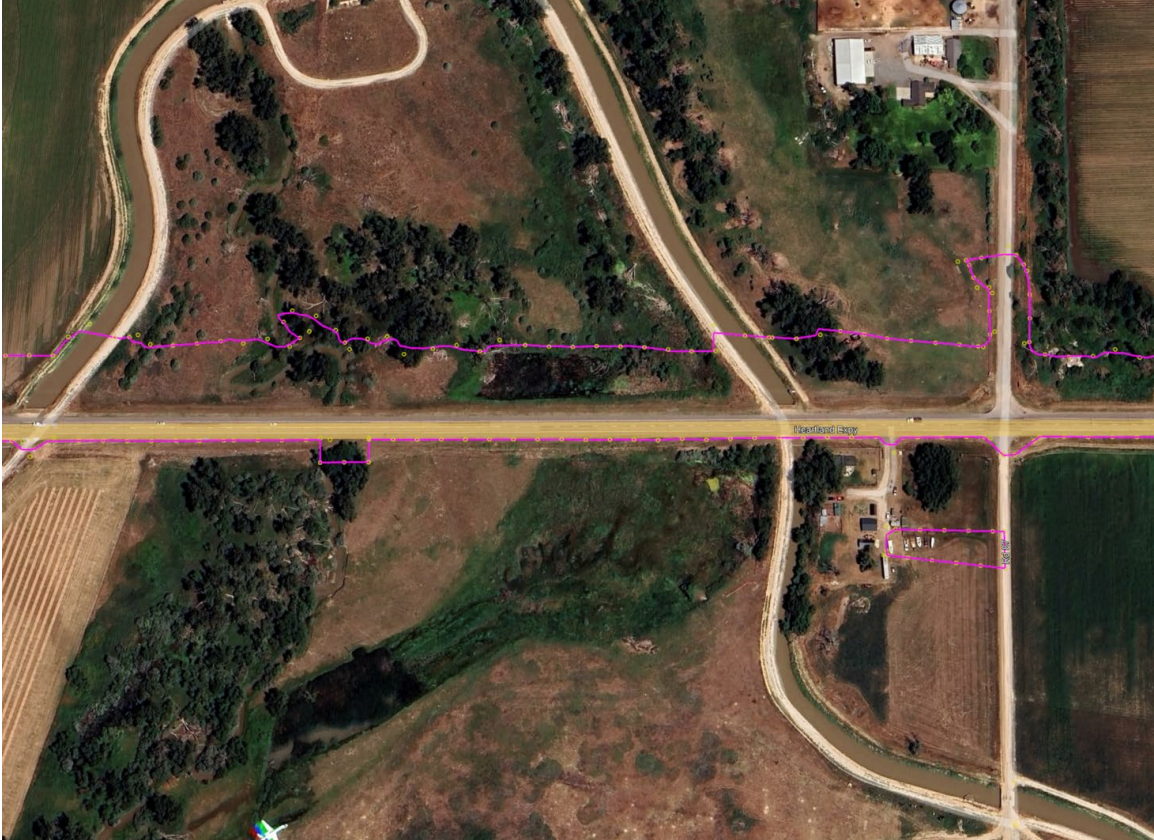
Figure 3. Location of suitable habitat for northern long-eared bat and tri-colored bat at Red Willow Creek with limits of Construction.
