Report SPR-P1(16)M041

Automated Chain Drag Testing

Hongbin Sun, Jinying Zhu

Department of Civil Engineering
University of Nebraska-Lincoln

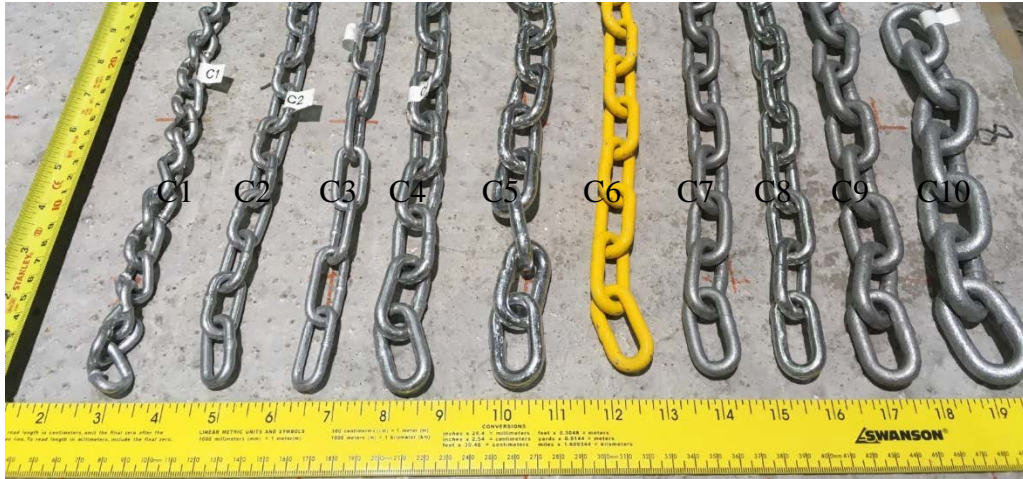
Many types of link chains are available, and they vary from material, coating, length per segment and weight. We tested ten different types of link chains (see **Figure 3-3**) and investigated noises caused by link clapping in air and surface friction when dragging on concrete surface. Test results indicate all links chains created high level noise in air, and many also have high level of noise when dragging on solid concrete surface. We chose link chains C5 (chain 1), C7 (chain 2) and the ball chain for detailed discussion. **Figure 3-4** shows two different types of steel link chains and the newly developed ball-chain.

Figure 3-3 Ten different types of steel link chains

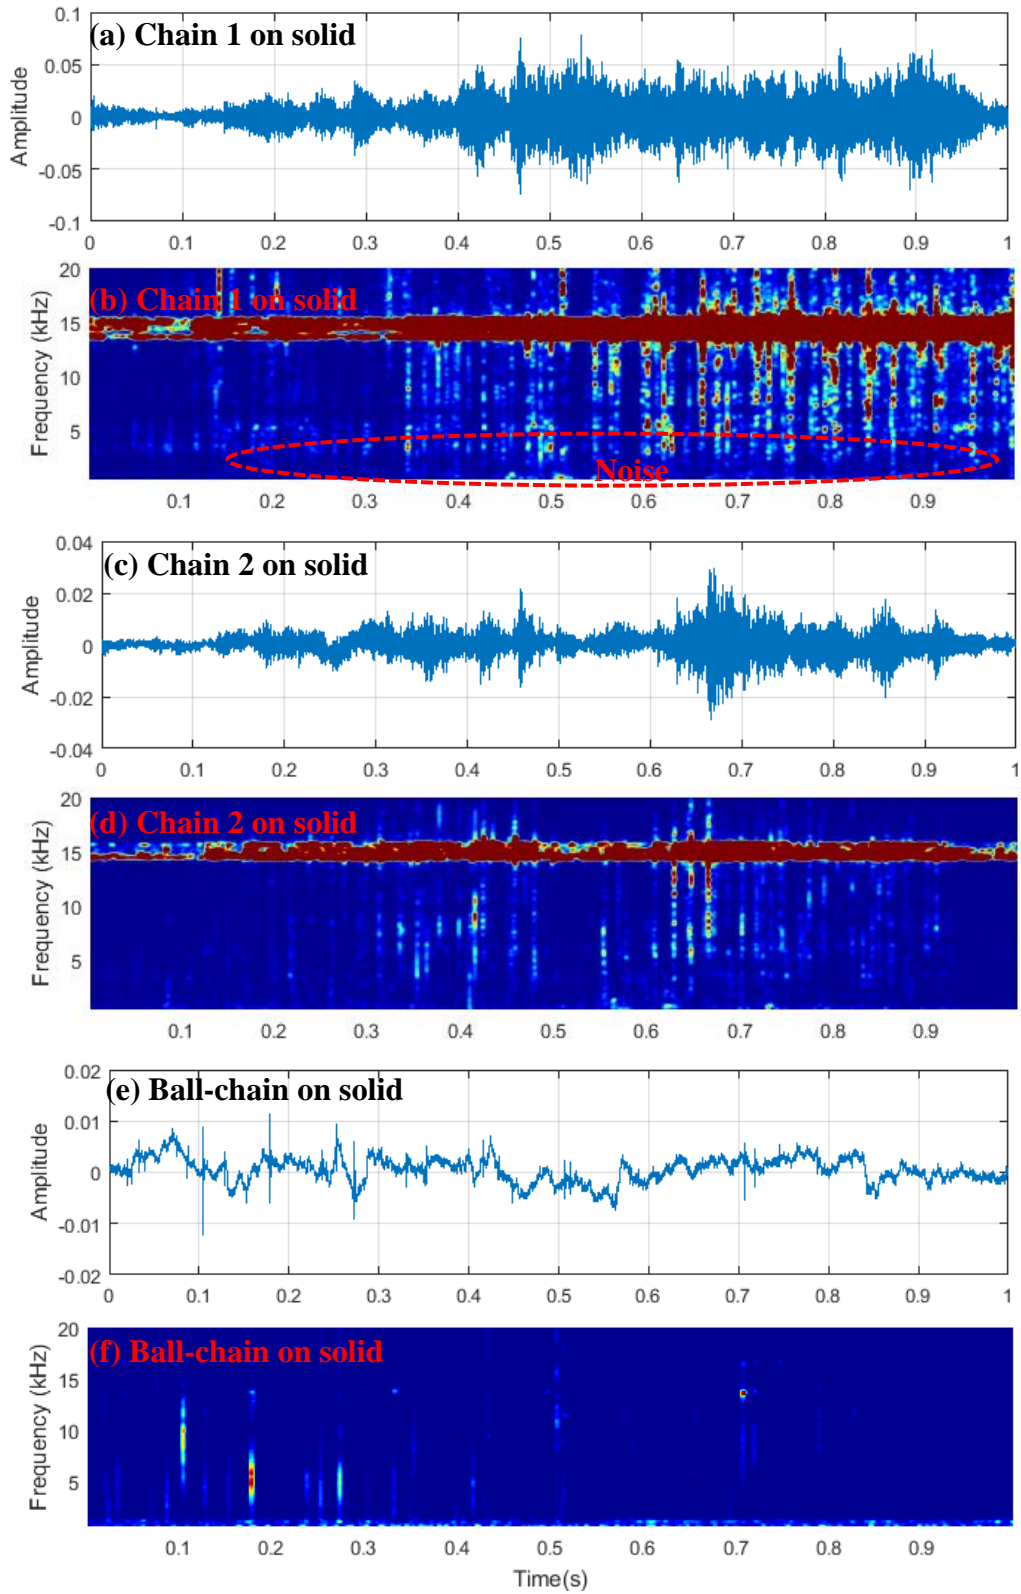
Acoustic signals were collected by dragging chain 1, chain 2 and the ball-chain on a solid concrete surface. The time domain signals and STFT spectrograms are shown in **Figure 3-6**. Both link chains show high level noise around 15 kHz (see (b) and (d)) when dragging on solid area. As discussed previously, the 15 kHz noises came from the clapping between chain links (**Figure 3-5**).

Figure 3-6 Time domain signals and STFT spectrograms of chain dragging on solid concrete surface

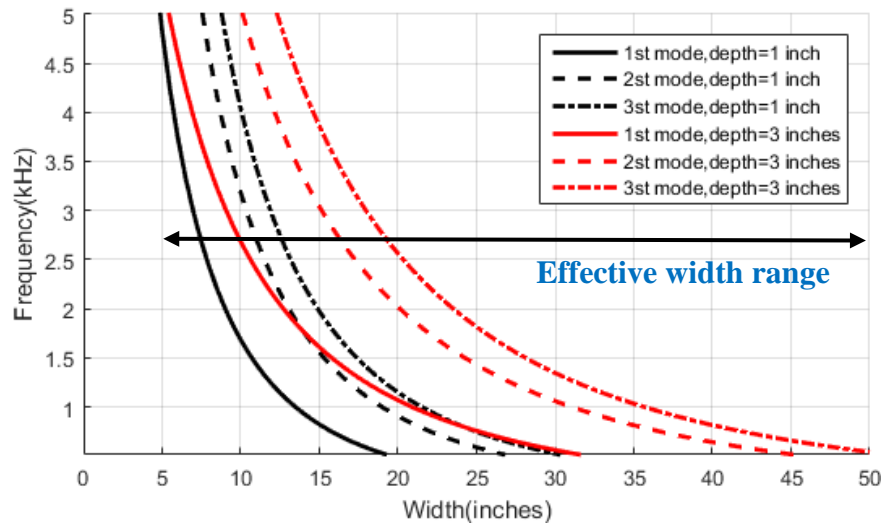
in which C_p is the P-wave velocity of concrete, ν is the Poisson's ratio of concrete, h is the depth of the delamination and c is the width of the delamination. In this experiment, the P-wave velocity is 4400 m/s and the Poisson's ratio is 0.22. Base on the two equations, relationships between frequency and delamination width are plotted in **Figure 3-7** for two depths: 1 inch and 3 inches. For depth of 1 inch, delaminations with width of 4.9 to 30 inches have the first three resonant frequencies in the range of 0.5 to 5 kHz. For depth of 3 inches, the width range is from 5 inches to 50 inches. It can be seen that the frequency range 0.5 to 5 kHz will cover major resonance modes for delaminations with lateral dimension in the range of 5-30 inches and at depth of 1-3 inches. In practice, most bridge deck delaminations occur at the top layer rebars, with a depth of 1-3 inches. Therefore, the major criterion for selecting proper sources is to ensure low noise level in 0.5 kHz to 5 kHz frequency range.

Figure 3-7 Relationships between resonance frequency and delamination width

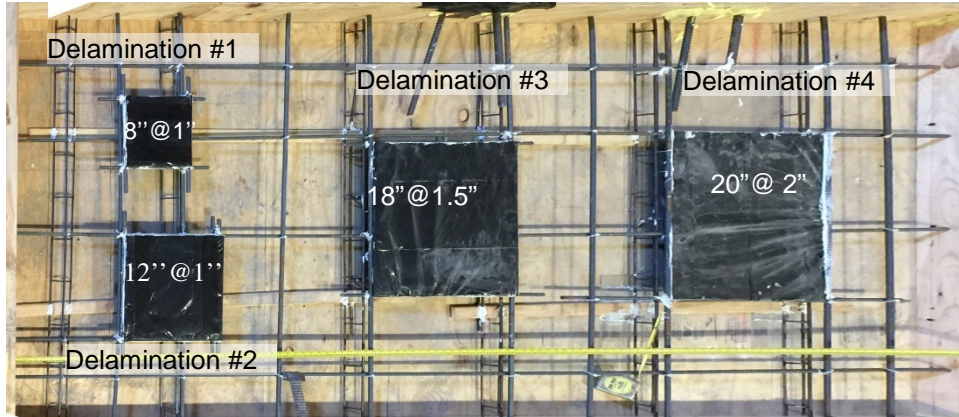
A 10 feet by 4 feet reinforced concrete slab (4 inches thickness) was fabricated with four artificial delaminations of different sizes and depths (see **Figure 4-1**). A polymethyl methacrylate sheet covered with black plastic film was used to create an artificial delamination. The slab was cast with ready mixed self-consolidated concrete (SCC). Sizes and depth of four delaminations are marked in the figure below.

Figure 4-1 Concrete specimen with four artificial delaminations

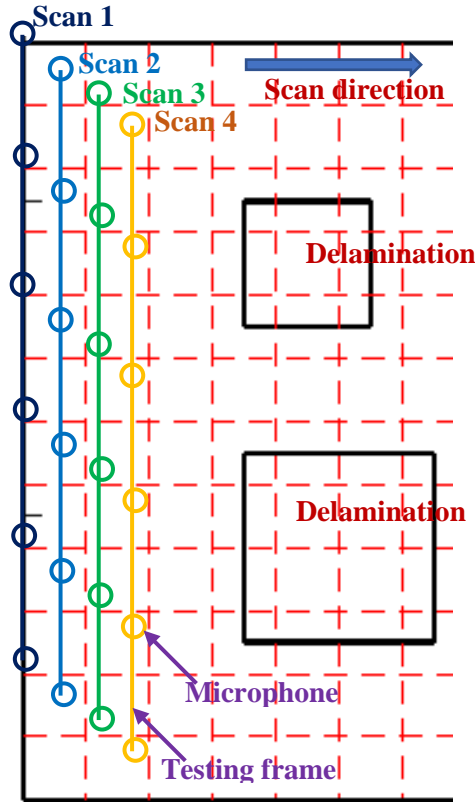
By stacking the $S(\text{dB})$ data sets from all channels, a two-dimensional map is generated, with two axes representing distance in the longitudinal (scanning) and transverse (across channels) directions. The amplitude of each pixel in the 2-D map represents the signal energy level $S(\text{dB})$ in the frequency range 0.5~5 kHz.

Figure 4-7 Schematic diagram of slab full scanning

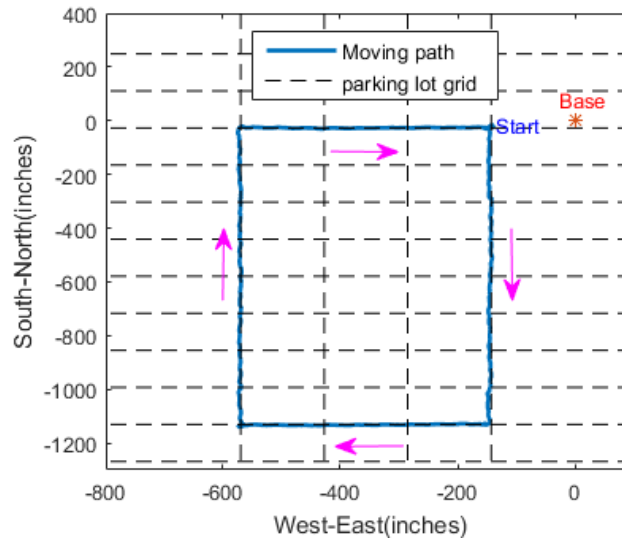
Before the field test, the RTK GPS accuracy was checked at a concrete parking lot with joints in south-north and west-east directions. These joints were used as the reference for the GPS rover moving paths and plotted as grid lines in **Figure 5-4**. The base GPS was placed at the origin and the rover GPS moved from the start point along the joints, then returned to the start point in clockwise direction. The relative positions of rover GPS to the base GPS were used to plot the moving path. It was concluded that the GPS has a satisfactory accuracy for bridge scanning. The measured static accuracy was within 1cm when the rover was not moving.

Figure 5-4 Moving path on the parking lot

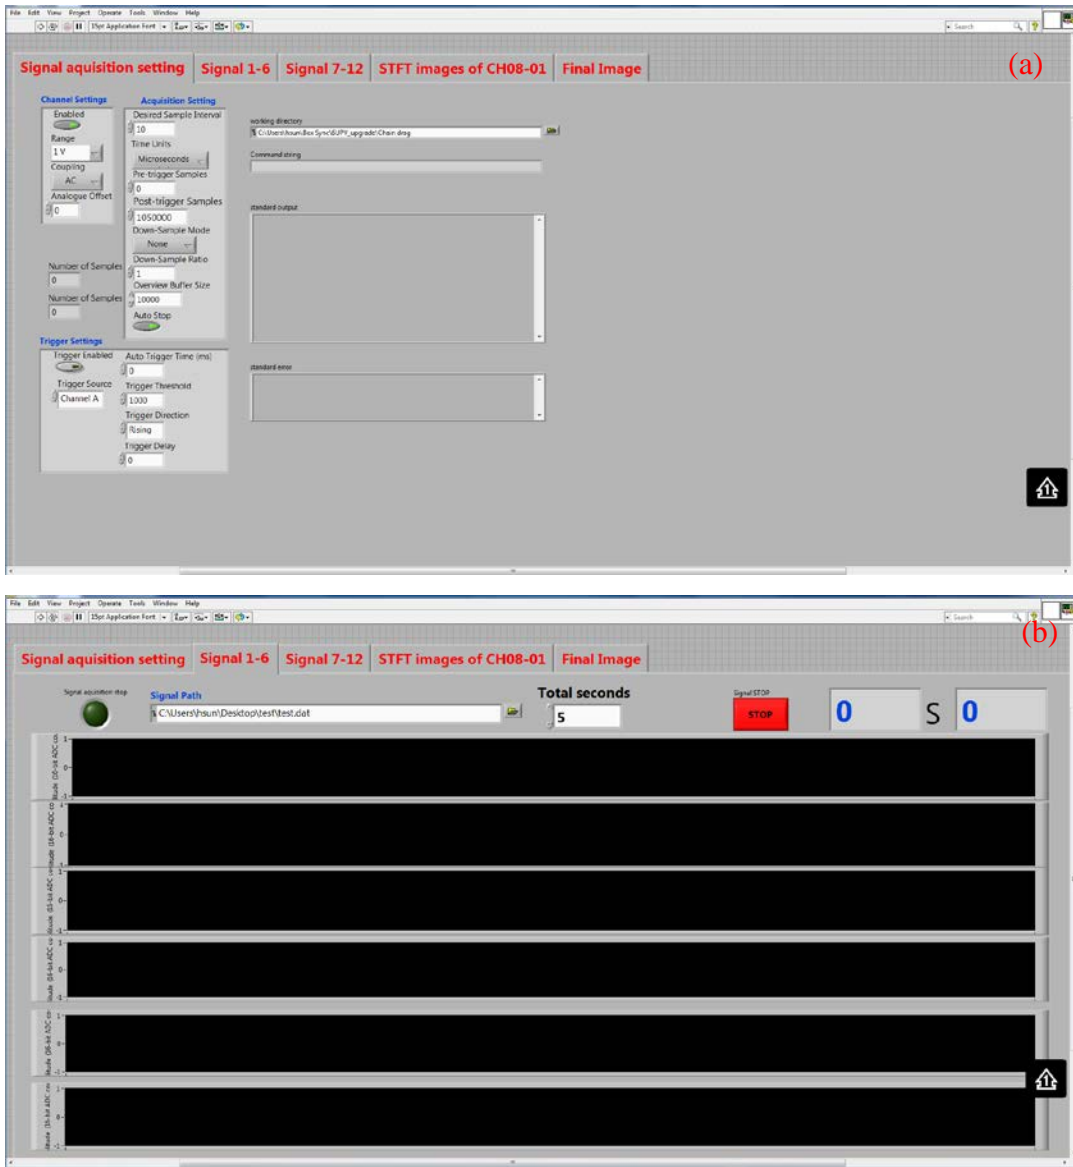
A data acquisition program was designed using LabVIEW. This program has two main parts: acoustic data acquisition and real-time GPS data recording. **Figure 5-5** shows the LabVIEW data acquisition program. The acoustic signals were acquired using the LabVIEW driver of the PICO scope and the GPS data was transmitted through a Python driver embedded in the LabVIEW program. An Android application (see **Figure 5-6**) was developed based on the open source driver provided by the Swift Navigation, so that a cell phone or a tablet computer (Android system) can be used to setup the GPS base unit and record the GPS data when surveying bridge deck boundaries.

Figure 5-5 LabVIEW data acquisition program: (a) Setting page, (b) Signal display page

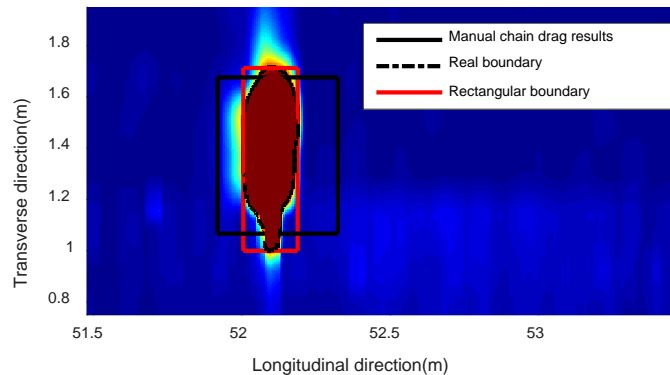
A delamination detected in one field test is used to illustrate the boundary tracing process using the algorithm described above. In **Figure 5-8**, the red area represents a detected delamination with high signal amplitude, and the blue color represents low amplitude of background signals in sound areas. The threshold value should be determined from experience. If the image presents amplitude in linear scale, $P_t = 10\%$ of the maximum amplitude gives reasonable size of the delamination.

Figure 5-8 Delamination boundary tracing of Delamination #1

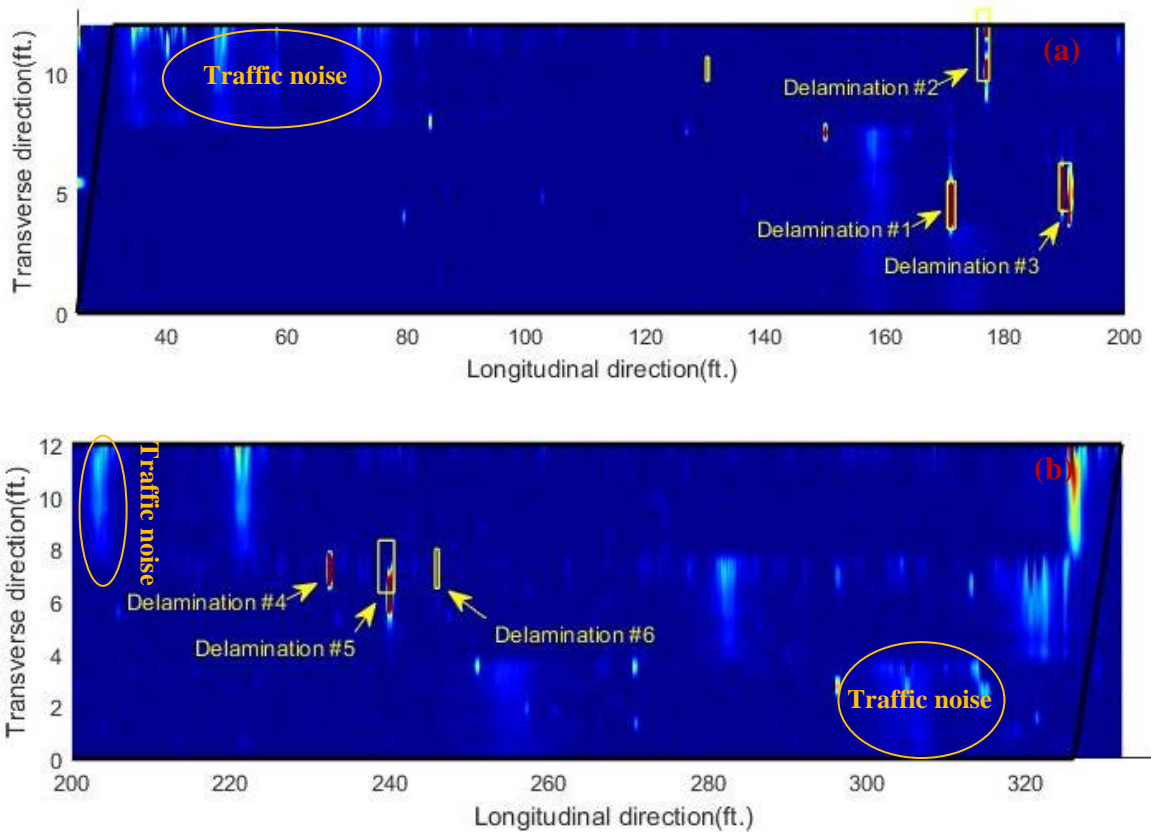
small delaminations. Using multiple ball-chains in each channel will improve longitudinal resolution by generating more impacts than using one ball-chain. Traffic noises (circled areas) can be observed in the images, which did not affect identification of the delaminations.

Figure 5-11 Scanning images of Bridge 1 (right lane): (a) 25-200 ft, (b) 200-335 ft

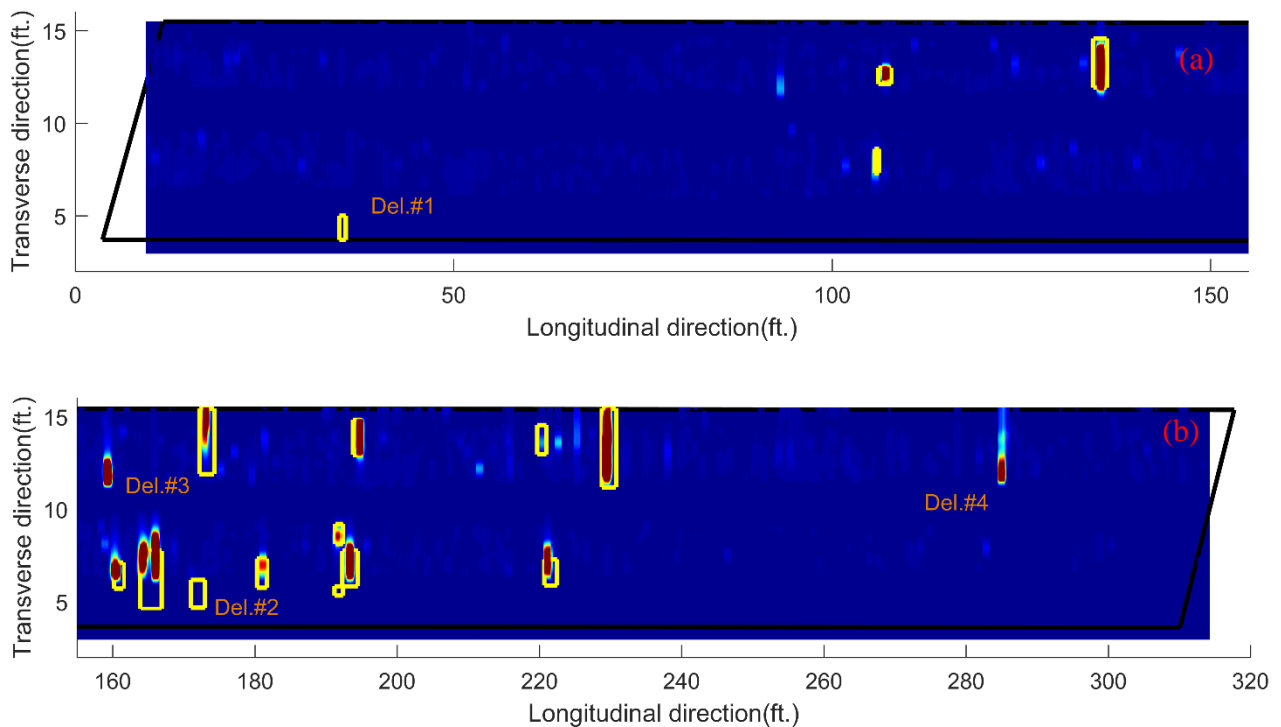
Figure 5-14 Scanning images of Bridge 1 (left lane): (a) 0-155 ft, (b) 155 ft-315 feet

Figure 5-14 shows the scanning images of the left lane of bridge deck. The image is split into two parts (0-155 ft and 155 – 315 ft). In the images, the black lines represent the bridge lane boundaries. Red spots indicate the delaminations in the bridge deck and the blue areas represent the sound deck areas. The positions of delaminations identified by the automated acoustic scanning match very well with the manual chain drag results, which are shown in yellow rectangles in the two images. However, the acoustic scanning results missed two delaminations (Del. #1 and Del. #2) which were identified by the manual chain drag. On the other hand, the acoustic scanning found two delaminations (Del. #3 and Del. #4) that were missed by the manual chain drag. Multiple scanning on the same lane confirmed these two delaminations. The total delamination area identified by the boundary tracing algorithm is about 48.1 ft². Compared with the scanned area 3824.4 ft² the delamination area percent is about 1.26 %.

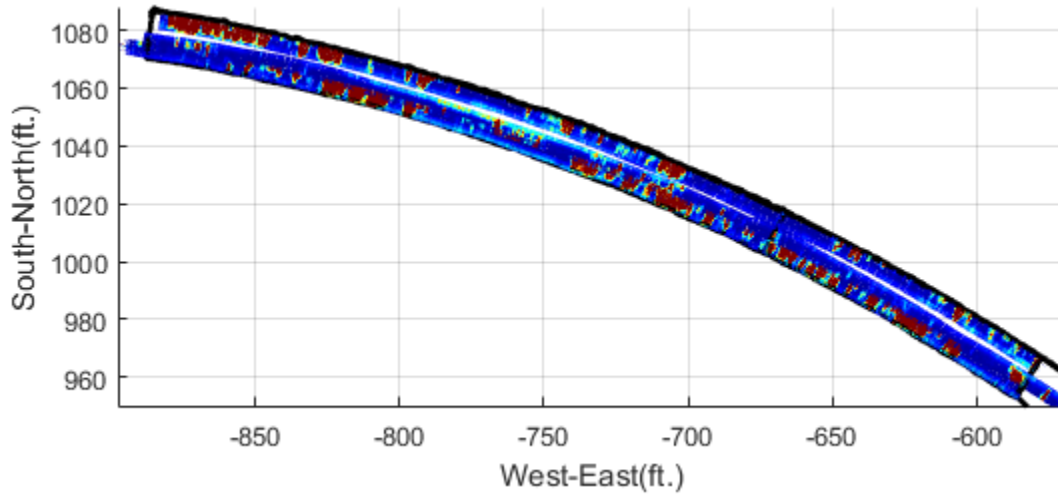
Figure 5-22 Acoustic scanning image of *segment 3* on Bridge 3
