Effectiveness of Chain Link Turtle Fence and Culverts in Reducing Turtle Mortality and Providing Connectivity along U.S. Hwy 83, Valentine National Wildlife Refuge, Nebraska, USA

FINAL REPORT

A report prepared for the
U.S. Fish & Wildlife Service, Headquarters Office,
Transportation Branch, 5275 Leesburg Pike, Falls Church, VA 22041

December, 2017

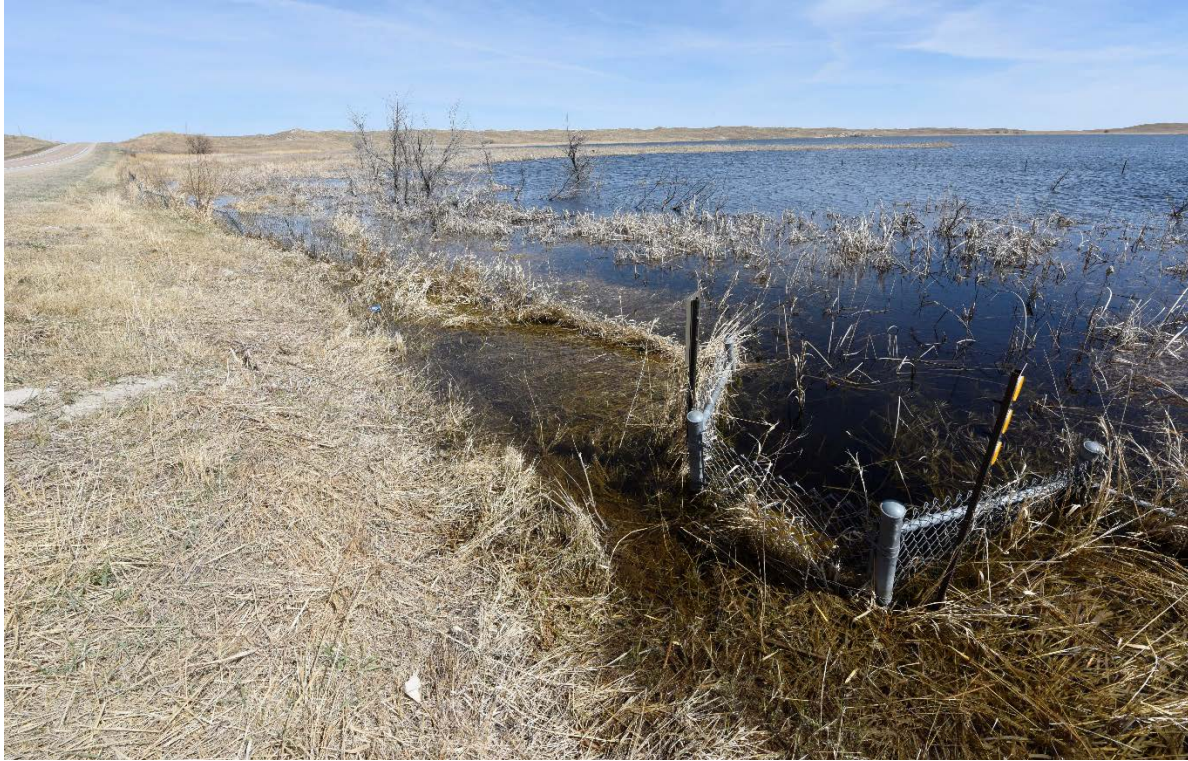
| Valley | Maintenance issues |
|---|--|
| Twin Lakes | East side, north end, multiple gaps under fence, could be easily filled with concrete blocks. West side, south end, two sections with fencing damaged, effectively lowering the fence. Both east and west fence top just above water level near the culvert. |

Figure 7: The turtle fence is almost completely under water (Twin Lakes), April 2016.

- Replacing fence material in select locations.
 - Replacing broken fence posts.
 - Fixing gaps in the fence (including gaps caused by erosion).
 - Removing vegetation that has overgrown the fence.

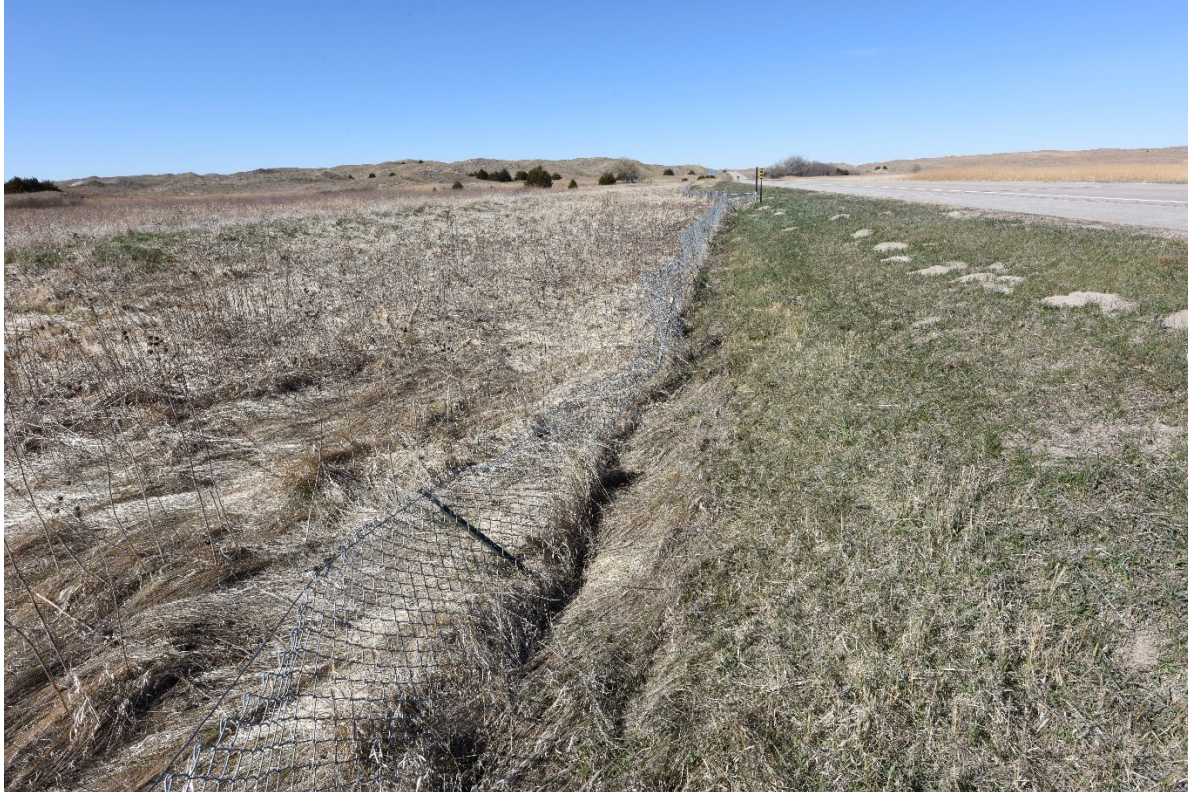
| Valley | Maintenance issues |
|---|--|
| Ballard's South and North | 2 fence posts broken |

Figure 8: The turtle fence has broken posts because a vehicle ran off the highway (Ballard's Marsh), April 2016.

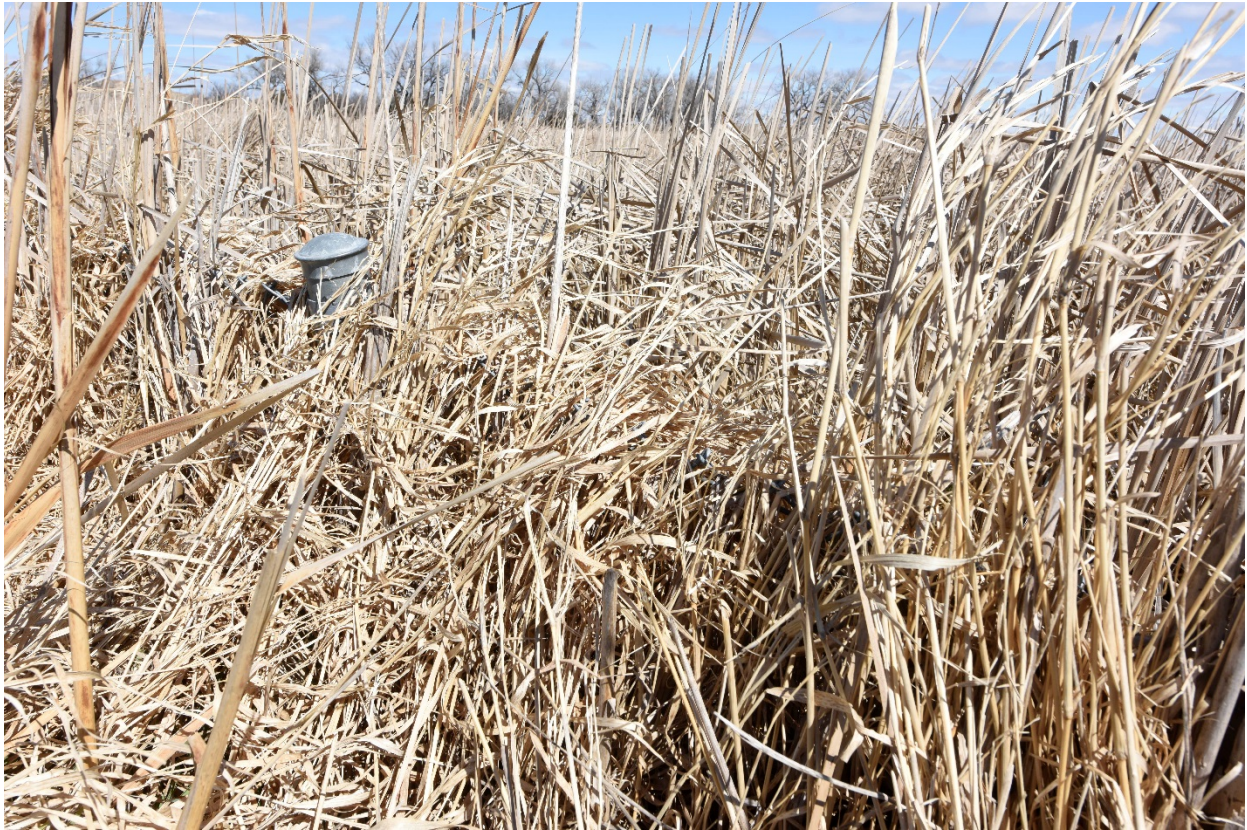
| Valley | Maintenance issues |
|---|--|
| Tom's Lake | East side partially in water, partially with dead vegetation on and over fence. Same on west side. But west side fence has even higher water level. Fence should probably be extended on both sides, north and south. No actual breaches in fence detected. |

Figure 9: Vegetation has overgrown the turtle fence (Tom's Lake), April 2016.

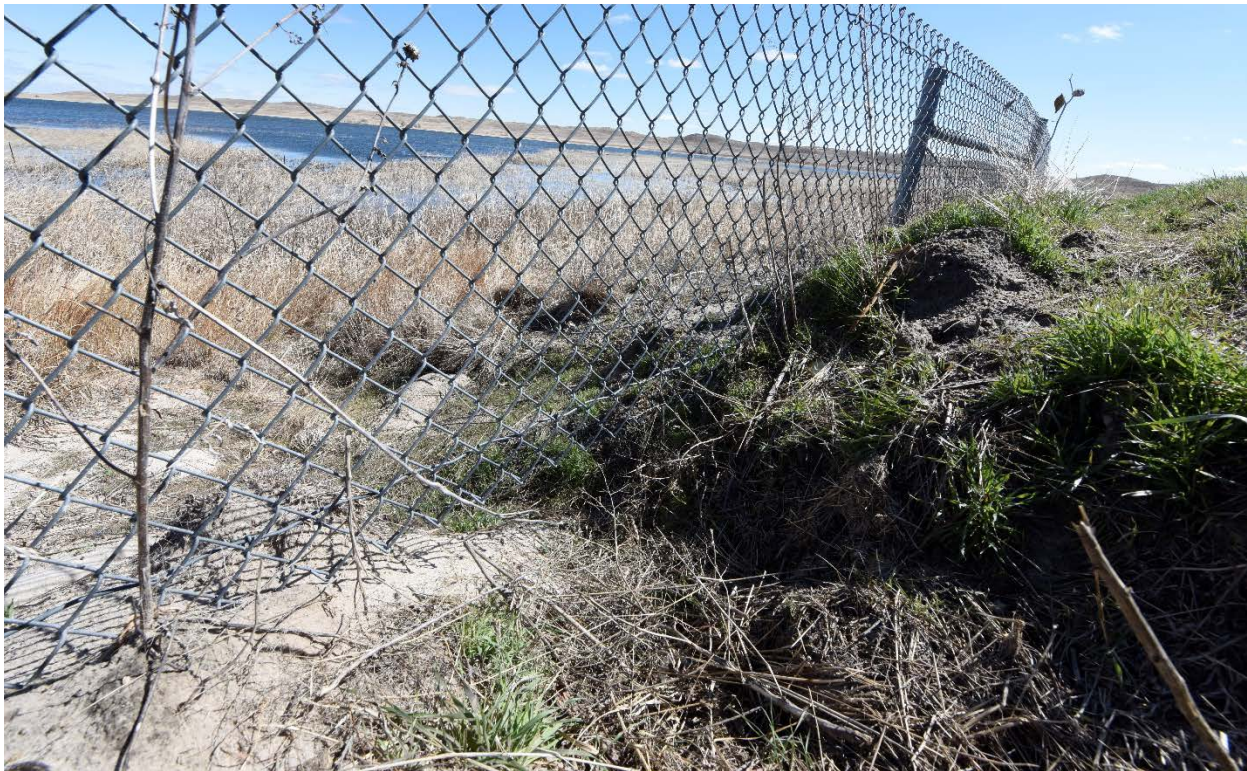
Figure 10: Gaps under the fence caused by erosion (Twin Lakes), April 2016.

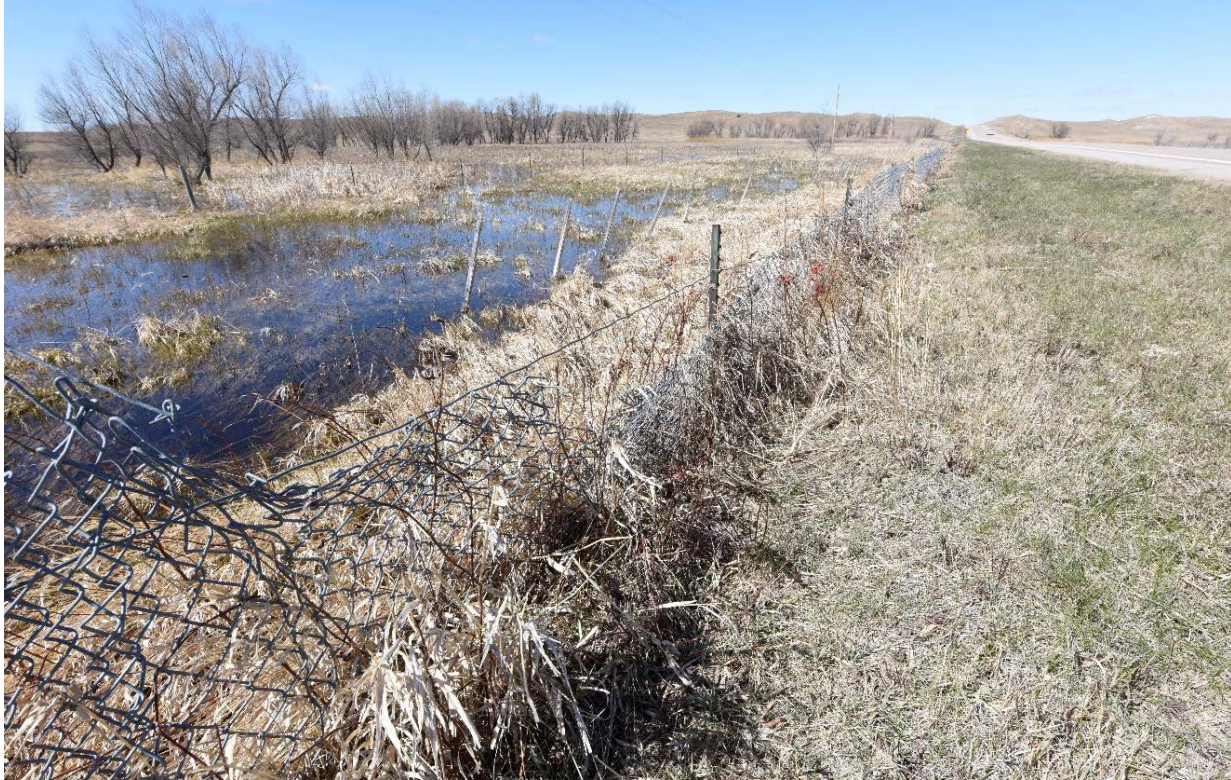
Figure 11: Fence detached from top wire and posts (Twin Lakes), April 2016.

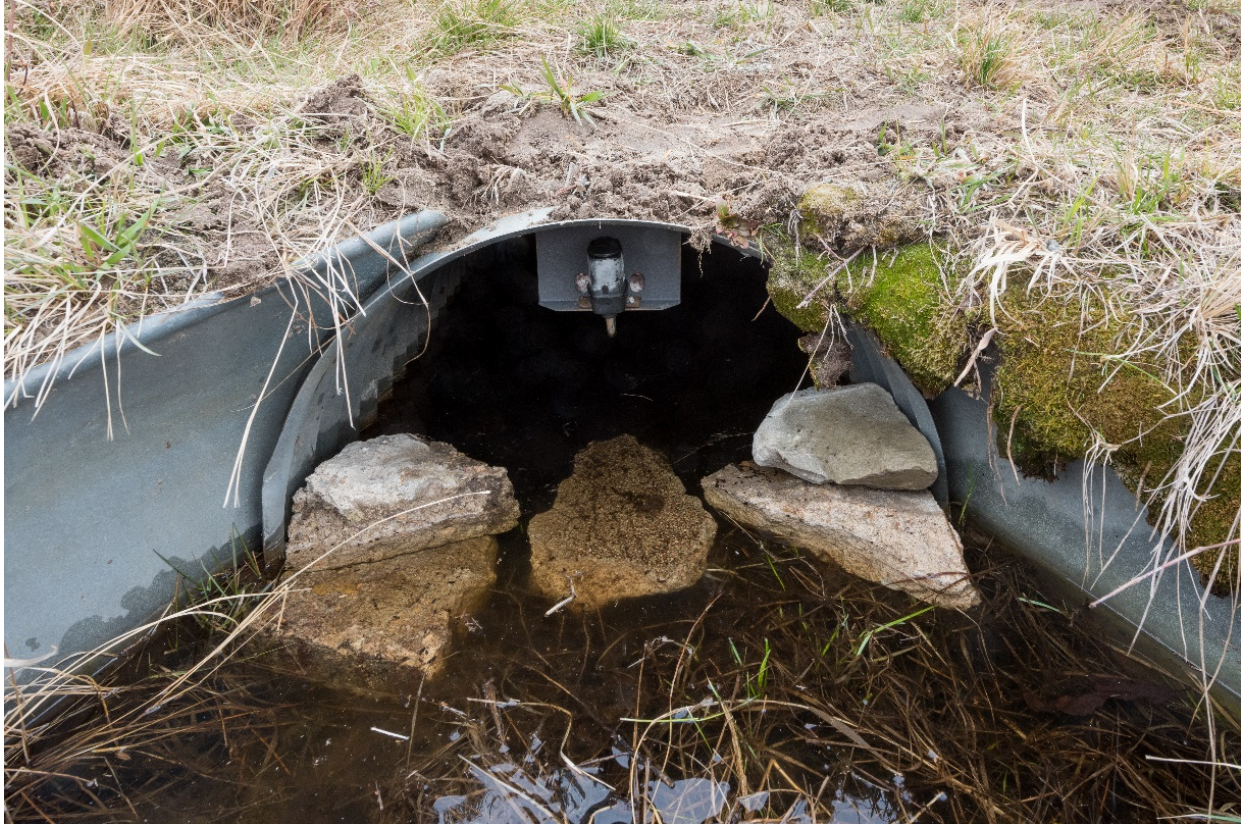
Figure 12: Turtle ramp made from concrete debris forced the turtles directly under the cameras and to the water surface (Pony Lake). Note that this culvert is not connected to a turtle fence.

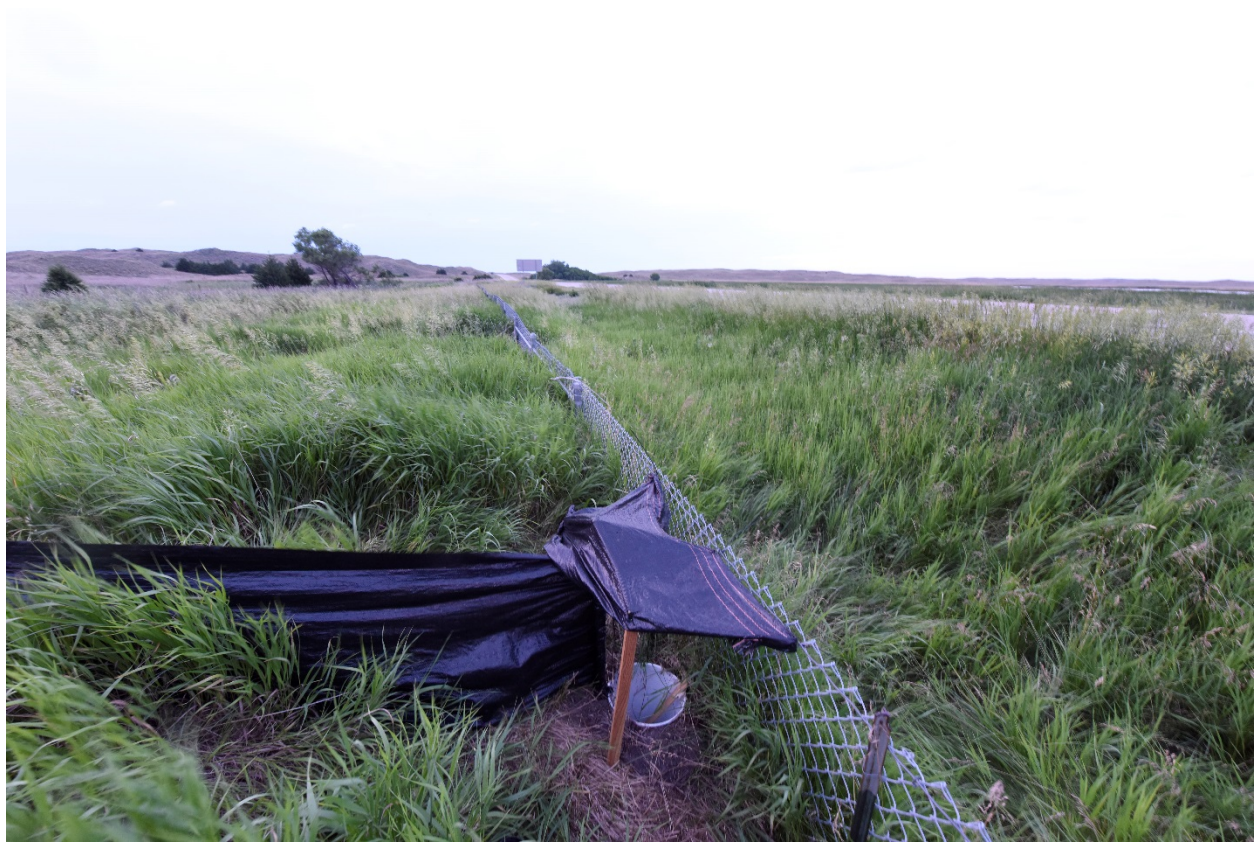
Figure 15: A pitfall arrangement in the field at Ballard's South.

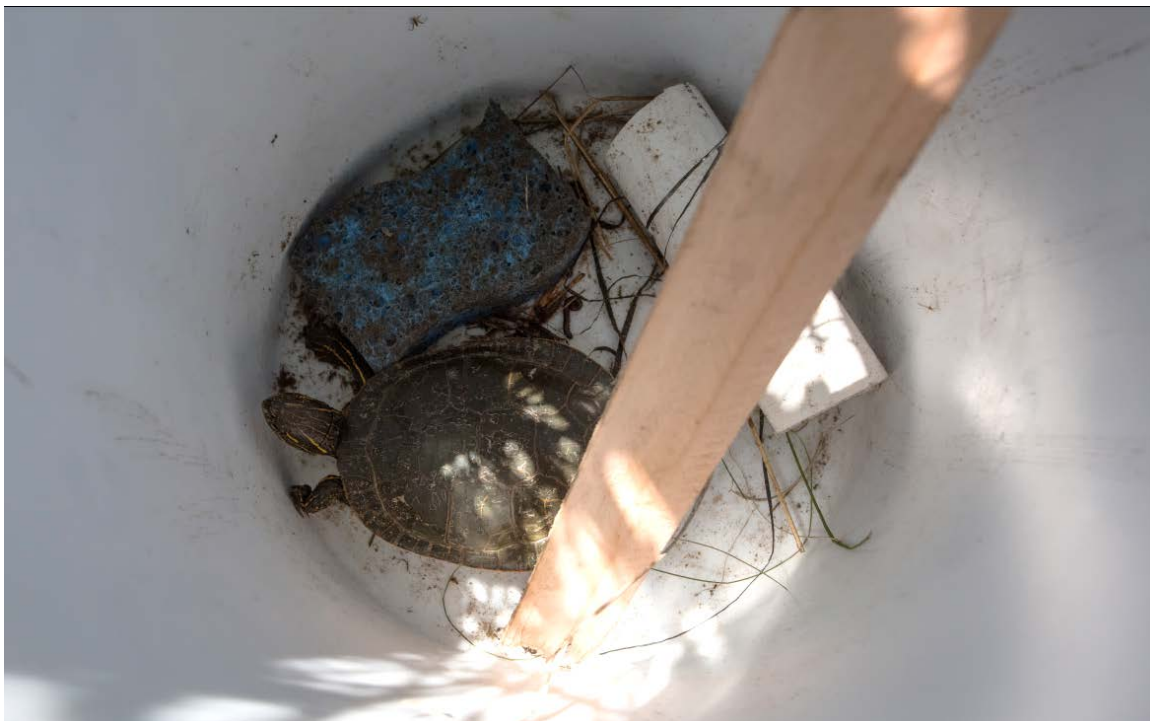
Figure 17: A Blanding's turtle passing through a culvert (Little Hay).

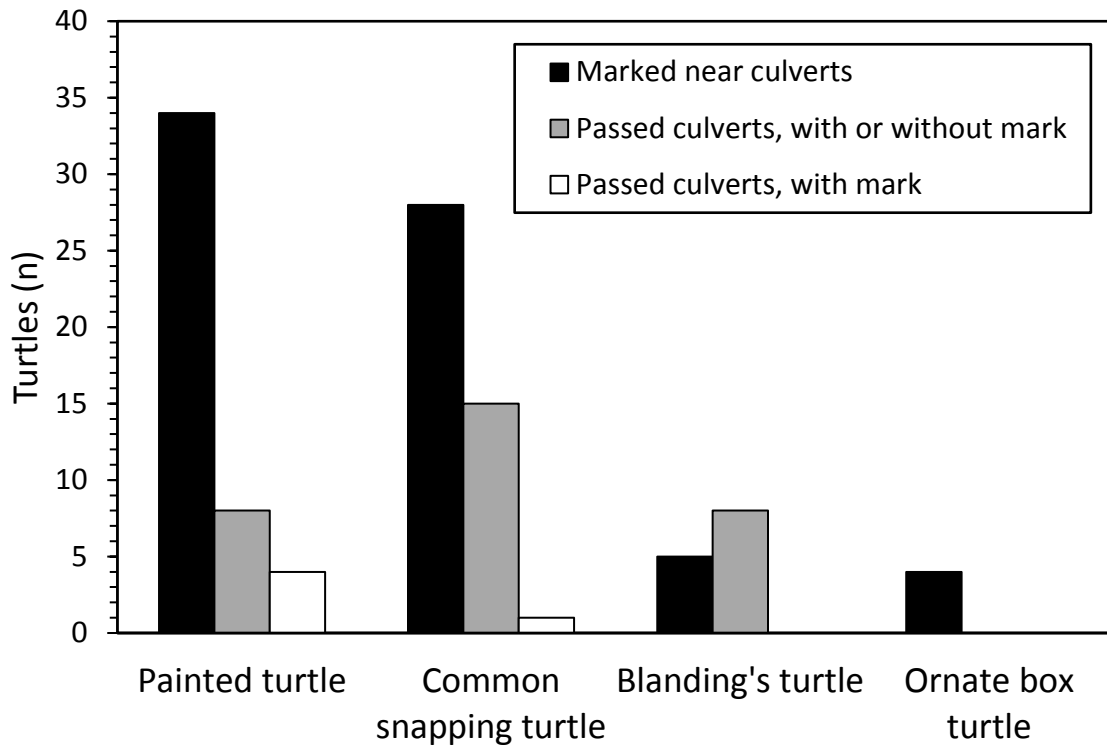
In 8 days we captured and marked 71 individual turtles near the 4 culverts that were part of the CMR experiment (34 painted turtles, 28 common snapping turtles, 5 Blanding's turtles, and 4 ornate box turtles) (Figure 18, 19). Of these 71 individual turtles, only 5 (7.0%) used the culverts between 7 June and 30 September 2016 (4 (11.8%) painted turtles, 1 (3.6%) common snapping turtle) (Figure 19, 20). Assuming all turtles that passed the 4 culverts in this period (n=31) were originally marked, connectivity was still only 44%. During 8 days of capturing, only 2 previously marked turtles (all common snapping turtles) were observed on or alongside of the road (road side of the fence at Sweetwater and at Little Hay). Note that the CMR experiment did not result in any turtle injuries or fatalities. Non-target species caught in the pitfalls are summarized in Appendix B.

Figure 19: The number of turtles captured and marked near the 4 culverts between 7-15 June 2016, and the number of turtles that passed through the culverts (with or without mark, and with mark) between 7 June and 30 September 2016.

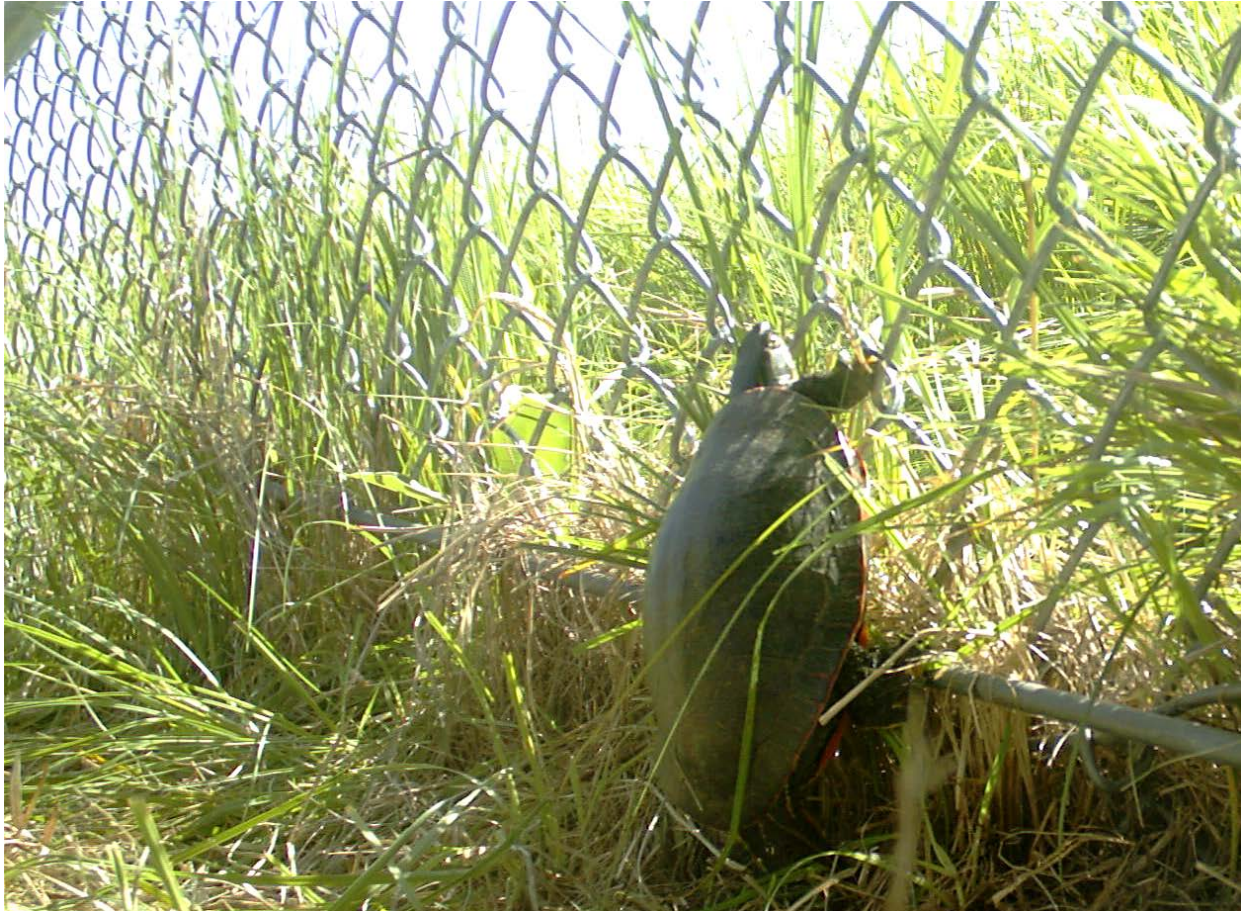
Figure 21: A highly motivated painted turtle attempting to climb or go through the turtle fence.

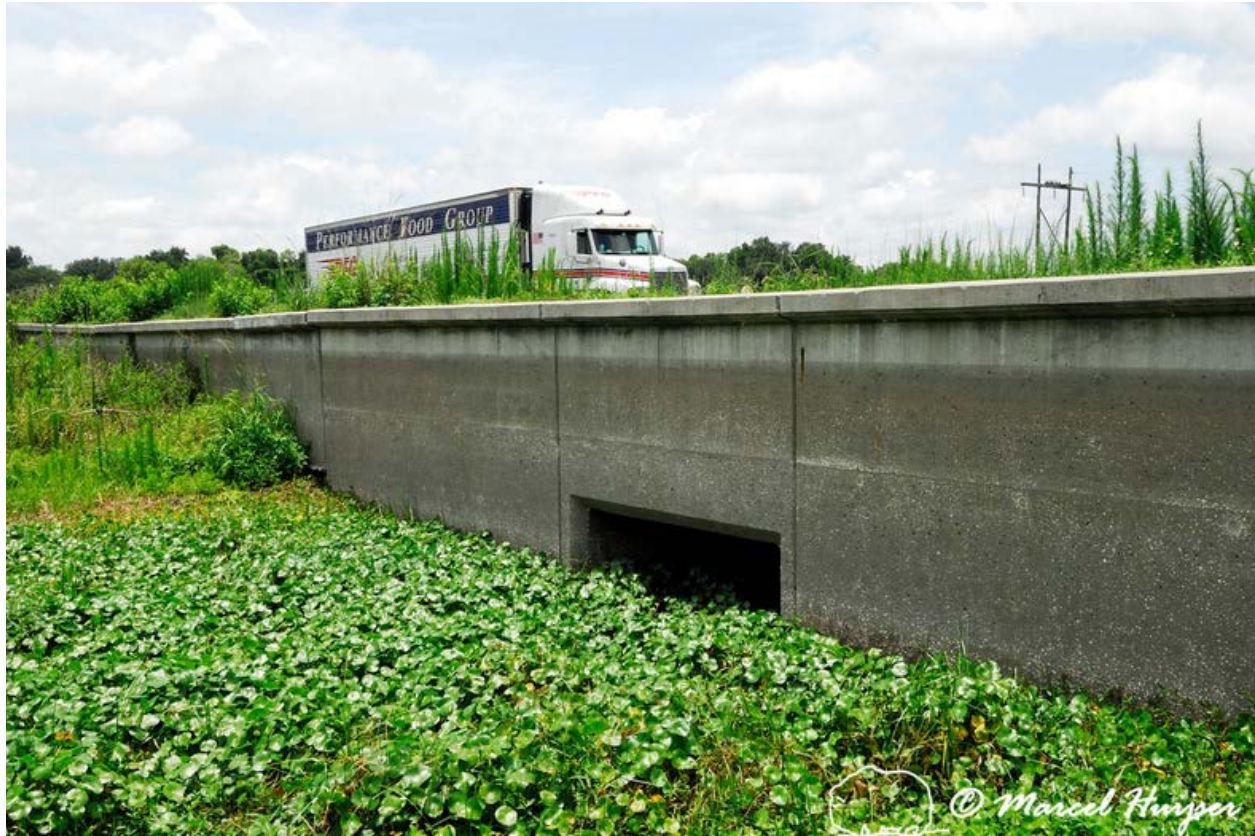
Figure 22: Underpass and barrier wall for reptiles, amphibians and small mammals, U.S. 441, Paynes Prairie Ecopassage, south of Gainesville, Florida, USA.

- When providing safe crossing opportunities, also consider making them suitable for amphibians and snakes. Amphibian culverts typically have openings in the ceiling of the culvert at-grade with the road surface. This allows for the temperature and humidity inside the culvert to be similar to that of the surroundings. Larger structures are better, and if the size allows, debris (branches, root wads) can provide better habitat inside culvert for small animal species including invertebrates, amphibians, snakes, and small mammals.
- The current chain-link fence is a barrier to turtles, but not to amphibians and snakes. If amphibians and snakes are also to be excluded from the highway, then consider smooth ABS sheets attached to turtle fence or barrier walls integrated into the road surface (Figure 23).

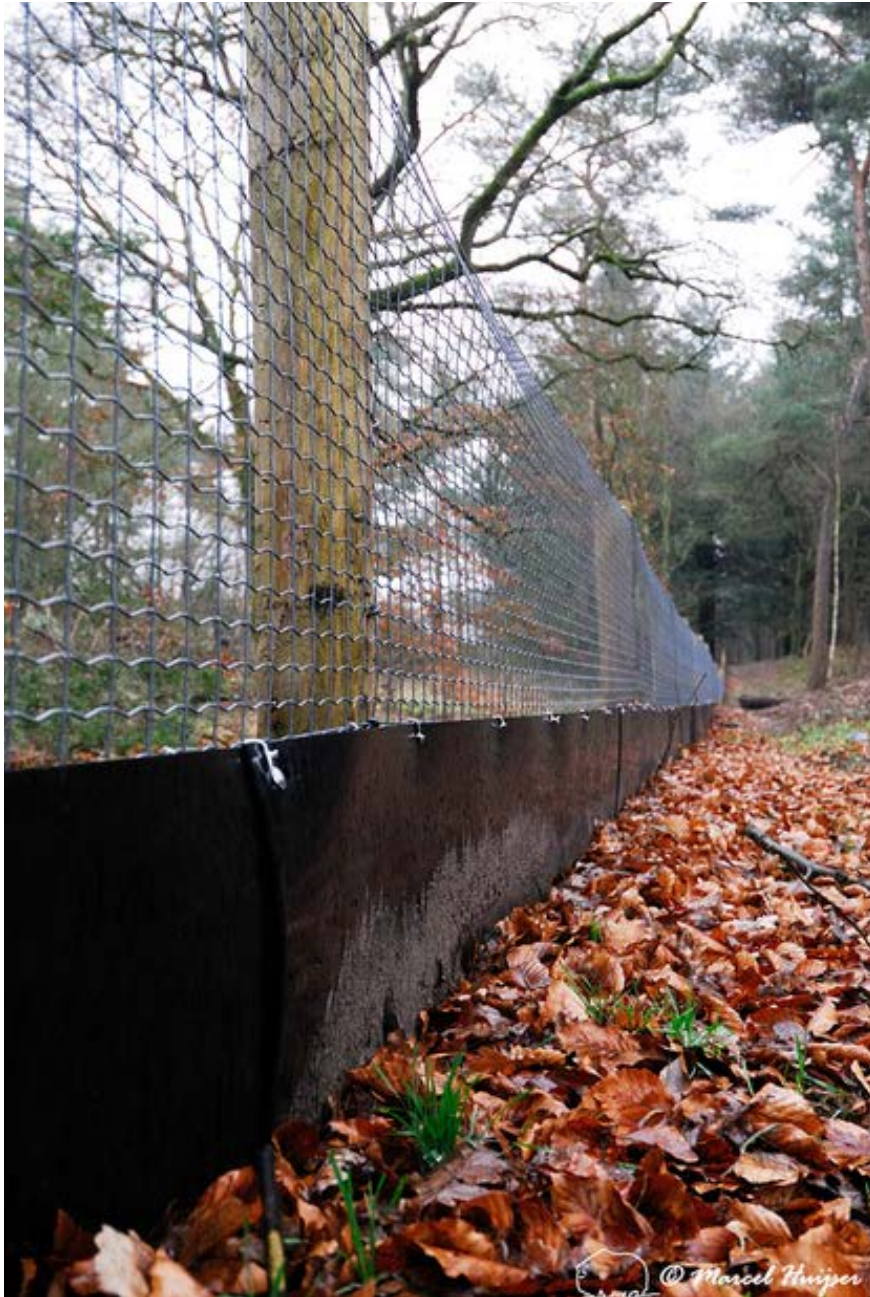
Figure 23: Wildlife fences including smooth plastic amphibian screen, N302, Leuvenumseweg, Sonnevank, east of Harderwijk, The Netherlands.
