DEPARTMENT OF TRANSPORTATION

Utilizing Kryton KIM Technology in Bridge Deck and Rail Construction to Protect Against Chloride Ion Penetration

May 2020

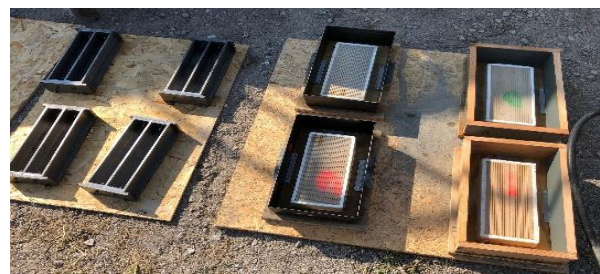
Figure 2 - Forms for T380 Mini-prisms (left) and forms for ponding blocks ready for casting.

Researchers cast specimens using NDOT mix design 47BD, used for structure applications, as the control samples and using mix design 47BD with KIM as an admixture to form ponding blocks and mini-prism specimens. The T380 forms and Ponding Block forms are shown in Figure 2.

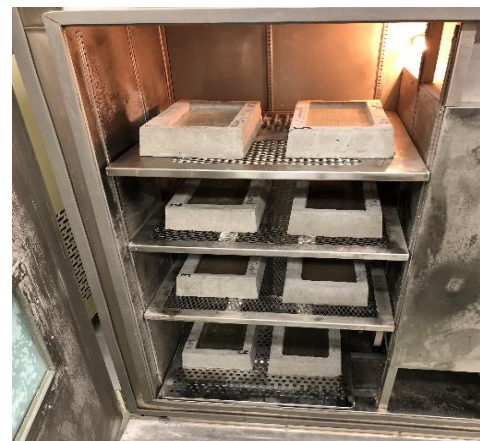
Figure 3 - The ponding blocks were subjected to F-T testing in the environmental chamber.

The ponding blocks were subjected to F-T testing in the environmental chamber in the PCC lab in accordance with C672 as shown in Figure 3. The cycles began on Mondays with ponding the blocks with fresh deicer and placing in the chamber to freeze at -20°C for 6-8 hours. After freezing, the blocks thawed at 23°C for 16-18 hours. The blocks cycled between freeze-thaw temperatures 5 times per week (Monday through Friday). The blocks remained ponded in the thawed state through the weekend, deviating from C672 Section 9.3 which calls for the blocks to remain in the frozen state or kept damp in the thaw state during cycle interruptions. Researchers directed the variation due to personnel shortage on weekends. On Monday mornings, researchers drained and flushed the blocks with distilled water, observed scaling degree, and then re-ponded the blocks with fresh deicer to restart the process. Testing continued for 85 F-T cycles.

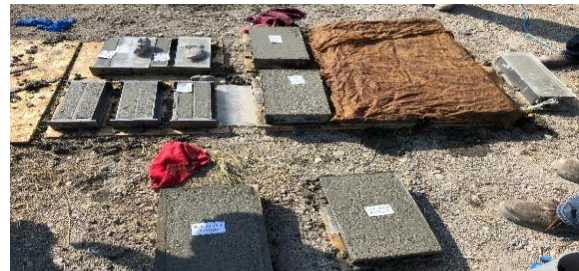
Figure 5 - Mini-prisms and ponding blocks, field curing. Half of the samples were exposed to ambient conditions, while the other half were cured according to NDOT standards.

Mini-prisms were cast at an outdoor site chosen for research in accordance with AASHTO Test Method T380 to compare expansion differences between 47BD and KIM. Six mini-prisms were cast using 47BD and six were cast using KIM. For each mix, three mini-prisms were cured and three were not cured at the testing site for 24-hours as shown in Figure 5. The mini-prisms were stripped from the molds and placed in soaking containers filled with NaOH as specified in T380. The specimens for each mix design were measured for expansion in triplicate at 3, 7, 10, 14, 21, 28, 42, 56, 70, and 84 days.

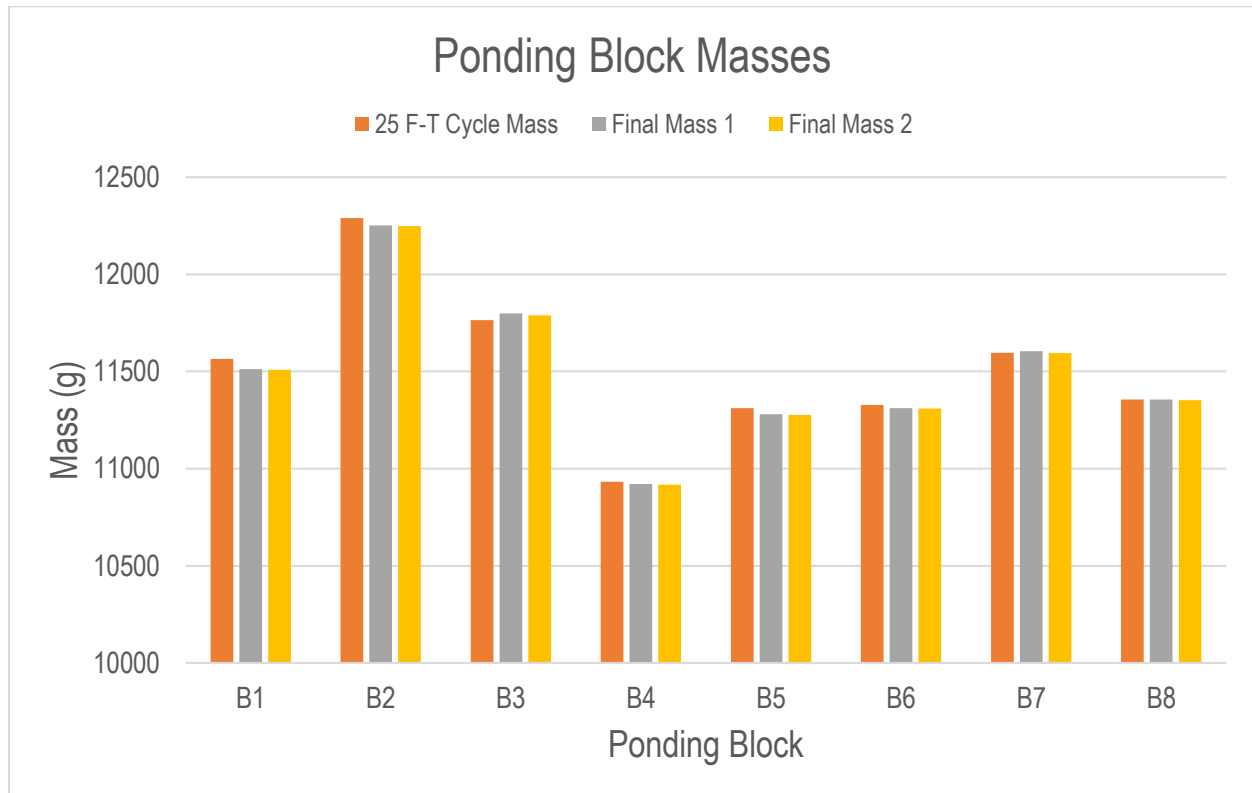
Figure 7 - The ponding blocks were weighed after 25 F-T cycles and twice at the end of testing. No significant mass change occurred.

The masses of each block were recorded after 25 F-T cycles and twice at the end of testing. Testing completed after 85 F-T cycles and two final masses were taken after drying. The blocks dried in the environmental chamber at 23°C for one week (Final Mass 1), were weighed, dried for a second week and were weighed again (Final Mass 2). None of the blocks showed significant mass change due to ponding. The largest mass percent change was -0.450%. The two blocks made with KIM and ponded with NaCl, B3 and B7, showed a slight mass gain. Details of each block are discussed later in the Individual Ponding Block Performance section. The results for all eight blocks are displayed in the graph shown in Figure 7.

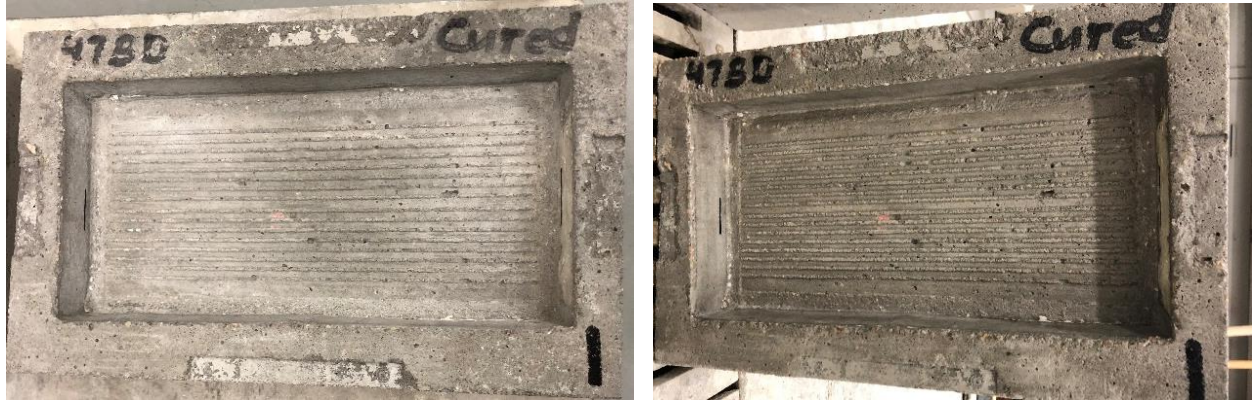
Figure 8 - B1 before testing (left) and after 85 F-T cycles showed no scaling.

Block B1 was made of 47BD, cured, and treated with PCS. It was ponded with $MgCl_2$. This block showed no scaling and was assigned a scaling code of 0. The block is pictured before and after testing shown in Figure 8. The mass of B1 decreased by 56 grams, or 0.48% of its 25-cycle mass.

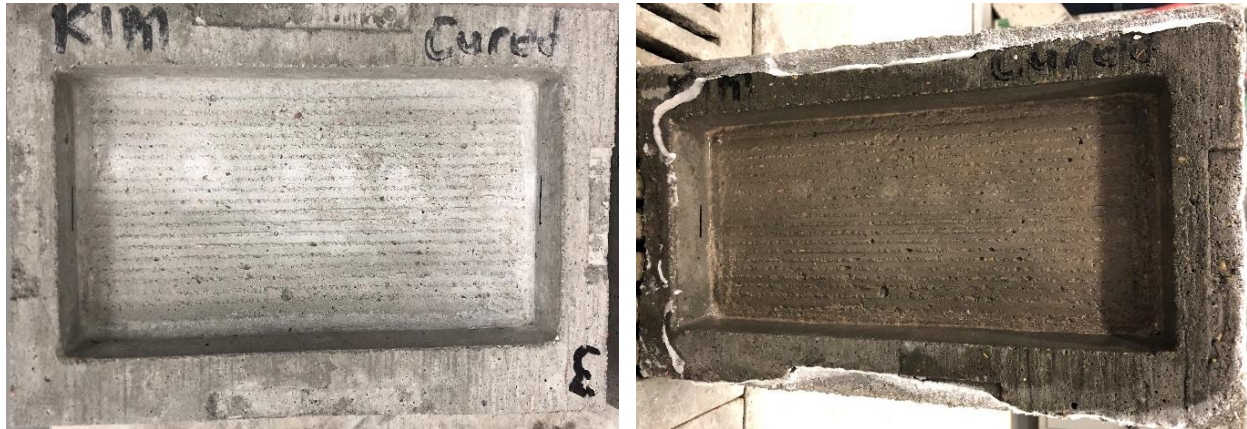
Figure 10 - B3 before testing (left) and after 85 F-T cycles showed moderate-heavy scaling on the rim and outer surfaces of the block.

Block B3 was made of KIM and cured. It was ponded with NaCl. The block is pictured before testing began and after testing shown in Figure 10. The mass of B3 increased by 24 grams, or 0.20% of its 25-cycle mass. The mass increase is likely due to the reaction between water and KIM, which would retain the mass of the reacted water within the structure.

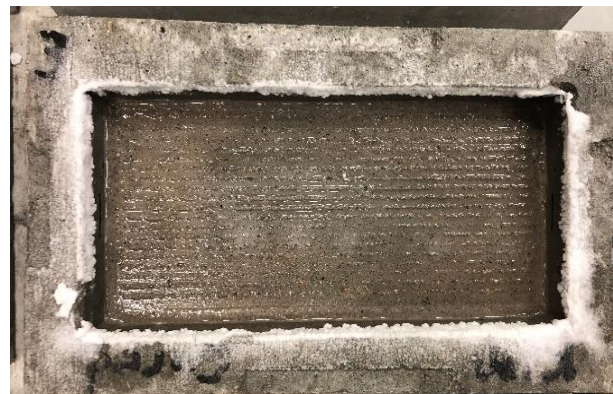
Figure 11 - NaCl deposited on the rim and outer surfaces of the ponding block during F-T testing.

Throughout testing, researchers observed the formation of a crystalline structure on the rim and outer surfaces of the ponding block, shown in Figure 11. Samples of the crystals were collected and analyzed in the NDOT chemistry lab. The results indicated that the crystal formation was NaCl.

Federal Highway Administration sponsored research declared “capillary absorption, hydrostatic pressure, and diffusion are the means by which chloride ions can penetrate concrete” [4]. Capillary absorption occurs when the liquid deicer contacts the dry concrete and is drawn into the concrete pores by capillary action. Hydrostatic pressure causes chloride penetration when a hydraulic head is applied to the faces of the concrete. Diffusion is driven by a concentration gradient where ions transport towards lower concentrations. Conditions for the three mechanisms were favorable, however researchers cannot definitively conclude that the mechanisms are responsible for the transport of sodium and chloride ions and the formation of the salt crystals on the outer surface of the block.

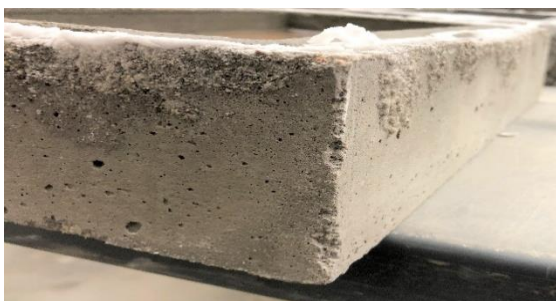
Figure 12 - The concrete blistered where NaCl deposits were.

Researchers observed mild scaling on the ponded surfaces, where some of the tying eroded and small aggregate was exposed. The most severe scaling occurred on the outer surfaces of the ponding block where the NaCl deposits were located. The concrete looked blistered and bubbles in the paste formed. The concrete in this condition was very brittle and flaked off even when gently touched, exposing aggregate. A close-up photo of the blistering is shown in Figure 12.

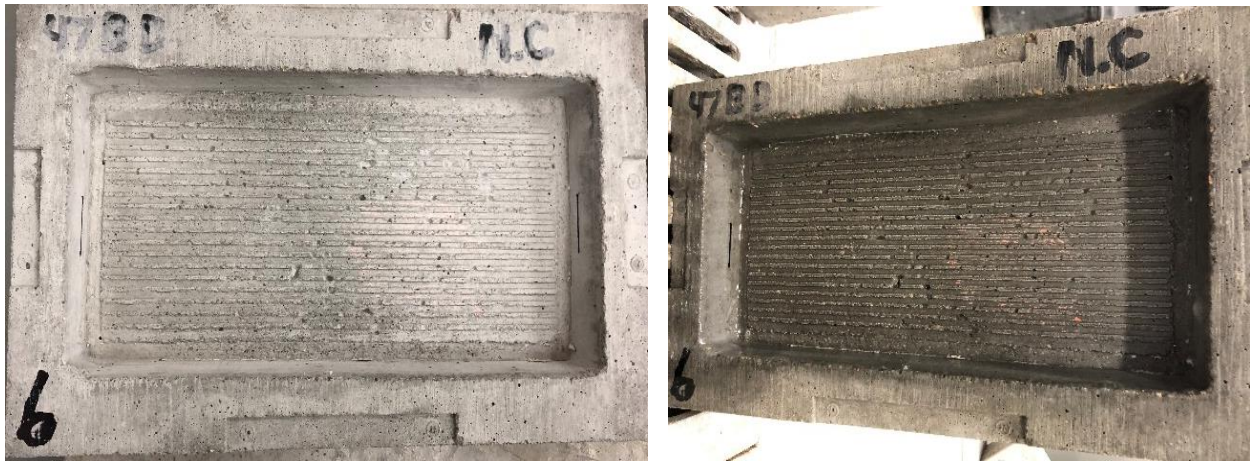
Figure 15 - B6 before testing (left) and after testing showed little signs of scaling after 85 F-T cycles.

Block B6 was made of 47BD and was not cured. It was ponded with $MgCl_2$. This block showed little scaling and was assigned a scaling code of 1. The block is pictured before and after testing shown in Figure 15. B6 also maintained a moist appearance after drying for two weeks in the environmental chamber. The mass of B6 decreased by 17 grams, or 0.15% of its 25-cycle mass.

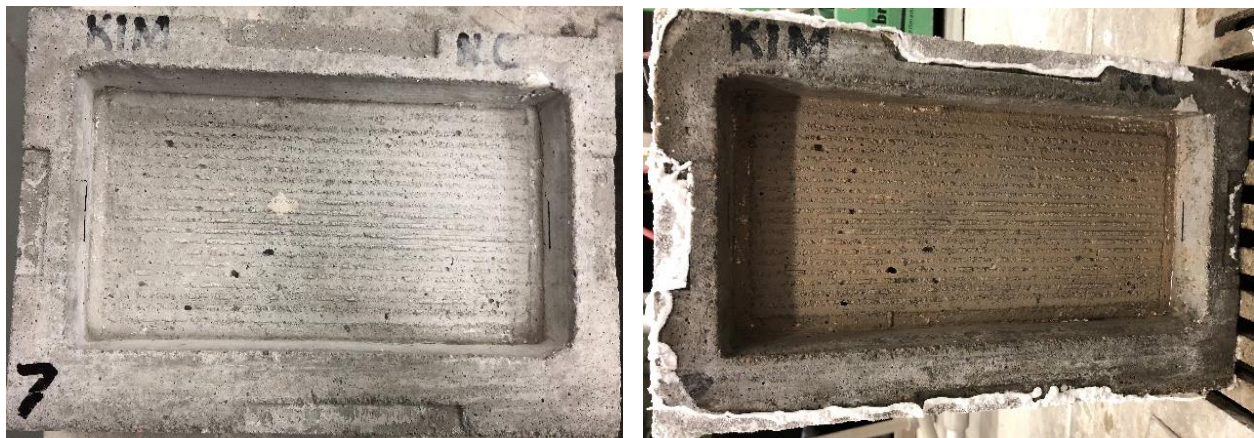
Figure 16 - B7 before testing (left) and after testing showed severed signs of scaling after 85 F-T cycles.

The block is pictured before and after testing shown in Figure 16. Block B7 was made of KIM and was not cured. It was ponded with $NaCl$. The pond showed light to moderate scaling, however the rim and outer surfaces significantly deteriorated and scaled by the end of testing.

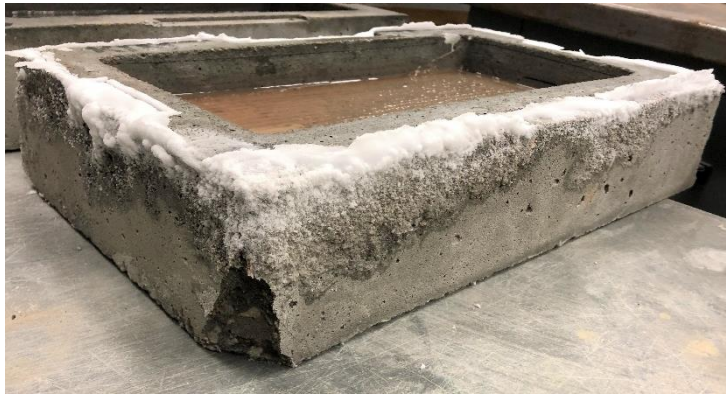
Figure 17 - A corner broke off of B7 during F-T testing. The block also exhibited a high degree of deposits.

A large chunk of the corner of B7 broke off between the 75th and 80th F-T cycles. The block also had a large amount of deposits and crystal formation on the rim and outer surfaces of the block. The missing corner and crystal formations are shown in Figure 17.

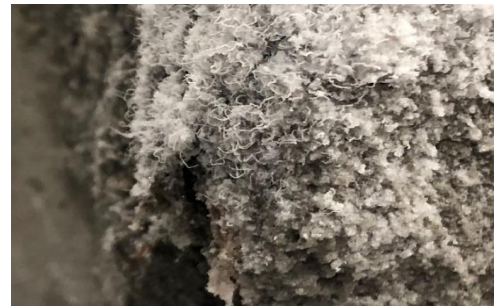
Figure 18 - Long, hair-like crystals formed on B7.

Researchers observed the formation of long, hair-like crystals on the ponding blocks, shown in Figure 18 and collected a sample. NDOT chemists analyzed the sample using XRF. The results indicate the sample was 99% NaCl. Calcium and silicon were present at about

0.57% and 0.138% respectively. Magnesium, potassium, iron, and sulfur were detected in less than 1000 ppm. Other elements were likely introduced by cement paste or KIM crystals potentially formed on the surface. The hair-like crystals could not be isolated and therefore the chemical composition cannot be determined.

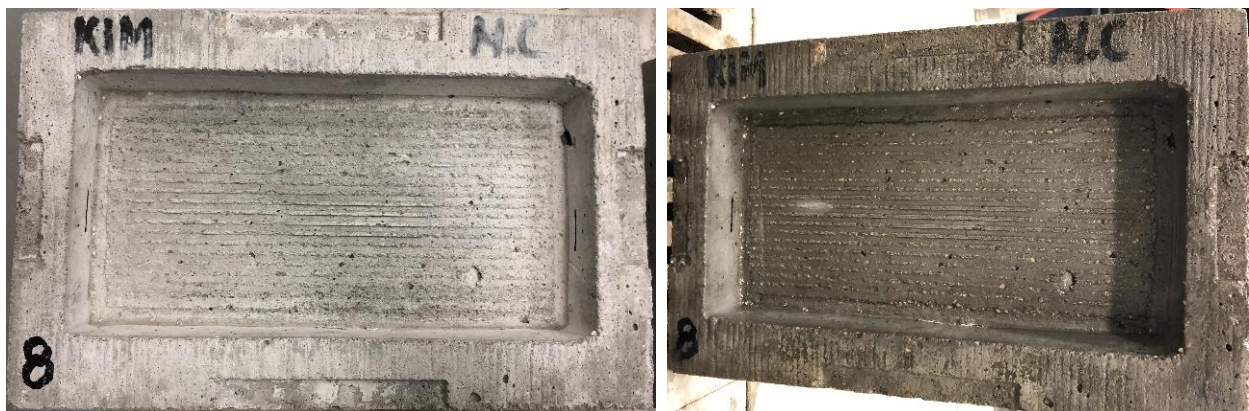
Figure 19- B8 before testing (left) and after testing showed light sign of scaling after 85 F-T cycles.

Block B8 was made of KIM and was not cured. It was ponded with $MgCl_2$ and only showed slight scaling and was assigned a scaling code of 1. This block was comparable to the cured KIM block, B4, in terms of scaling performance. The block is pictured before and after testing shown in Figure 19. B8 also maintained a moist appearance after drying for two weeks in the environmental chamber. The mass of B8 decreased by 3 grams, or 0.03% of the 25-cycle mass.

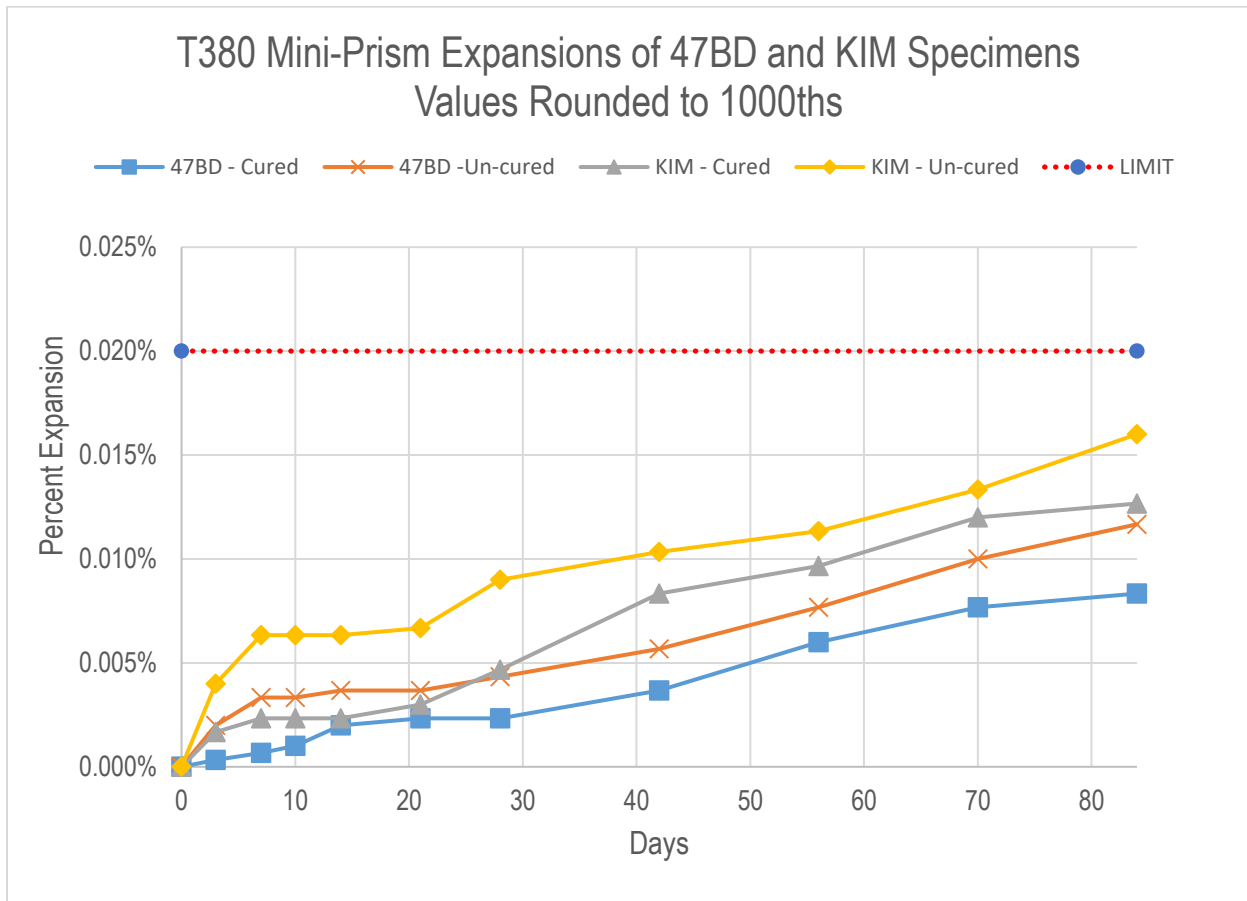
Figure 20 - T380 expansions comparing 47BD and KIM mixed specimens.

All four mix designs, 47BD cured, 47BD uncured, KIM cured, and KIM uncured, passed the T380 test with less than 0.02% expansion permitted by the test. Technicians in the PCC laboratory reported the following expansions for the specimens: 47BD cured — 0.008%; 47BD uncured — 0.012%; KIM cured — 0.013%, and KIM uncured — 0.016%. For both 47BD and KIM mixes, the cured specimens showed less expansion than the uncured specimens. This highlights the importance of curing concrete structures properly. The KIM samples expanded slightly more than the 47BD samples possibly due to the formation of KIM crystals within the sample. All four mix designs adequately protected against ASR expansion. The expansions of each mix design are graphed in Figure 20.
