# Investigating the Interaction of NDOT Hot-Pour PCC Joint Sealant and Penetrating Concrete Sealers

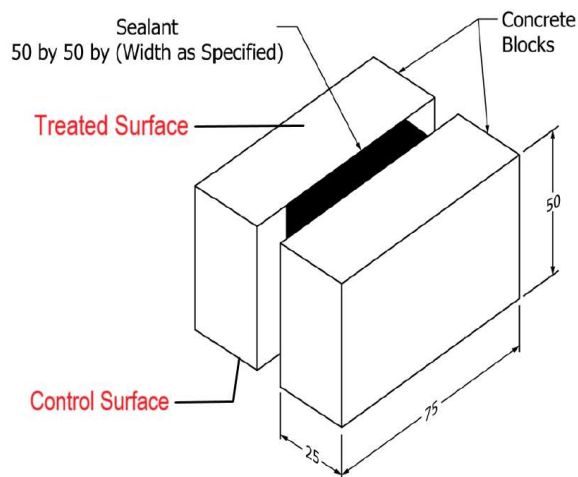
Figure 2 - The diagram of the concrete extension blocks from ASTM D5329 <sup>[2]</sup>. The treated and control surfaces are identified by NDOT researchers.

The investigation commenced with a meeting between researchers and Technical Adviser Committee (TAC) members. During this meeting, a plan was developed to test the five PCS products approved by the Department in accordance with ASTM D5329, *Standard Test Methods for Sealants and Fillers, Hot-Applied, for Joints and Cracks in Asphalt Pavements and Portland Cement Concrete Pavements*<sup>[2]</sup>. After testing completed, a TAC member proposed constructing a modified cupped block to model a depression observed in field application of hot-pour sealant. A set of blocks was constructed following ASTM D5329 with a modification in the form to create a depression. Construction and testing details of each block type are discussed in the following sections. Figure 2 shows a diagram of a block with dimensions in millimeters and illustrates the treated surface and the control surface.

One set of three blocks was tested for each product. The first block was sprayed twice with PCS on the surface, identified as the treated surface shown in Figure 2. The PCS was applied using a handheld mist sprayer and left to sit on the table top. The remaining two blocks were placed face down in two separate CoorsTek 60236 Porcelain Ceramic Evaporating Dishes each containing 15mL of PCS. The second block soaked for 1 minute, and third block soaked for 5 minutes. The PCS was approximately 1 mm deep but the blocks wicked up the PCSs approximately 3-6 mm, shown in Figure 4. Visual observations were noted and are discussed in the results section. For a control, researchers examined the opposite side of the block that was not treated with PCS, defined as the control side in the diagram shown in Figure 2.

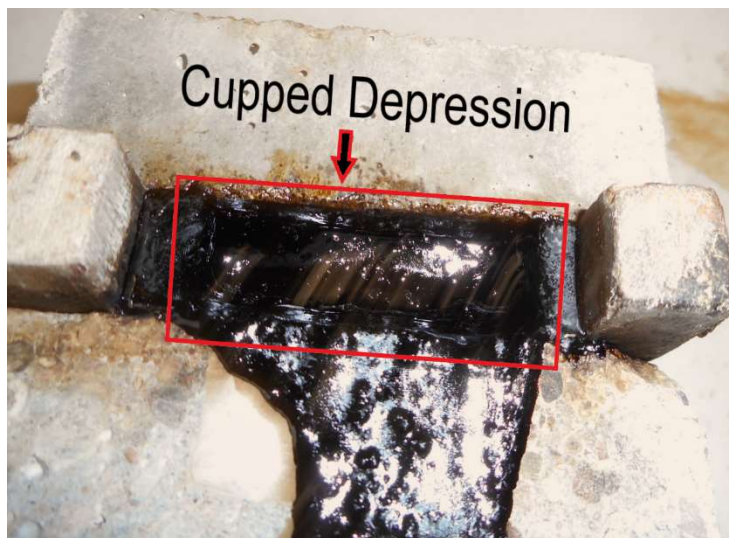
Figure 5 - A set of blocks was modified to create a cupped depression in the hot-pour sealant.

A set of three blocks was constructed with a modified mold designed to provide a cupped surface. Cupping is a depression created as hot pour sealant settles and cools in a joint and has been observed in the field. Cupping causes liquids to pond on the surface of the hot pour sealant. To create the depression, or cup, the physical testing laboratory provided the bituminous lab with a ½-round bar of 12.7 mm diameter, and 38 mm length. The bar was placed in the mold and the testing blocks were made in accordance with ASTM D5329. For this experiment, the three cupped blocks were ponded with Product 5 and allowed to evaporate and dry prior to extension testing. One of cupped blocks was photographed during the testing process. The cupped depression, boxed in red, is shown in Figure 5.

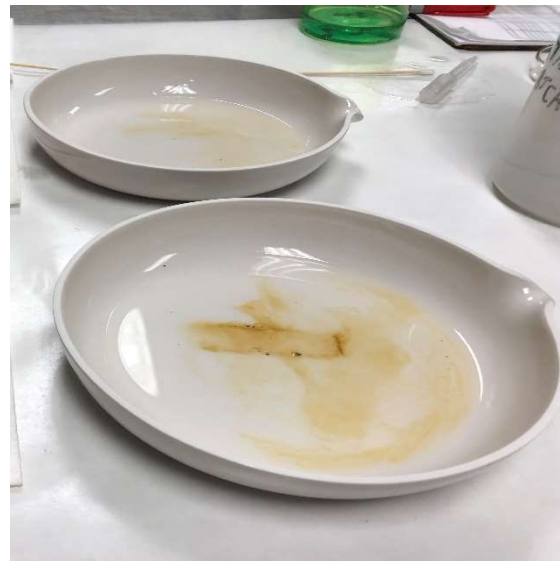
Figure 7- The Product 1 field sample 1-minute soaking dish (top) and the 5-minute soaking dish (bottom) each showed discoloration of the penetrating concrete sealer. The 5-minute soak shows more dissolution than the 1-minute soak.

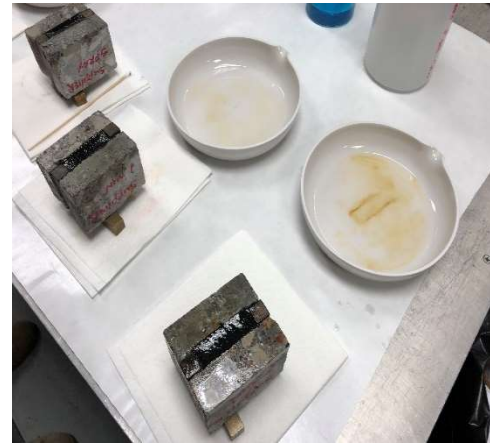
Figure 8 - Product 1 from the supplier showed similar results as the Product 1 field sample.

The second set of blocks tested with Product 1 received from the supplier exhibited similar levels of discoloration and dissolution as the field supplied sample shown in Figure 8. All blocks passed the extension test. Results are summarized in Table 3.

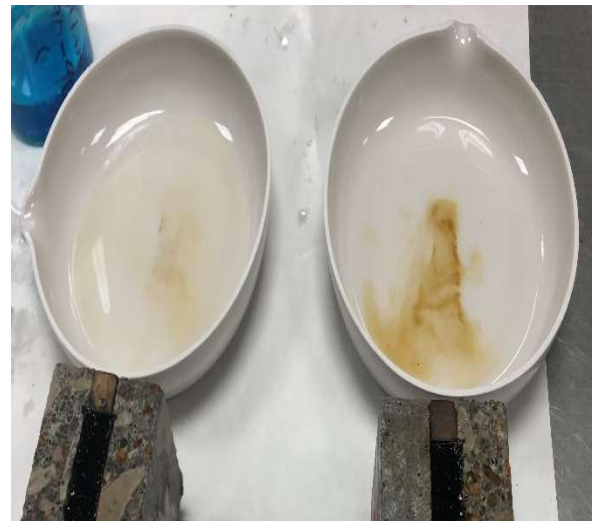
Figure 10 - Product 3, 1-min. and 5-min. post-test dishes showing discoloration.

Product 3 exhibited discoloration and dissolution, shown in Figure 10. All blocks passed the extension test. The results are summarized in Table 5. Product 3's 1-minute block showed some debonding along one side edge after the 3rd pull. The debonding is shown in Figure 11. The edge that debonded was not exposed directly to the PCS, however wicking might have drawn PCS up the side of the block. Inspection showed a pit, possibly caused by loose aggregate in the concrete block, where the debonding occurred. Researchers concluded that this damage was not caused by PCS.

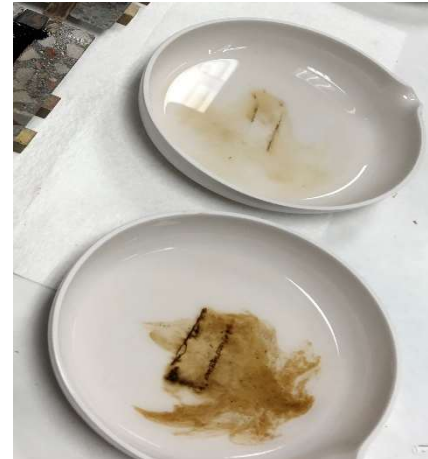
Figure 13 - Product 5; the 5-min (bottom dish) soak showed the most discoloration of any of the tests.

Product 5 showed the most discoloration of all products, shown in Figure 13. Researchers observed small particles floating in the dish, shown in Figure 14. After the third extension, researchers observed that sealant flowed down the side of the block, as shown in Figure 15. Researchers also observed that sealant treated with Product 5 was sticky. Despite these observations, all blocks passed the extension test. The results are summarized in Table 7.

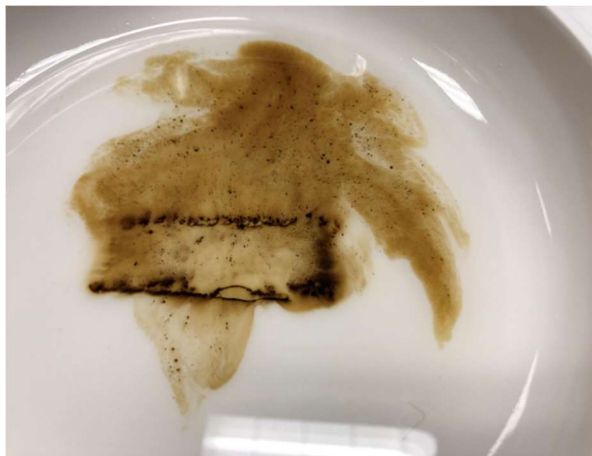
Figure 14 - The 5-min soak of Product 5 left solids in solution.

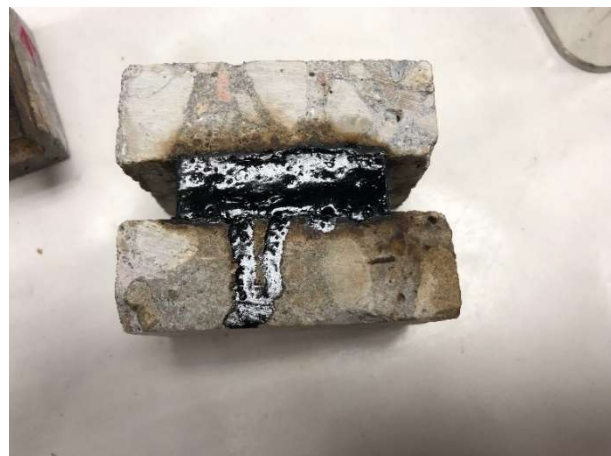
Figure 15 – NE-3405 sealant ran down the face of Product 5's 5-minute block.
