DEPARTMENT OF TRANSPORTATION

Resealing Concrete Median Barriers with Penetrating Concrete Sealers

May 2022

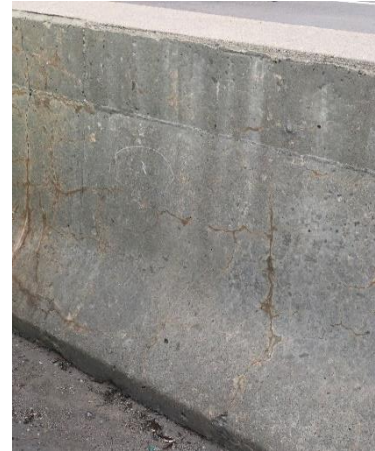
In 2013, concrete median barriers along I-80, I-480, and I-680 in Omaha, and West Limits North 27th street in Lincoln, Nebraska showed Alkali Silica Reaction (ASR) deterioration (Figure 1). To prevent further damage, the barriers were sealed with penetrating concrete sealer (PCS). The Department programmed a project in 2022 to seal additional concrete median barriers and to reapply PCS to the barriers that were sealed in 2013. However, the Pavement Design Engineer expressed the need for more information before the Lincoln and Omaha median barriers got programmed for the application and reapplication of concrete sealer.

Figure 1 - Concrete median barriers along I-80, I-480, and I-680 showed ASR deterioration.

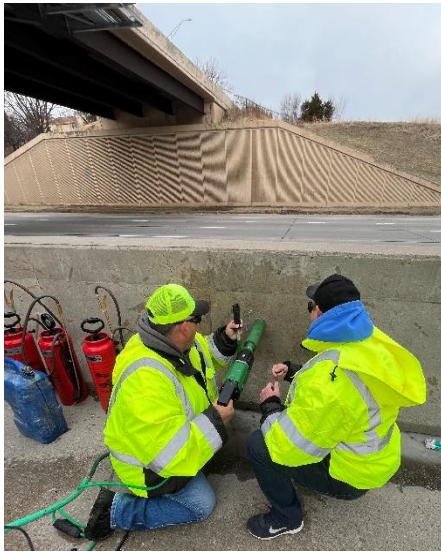
Figure 2 - The coring crew used a handheld coring drill to cut cores from the barrier.

The coring crew took four, 3"x3" cores from the barrier for this research (Figure 2). Two cores were taken from each section (control and power washed): one before sealer application and one six days after application. All four cores were taken to the PCC lab where they were examined for depth of penetration via visual examination. Finally, they were taken to the chemistry lab and examined via a blue dye test (BDT).

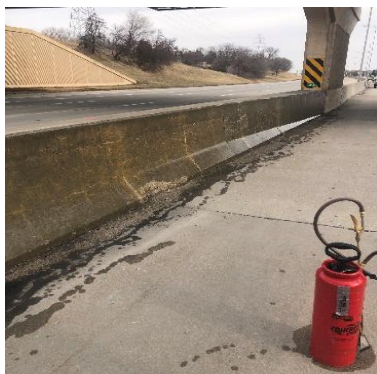
Researchers applied approximately 1.1 gallons of PCS to approximately 210 ft² area of the control section by two members of the coring crew (Figure 3). The calculated application rate was 191 ft²/gallon. The sealer dried in approximately 30 minutes. The pre-application and post-application cores were examined for depth of penetration. The pre-application core showed no observable sealer present in the visual examination or the BDT (Figure 4). The post-application core showed partial penetration as deep as 1 inch, however PCS penetration was blotched (Figure 5). Researchers observed PCS wicking into cracks in the structure, some of which were likely blocked with dirt and debris causing the blotched penetration pattern. The results for control section are listed in Table 1.

Figure 4 - PCS was applied to the designated control section.

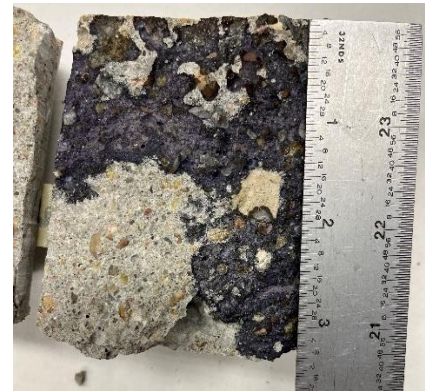
Figure 3- The control section core after sealer was applied.

Location	Depth of Penetration Pre-Application	Depth of Penetration Post-Application	Application Rate	Drying Time	Weather Conditions
I-680	no observable presence	partial coverage along crack lines as deep as 1"	191 ft ² /gallon	30 mins	45°F 48% Humidity Partly Sunny

All vertical surfaces shall be cleaned by power washing
 All vertical surfaces should be dry for 72 hours prior to application.

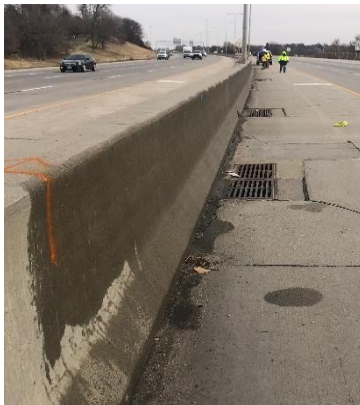
Researchers applied approximately 3.15 gallons of PCS to about 900 ft² area of the control section by two members of the research team (Figure 6). The calculated application rate was 285 ft²/gallon. The sealer dried in approximately 30 minutes. The pre-application and post-application cores were examined for depth of penetration. The core taken from the power washed section prior to PCS application showed little to no sealer present (Figure 7). The core from the power-washed section after application showed considerable depth of penetration. Researchers observed PCS wicking into cracks in the structure. Power washing appears to have cleared blockages and allowed thorough sealer penetration.

Figure 7 - The power washed section after sealer was applied.

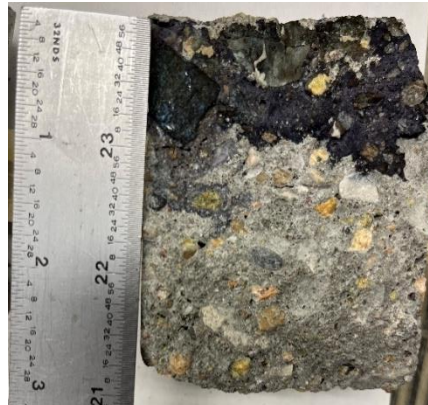
Figure 8 - The power washed section core before sealer was applied.

Location	Depth of Penetration Pre-Application	Depth of Penetration Post-Application	Application Rate	Drying Time	Weather Conditions
I-680	no observable penetration	extensive coverage along crack lines as deep as 1 1/2"	285 ft ² / gallon	30 mins	45°F 48% Humidity Partly Sunny

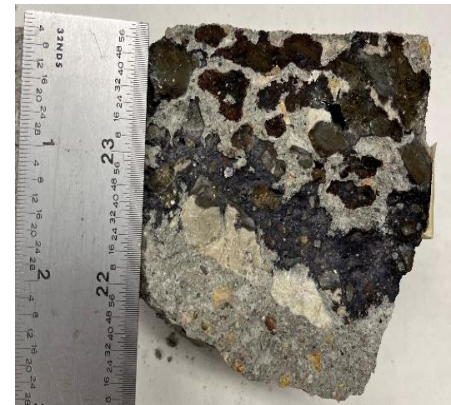
Figure 6 - The power washed section core after sealer was applied.

Based on the observations from the depth of penetration test, a significantly larger area of coverage is obtained by preparing the surface for application by power-washing which removes debris, dirt, ASR, and other materials which may block the sealer from penetrating. It is noted that the two test sections received different application rates, however both were applied according to the manufacturer's recommendation for vertical surface. The pattern of penetration is also more uniform in the core from the power-washed section, indicating that cleaning the surface will provide the best penetration.
