## **Research**

Field Performance of Sealers for Portland Cement Concrete Pavements (PCCP)

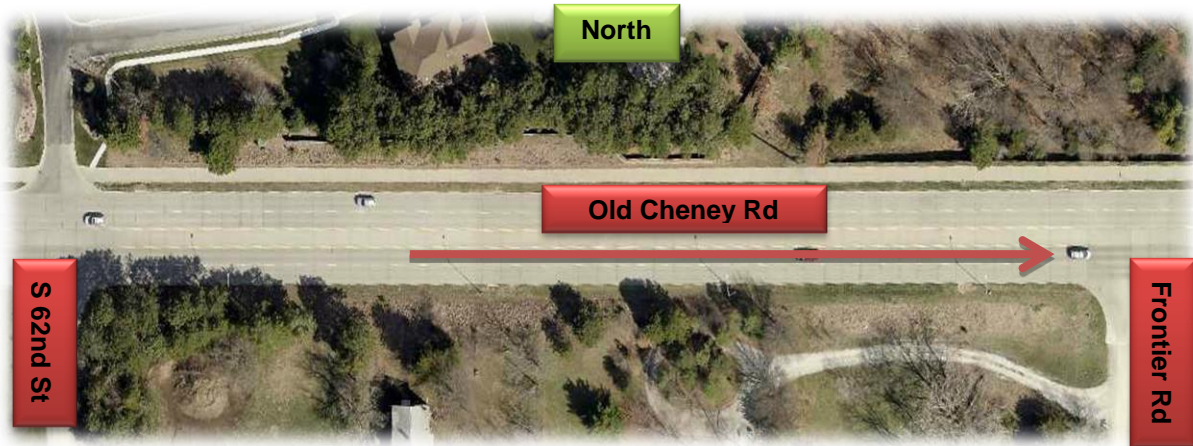
**Figure 1. Old Cheney Segment Between 62nd and Frontier Rd**

Figure 1 shows the Segment of Old Cheney Rd. between 62<sup>nd</sup> St. and Frontier Rd containing the test segment of sealer treatments.

This evaluation was based on a road segment of Old Cheney between 62<sup>nd</sup> St. and Frontier Rd., in Lincoln, Nebraska. It was built in 2002 and was eight years old at the time of the sealer application. Since this section was built without SCMs to mitigate ASR, this segment was a good candidate for the four-year evaluation. The evaluation consisted of sections of untreated control panels adjacent to sections of sealer treated panels. All sealers were applied per the manufacturer recommendations.

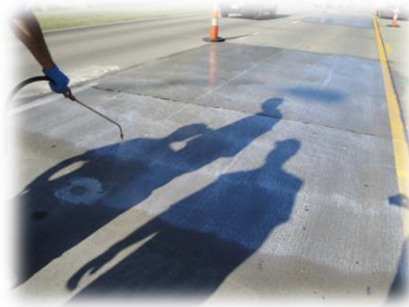
**Figure 2. Sealer Application  
by Industrial Sprayer**

The total test segment contained treated sealed sections and untreated control sections. The sealers were applied August 2010. All sealers, with the exception of the Lithium & Silane/Siloxane blend, were applied as recommended by the manufacturer after the pavement was washed with high-pressure water and had 4 hours to dry. The sealers were applied by NDOR Materials & Research personnel with an industrial pump sprayer, as shown in Figure 2. The Lithium & Silane/Siloxane blend was applied by the supplier after cleaning the pavement surface with hot water.

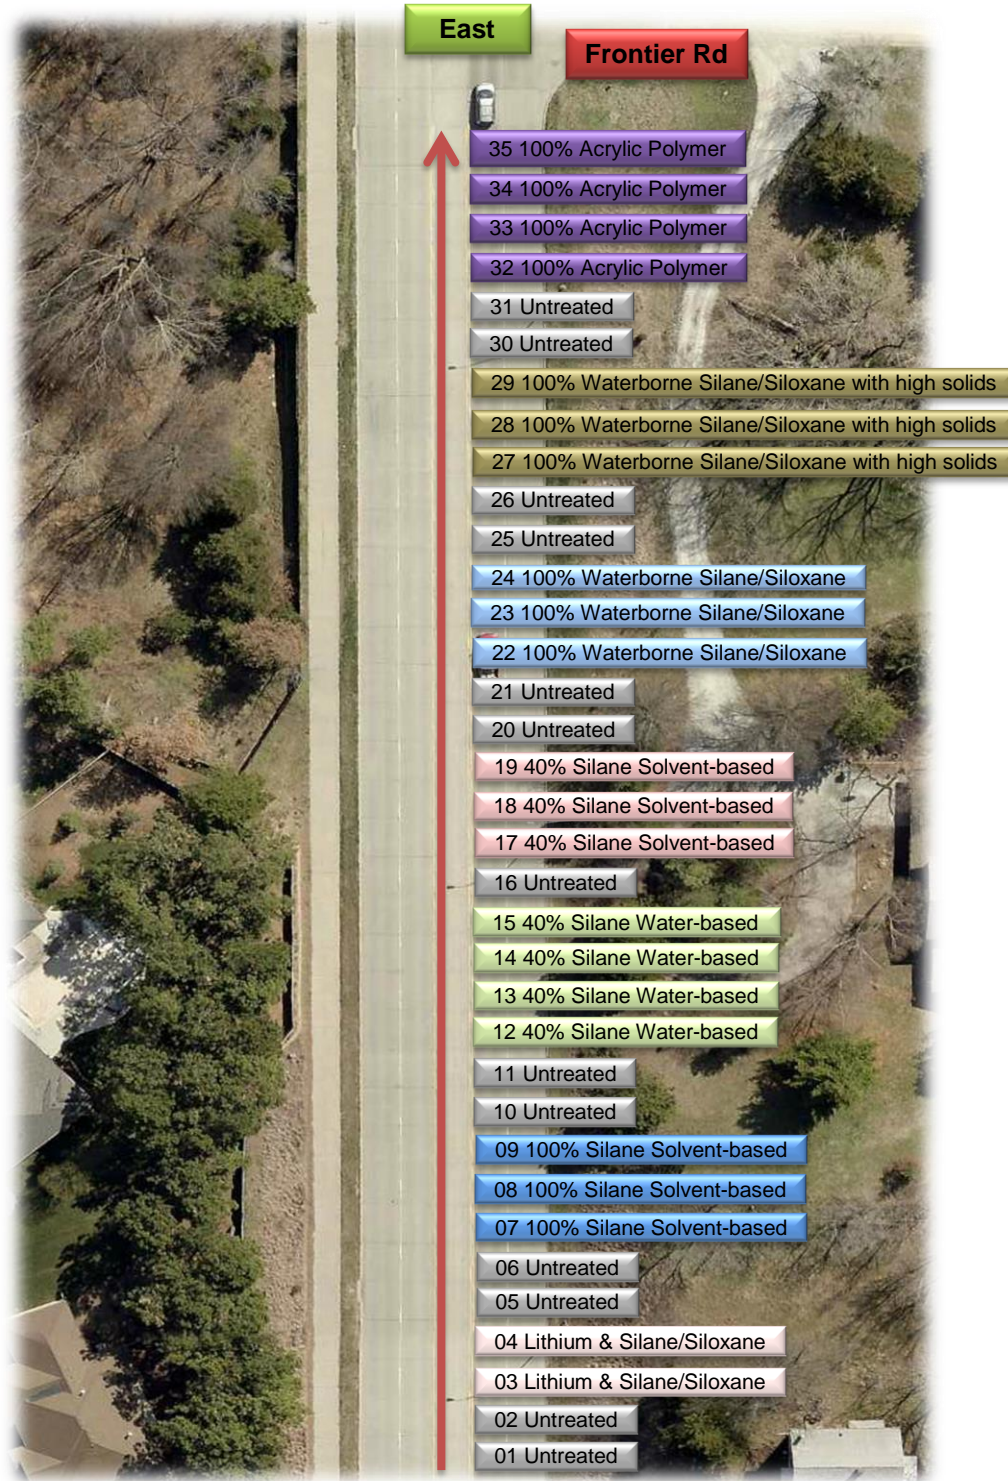
**Figure 3. Layout of Sealer Test Panels**  
Old Cheney between 62nd St and Frontier Rd

Each sealer treated section consisted of three concrete panels. There were three exceptions; the Lithium & Silane/Siloxane blend, the 100% acrylic polymer, and the 40% Silane Water-based. The Lithium & Silane/Siloxane blend consisted of two panels instead of three due to the manufacturer's application. 100% acrylic polymer and 40% Silane water-based were each four panels due to unexpected application in the field. The treated sections were each separated by a set of two untreated panels; the locations of each treated and untreated panel are shown in Figure 3.

Sampling was performed in accordance with Table 1. All samples collected from the segment were labeled as shown in Figure 3.

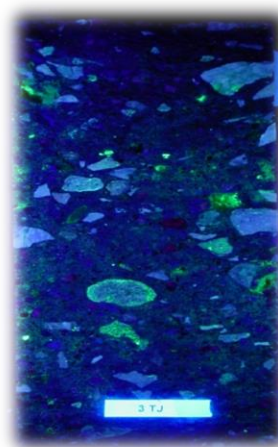
**Figure 5. Uranyl Acetate Test for ASR**

The 2010 baseline forensic analysis of all the test sections prior to sealer application indicated the concrete substrates are dense and in overall good condition, as shown in Table 2. The hardened entrapped air was high; however, the mix design used for the existing pavement project segment tended to entrap air due to a gap gradated mix design. In addition, ASR was identified by SHRP C-315 (Strategic Highway Research Program, 1991-1993) using Uranyl Acetate Testing to identify ASR pavement in situ, as seen in Figure 5 with the fluorescent green.

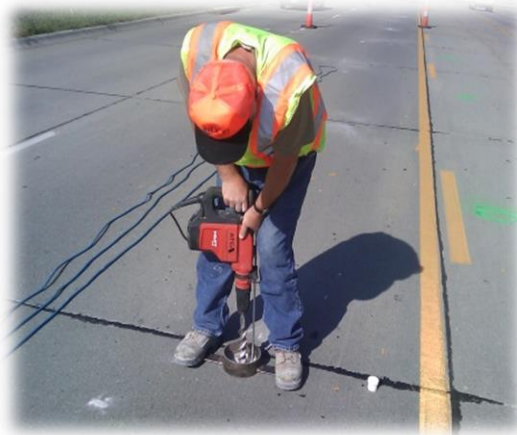
**Figure 6. Chloride Ion Sample Drilling**  
*Inside joint, position (RT)*

The sample collection was conducted by drilling, as shown in Figure 6. Each sample was collected one half inch from the joint at depth increments of 0-1/2", 1/2"-1" and 1"-1 1/2". Samples were collected near the inside joint as shown in Figure 6. The 2010 baseline and 2011 first year of analysis results are shown in Figure 7, Figure 8, and Figure 9. The following data results are for the first year only found in Figures 7 to 9. Some sealers at depths of 0-1/2" to 1/2'-1" and 1"-1 1/2" seemed to allow greater chloride penetration than the untreated control panels. They are represented by a negative effectiveness as shown in Figure 7, Figure 8, and Figure 9.

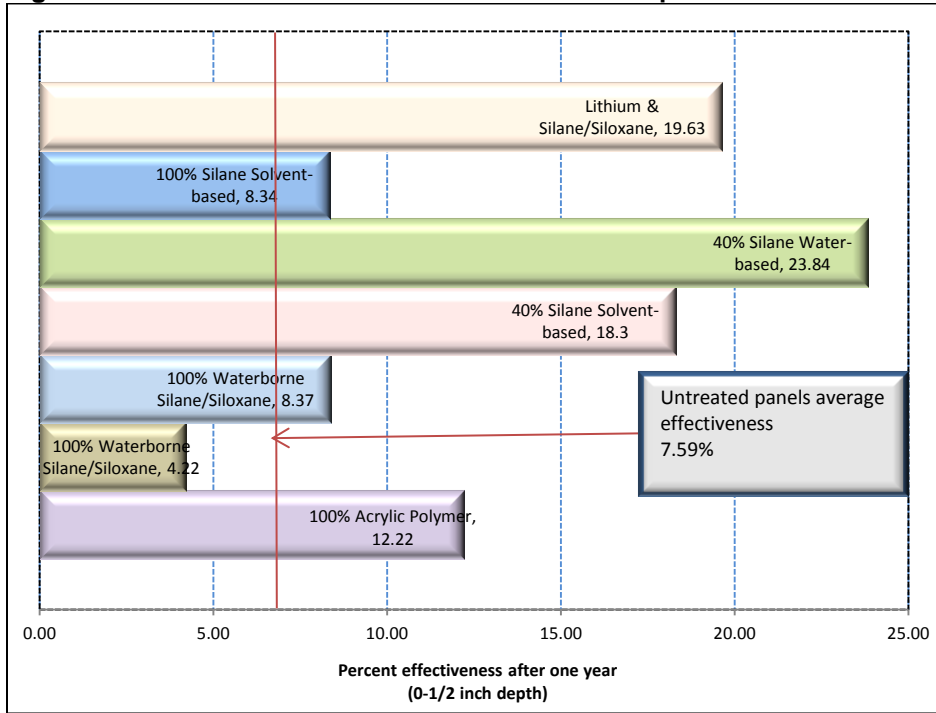
Figure 7. 2010-2011 Sealer Effectiveness at 0-1/2" Depth

Figure 7 shows the effectiveness of the sealers at the 0-1/2" depth. The red line shows the untreated effectiveness baseline. With the exception of the 100% waterborne Silane/Siloxane with high solids, all sealers showed effectiveness greater than the untreated baseline.

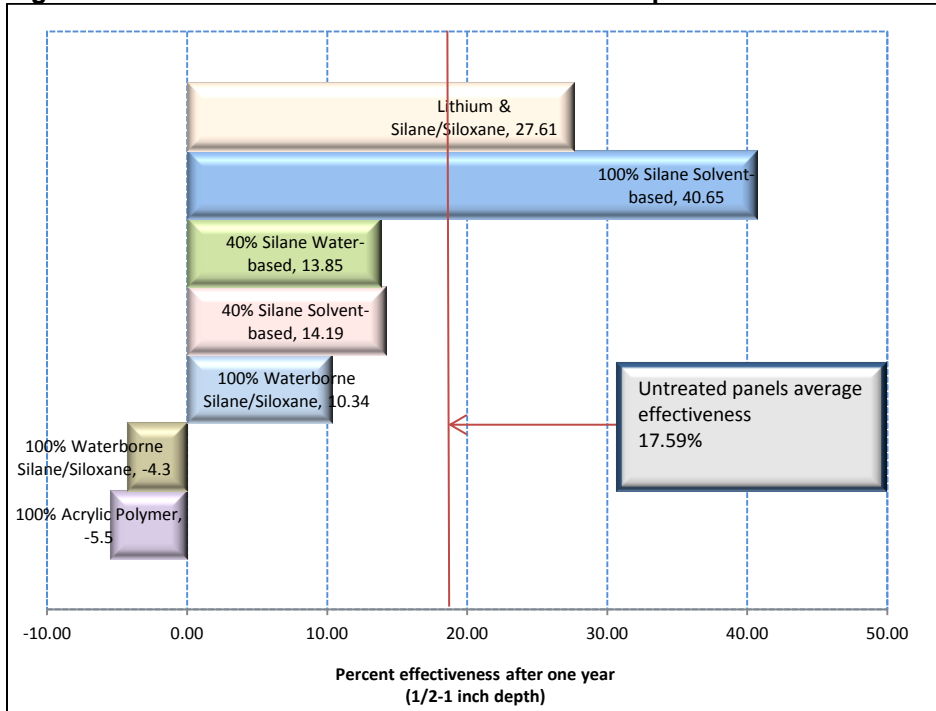
Figure 8. 2010-2011 Sealer Effectiveness at 1/2-1" Depth

Figure 8 shows the effectiveness of the sealers at the 1/2-1" depth. The red line shows the untreated effectiveness baseline. The 100% Silane Solvent-based and Lithium & Silane/Siloxane were the only sealers with effectivenesses greater than the untreated baseline.

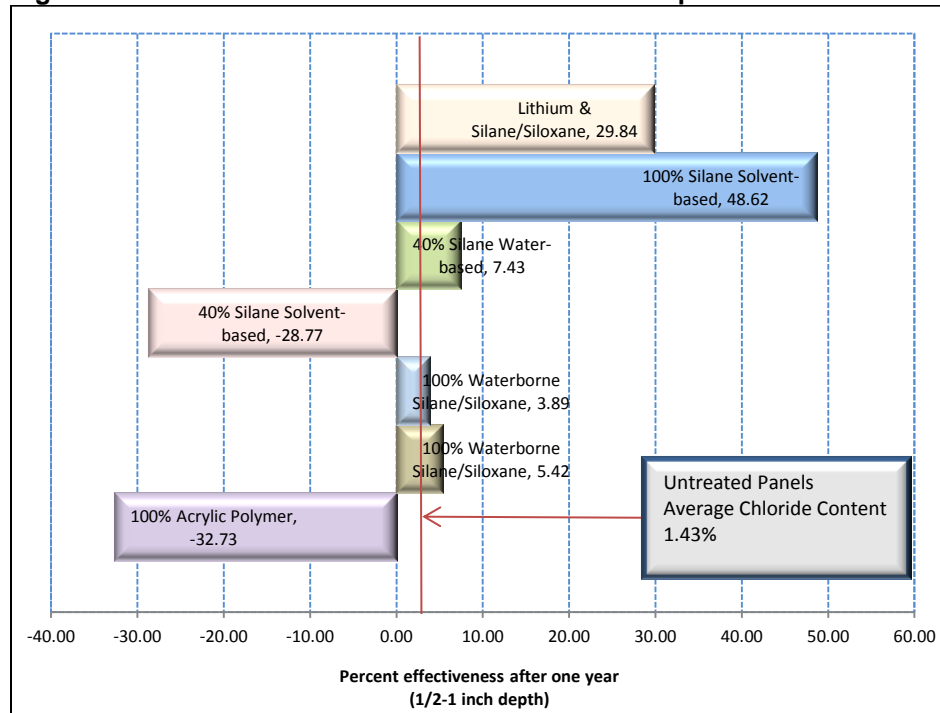
**Figure 9. 2010-2011 Sealer Effectiveness at 1-1½” Depth**

Figure 9 shows the effectiveness of the sealers at the 1-1½” depth. The red line shows the untreated effectiveness baseline. The 100% Silane Solvent-based and Lithium & Silane/Siloxane blend both rated high on the percent effectiveness compared to the untreated baseline.

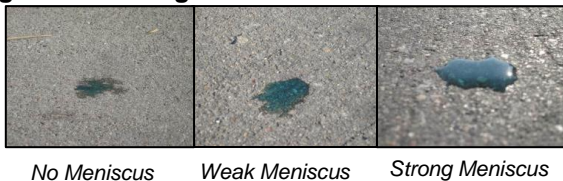
**Figure 10. Rating Values for the Visual Bead Test**

Analysis was performed by inspecting the water to determine the quality of the convex meniscus that was formed, as shown in Figure 10. The images of the test were evaluated on a scale of 0 to 2 based on the criteria shown in Table 4. The complete results of the analysis of 2012 and 2014 are shown in Table 3.

Rating	0	1	2
Meniscus	No Meniscus	Weak Meniscus	Strong Meniscus

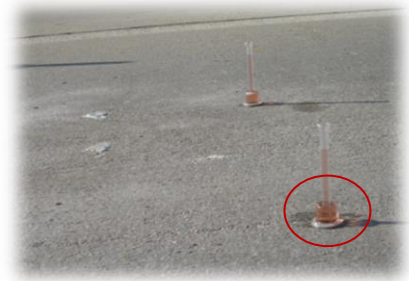
**Figure 11. Measuring Fluid Leakage**

Test was performed by attaching an open-ended 5 mL graduated cylinder to the pavement surface, as shown in Figure 11, by using putty to form a watertight seal between the pavement and the cylinder. The cylinder was then filled with dyed water. The absorption is measured by tracking the change of water volume in the cylinder at 5, 10, 15, 20, 30, and 60 minutes intervals.

While some of the results showed promise, the method was discontinued due to issues with reliability and reproducibility of the results. The identified problem was an issue maintaining a watertight seal between the tube and the pavement surface. The leaking of fluid can be seen in Figure 11. The results of the testing are shown in Table 5.

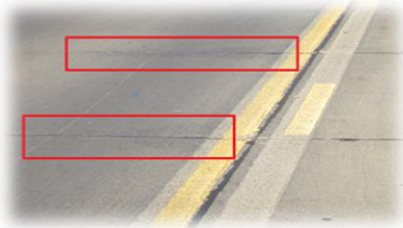
**Figure 13. Panel Joints with Shading**

Shading at the joint is an early sign of ASR. It was observed at the joints of the pavement in 2012, prompting future monitoring of the panels for this indication. Pictures were taken for the years 2012-2014 at the right joint of the panels. Examples of the shading and non-shading observed are shown in Figure 14 and Figure 15. The results of the visual shading analysis are shown in Table 7.

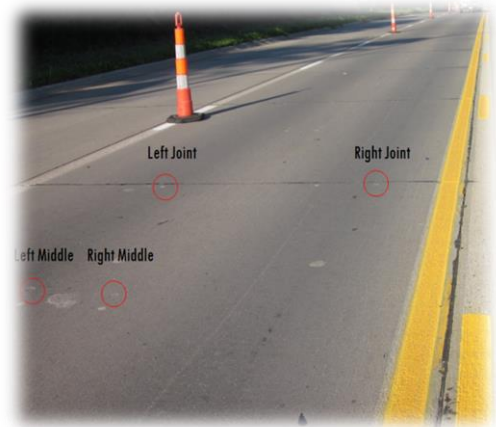
**Figure 15. Chloride Ion Sample Locations on the Panel 2012-2014**

Based on the 2011 test results, the research team decided to increase the number of locations on each panel to improve confidence in the NDR T 260 (NDOR, 2016) chloride ion analysis. The locations added were the left joint (LT), middle left (ML), and middle right (MR) on the panel. Depth increments remained the same at 0- $\frac{1}{2}$ ",  $\frac{1}{2}$ "-1" and 1"-1  $\frac{1}{2}$ ". The middle left and middle right were added to provide consistent results that are mainly effected by the penetration of the chloride ions through the surface sealer and not from the joint where there is a greater penetration of moisture and chemicals. Figure 15 shows the locations of sample collection for 2012-2014.

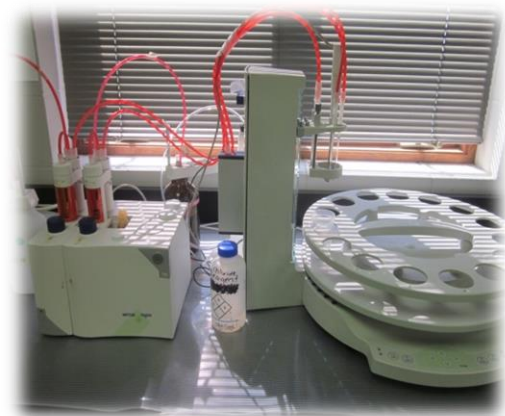
**Figure 16. Chloride Ion Testing by Automatic Titrator**

It was concluded from the research that changes could be made to improve accuracy and precision, and reduce operational costs. These procedure changes were adapted at the end of 2012 and were used on the chloride ion content testing by an automatic titrator for years 2012 thru 2014 as shown in Figure 16. The modifications were as follows:

- Samples are to be prepared at a final volume of 100 mL.
- Samples are to be tested in triplicate with results differing not to differ by more than 68 ppm.
- Samples are recommended to be tested by use of an automatic titrator.

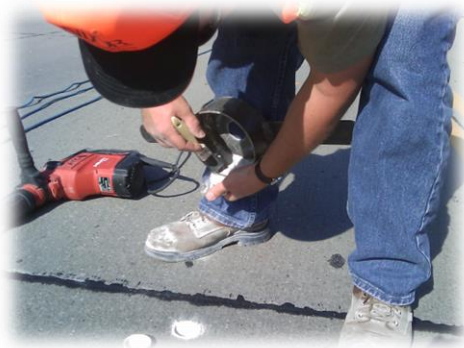
**Figure 17. Drilled Dust Sample Collection**

The analysis of data from 2012 thru 2014 was based on depth increments at 0-½", ½-1" and 1-1½" from right joint (RT), left joint (LT), middle left (ML), and middle right (MR) of the panel in accordance with the modified NDR T 260 test method III. 420 Samples were gathered each year. The performance the sealers was assessed based on the percent reduction of chlorides ions, in parts per million (ppm), from year to year. As it was mentioned throughout the report, drill dust samples, as shown in Figure 17, were collected annually for 4 years, and analyzed for chloride ion content. The results for each section were averaged among all panels at each depth.

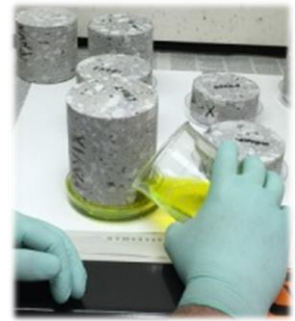
**Figure 18. Yellow Dye Application**

Field Cores are placed surface down in a petri dish. The petri dish is then filled with the yellow dye (Sodium Fluorescein) to submerge the core for 4 days as shown in Figure 18, and then air-dried for 2 days. The cores are then split lengthwise. The sealer penetration is observed as the location near the core surface that did not fluoresce yellow-green under a short wave UV light source, as shown in Figure 19. In contrast, Figure 20 shows the yellow dye application on the unsealed surface.

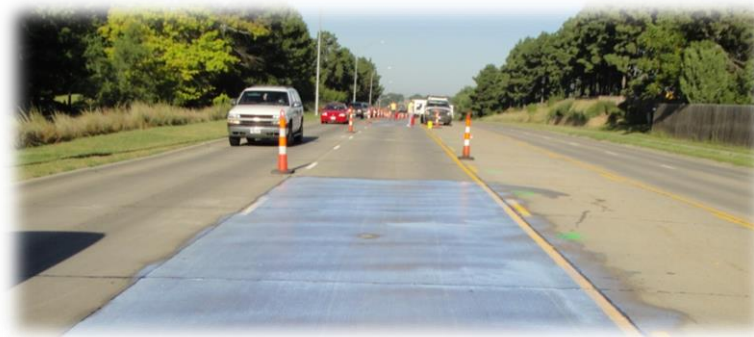
**Figure 21. Sealer Dry Time After Application**

The initial and successive applications of sealers require traffic to be closed to allow adequate time for the sealer to penetrate and dry, see Figure 21. This study did not investigate how much time it would take for the sealer to properly penetrate and dry. The research team found that the surface preparation is critical before the sealer is applied. Therefore, it was suggested that the Department perform the following prior to application:
