# **Guidelines for the Installation, Inspection, Maintenance and Repair of Structural Supports for Highway Signs, Luminaires, and Traffic Signals**

# **Guidelines for the Installation, Inspection, Maintenance and Repair of Structural Supports for Highway Signs, Luminaries, and Traffic Signals**

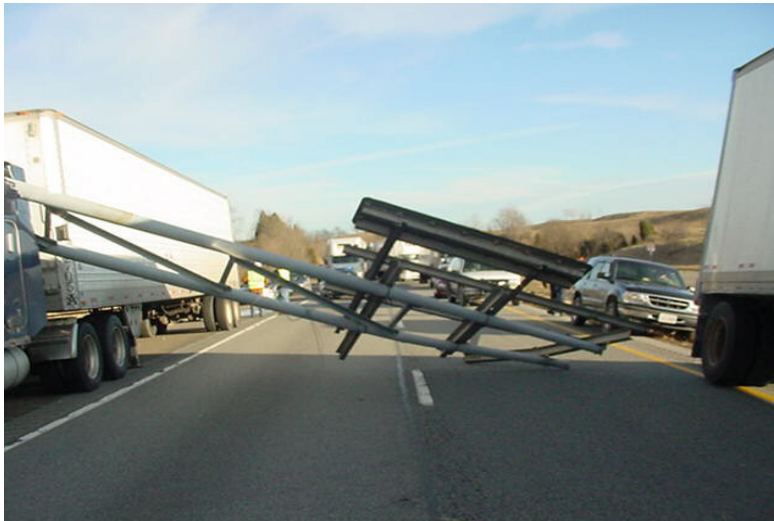
**Figure 1. Cantilever Sign Structure Failure.**

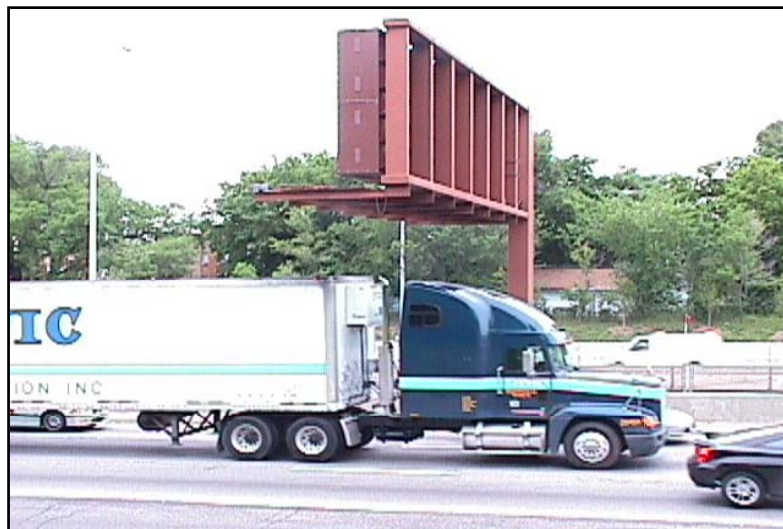
The passage of trucks beneath support structures induces both horizontal and vertical gust loads on the structure, creating a motion that is primarily vertical but may also include a significant horizontal component as well. The magnitude of the horizontal truck gust is negligible relative to the natural wind gust and is therefore ignored in the specifications. The vertical truck gust load in the specifications is an equivalent static pressure range applied to the underside of the mast arm or truss and any attachments. Due to the large depth of variable-message signs (VMS) in the direction of traffic flow (up to 1.2 m for older signs), the support structures are the most susceptible to truck-induced wind gust fatigue because they present a large area in the horizontal plane, as seen in Figure 3.

**Figure 3. Truck Passing Under VMS.**

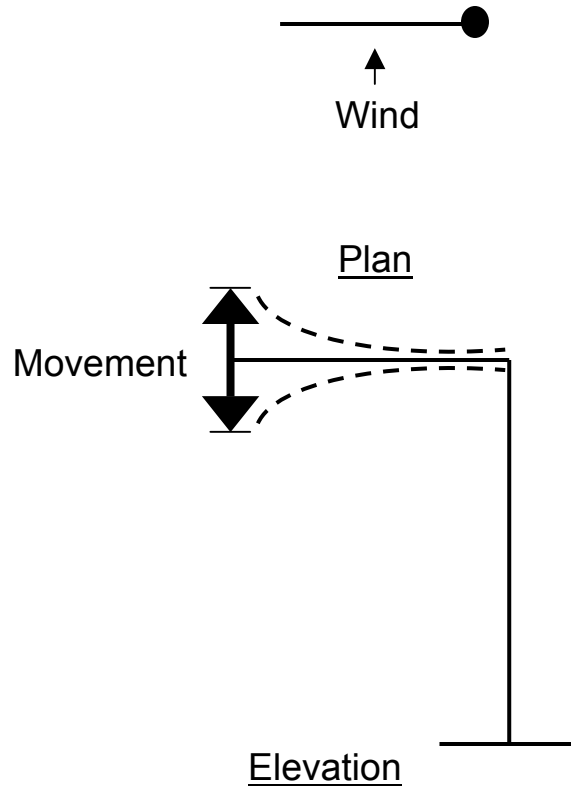
Galloping is different than vortex shedding but also results in large-amplitude, resonant oscillations perpendicular to the direction of wind flow as shown in Figure 4(B). Unlike vortex shedding, galloping occurs on asymmetric members (i.e., those with signs, signals, or other attachments) rather than circular members. Therefore, it is the mast arms rather than the poles that are susceptible to galloping. Galloping has caused mast arms to move up and down with a range greater than 1 m. According to NCHRP Report 469, a large portion of the vibration and fatigue problems that have been investigated for cantilevered sign and signal support structures were caused by galloping.

**Figure 4B. Wind Effects**

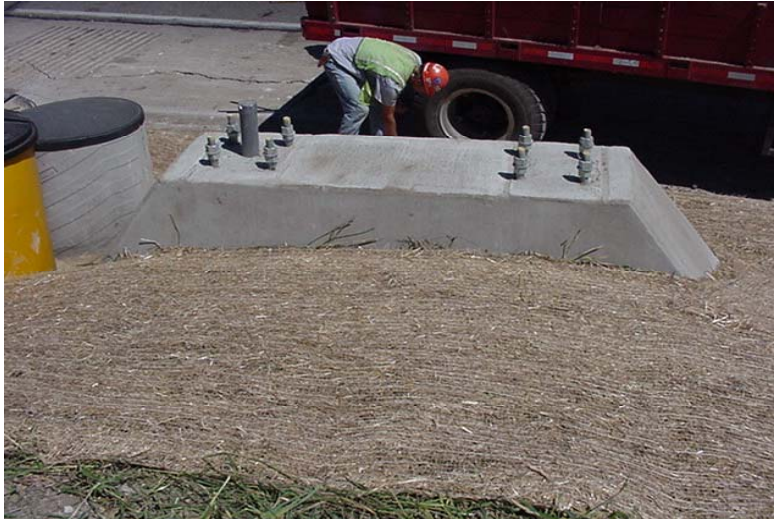
The erector should verify that the foundations are set to the proper elevation and anchor rods are set in the correct pattern and orientation, are of the correct size, and are plumb with the specified extension and thread length above the top of concrete, as seen in Figure 5.

**Figure 5. Foundation Ready for Structure Installation.**

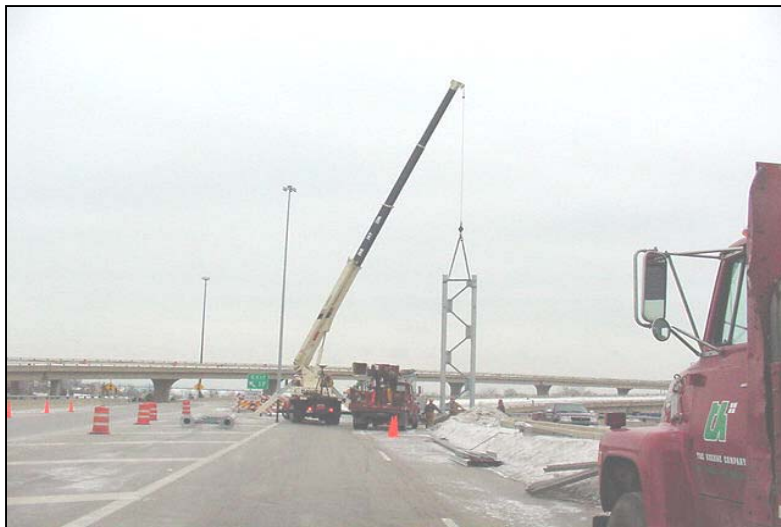
**Figure 6. End Frame Being Set Onto Its Foundation.**

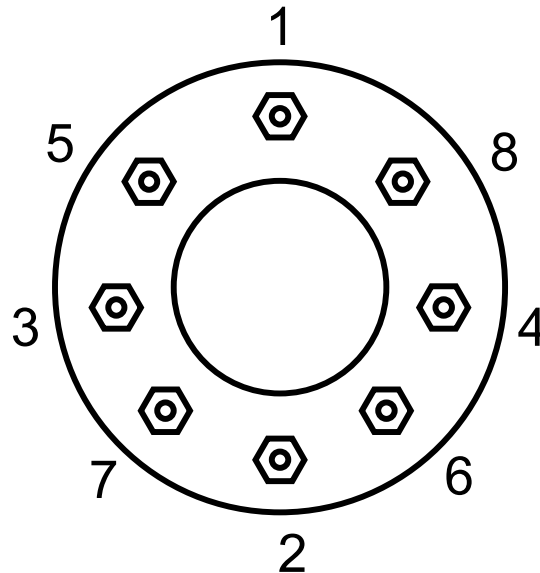
sheets of other metals) should not be placed between these flanges, even to try to achieve better contact. Tightening of bolts should be performed in a manner that brings the faying surfaces up “evenly.” For flange type connections, a star tightening pattern as shown in Figure 8 is recommended.

**Figure 8. Star Pattern Tightening Sequence.**

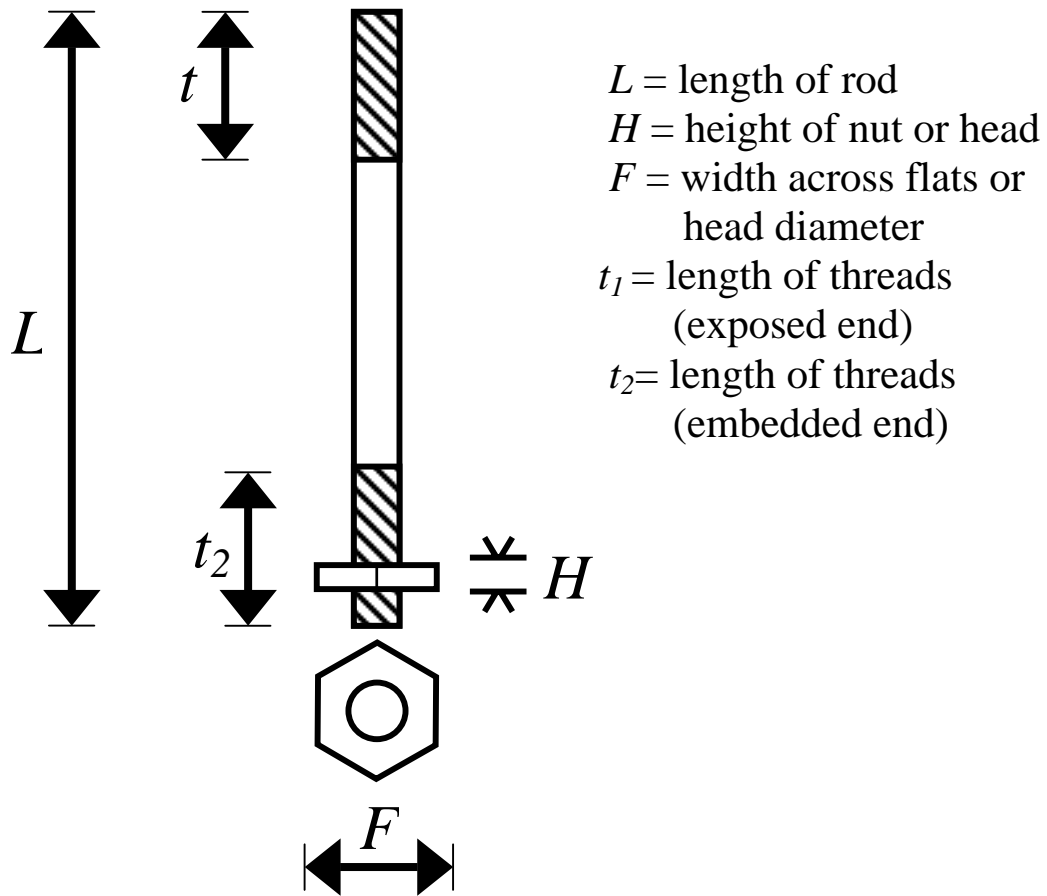
Figure 10. Headed Anchor Rod.

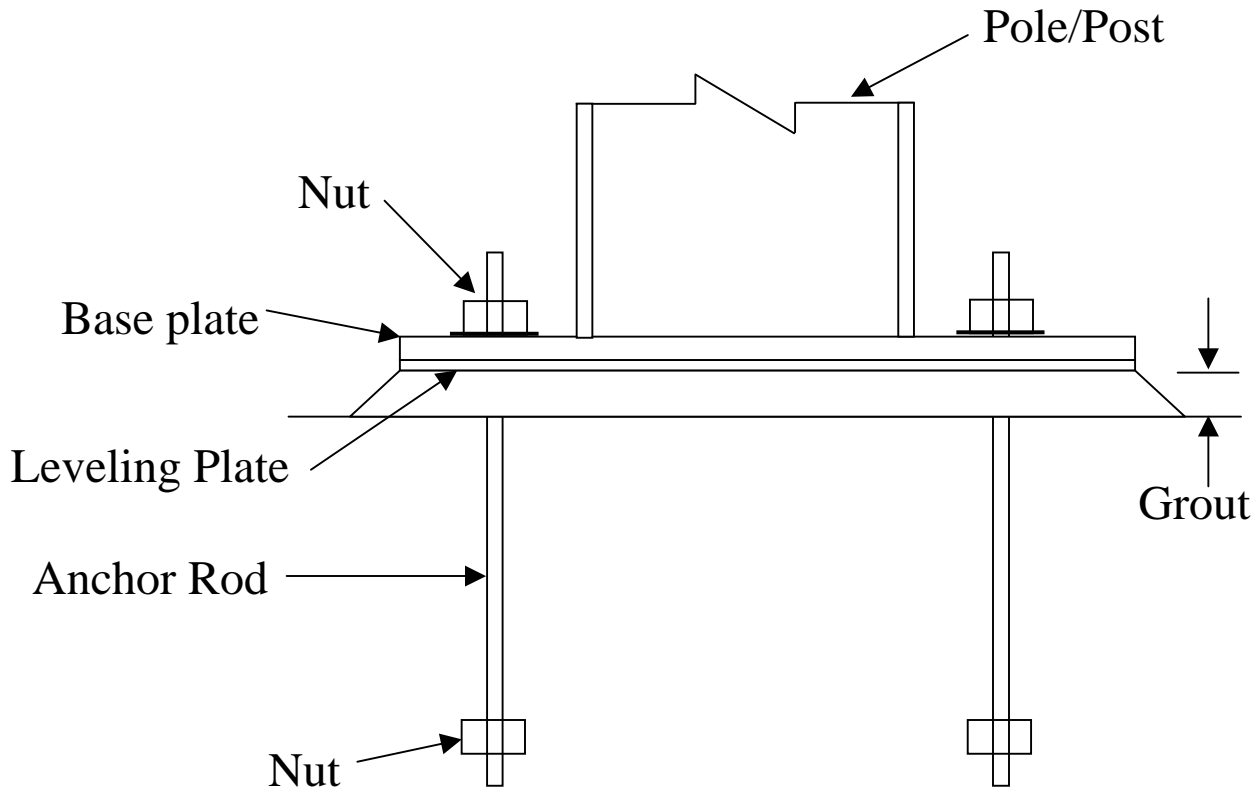
The threaded-shear-and-uplift joint rests directly on the concrete or on a grout pad (Figure 11). The base plate is held down by nuts atop the base plate. Single nuts are most common, but double nuts are sometimes used. For proper joint performance, the base plate must be in direct contact with the grout and not be supported by leveling nuts or shim packs. One technique to achieve full grout support is to set the base on shim packs to proper elevation, grout the base and then remove the shims and grout the resulting voids. Only then can the anchor rods be fully pretensioned. Use of proprietary prepackaged grout mixes, so called “non-shrink grout” is recommended and should be carefully installed to manufacturers’ recommendations. The threaded-shear-and-uplift joints can develop some resistance to bending moment as a couple between compressive bearing force on the grout and tensile forces in the anchor rods. It may be difficult to retain the pretension in the anchor rods under cyclic loads as the base plate wears the grout. For these reasons, this type of joint is not recommended by NCHRP Report 469 for large cantilevered support structures, although it is still commonly used for many luminaries and small traffic signal supports. This type of joint is suitable for bridge support structures where there are multiple posts.

**Figure 11. Threaded-Shear-and-Uplift Joint.**

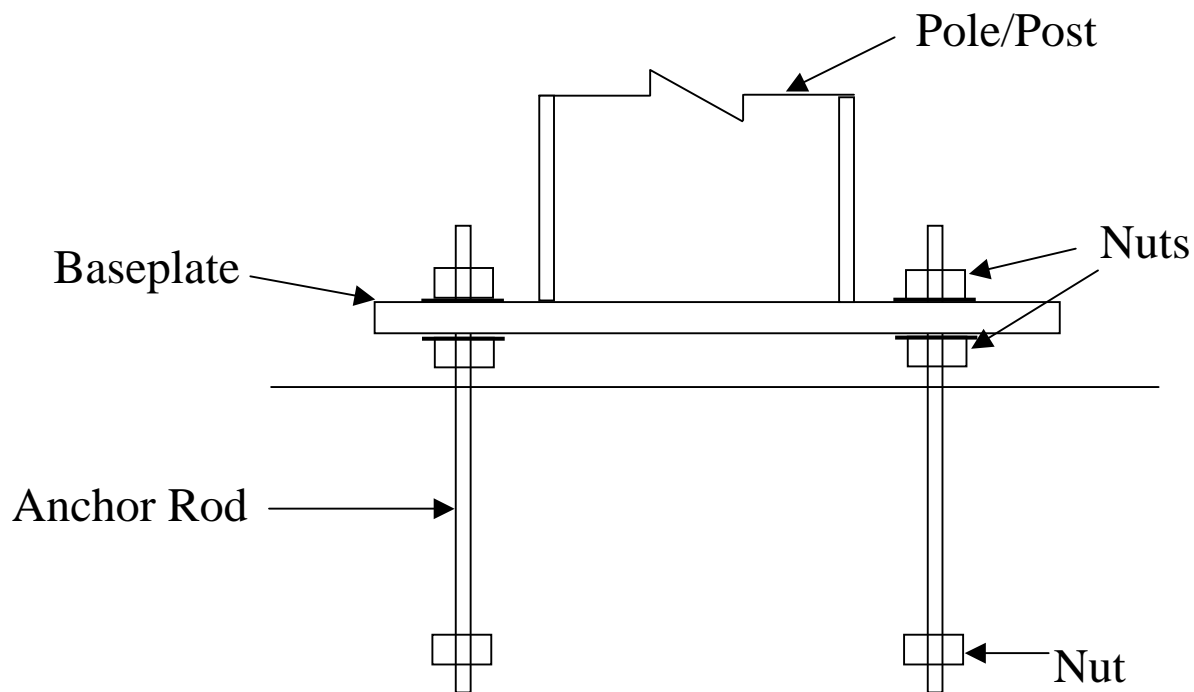
In double-nut-moment joints, the base plate stands off from the concrete foundation and bears on leveling nuts (Figure 12). Thus, the base plate is attached to anchor rods through double nuts: the leveling nut and a top nut (or nuts). This type of joint may be suitable for any type of support structure and is required for cantilevered support structures designed by the 2001 Specifications. Washers should be used under both nuts, and beveled washers should be used if the misalignment exceeds 1:40 for the double-nut-moment joints. Double-nut-moment joints are easy to level and plumb and are also very reliable for transmitting moment to the foundation; therefore, they are satisfactory for non-redundant structures and seismic or fatigue-loaded structures such as highway sign, signal, and light supports.

**Figure 12. Double-Nut-Moment Joint.**

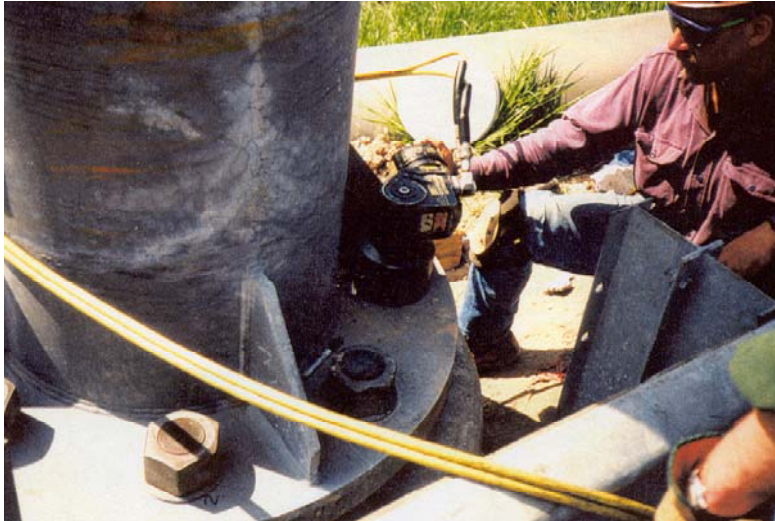
- ◆ A hydraulic torque wrench (Figure 15) or
- ◆ A box end "slug" or "knocker" wrench with a 3 meter (10-ft), long pipe or extension handle.

**Figure 15. A Hydraulic Torque Wrench Tightening Anchor Rod Nuts to Achieve Needed Rotation.**

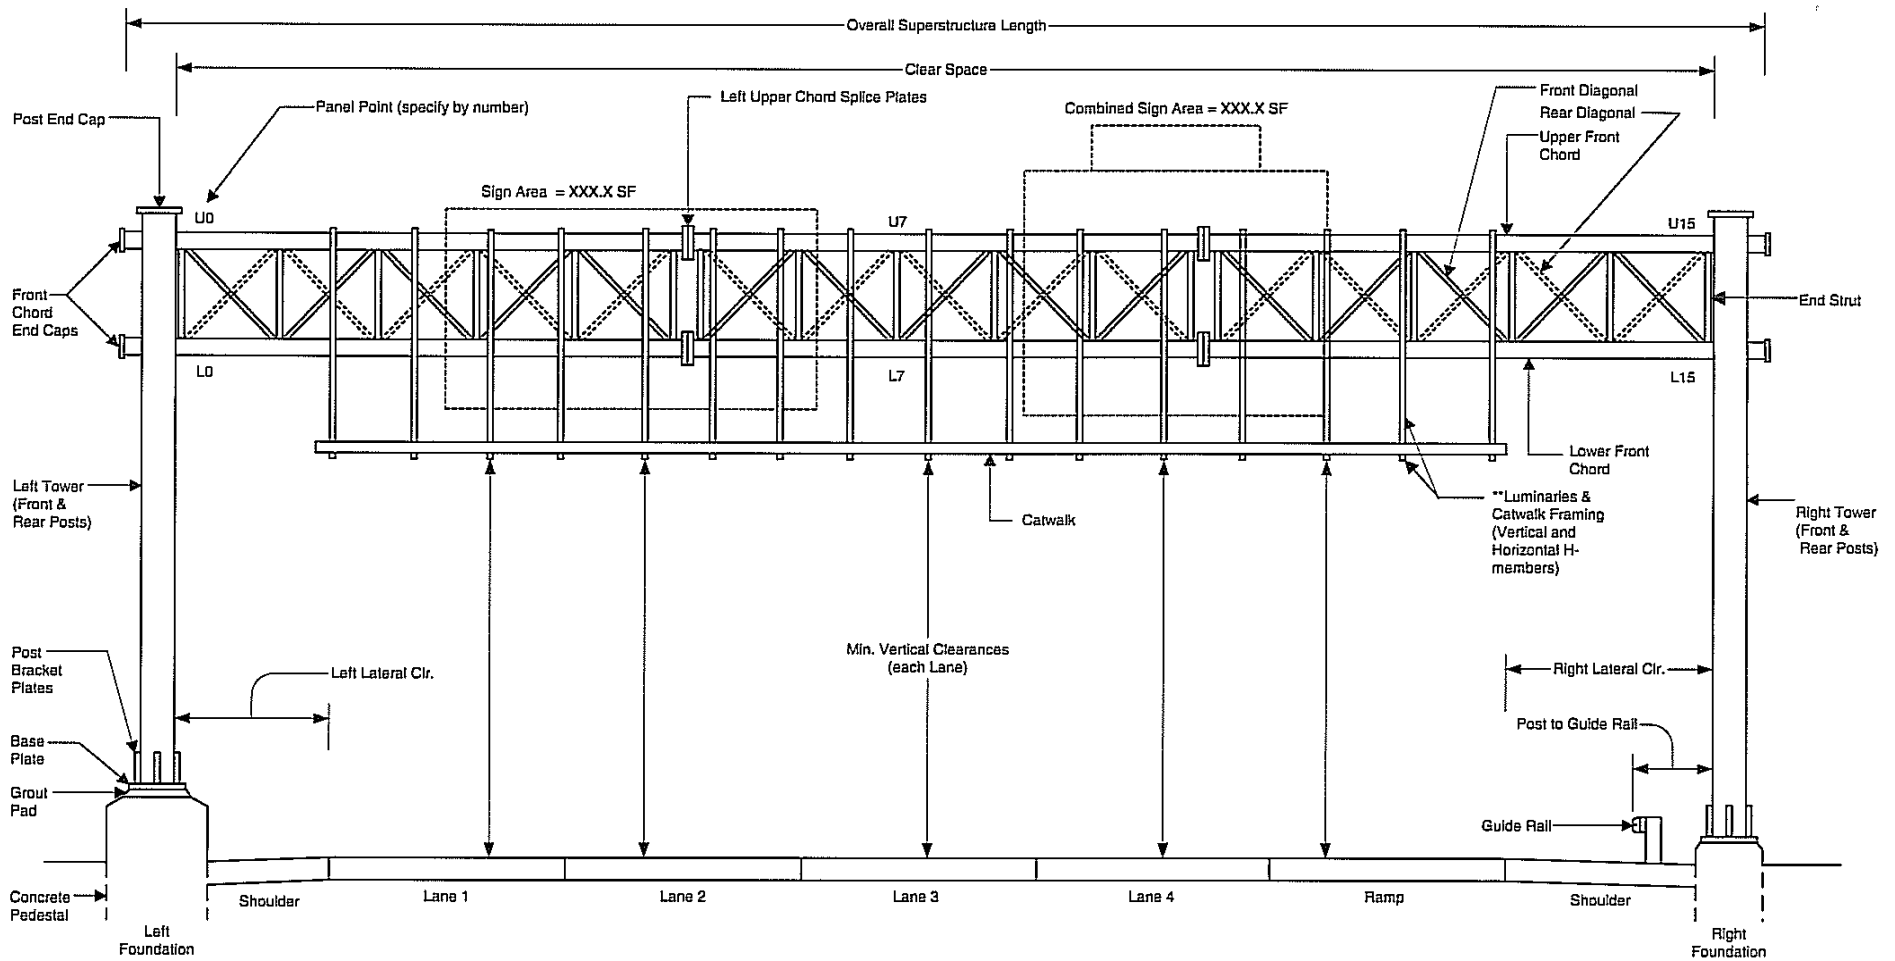
**Figure 20. Nomenclature Associated with Sign Bridge.**

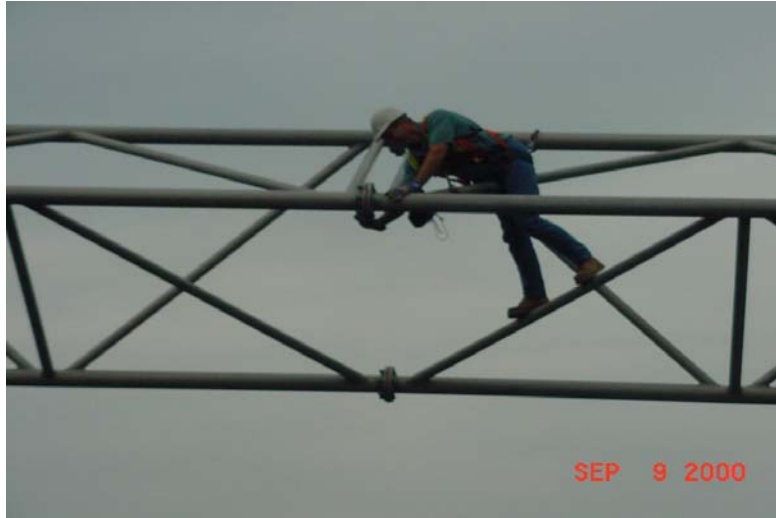
For structures such as signal supports it is usually possible to conduct the inspection from a bucket truck with minimal traffic disruption. High mast lights may require specialized techniques, which are discussed in Section 12.3.3.

**Figure 25. Hands on Inspection of Overhead Signs.**

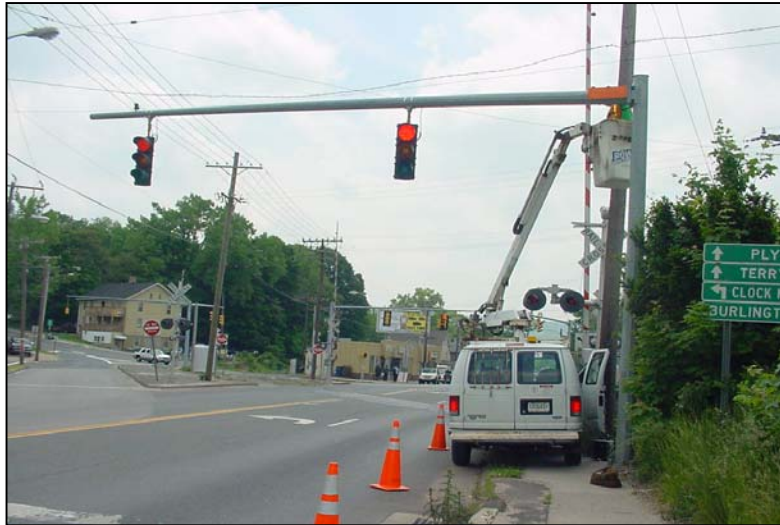
The inspection of mast arm structures and signal supports proceeds generally the same as for a sign structure, working from the base on up, see Figure 26. For many of the mast arm and signal supports, the anchor rod nuts are covered by a cap. These must be removed to examine the top nuts, even if removal results in damage. Damaged caps should be reported for future replacement, or the inspection team may be supplied with spares for installation.

**Figure 26. Inspection of a Mast Arm Structure.**

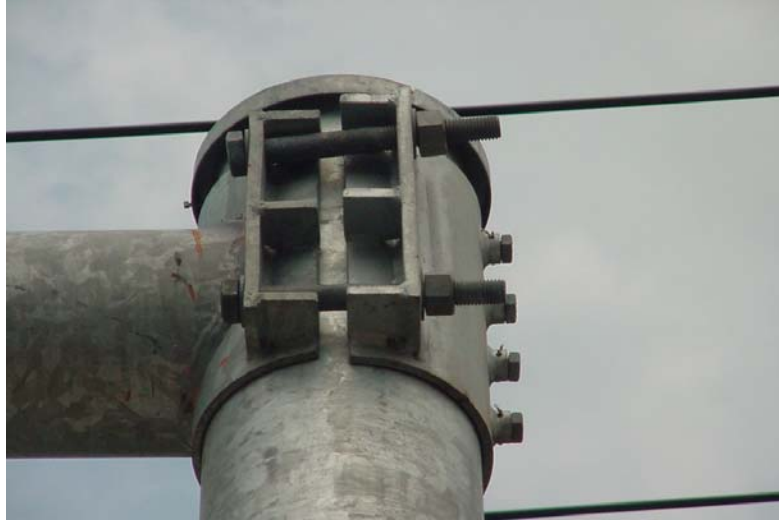
The mast arm to pole connection should be carefully examined. A wide variety of post to arm connections are used. Loose and missing bolts, misaligned fasteners, and weld cracks are often found (Figure 27). Mast arm to post connections where the post connection consists simply of two side plates welded to the pole with a face plate that accepts the bolted arm connection have been found especially susceptible to cracks at the plate to post welds.

**Figure 27. Post to Arm Connection Showing Poor Fit-Up Due to Use of Incorrect Components.**

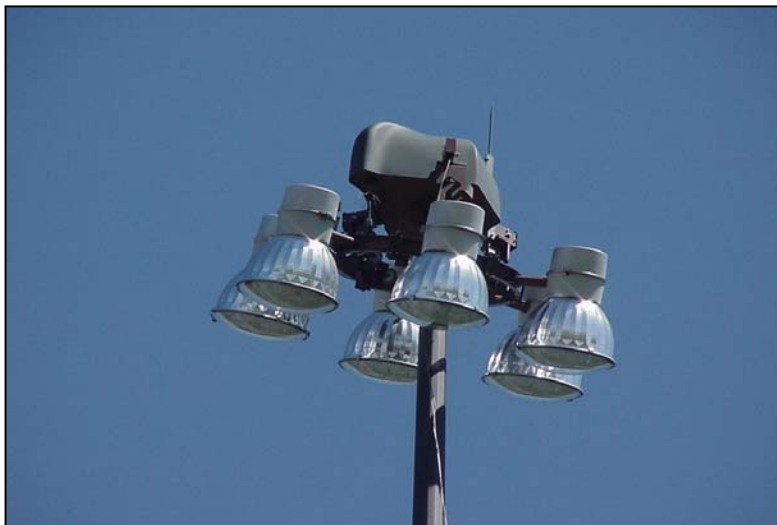
Inspection of the luminaire ring is not usually part of the structural inspection. However, visual observation of any defects should be recorded for future inspection by appropriate personnel. Some defects noted in the luminaire ring may relate to mechanical or structural components and should be examined further. Figure 30 shows a misaligned luminaire ring which was found to be the result of a broken support cable.

**Figure 30. Misaligned Luminaire Ring.**

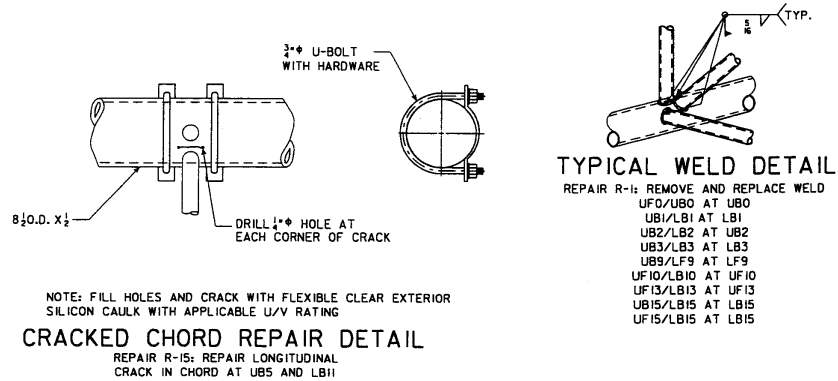
A drilled hole is often used to arrest a crack that goes through the entire thickness of the weld material. For small cracks this may be enough to arrest the crack permanently, but offers only a temporary fix for larger cracks. The diameter of the hole to be drilled is often taken as 20mm (.75 inch); however, a more structure specific hole size can be calculated based on the stress range, edge distance and yield strength of the material. The inside of the drilled hole should be tested with dye penetrant to assure that the crack end was removed. Figure 36 illustrates actual crack repair details.

**Figure 36. Repair Detail for Overhead Sign Truss Chord Crack.**

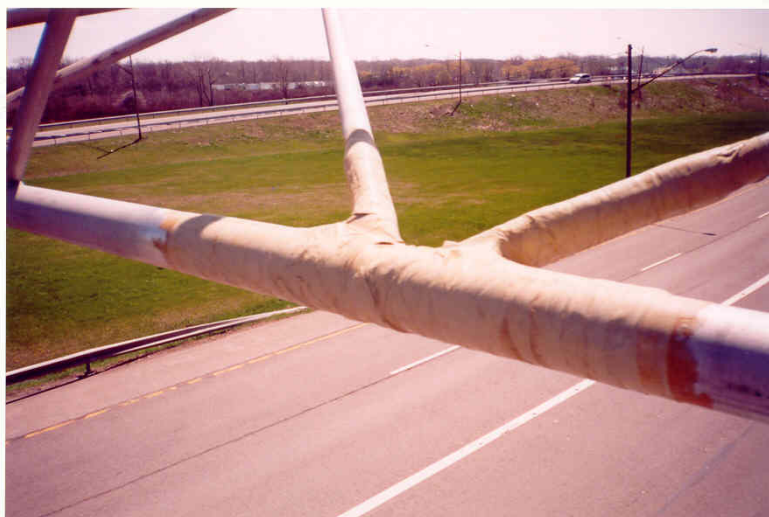
A good example of such an application is repair to an aluminum sign truss bridge. During inspection it was found that the welds connecting the diagonals to the chord had cracked over a significant portion of their length. FRP was chosen as a repair technique. The application included member cleaning and application of the FRP material using strips wrapped around the members. Figure 37 below shows the completed application. These repairs, initially thought to be just temporary for one year or less, are now being considered as a permanent repair solution.

**Figure 37. Repair of Truss Members Using FRP.**

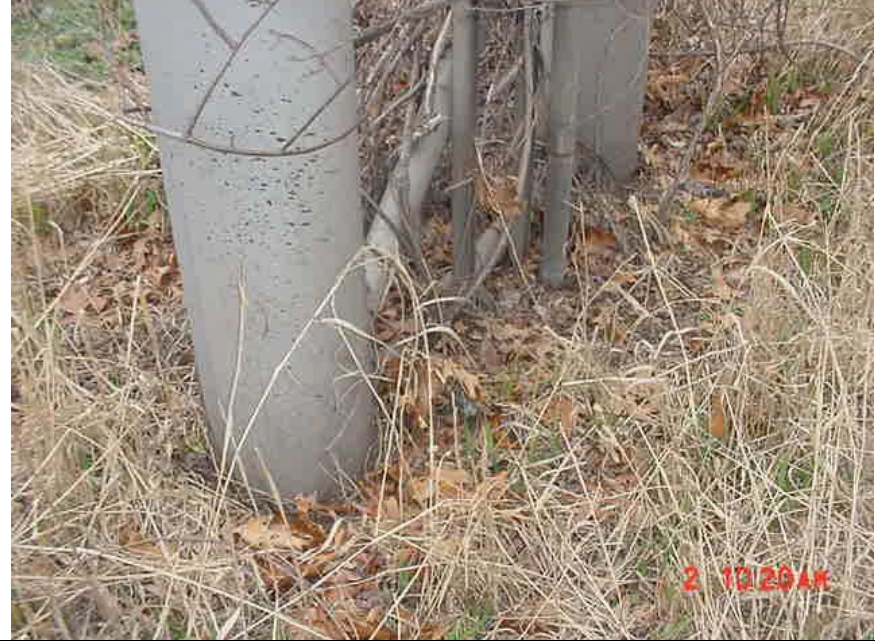
<p><b>Figure A1</b></p> <p>Buried Foundation S.01 rate as '0', Not Applicable. However, if opposite tower foundation is exposed, rate S.01 for that foundation, state in notes buried foundation and recommend as Priority 3 to expose.</p>

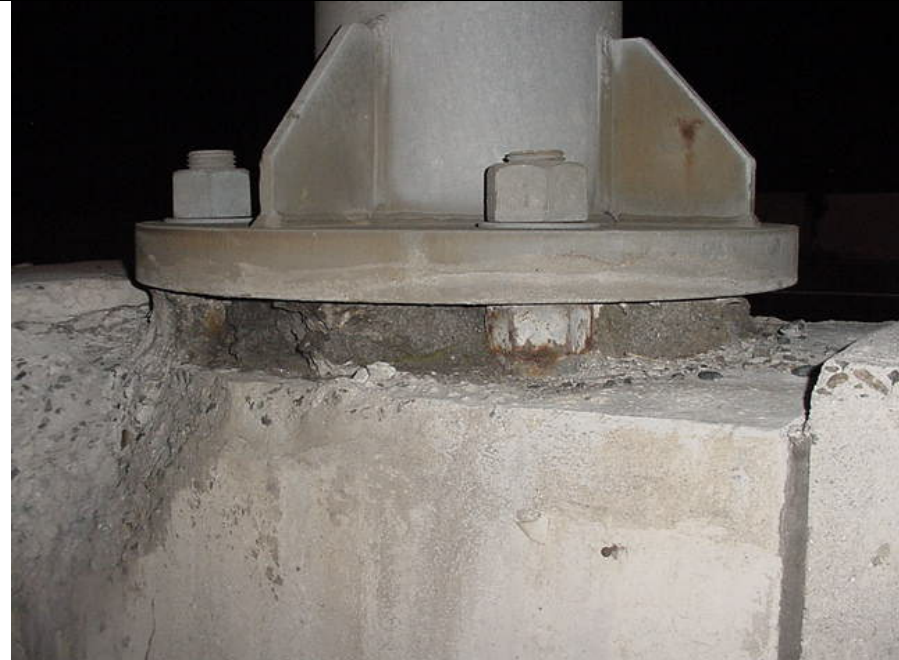
<p><b>Figure A2</b></p> <p>Deteriorated Grout Pad S.01 rate as 3, Priority 2 repair. Note also leveling nut corrosion (S.02 Item).</p>

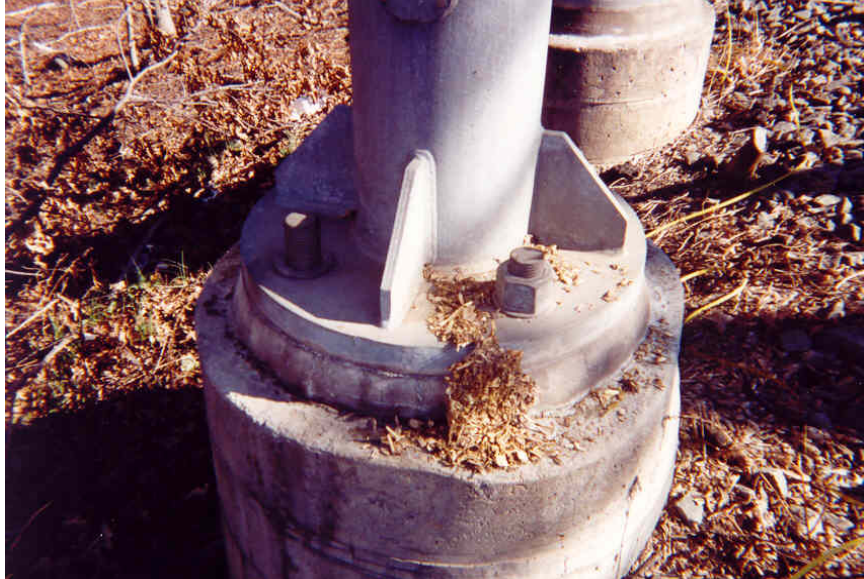
**Figure A3**  
Missing Anchor Nut.  
If Span structure, rate as 2,  
Priority Repair 2. If Cantilever  
structure, rate as 3, Priority  
Repair 1.

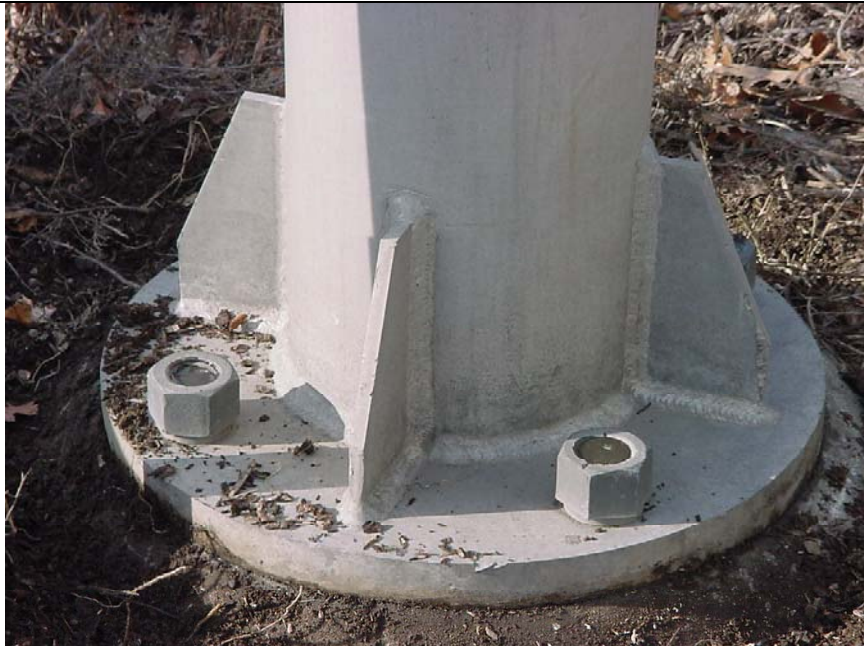
**Figure A4**  
Anchor rods not fully engaged.  
If 80% threaded, note on report,  
rate S.02 as '1', no repair.

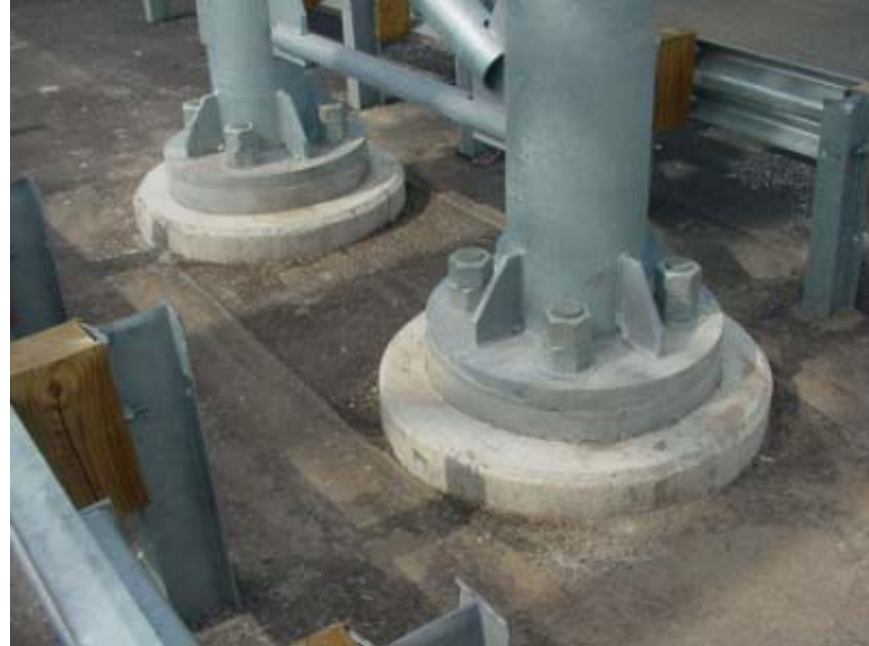
**Figure A5**

Steel Base Plates  
Rate as '1', Good Condition  
No weld cracks, no cracks in  
base plate, and no visible  
warping.

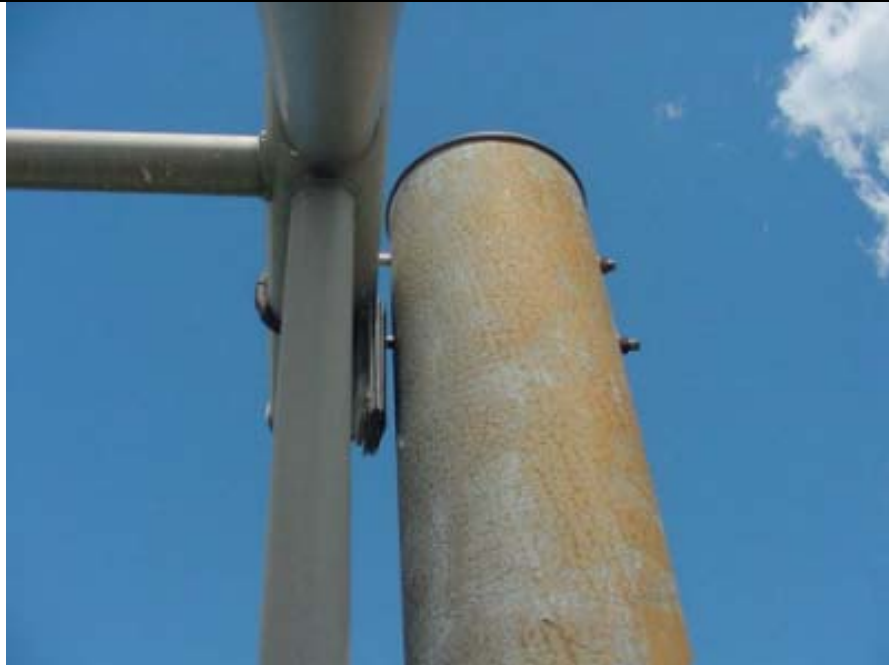
**Figure A9**

Gap between upper chord and shim pack and inadequate shim plate placement. Rate 2, Repair priority 3. Repair recommendation would be to properly place and add shim plates as necessary.

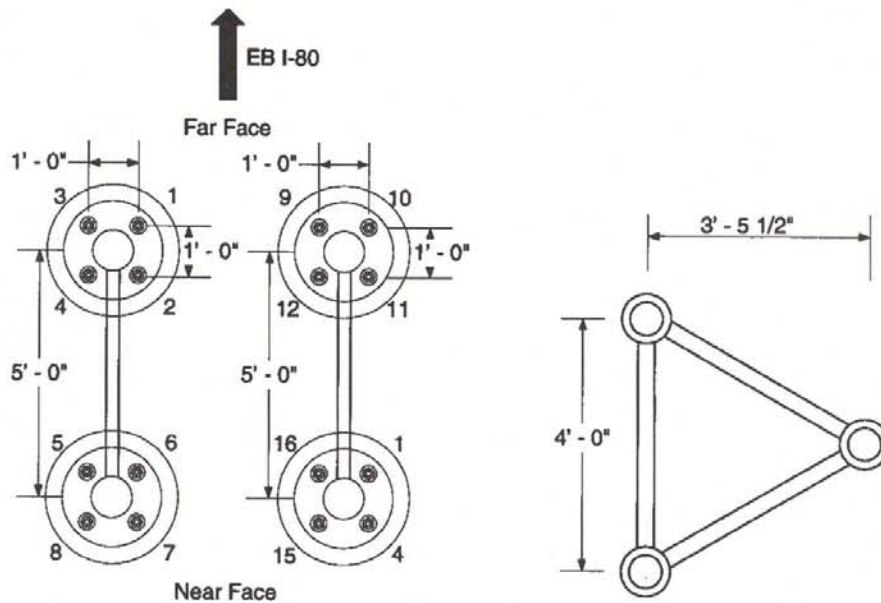
<b>Typical Tower To Foundation Connection</b>
Diameter = 1 1/2"
Bolt Length = 70"
Base Plate Thickness = 1 1/2"

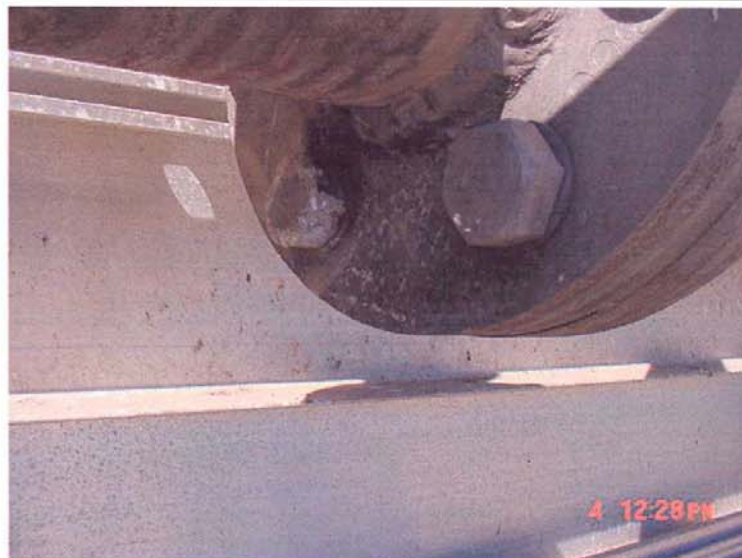
<b>Image No.:</b> 10	<b>Type:</b> jpg	<b>Date:</b> 20020403	<b>Path:</b> c:\njsignimages\1414203_20020403_10bdu.jpg
<b>Description:</b> Lower Chord Splices at L13 - One bolt head is deteriorated.

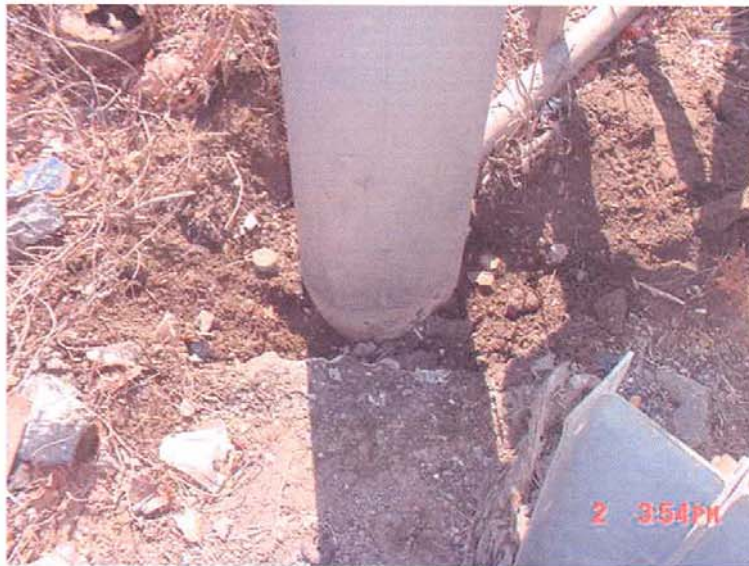
<b>Image No.:</b> 12	<b>Type:</b> jpg	<b>Date:</b> 20020402	<b>Path:</b> c:\njsignimages\1414203_20020402_12fdr.jpg
<b>Description:</b> Right foundation - Partially exposed for ultrasonic testing of the anchor bolts.
