Assessment and Evaluation of Timber Piles Used in Nebraska for Retrofit and Rating

**Department of Civil and Environmental Engineering
Florida International University
Miami, Florida**

Sponsored By
Nebraska Department of Roads

April, 2014

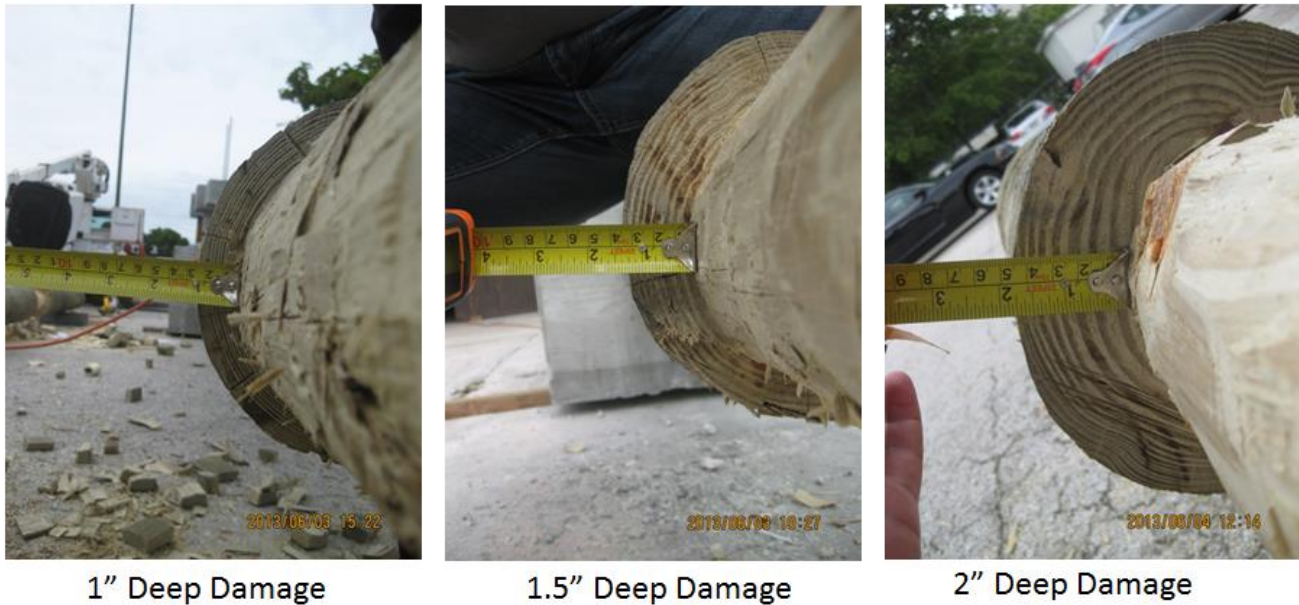
Figure 5.3: Different levels of damage in timber pile test specimens

Different details of the timber pile test specimens are provided in Table 5.1. The five test specimens have different levels and location of damages, and are repaired by different method as shown in Table 5.1. Three different damage levels were used in the test specimens. Specimen 2 and 3 have 1.0 inch and 1.5 inch deep damage respectively and specimen 4 through 6 have 2.0 inch deep damage. The length of damage is kept constant for all test specimens. Different levels of damage are shown in Figure 5.3.

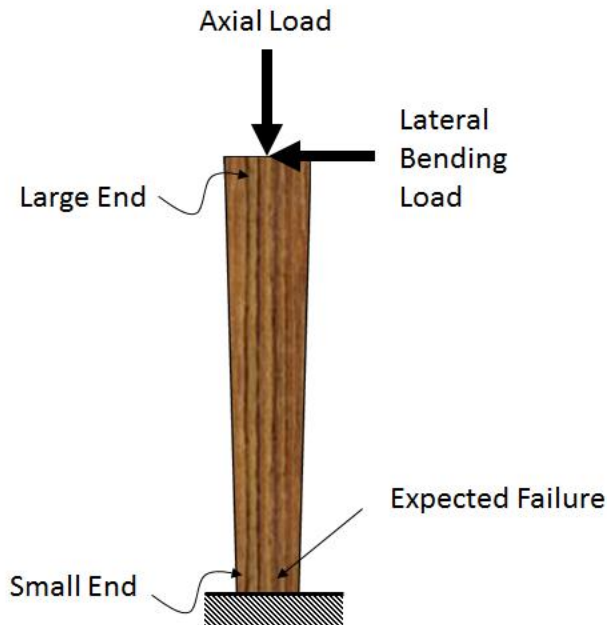
Figure 5.4: Expected failure at the small fixed end of the pile

rotation free at the large end. With the large end of pile free to rotate and the small end fixed, the failure is expected in the pile section near the small fixed end of the pile as shown in Figure 5.4. However as discussed earlier, due to heterogeneous timber material, non-uniform specimens, and accompanied loading eccentricities, it is difficult predict precise location of the failure.
