Report MPMC-04

# Evaluation of Dowel Bar Inserter Practices in PCC Pavements with Magnetic Tomography Technology

**Evaluation of Dowel Bar Inserter Practices in PCC Pavements with  
Magnetic Tomography Technology**

December 2016

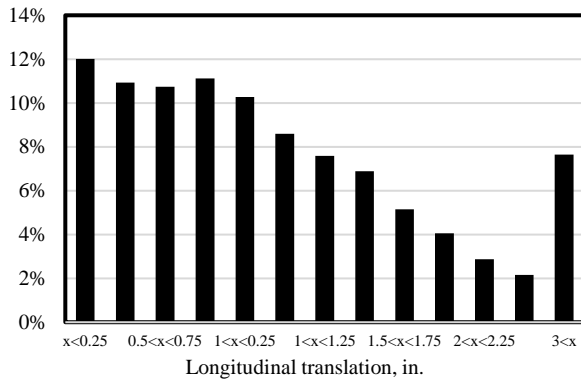
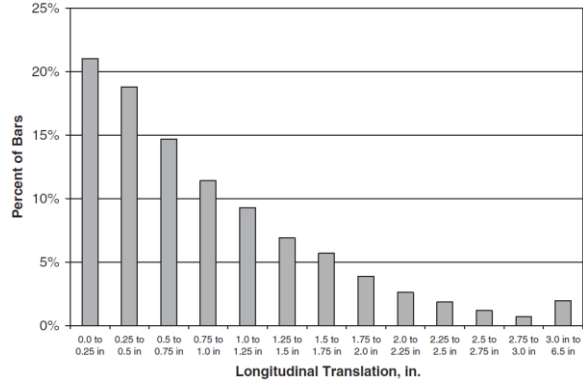
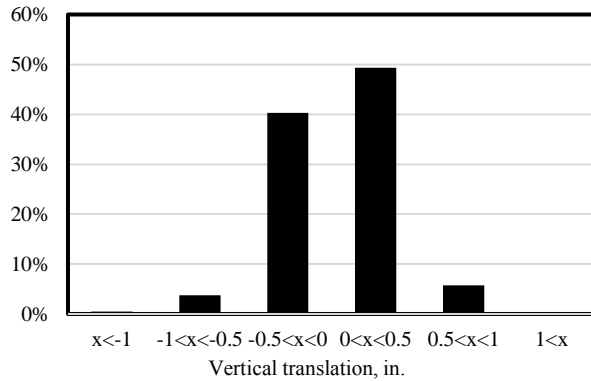
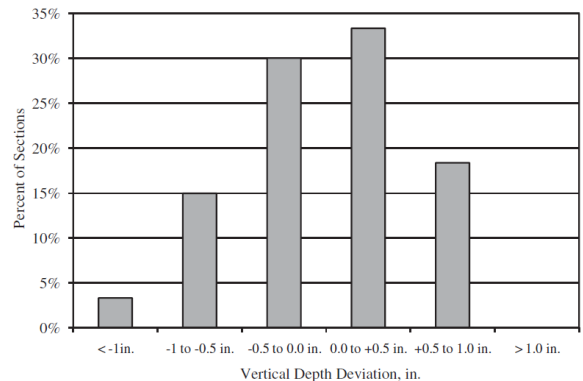
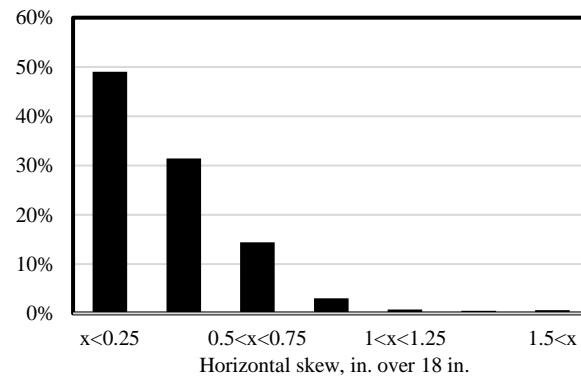
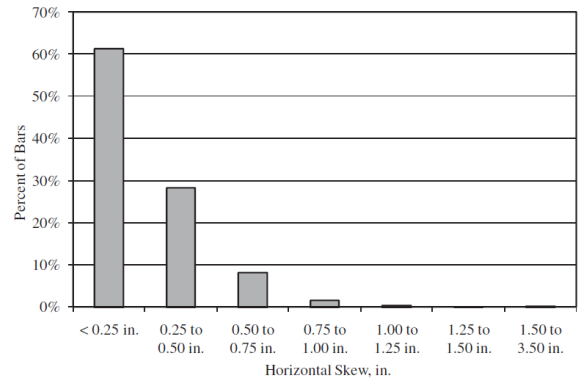
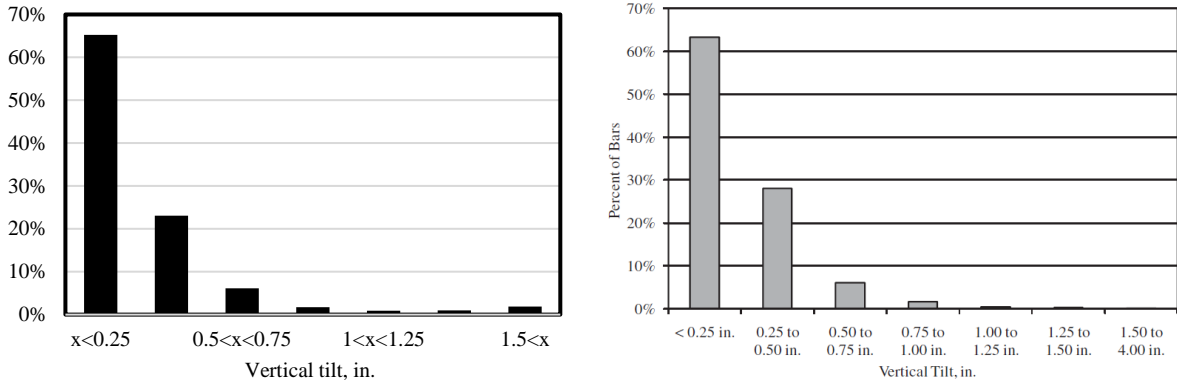
**Figure 3.5** Comparison of MIT Scan-2 data with results of NCHRP study

To compare the performance of the DBI used in these 4 projects with typical DBI and dowel basket practices, misalignment graphs of all projects have been juxtaposed with data from the study by Khazanovich et al. (2009) for over 2,300 joints. Figure 3.5 shows that longitudinal translation values of the dowels placed by the DBI are higher than the average reported by the NCHRP study. This could have happened due to inaccurate marking of the joints for saw-cut operations, as well as using a defective DBI. The vertical translation of the dowels, however, was

better than NCHRP values, which could mean that the concrete mix used with the DBI was stable enough to hold the dowels in place after insertion. Horizontal skew and vertical tilt values for the scanned joints are comparable with average values reported by Khazanovich et al. (2009).
