EXHIBIT A

PROJECT STATUS AND SCHEDULE

Bridge As-Built Plans

ROADWAY AS-BUILT PLANS

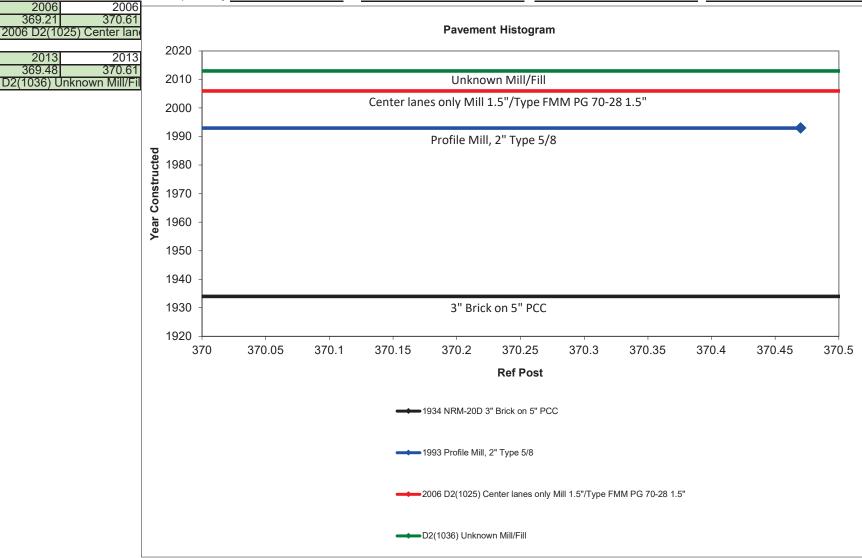
PAVEMENT HISTORY

1934 1934		Mainline Profile Summary:	Shoulder Profile Summary:
369.18 370.58 1934 NRM-20D 3" Brick or	Hwy # US-6	2" Mill, 2" ACSC	
	Location Saddle creek Rd Bridge NH-6-7(187)	1.5" Mill, 0"FMM Mill, 1.5" ACSC	
1993 1993	C.N. 22761		
368.21 370.47	Ref Posts 370.0070.50		
1993 Profile Mill, 2" Type 5	Date <u>9/17/20</u>		
	Prepared by BAD	AC on Brick on PCC???	
2006 2006 369.21 370.61 2006 D2(1025) Center lan		Pavement Histogram	
2013 2013 369.48 370.61	2020		
509.40 570.01	2010 -	Hoknown Mill/Eill

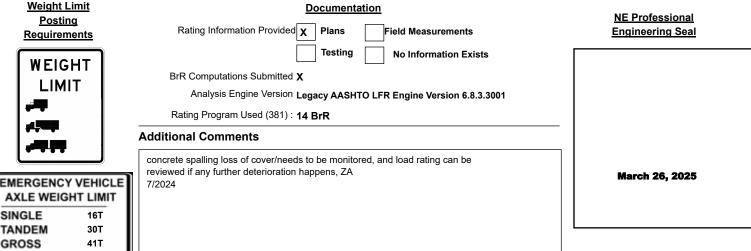
Inventory Rating		Operating Rating		lenal l		- Booting		Control Location		on	
Truck	Rating Factor	Tons	Rating Factor	Tons	Rating Factor	Tons	Posting Value (tons)	Member	Span	Location (ft)	Percent of Span	Limit State
SU4					1.51	40	-	S1	1	0.00	0.00	Design Flexure - Concrete
EV2					1.48	42	24	S1	1	0.00	0.00	Design Flexure - Concrete
HS/HL93	0.77	27					N/A	S1	1	0.00	0.00	Design Flexure - Concrete
SU5					1.37	42	-	S1	1	0.00	0.00	Design Flexure - Concrete
EV3					0.98	41	30	S1	1	0.00	0.00	Design Flexure - Concrete
NE Type 3-3					2.03	87		S1	1	0.00	0.00	Design Flexure - Concrete
NE Type 3					1.73	43		S1	1	0.00	0.00	Design Flexure - Concrete
SU7					1.15	44	-	S1	1	0.00	0.00	Design Flexure - Concrete
HS/HL93			1.28	45			N/A	S1	1	0.00	0.00	Design Flexure - Concrete
NE Type 3S2					1.81	66		S1	1	0.00	0.00	Design Flexure - Concrete
SU6					1.24	42	-	S1	1	0.00	0.00	Design Flexure - Concrete
Triple-Triple			1.12	78			N/A	S1	1	0.00	0.00	Design Flexure - Concrete

The Rating and Posting Values for this structure is based on a theoretical analysis of the structural elements involved and on a limited amount of information concerning the structural condition. These weight limits are intended only as a general guideline and may be varied accordingly by the officials responsible for this structure after an investigation of the structural condition, reaction to vehicular loads and any other items where judgment is required to establish a proper weight limit.
