Final Report SPR-FY24(026)

# Evaluation of Critical Shear Strength of Soils in Nebraska Based on Revised CPT

Department of Civil and Environmental Engineering  
University of Nebraska-Lincoln

Nebraska Department of Transportation

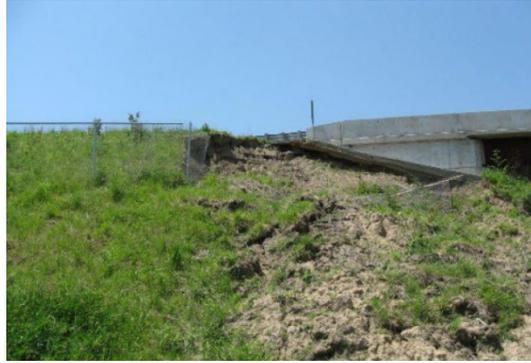
Figure 1.1 Failed slope at US-75

Nebraska has experienced gradual movement and failure in several roadside slopes, as identified in different research studies conducted by the Nebraska Department of Transportation (NDOT) and illustrated in Figure 1.1 (Bitar, 2020; Song et al., 2019, 2021). Back-calculated soil strengths for these failed slopes were significantly lower than those measured during the design phase (Song et al., 2019, 2021). Notably, the strength of soils at the failed slopes was reduced by 22–90% of their initial values under conditions of soil saturation and reduced effective overburden pressure, as detailed in Table 1.1.

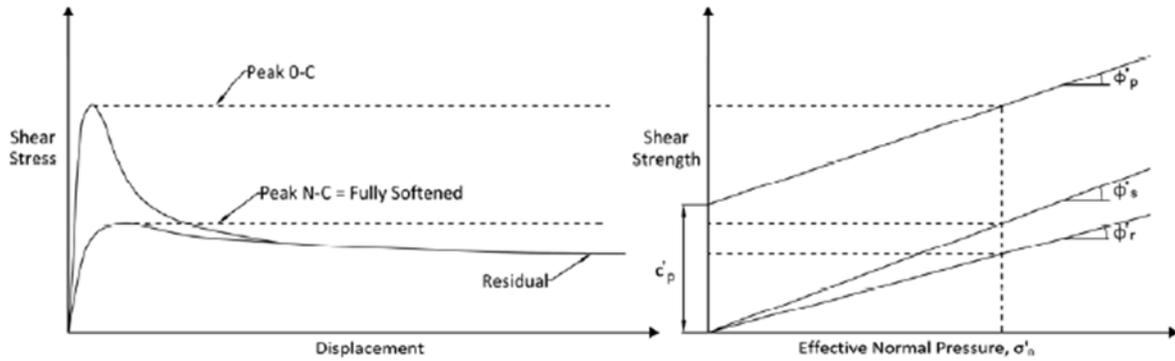
Figure 2.1 Shear Characteristics of Clays (Skempton, 1970)

Skempton (1970) examined the strength characteristics of over-consolidated clays in the context of first-time slope failures. The fully softened shear strength was defined as the drained peak shear strength of clay in a normally consolidated state, representing the strength after the clay's structure has been destroyed but before the development of a continuous shear surface as shown in Figure 2.1.

Skempton (1970) argued that the fully softened strength is a more realistic and appropriate limit than the residual strength in such conditions. Researchers described the post-peak behavior of over-consolidated clays in two stages: first, dilatancy and fissure opening lead to increased water content and a drop in strength to the fully softened value, forming a softened shear zone; second, principal shears develop, eventually linking to form a continuous shear surface at residual strength. The findings emphasize the role of fissures as stress concentrators and their contribution to clay softening, highlighting that the fully softened strength should be used in designing first-time slides, especially in London Clay.

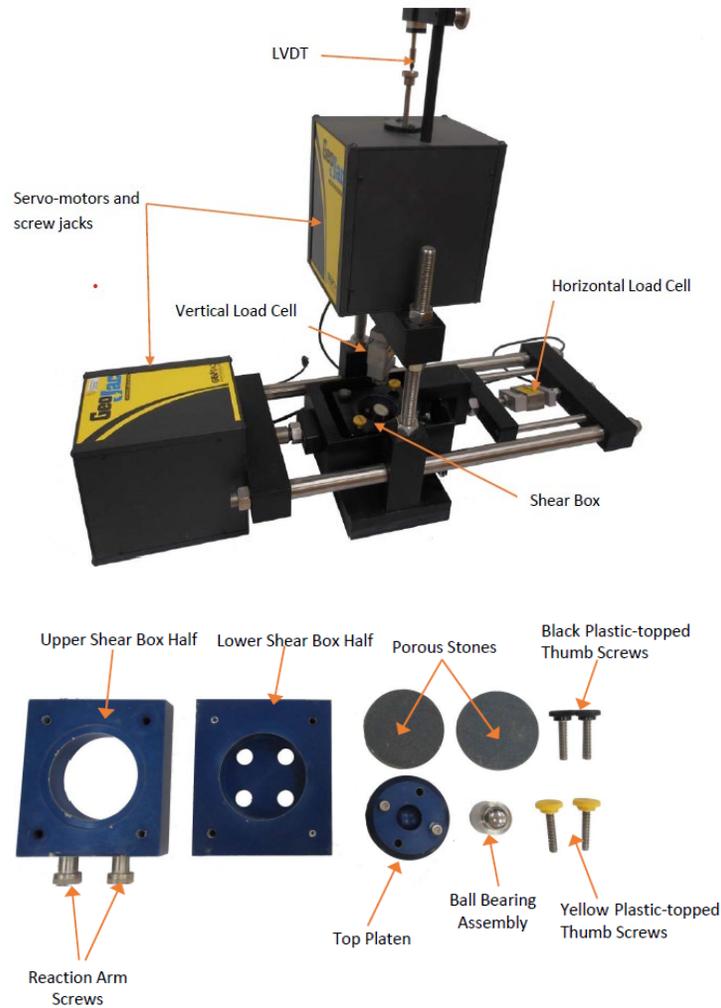
Figure 3.15 DigiShear Automated Direct Shear System and Shear Box Assembly (Castellanos, 2014)

The direct shear test was conducted following ASTM D-3080 to evaluate the shear strength of the soils under two conditions: at their natural field moisture content and after being submerged in water for 48 hours. This method was employed to replicate the field conditions present during the Cone Penetration Tests (CPT). DigiShear Automated Shear System was used to find the shear strength of the soil, the device is shown in Figure 3.15.

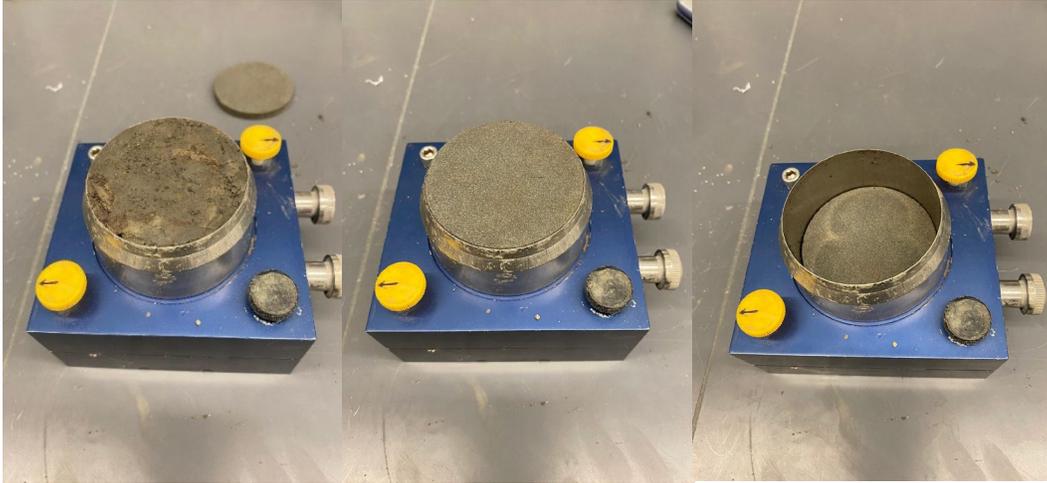
Figure 3.16 Field Moisture Condition Sample Preparation for Direct Shear Test

The samples for field moisture condition testing were extracted from the Shelby tube using steel cutting rings, 2.5 inches in diameter and 1.3 inches in height, which corresponded to the final sample size. The sample was then gently placed into the shear box using a porous stone. The process of preparing the field moisture condition samples is illustrated in Figure 3.16.

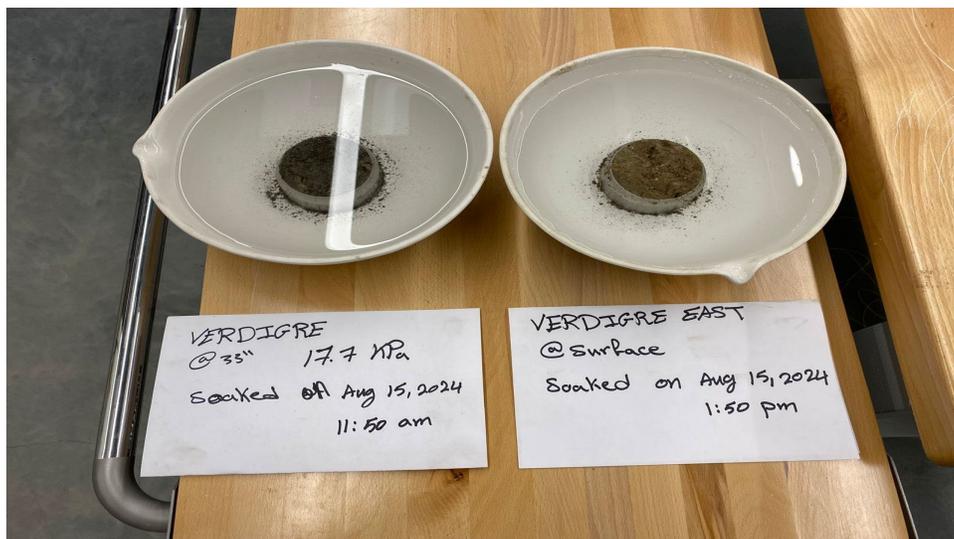
Figure 3.17 Submerged Direct Shear Samples

The samples prepared for testing under laboratory wet conditions were trimmed using the same method as the samples for field moisture conditions. They were then submerged in water for 48 hours while remaining inside the cutting ring. The cutting ring stayed in place during the submersion, ensuring that the sample was fully submerged and could be easily transferred to the shear box without any disturbance. Submerged samples are shown in Figure 3.17.

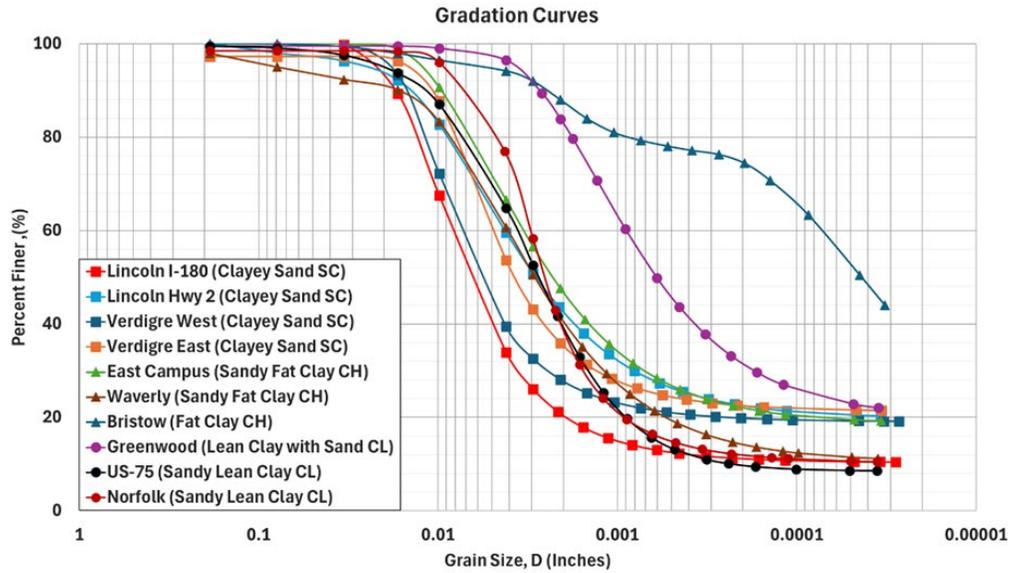
Figure 4.1 Gradation Curves for All Samples

According to a unified soil classification system (USCS), the tested locations were categorized into three primary groups: clayey sand (SC), fat clay (CH), and lean clay (CL). The data reveals that different soil types shared a similar clay size fraction, approximately 10%. This includes Lincoln I-180 (SC), US-75 (CL), Norfolk (CL), and Waverly (CH). In contrast, Verdigre South and East (SC), Lincoln Hwy-2 (SC), and UNL East Campus (CH) had a clay size fraction closer to 20%. Greenwood (CL) contained a higher proportion of finer particles compared to the other locations. Notably, the Bristow gradation exhibited a gap-graded distribution, which is uncommon in natural soil.

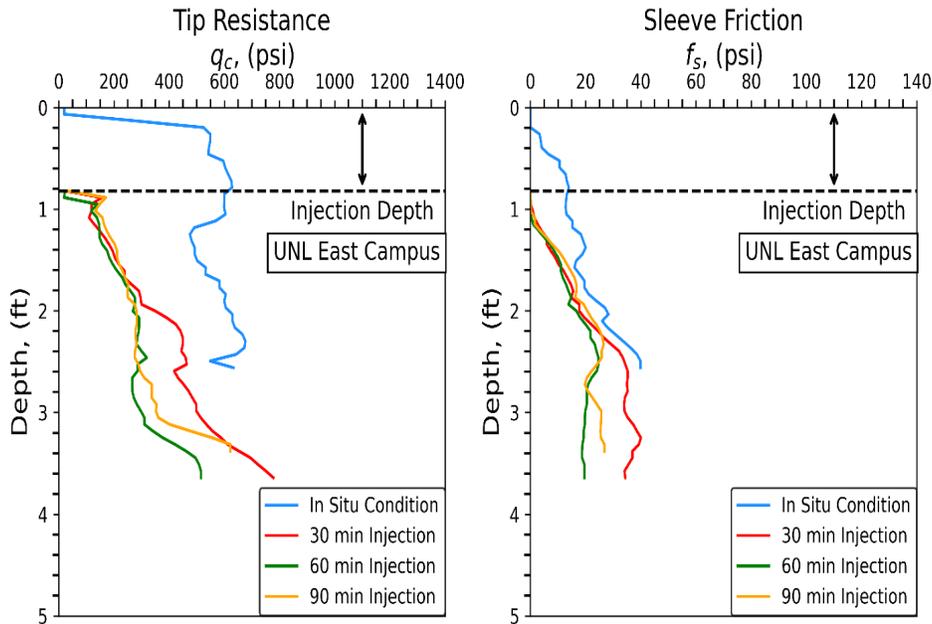
Figure 4.2 UNL East Campus Revised CPT Results

yellow lines), both  $q_c$  and sleeve friction ( $f_s$ ) drop by roughly 65%, with  $q_c$  decreasing from 580 psi to 150 psi and  $f_s$  from 15 psi to 5 psi (Figure 4.2).

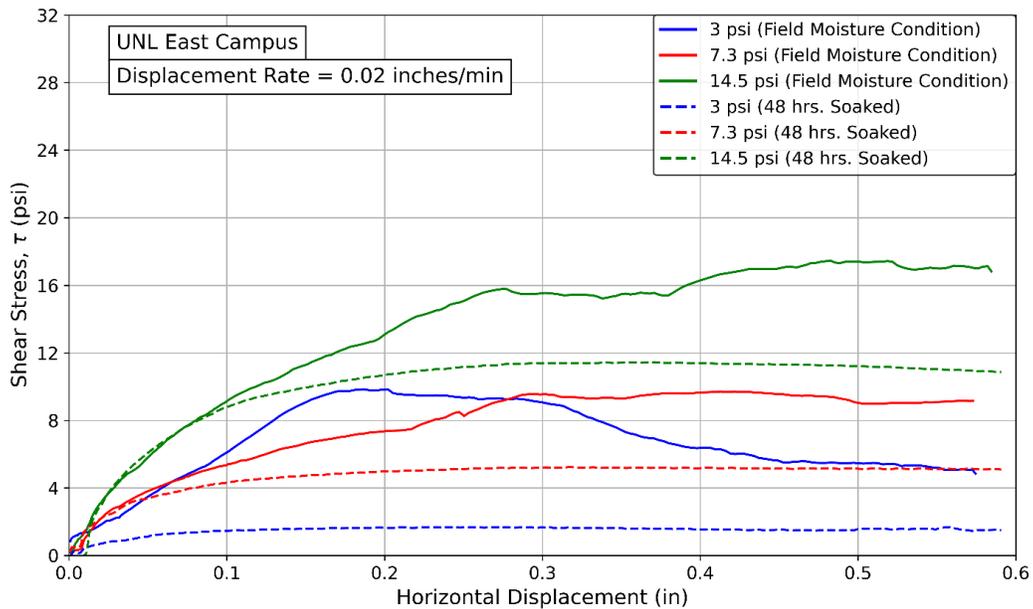
Figure 4.3 UNL East Campus Shear Stress vs. Horizontal Displacement

resistance after water injection, particularly at shallow depths (1 – 2.5 ft) due to lower overburden pressure and higher moisture susceptibility.

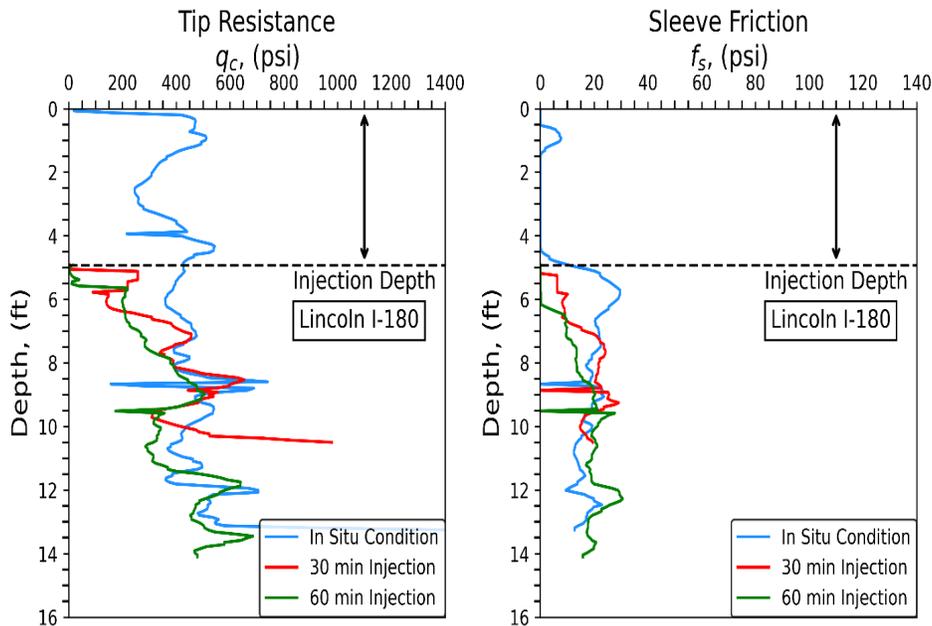
Figure 4.4 Lincoln I-180 Revised CPT Results

Lincoln I-180 is classified as Clayey Sand (SC), which contains a 10.5% clay size fraction and has a plasticity index PI of 23.1. Figure 4.4 presents the revised (CPT) results for Lincoln I-180. Under in-situ conditions (blue lines in Figure 4.4), the Clayey Sand (SC) exhibited a tip resistance ( $q_c$ ) of approximately 500 psi and sleeve friction ( $f_s$ ) of around 25 psi. After 30 minutes of water injection,  $q_c$  decreased to 300 psi, reflecting a 40% reduction, while  $f_s$  dropped to 10 psi, indicating a 60% reduction. A similar trend was observed after 60 minutes of water injection, where  $q_c$  and  $f_s$  stabilized at 300 psi and 10 psi, respectively. However, the effect of water injection extended to a depth of three feet after 60 minutes, whereas after 30 minutes, the impact was limited to just 1.5 feet below the injection depth.

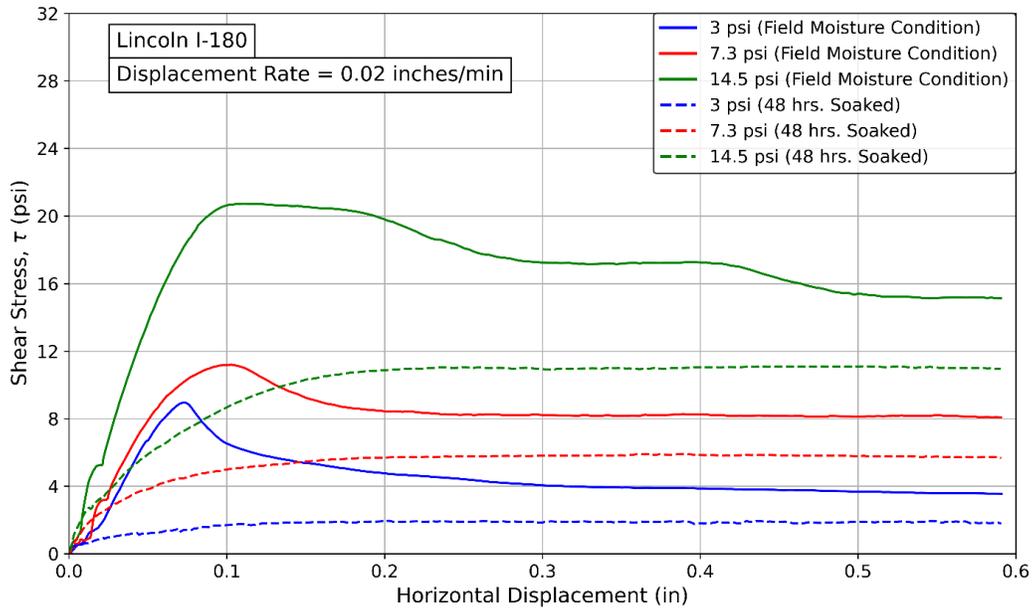
Figure 4.5 Lincoln I-180 Shear Stress vs. Horizontal Displacement

The direct shear test results further corroborate these findings, revealing reductions in shear stress of 78% at 3 psi, 45% at 7.3 psi, and 48% at 14.5 psi after 48 hours of submersion, as presented in Figure 4.5. These reductions align with the CPT trends, where tip resistance ( $q_c$ ) was reduced by 40.0% and sleeve friction ( $f_s$ ) was reduced by 60.0% upon water injection. The more pronounced reduction in  $f_s$  and the substantial strength loss at lower normal stresses in the shear test highlight the material's moisture sensitivity.

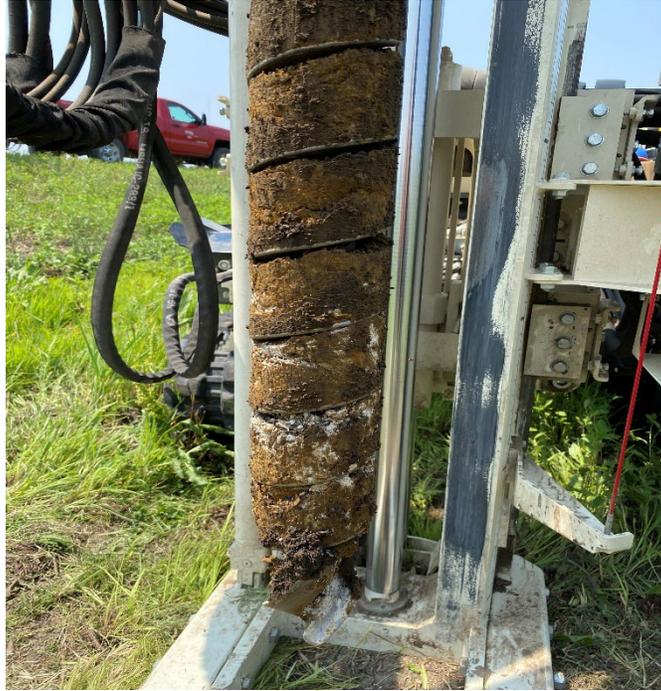
Figure 4.6 Lincoln Hwy-2 Soil After Drilling

Lincoln I-180 is classified as Clayey Sand (SC), which contains a 21% clay size fraction and has a plasticity index PI of 32.2. Lincoln Hwy-2 soil after drilling is shown in Figure 4.6. The results from the revised Cone Penetration Test (CPT) indicated that there was no reduction in strength after injecting water into the soil for 60 minutes. In fact, both the tip resistance ( $q_c$ ) and sleeve friction ( $f_s$ ) values were higher compared to the in-situ condition results, as illustrated in Figure 4.7.

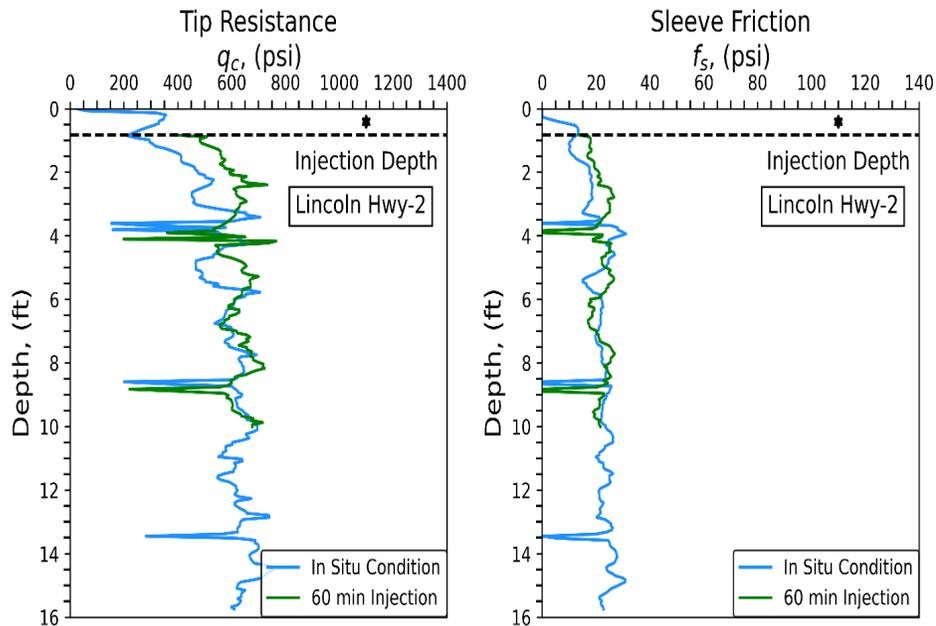
Figure 4.7 Lincoln Hwy-2 Revised CPT

Given the high plasticity index (32.2) and clay fraction (21%), a reduction in shear strength upon wetting is anticipated, consistent with observations at previous test locations. However, the unexpected behavior observed in this case may be attributed to variability in soil composition as a natural material. Additionally, the rapid drainage of the sand fraction could have facilitated a decrease in pore water pressures, mitigating the expected strength reduction. Furthermore, the specific clay mineralogy plays a role, as variations in swelling potential and moisture sensitivity can significantly influence the soil's mechanical response.

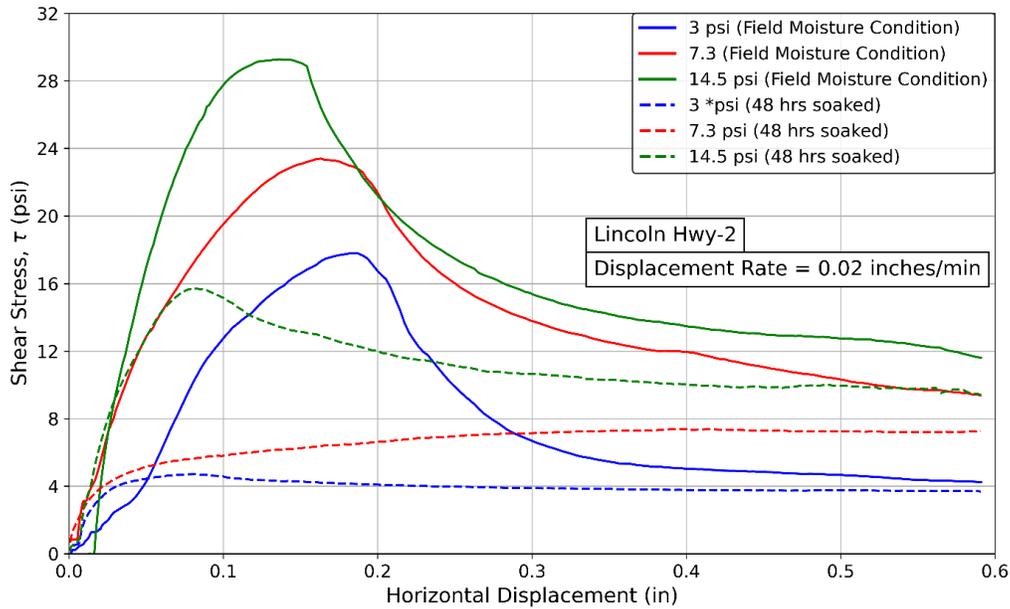
Figure 4.8 Lincoln Hwy-2 Direct Shear Test Results

The direct shear test results indicate that the initial peak shear strength under field moisture conditions suggests an over consolidated state, likely influenced by negative pore water pressure, as the field moisture content at Lincoln Hwy-2 was 20.9%. However, after 48 hours of soaking, the soil exhibits a substantial reduction in shear resistance, with shear stress decreasing by 78% at 3 psi, 70% at 7.3 psi, and 43% at 14.5 psi, as illustrated in Figure 4.8.

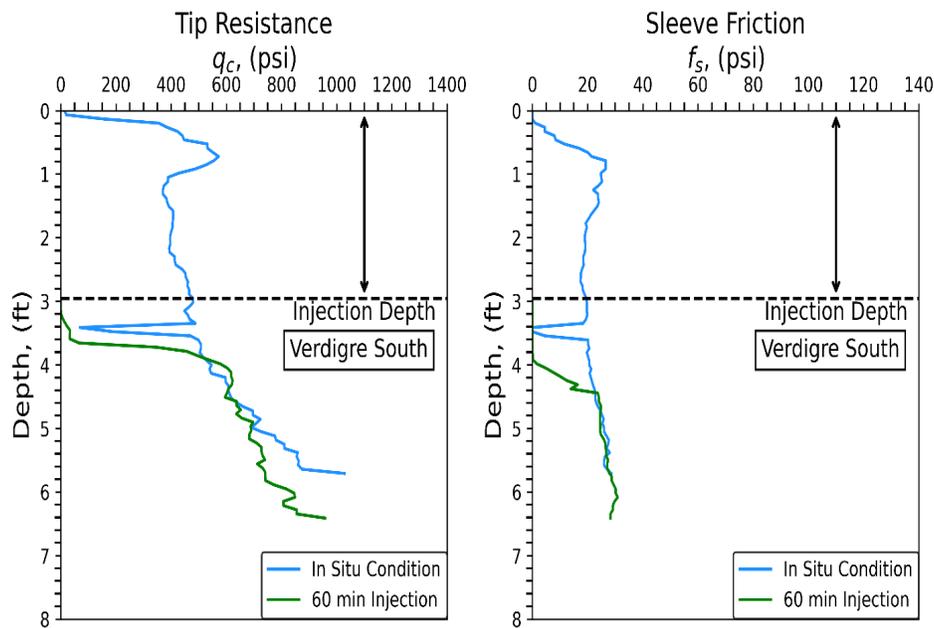
Figure 4.9 Verdigre South Revised CPT Results

100% loss. The depth of influence remained constrained to approximately 1 ft, demonstrating the soil's low hydraulic conductivity and its tendency to limit vertical moisture migration. The pronounced reduction in strength parameters at shallow depths suggests a moisture-induced degradation of cohesion, driven by the high clay content and plasticity.

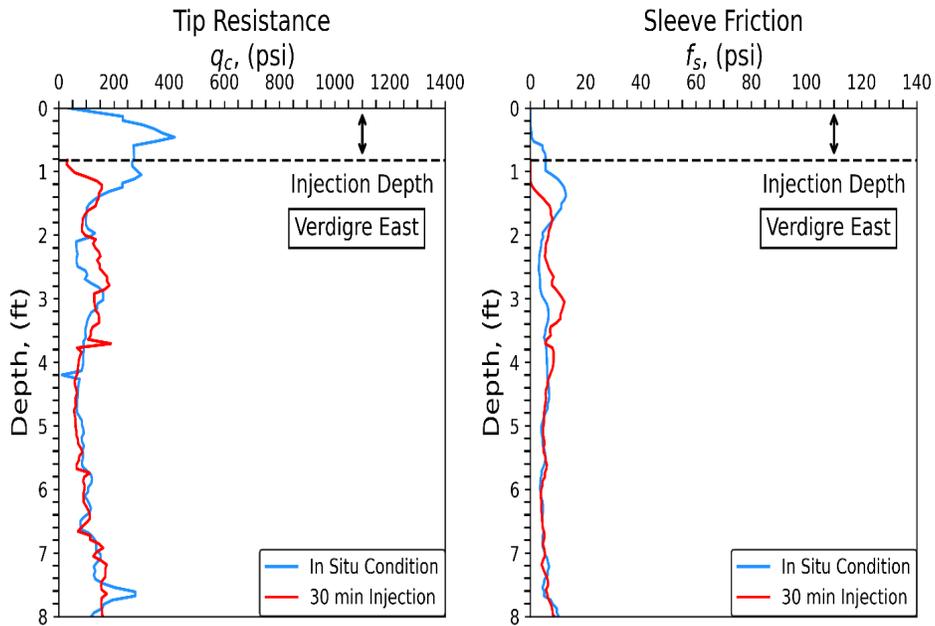
Figure 4.11 Verdigre East Revised CPT Results

restricted vertical moisture dissipation. The response was consistent across both sites, with the only difference being an injection duration of 60 minutes in Verdigre South and 30 minutes in Verdigre East.

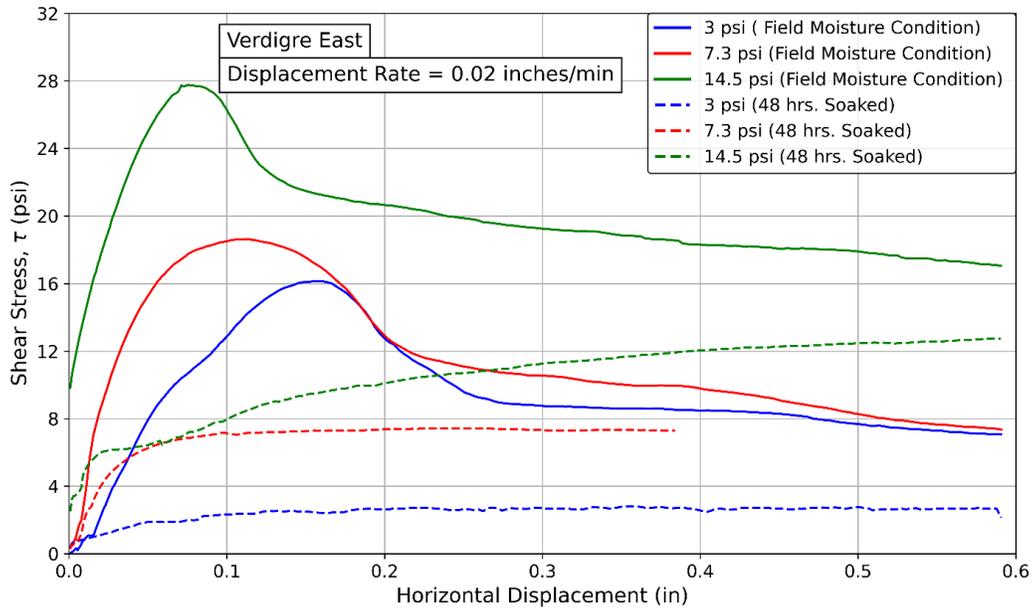
Figure 4.12 Verdigre East Direct Shear Test Result

The behavior confirms that the clay low permeability localized the strength reduction immediately below the injection depth, since the 30-min injection in Verdigre East impacted 0.5 ft below the injection depth, while 1 ft was impacted in Verdigre South after a 60-min injection.

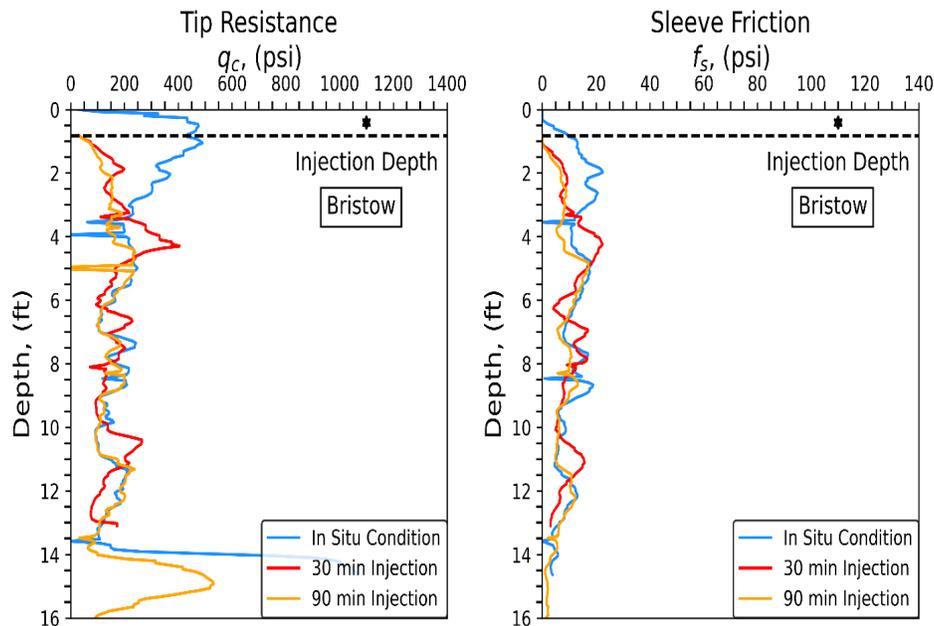
Figure 4.13 Bristow Revised CPT Results

Bristow is classified as fat clay (CH) and has a clay content of 62%, a plasticity index (PI) of 40.7, and a field moisture content of 28.3%. The results from the Cone Penetration Test (CPT) conducted at Bristow show a significant decrease in tip resistance ( $q_c$ ) and sleeve friction ( $f_s$ ) following water injection, as illustrated in Figure 4.13. Under in-situ conditions,  $q_c$  decreased from 350 psi to 150 psi, representing a reduction of approximately 57% after 30 minutes of injection, and similarly at the 90-minute mark. At the same time, sleeve friction ( $f_s$ ) dropped from 15 psi to 5 psi, indicating a reduction of about 67%. These reductions in  $q_c$  and  $f_s$  extended up to 1 ft below the injection depth after 30 minutes and up to 1.5 ft after 90 minutes.

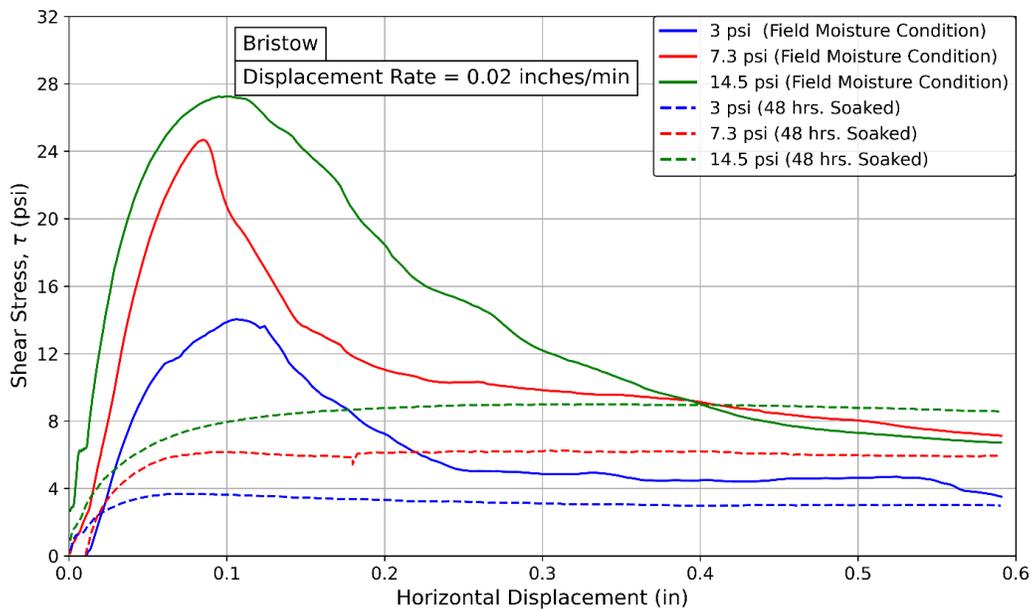
Figure 4.14 Bristow Direct Shear Test Results

These reductions align with the direct shear test results, which demonstrate a shear strength decrease of 79% at 3 psi, 75% at 7.3 psi, and 68% at 14.5 psi after 48 hours of soaking, as presented in Figure 4.14. The initial peak shear strength under field moisture conditions indicates an over consolidated state, attributed to low hydraulic conductivity and strong inter-particle bonding. However, post-soaking, the soil exhibits a substantial reduction in shear resistance driven by clay swelling and inter-particle bond weakening.

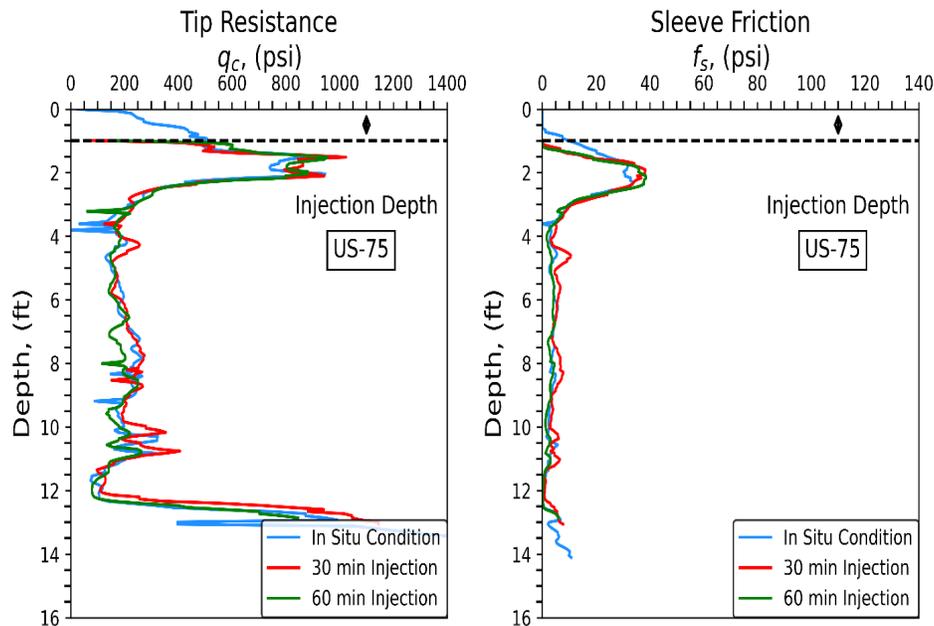
Figure 4.15 US-75 Revised CPT Results

suggesting that the soil retains its strength despite moisture infiltration. This behavior can be attributed to the low clay fraction (9%) and moderate plasticity index ( $PI = 16$ ), which limit the soil's susceptibility to significant strength loss upon wetting. Additionally, the lack of noticeable strength reduction below the injection depth implies that the permeability of this soil allows for rapid drainage, preventing pore pressure buildup and subsequent weakening.

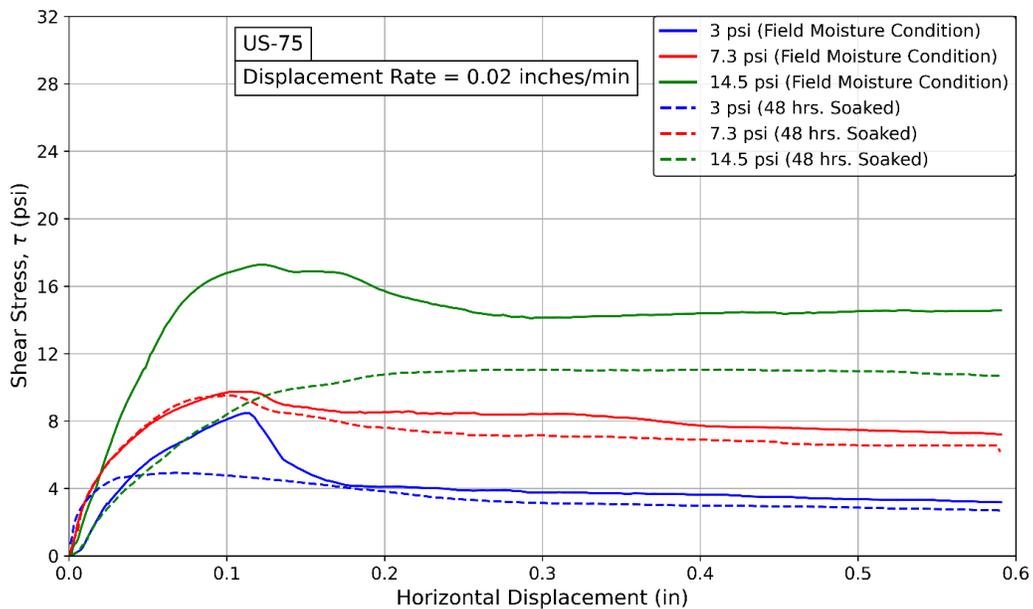
Figure 4.16 US-75 Direct Shear Results

we observe reductions of 38% and 35% under normal stresses of 14.5 psi and 3 psi, respectively. This reinforces the findings from the Cone Penetration Test (CPT), showing that US-75 Sandy Lean Clay retains its structural integrity even under prolonged exposure to water. The minimal loss in strength highlights the stability of this soil type in wet conditions, making it less susceptible to strength degradation-related failures compared to more plastic clays such as CH or CL, which have a higher clay fraction.

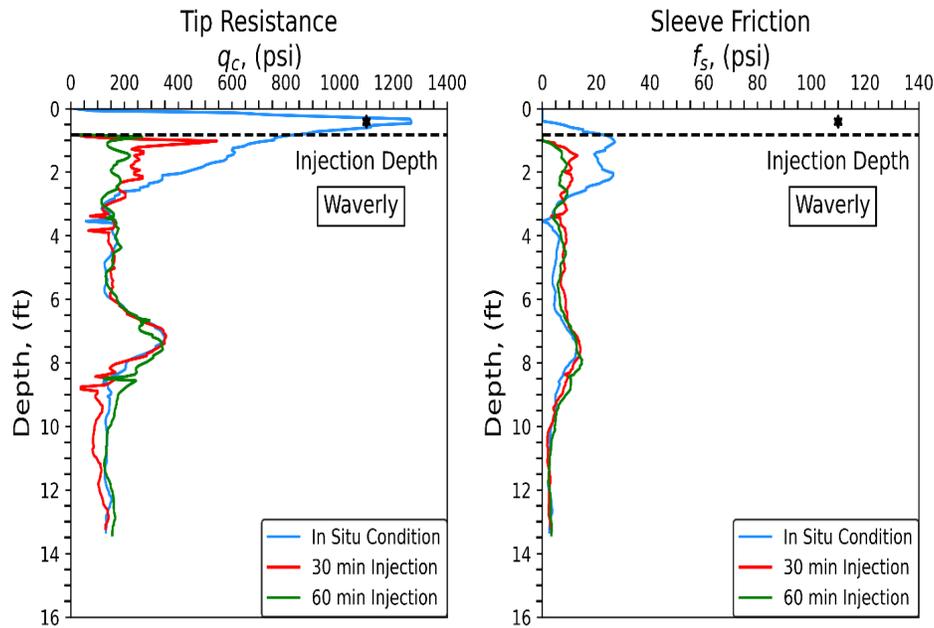
Figure 4.17 Waverly Revised CPT Results

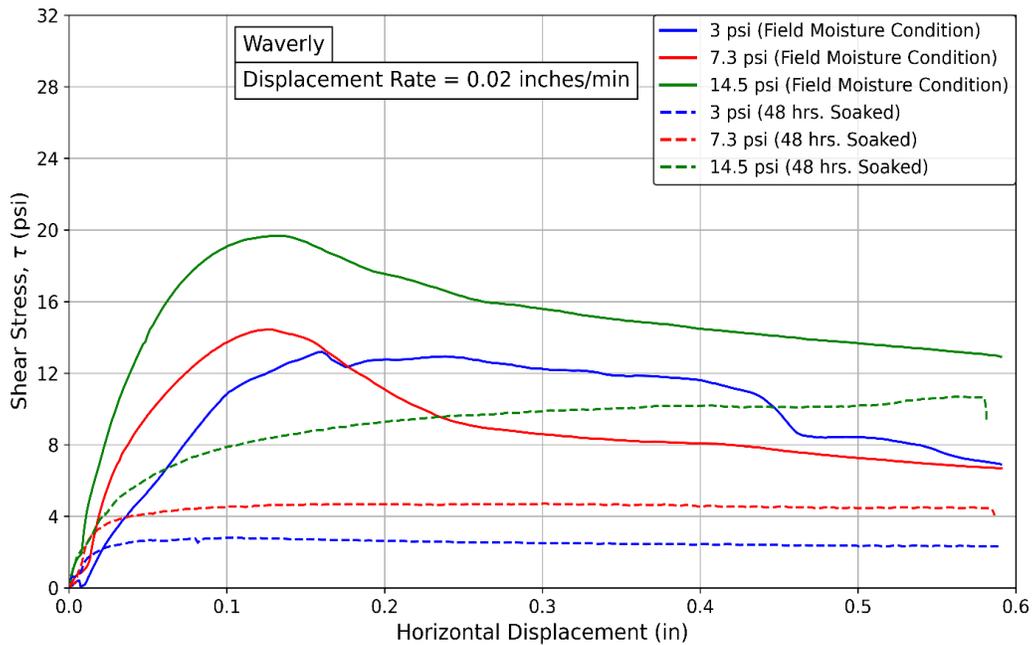
Figure 4.18 Waverly Direct Shear Test Results

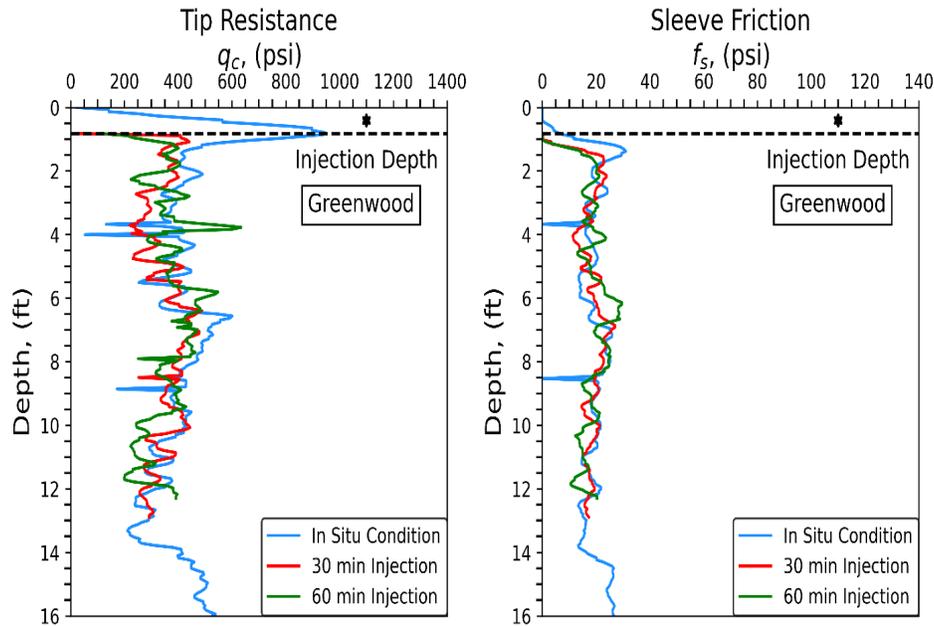
Figure 4.19 Greenwood Revised CPT Results

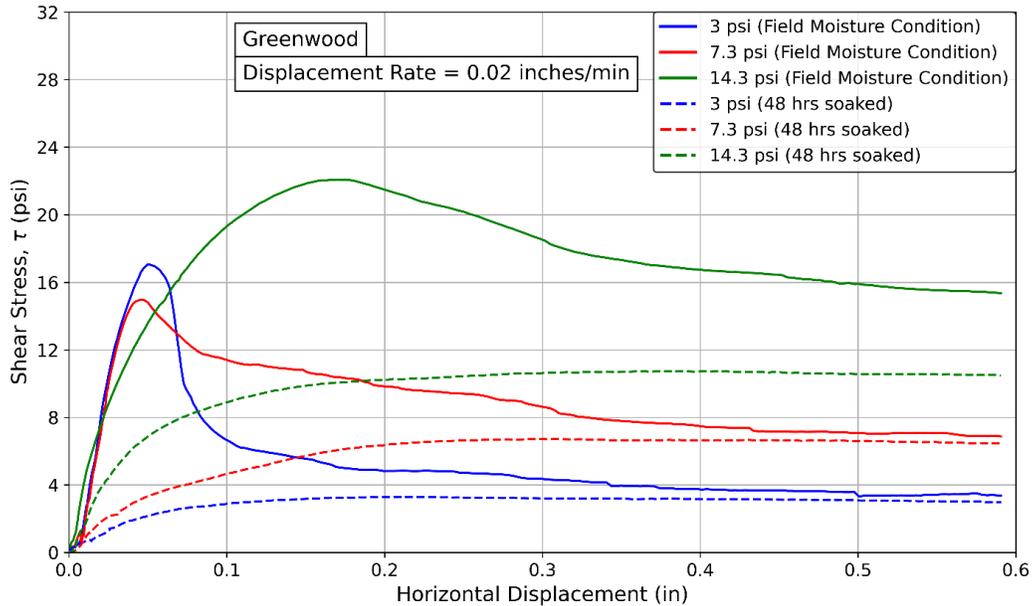
Figure 4.20 Greenwood Direct Shear Test Results

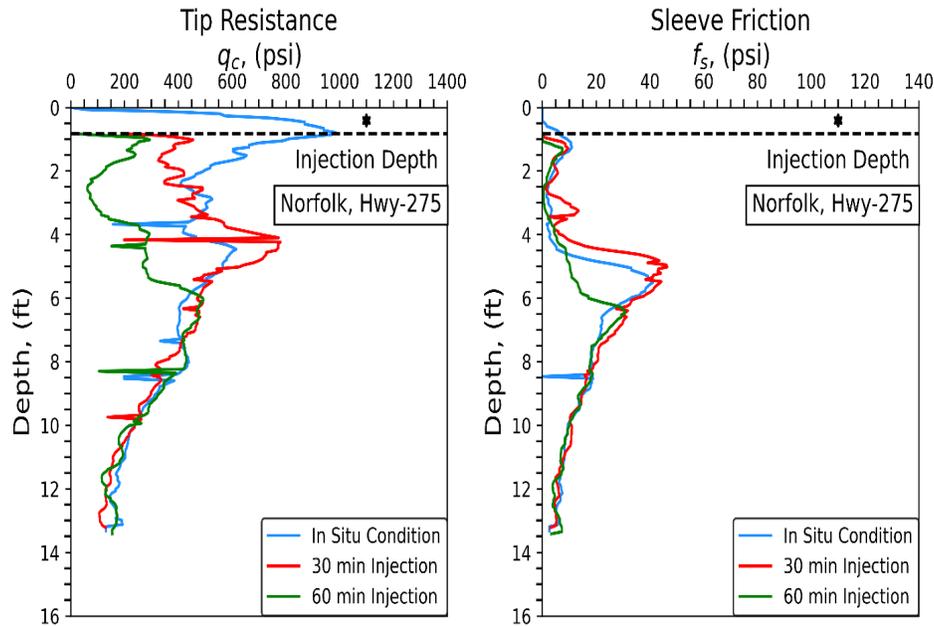
Figure 4.21 Norfolk Revised CPT Results

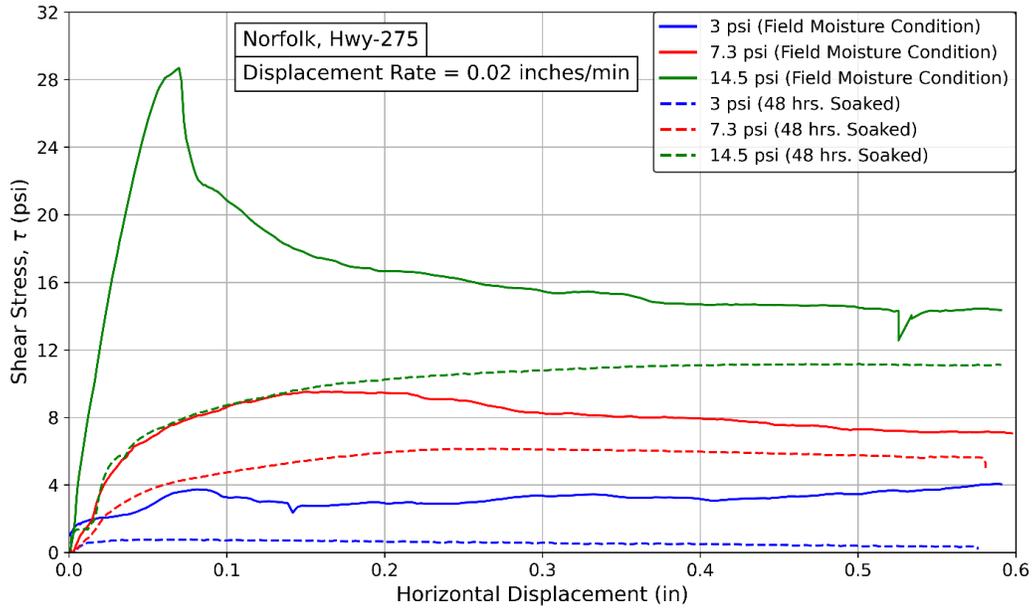
Figure 4.22 Norfolk Direct Shear Test Results

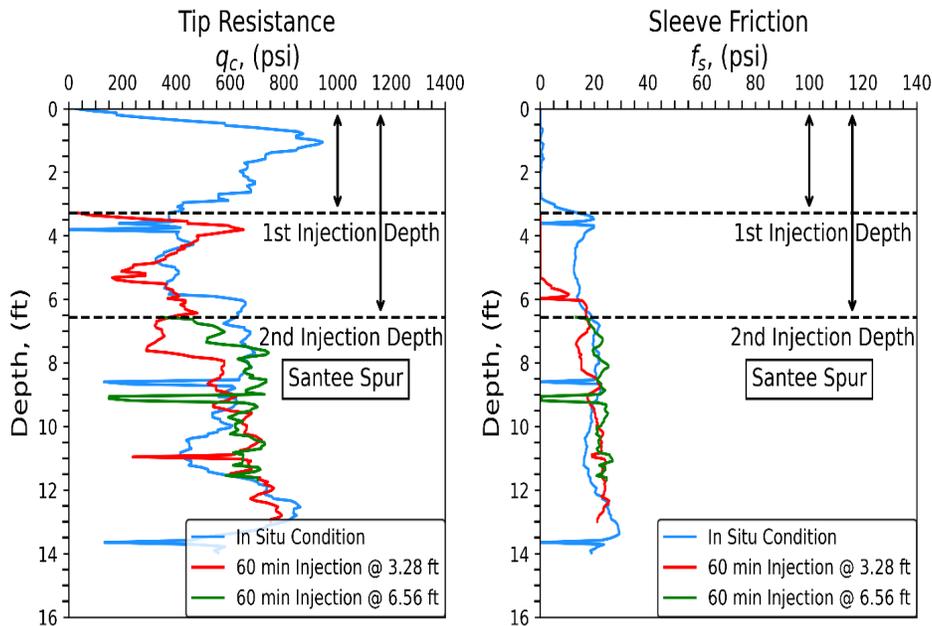
Figure 4.23 Santee Spur Revised CPT Results

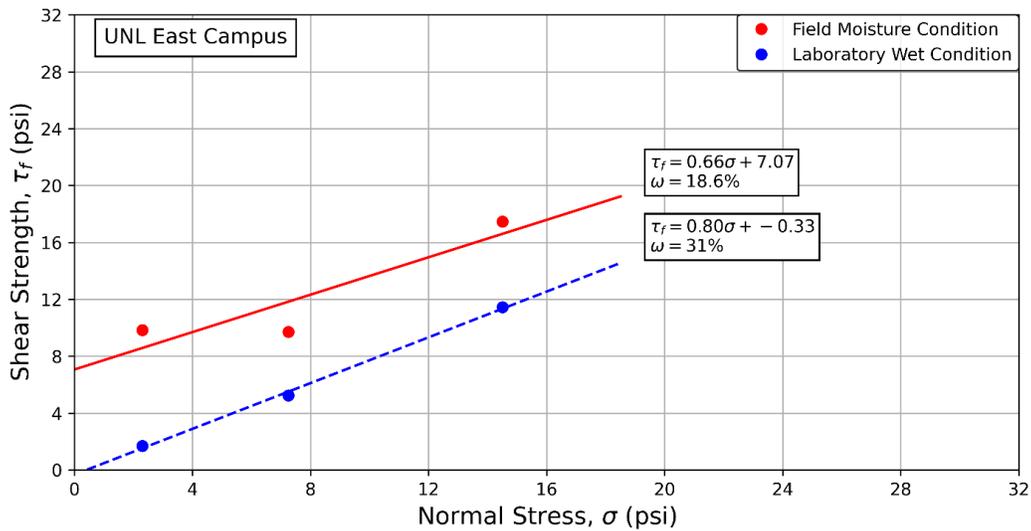
Figure 5.1 UNL East Campus Shear Strength Parameters

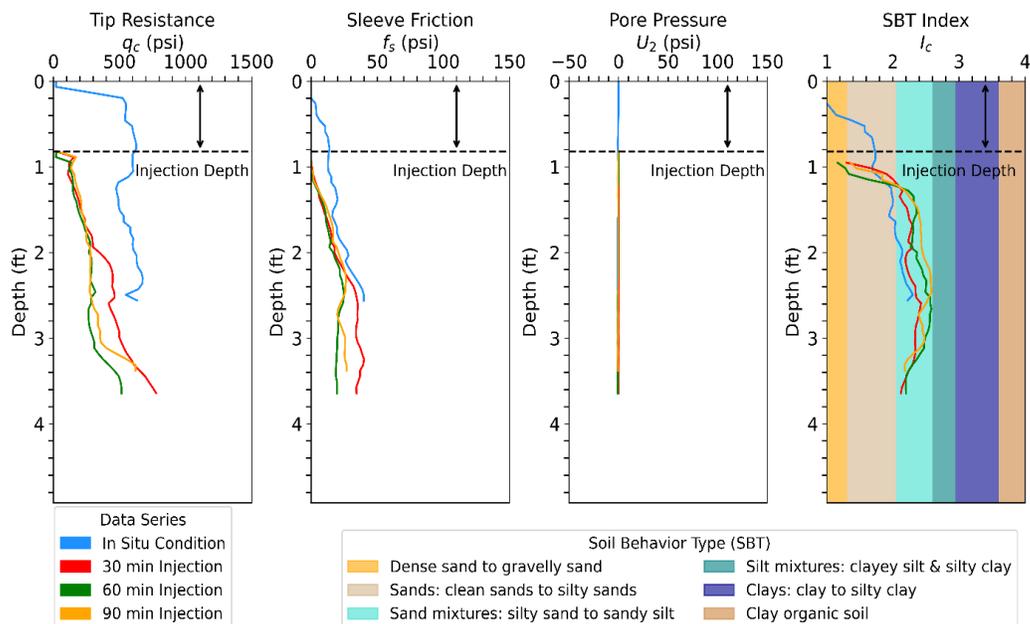
Figure 5.2 UNL East Campus SBT

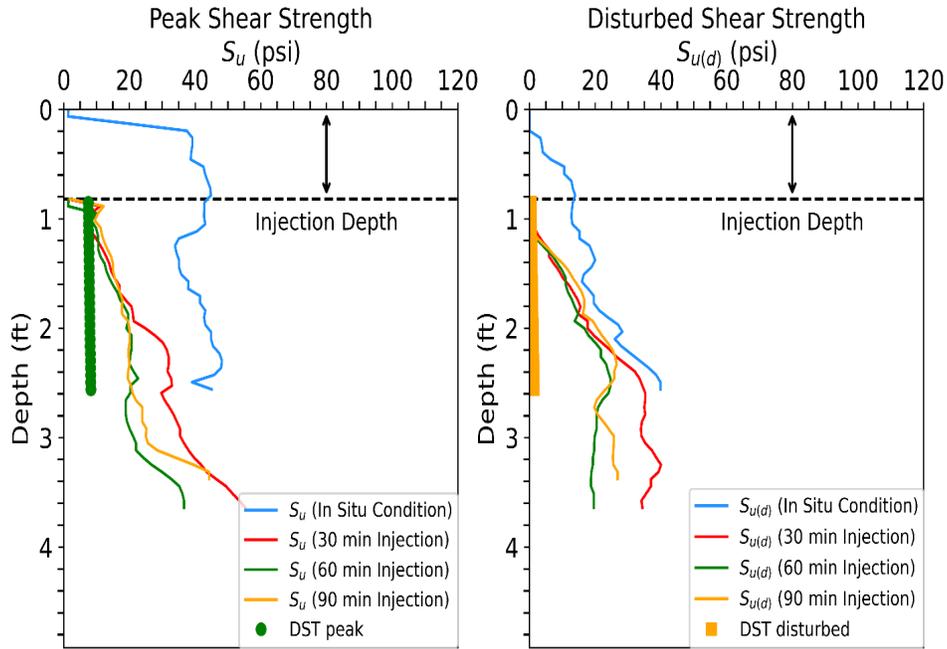
Figure 5.3 UNL East Campus Peak and Disturbed Shear Strength form CPT and DST

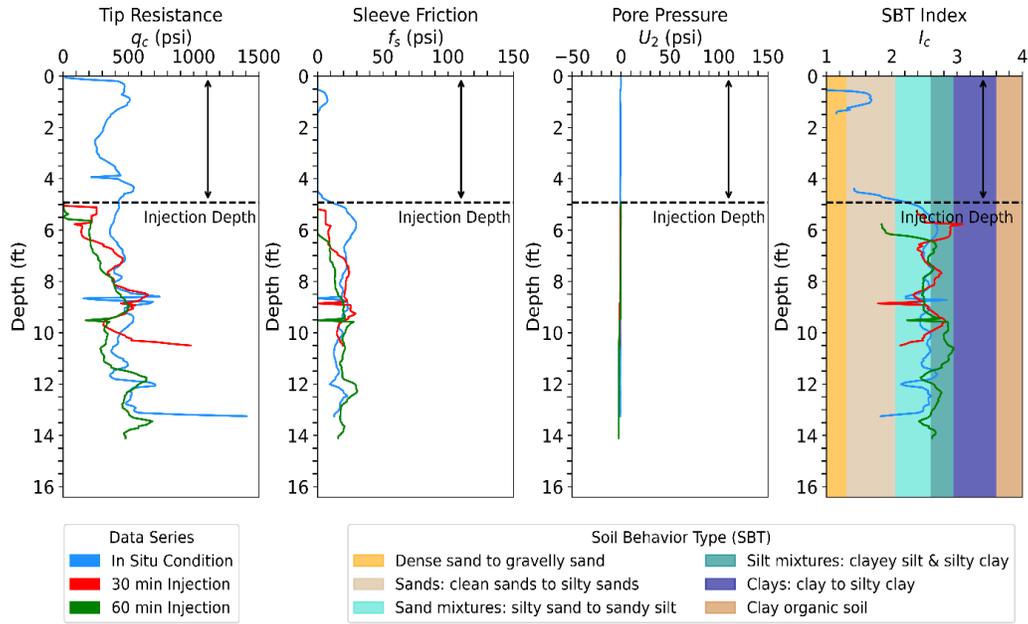
Figure 5.4 Lincoln I-180 SBT

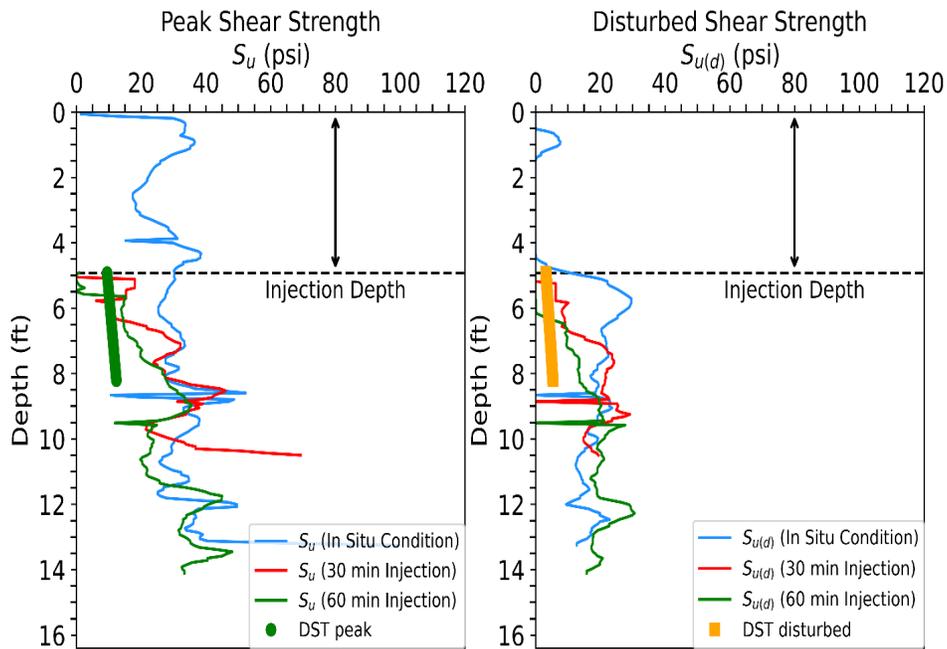
Figure 5.5 Lincoln I-180 Peak and Disturbed Shear Strength from CPT and DST

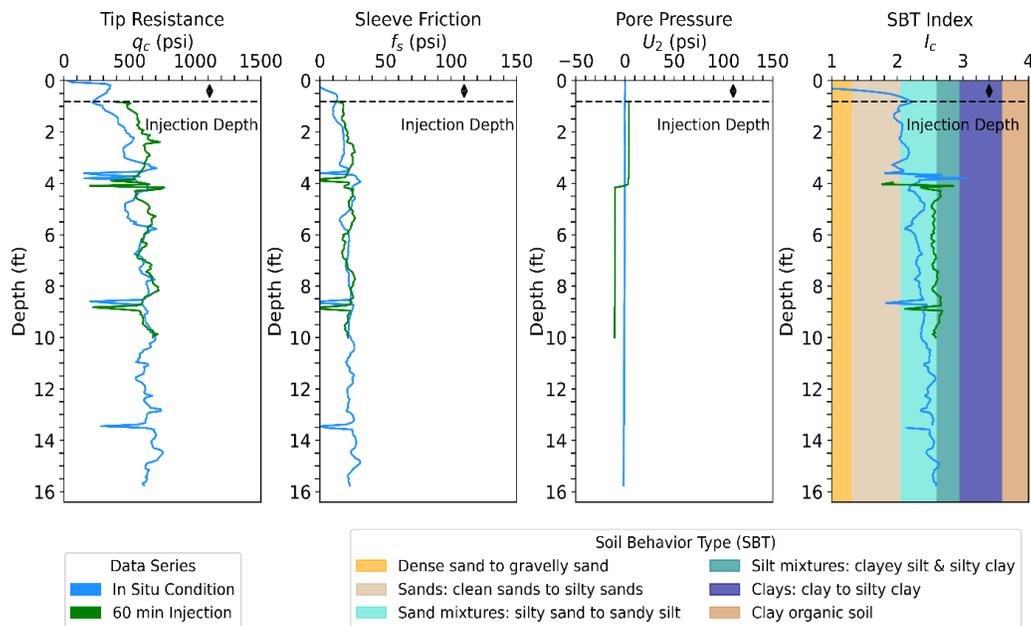
Figure 5.6 Lincoln Hwy-2 SBT
