Final Report SPR-FY24(026)

# Evaluation of Critical Shear Strength of Soils in Nebraska Based on Revised CPT

Department of Civil and Environmental Engineering  
University of Nebraska-Lincoln

Nebraska Department of Transportation

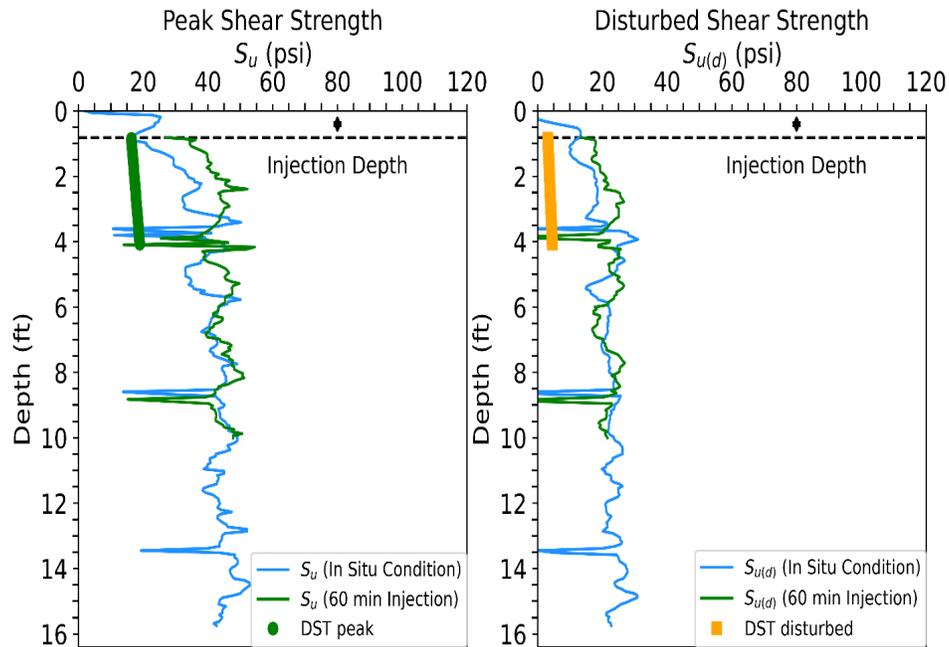
Figure 5.7 Lincoln Hwy-2 Peak and Disturbed Shear Strength form CPT and DST

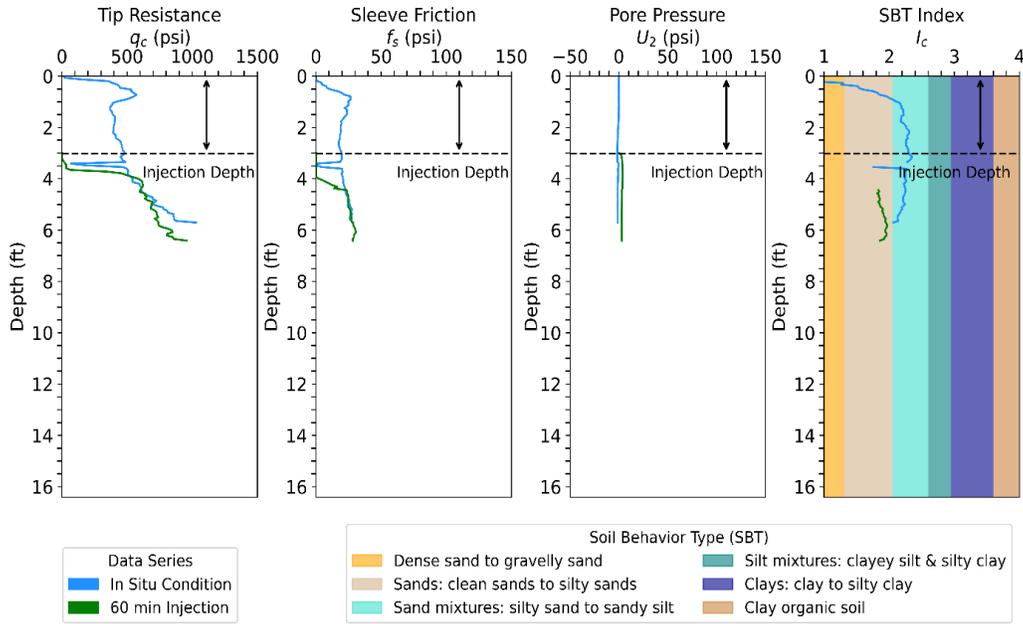
Figure 5.8 Verdigre South SBT

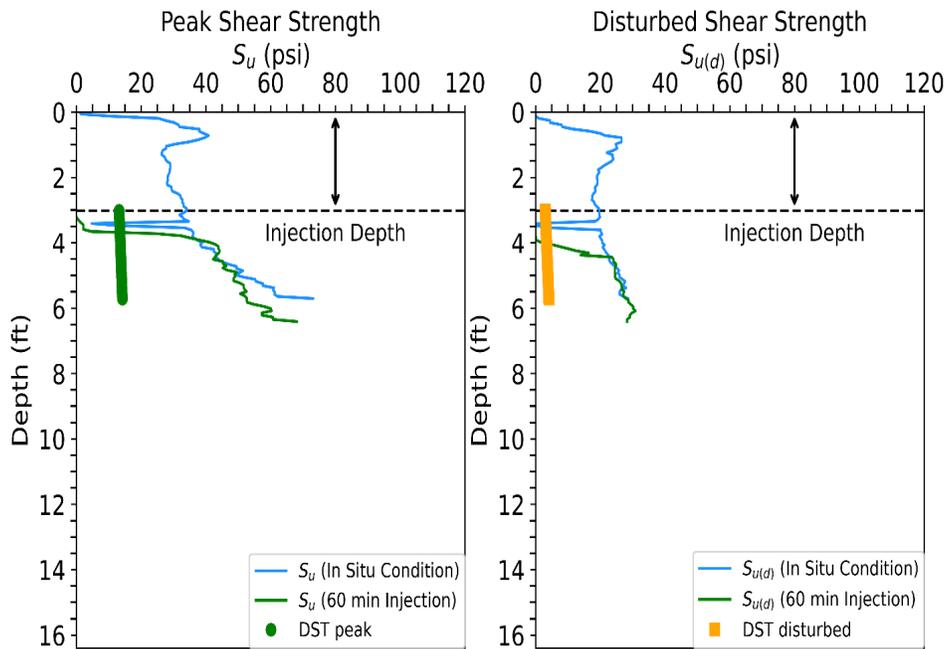
Figure 5.9 Verdigre South Peak and Disturbed Shear Strength form CPT and DST

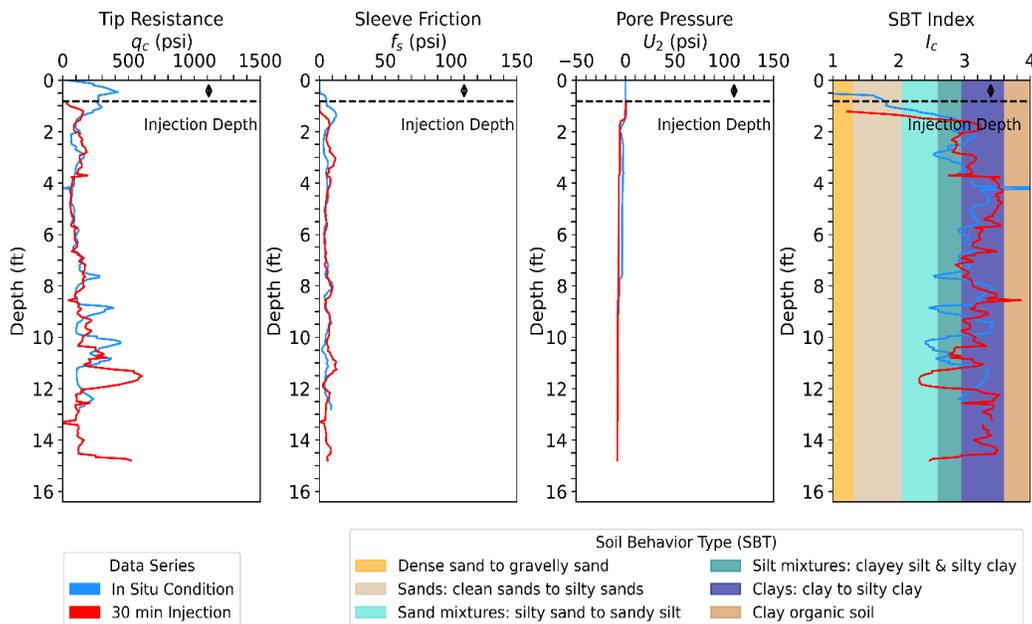
Figure 5.10 Verdigre East SBT

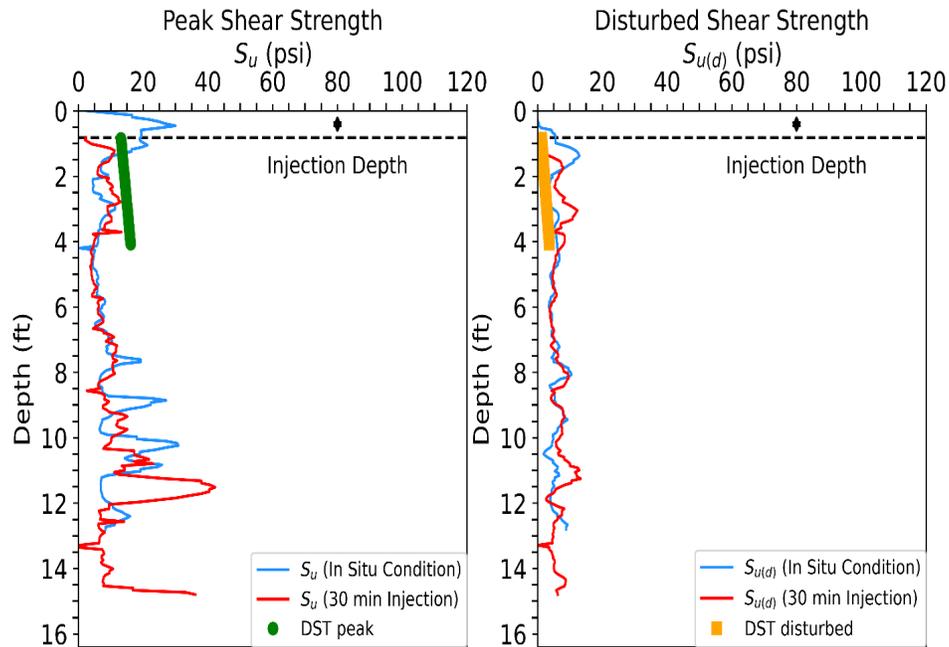
Figure 5.11 Verdigre East Peak and Disturbed Shear Strength form CPT and DST

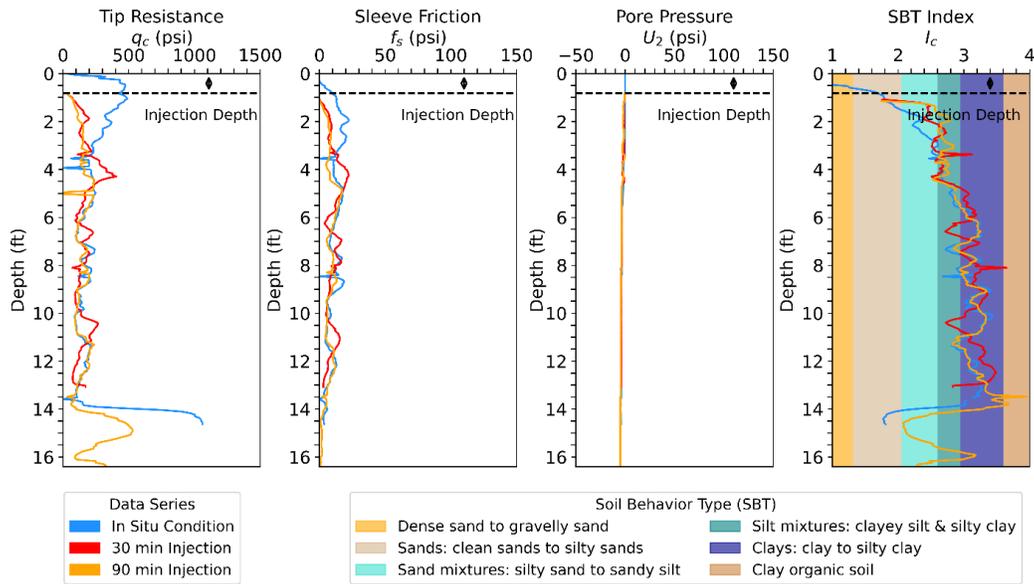
Figure 5.12 Bristow SBT

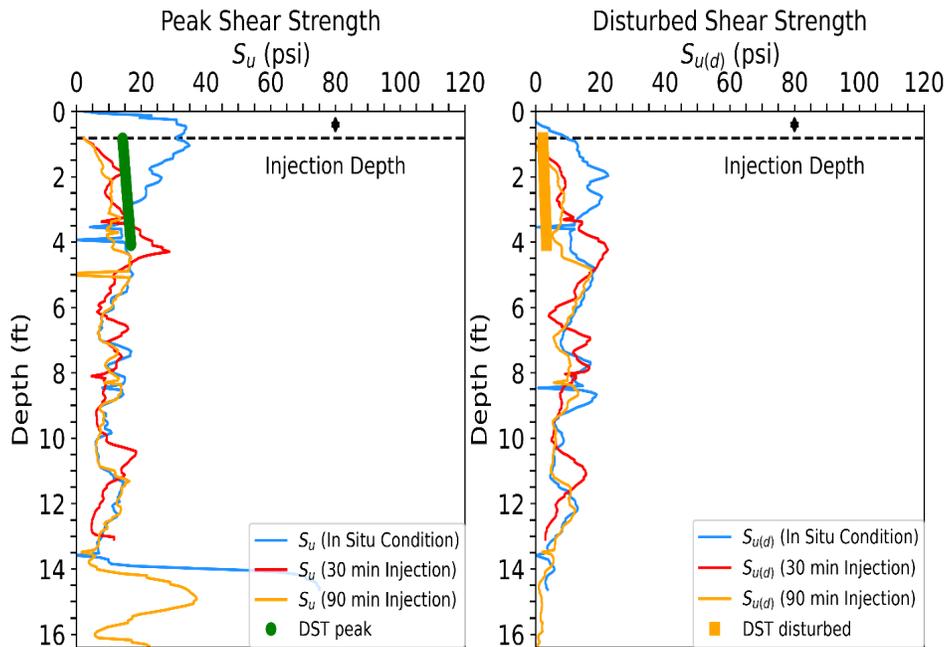
Figure 5.13 Bristow Peak and Disturbed Shear Strength from CPT and DST

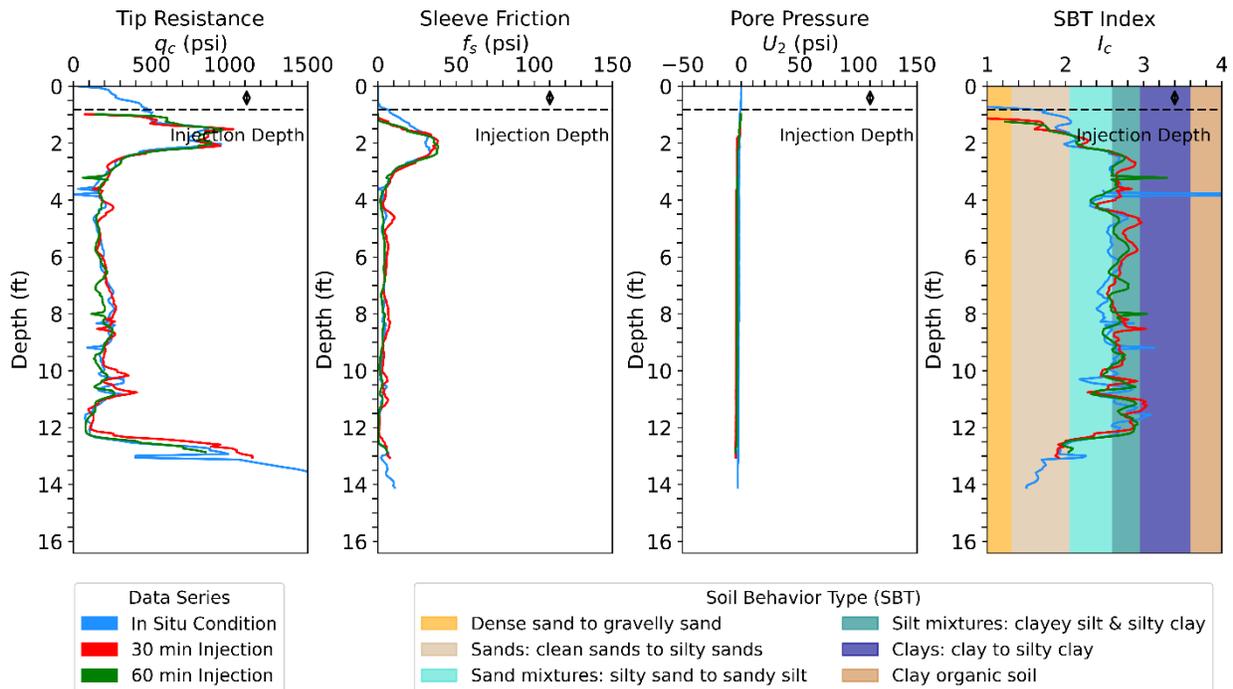
Figure 5.14 US-75 SBT

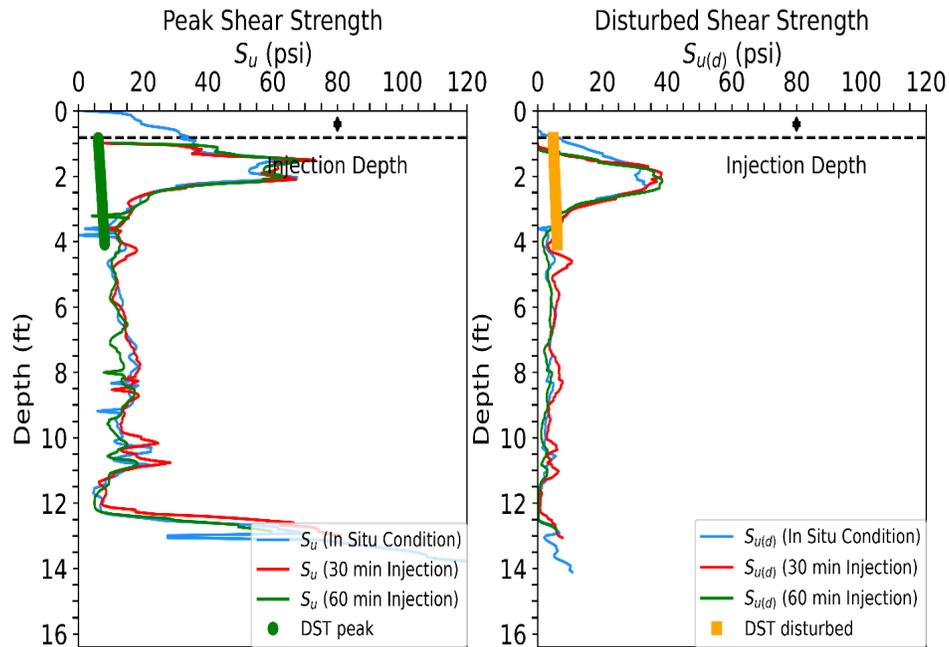
Figure 5.15 US-75 Peak and Disturbed Shear Strength form CPT and DST

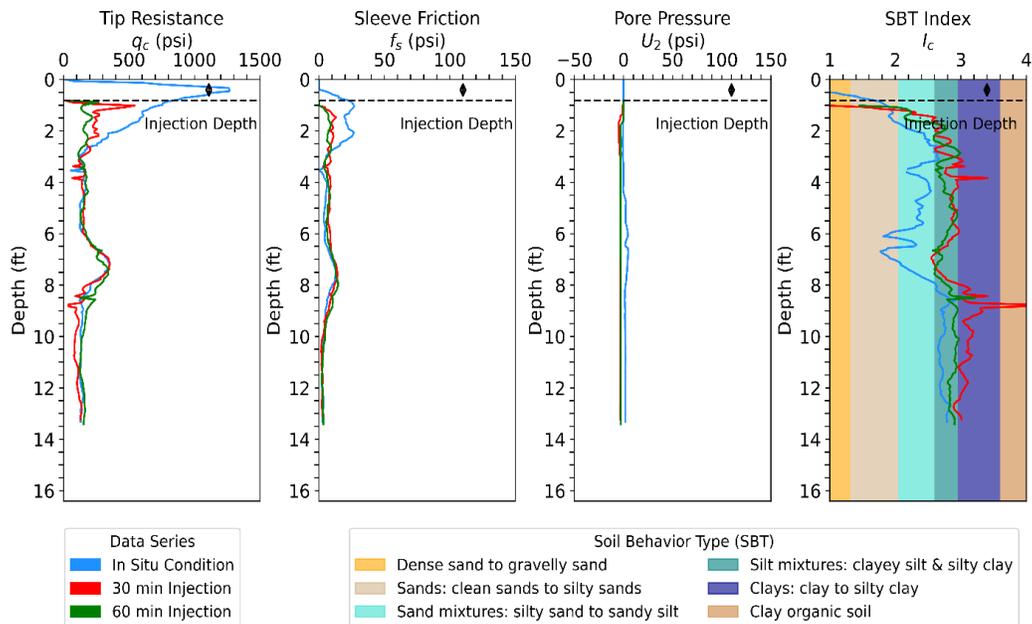
Figure 5.16 Waverly SBT

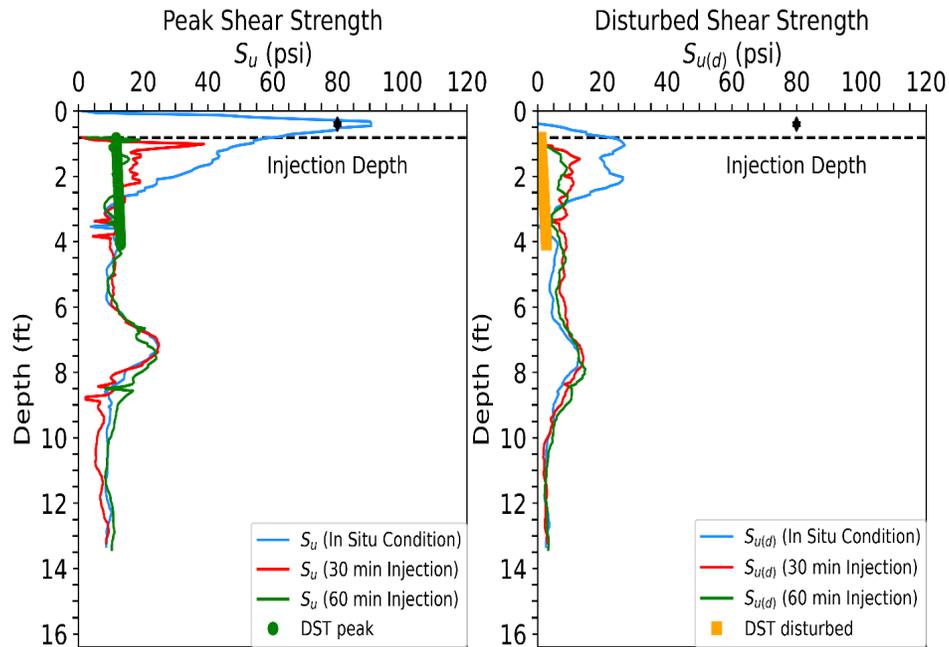
Figure 5.17 Waverly Peak and Disturbed Shear Strength form CPT and DST

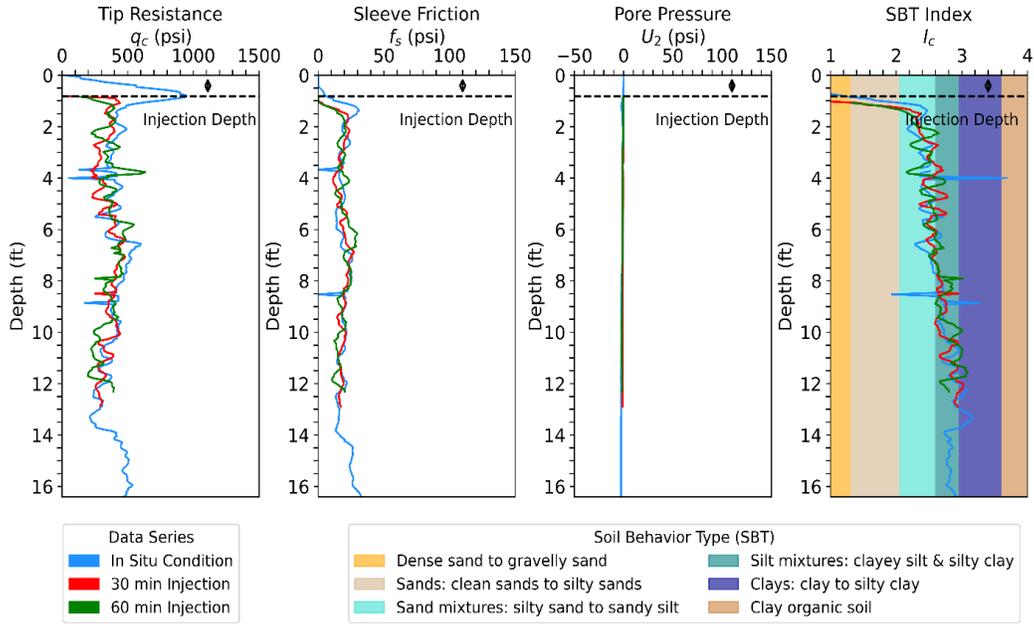
Figure 5.18 Greenwood SBT

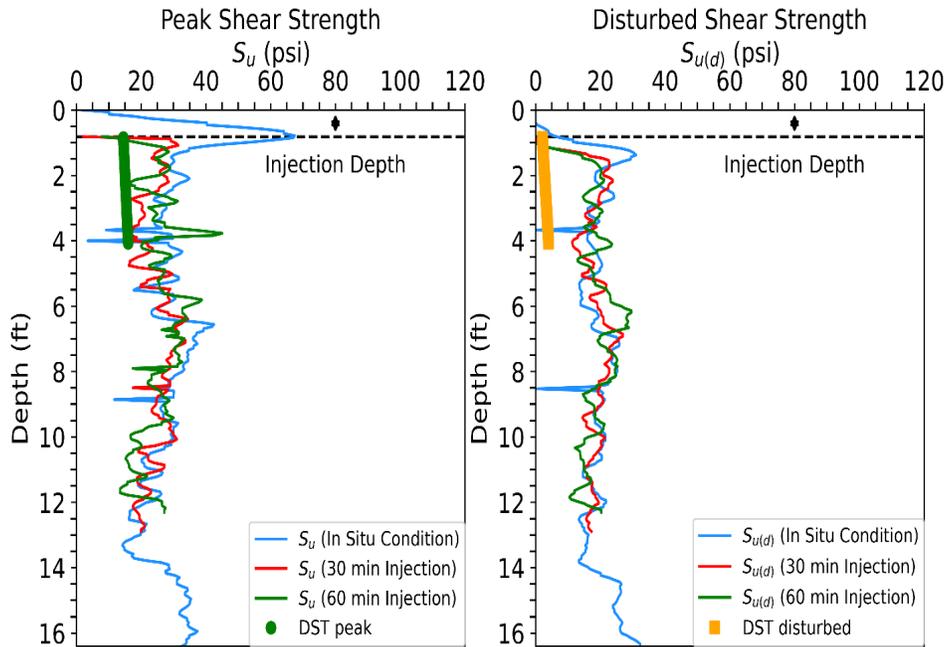
Figure 5.19 Greenwood Peak and Disturbed Shear Strength form CPT and DST

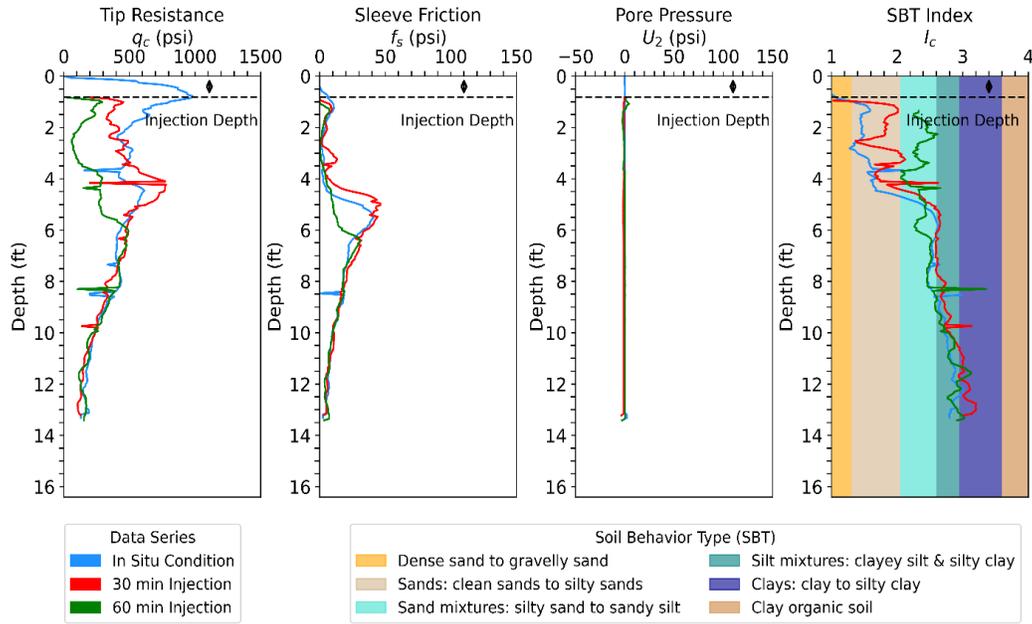
Figure 5.20 Norfolk Hwy-275 SBT

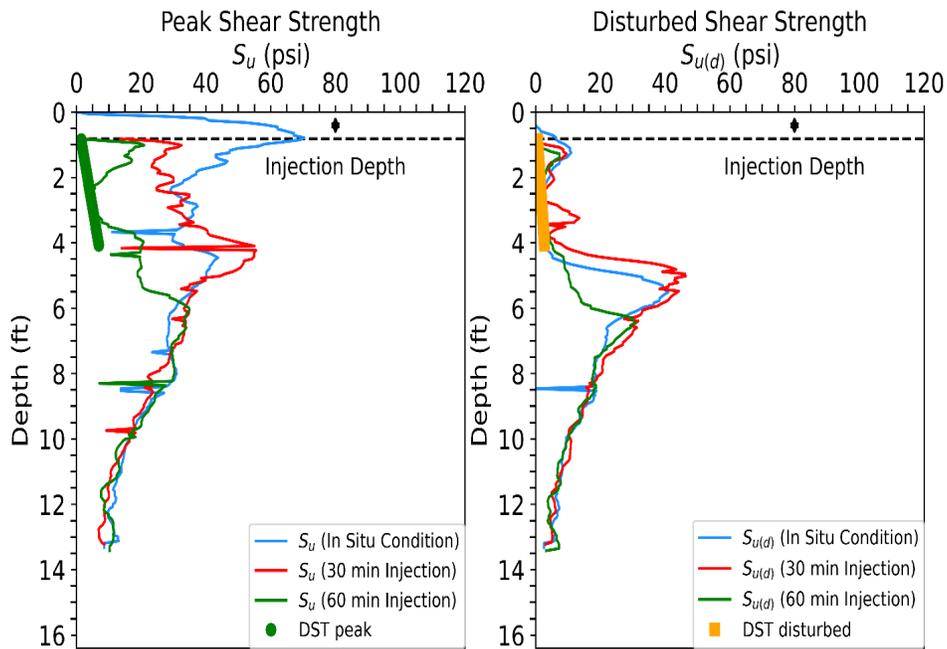
Figure 5.21 Norfolk Hwy-275 Peak and Disturbed Shear Strength from CPT and DST

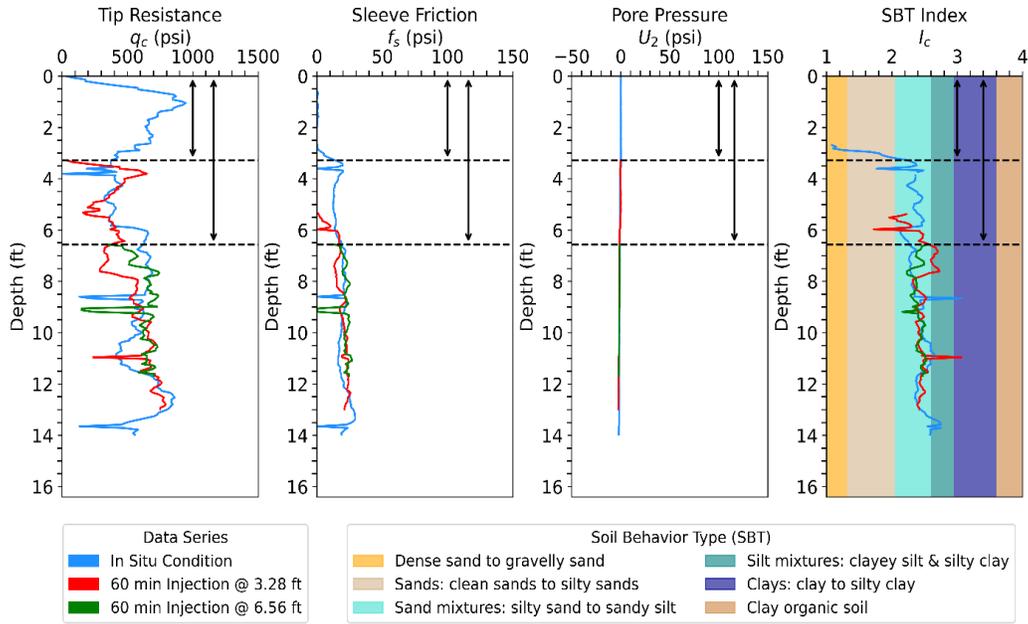
Figure 5.22 Santee Spur SBT

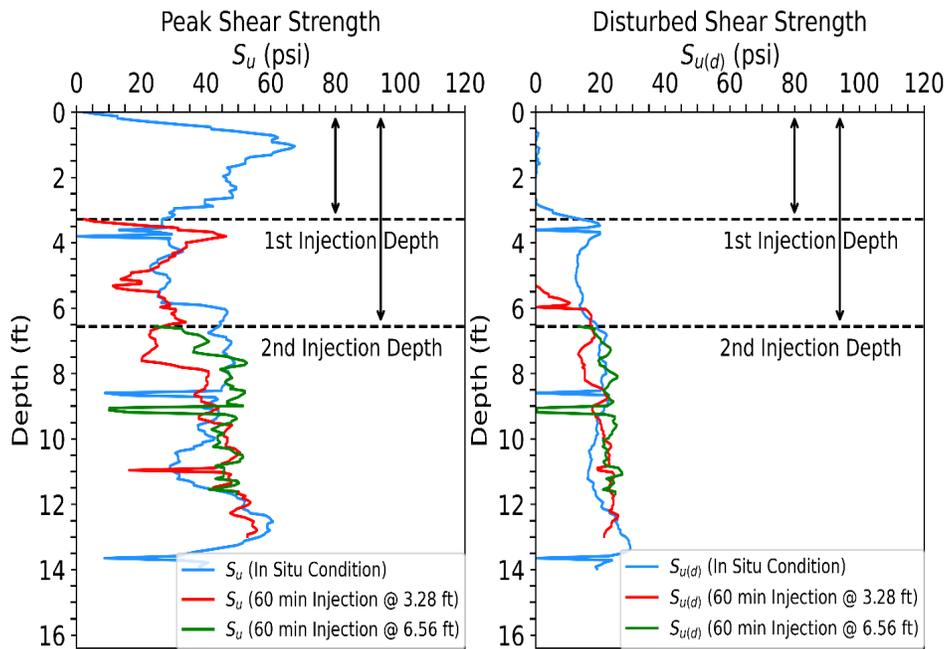
Figure 5.23 Santee Spur Peak and Disturbed Shear Strength from CPT

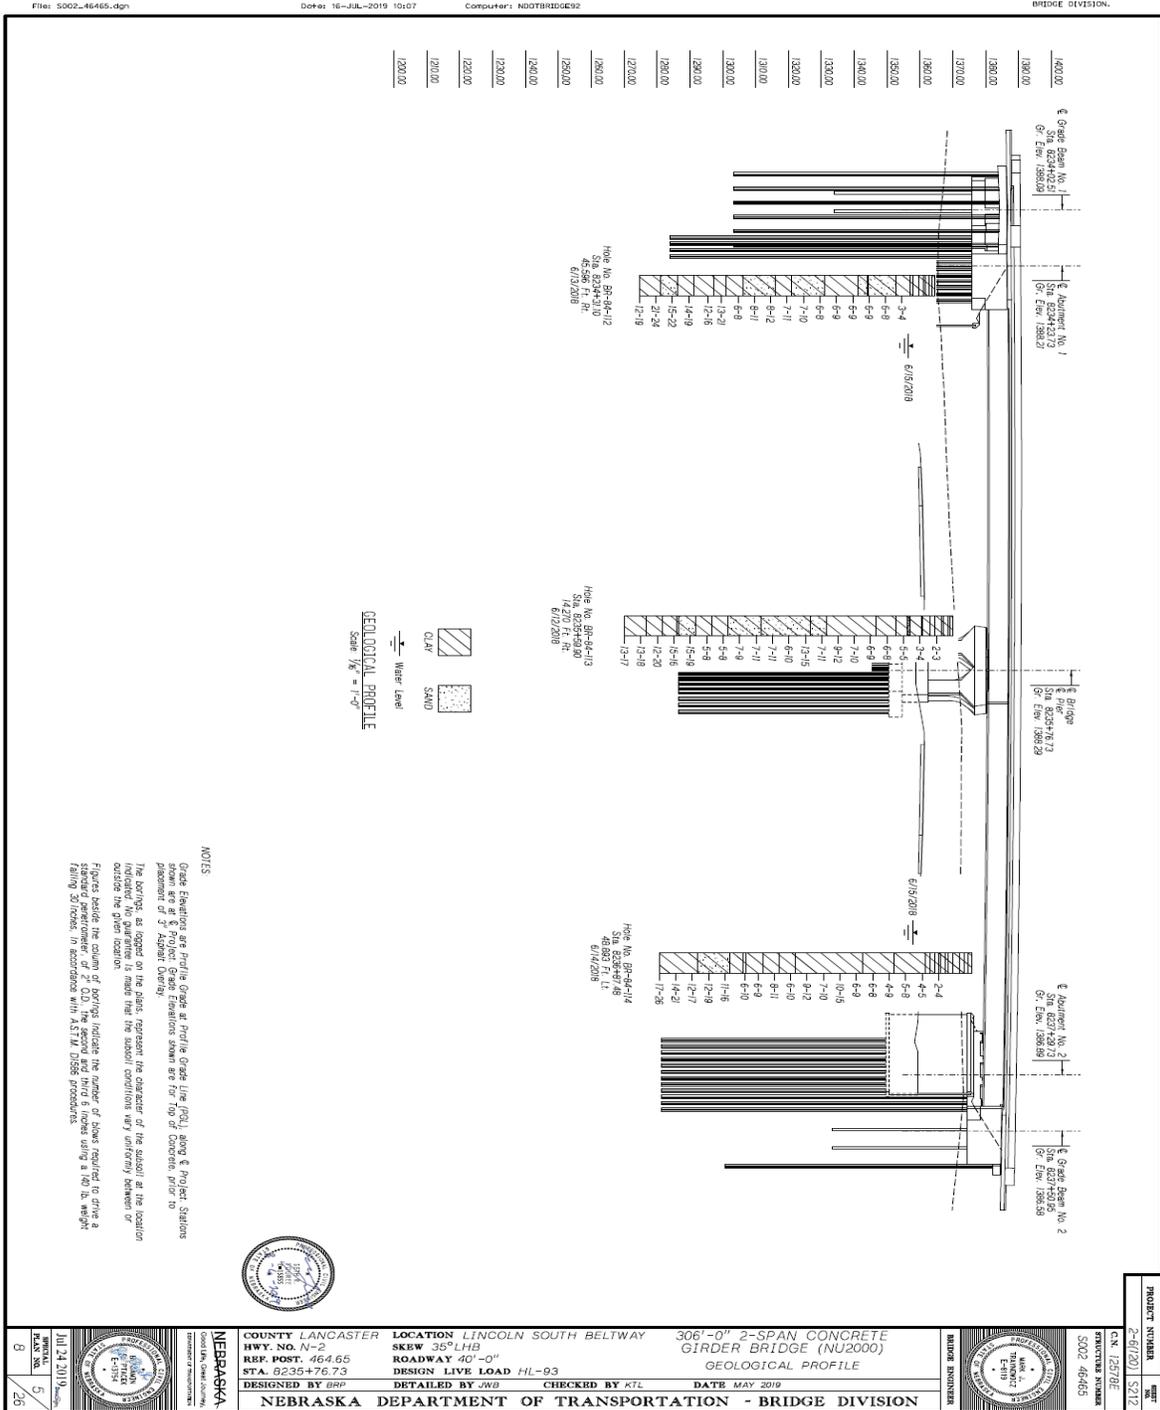
Figure A.1 Lincoln Hwy-2 Soil Profile

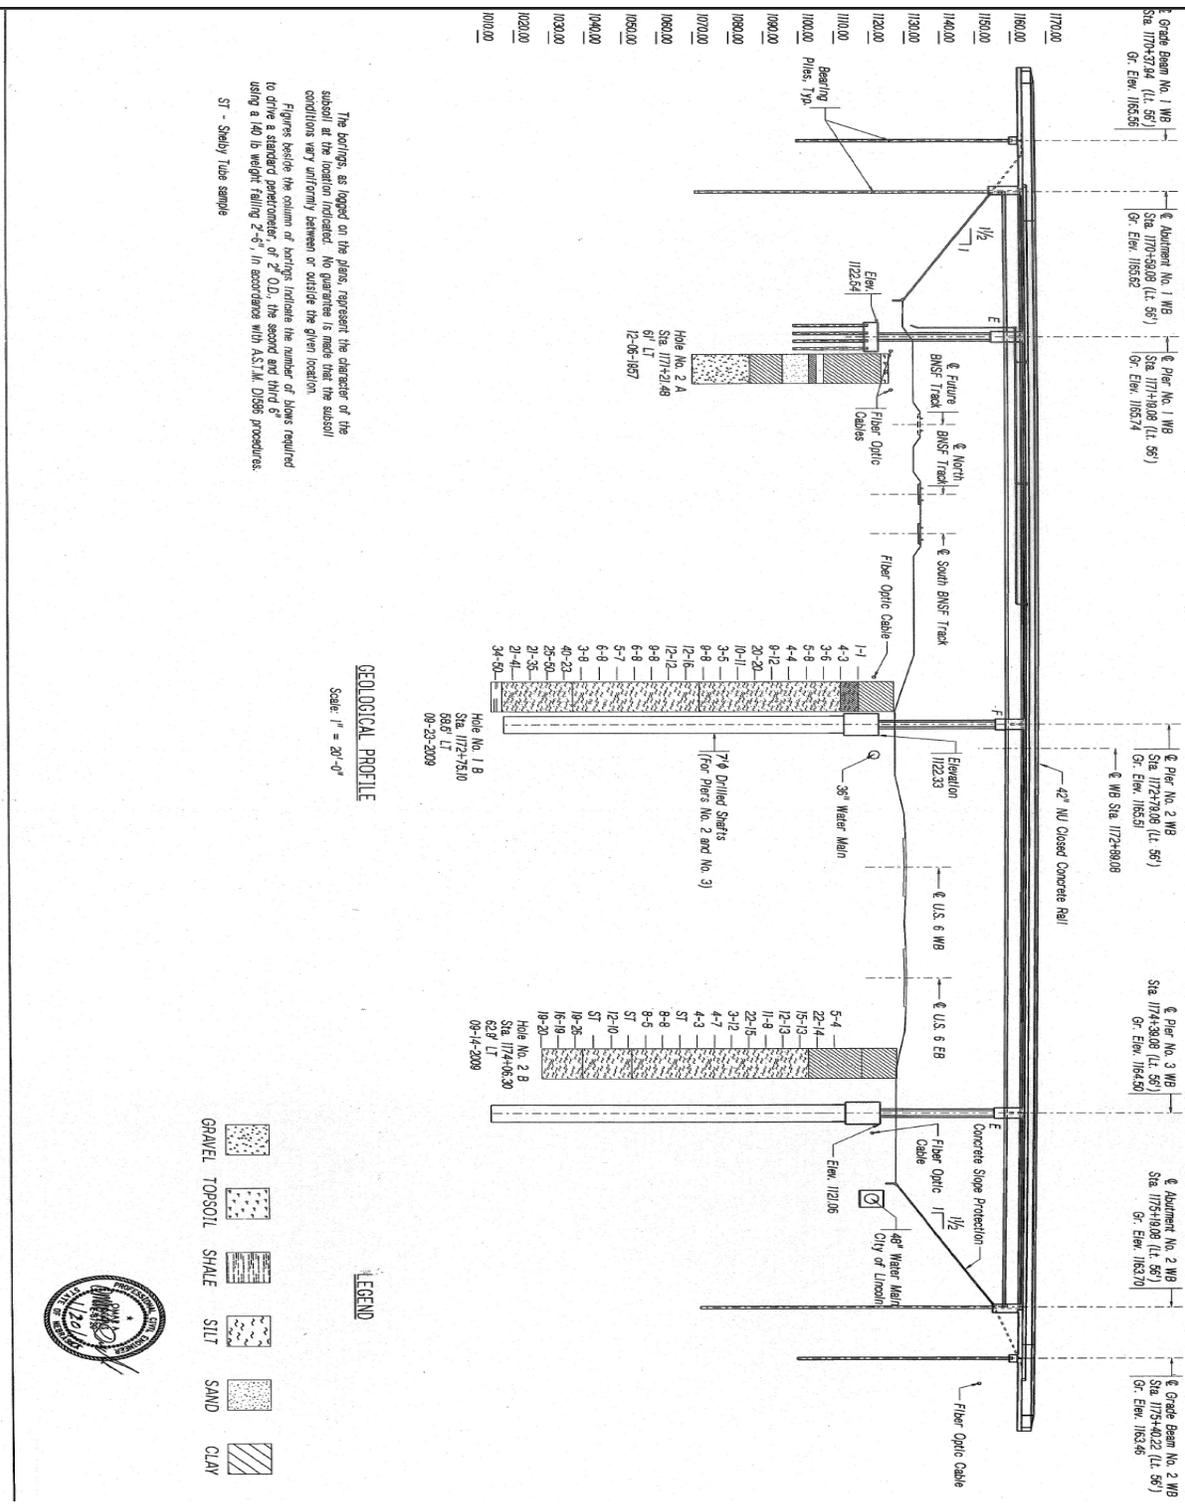
Figure A.2 Waverly Soil Profile

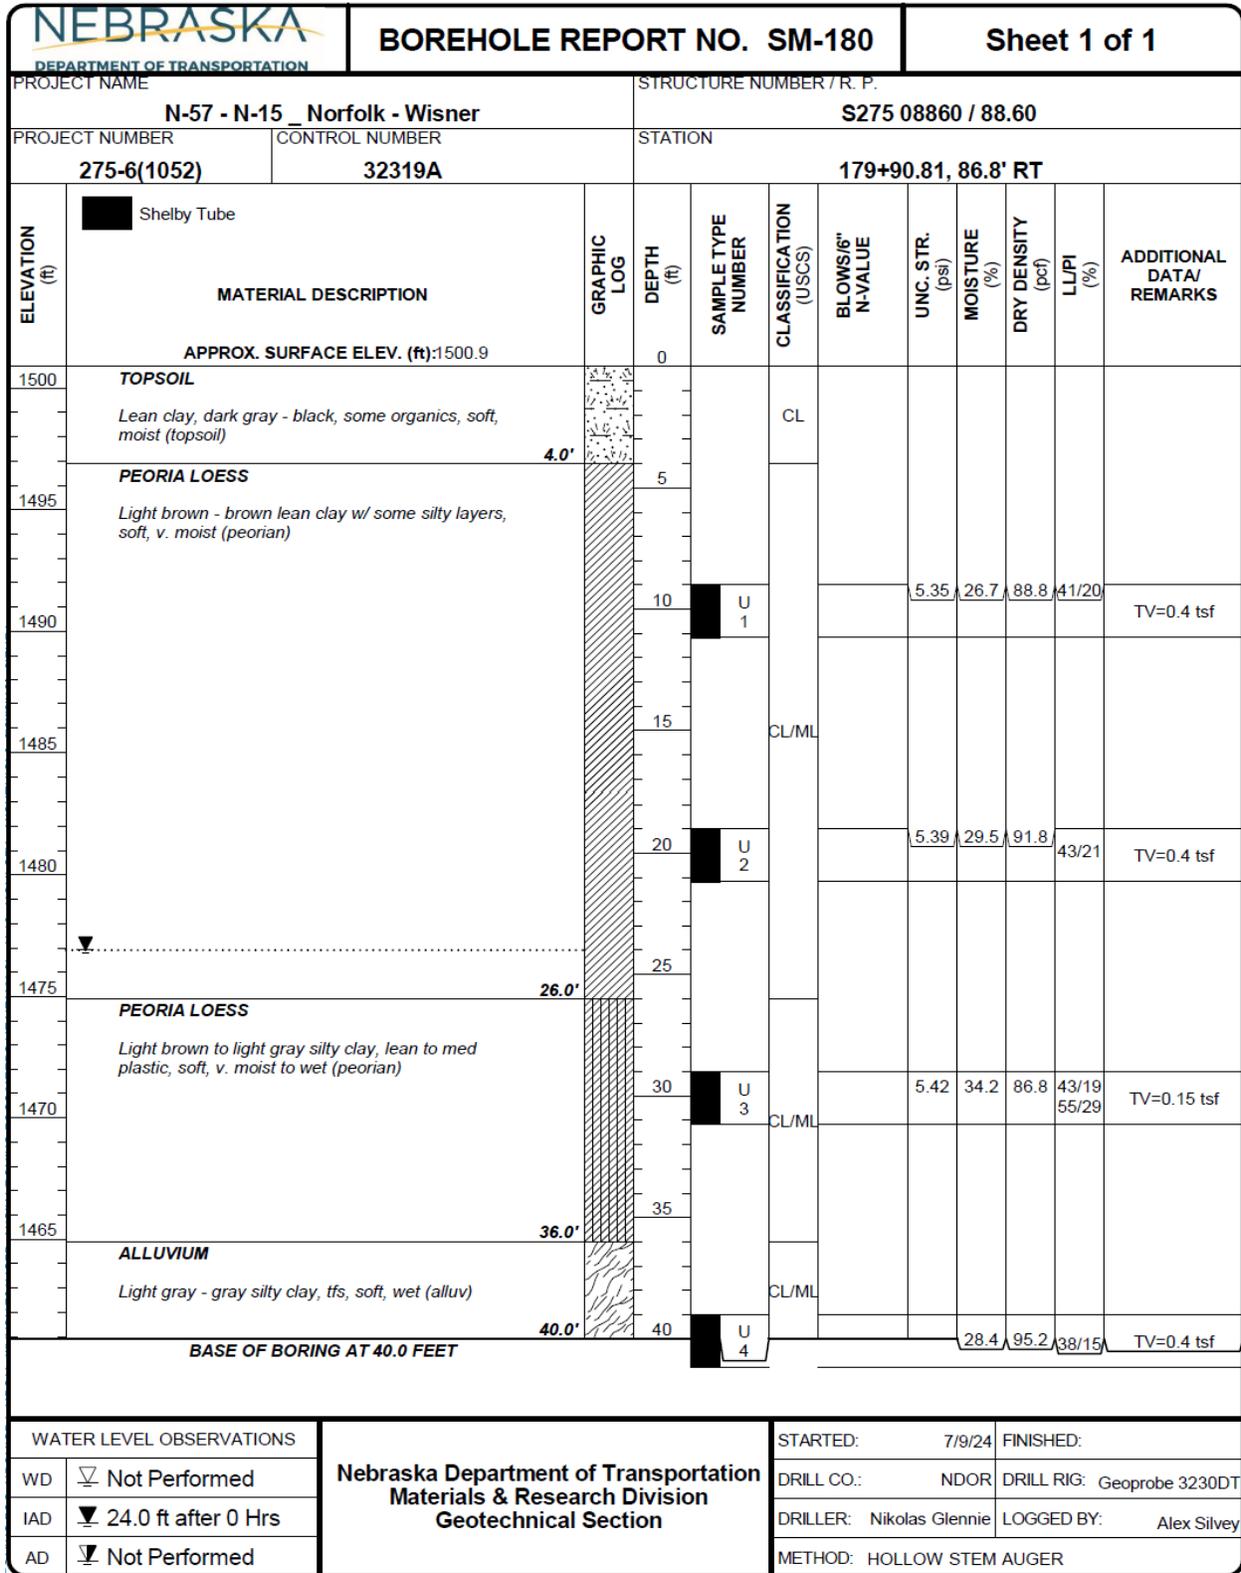
Figure A.4 Norfolk Hwy-275 Soil Profile

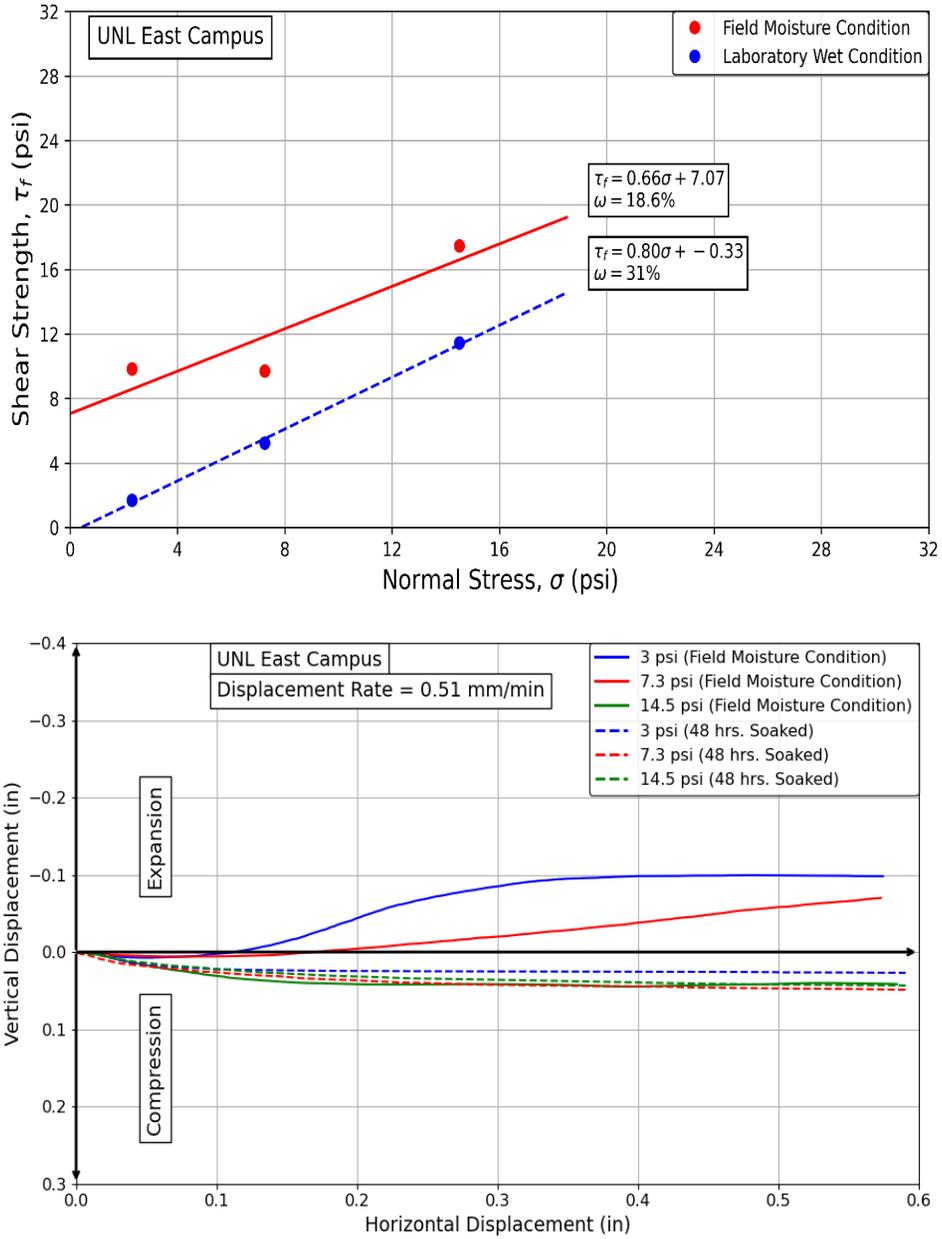
Figure B.1 UNL East Campus Shear Strength Parameters and Change in Height of Specimen against Shear Displacement

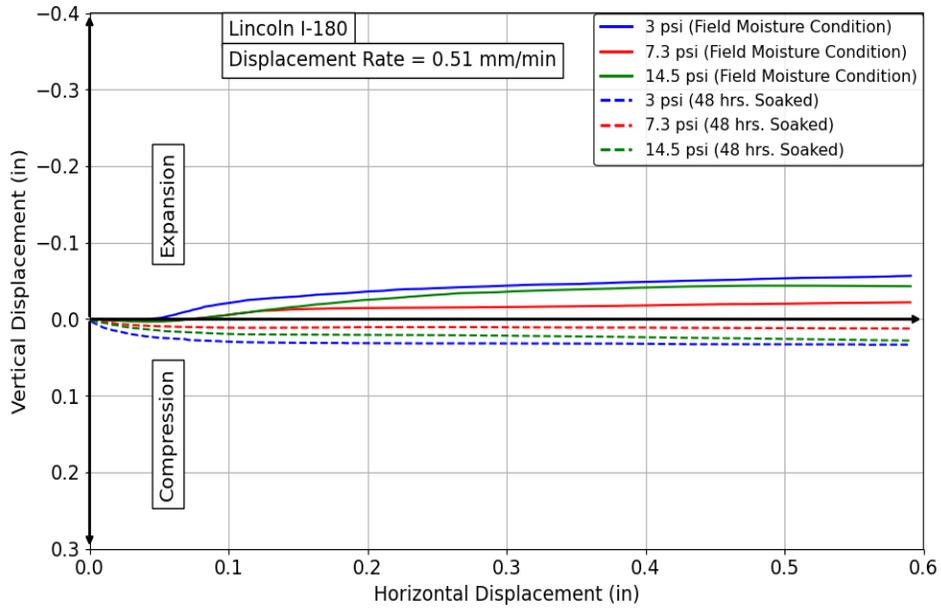
Figure B.2 Lincoln I-180 Shear Strength Parameters and Change in Height of Specimen against Shear Displacement

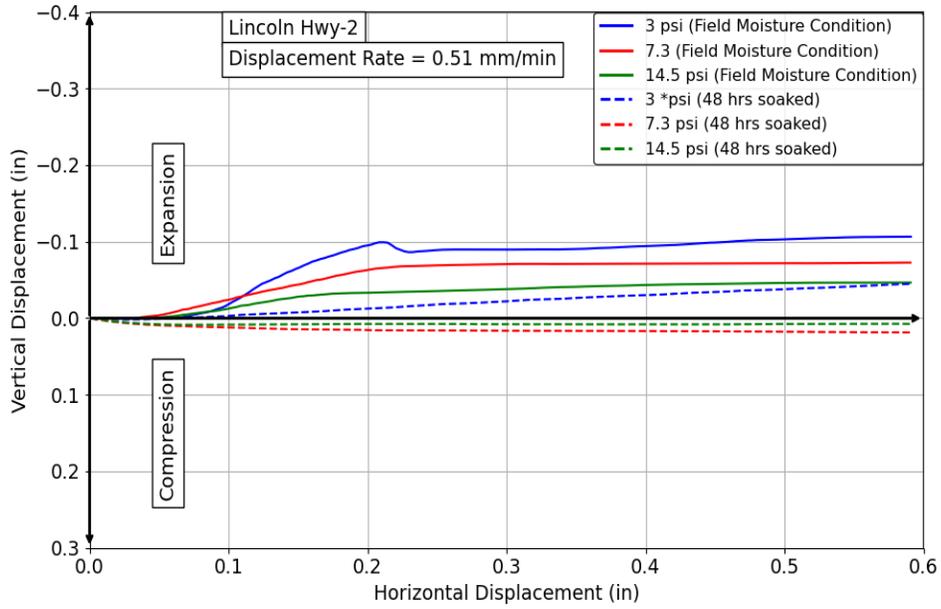
Figure B.3 Lincoln Hwy-2 Shear Strength Parameters and Change in Height of Specimen against Shear Displacement

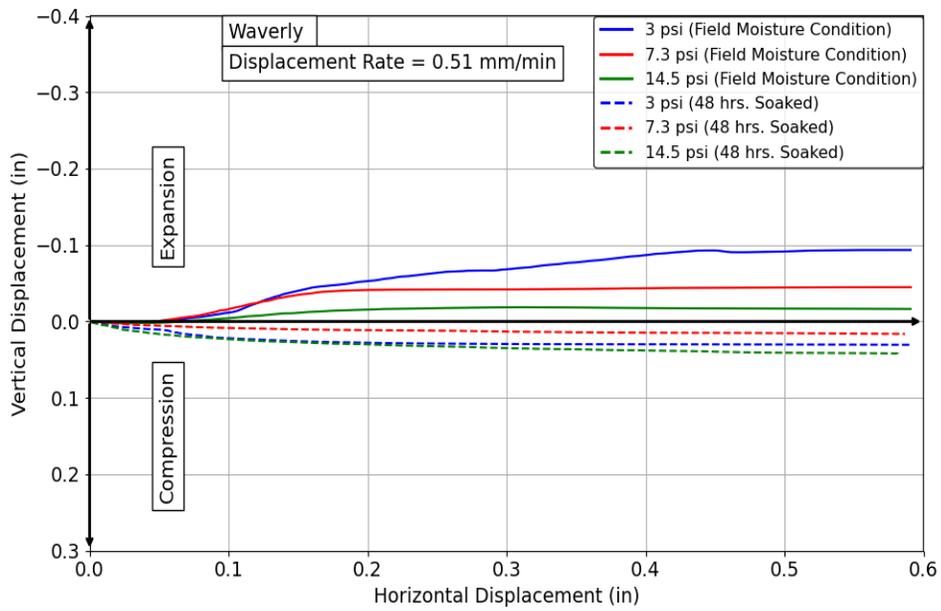
Figure B.8 Waverly Shear Strength Parameters and Change in Height of Specimen against Shear Displacement

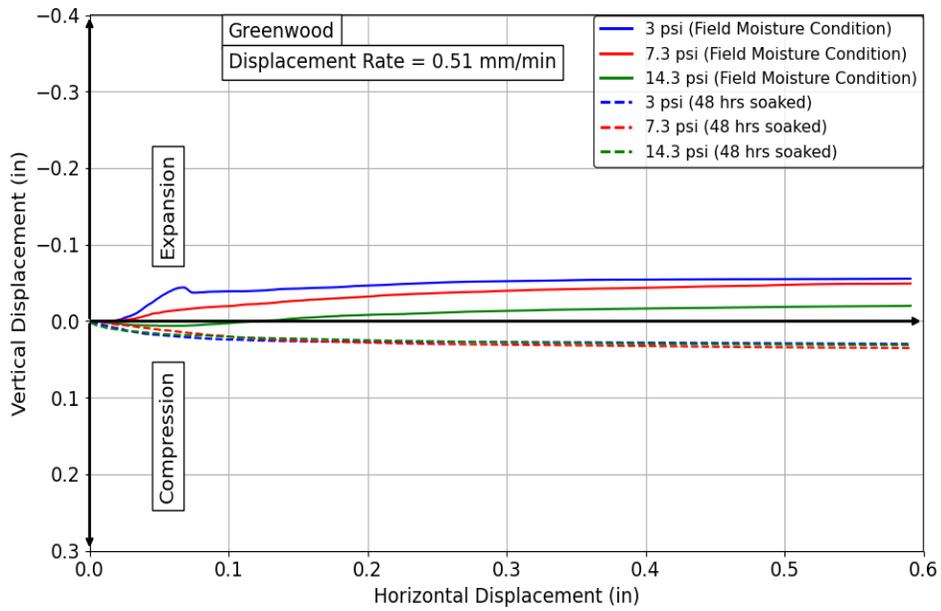
Figure B.9 Greenwood Shear Strength Parameters and Change in Height of Specimen against Shear Displacement
