DEVELOPMENT AND EVALUATION OF BEST MANAGEMENT PRACTICES (BMPS) FOR HIGHWAY RUNOFF POLLUTION CONTROL

Project Number: SPR-1(12)M314

Nebraska Department of Roads (NDOR)

FINAL REPORT

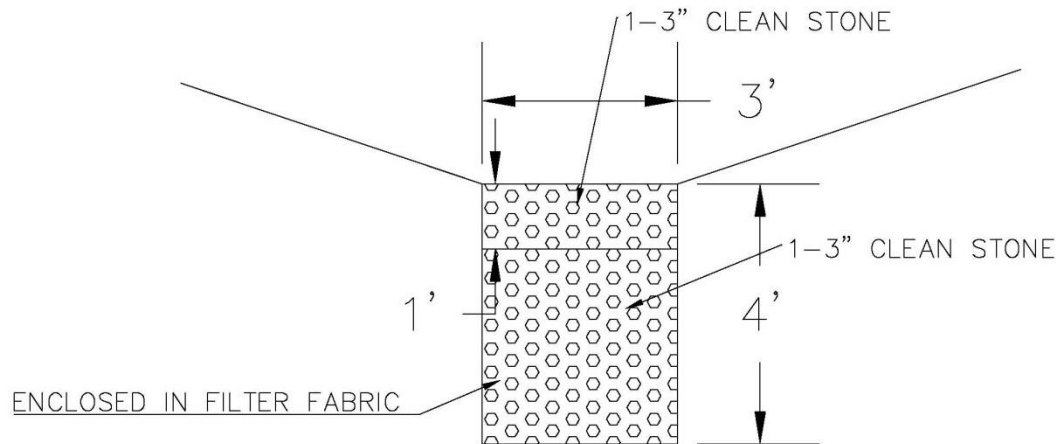
Figure 2.7 Infiltration trench cross section

The infiltration trench at the Salt Valley site is located in a drainage ditch with a 2.8 percent slope. The trench is 118 ft long, 3 ft wide and 4 ft deep. As shown in Figure 2.7, the trench was filled with 1-3 inch clean stone; the bottom and side walls were wrapped in Mirafi® 170N non-woven polypropylene geotextile filter fabric. The top of the filter fabric enclosure was placed 1ft below the surface to keep any sediment in the upper foot of media. The WQV for the infiltration trench was calculated by multiplying the volume of the trench by the void ratio of the media (typically 0.4). The WQV treated by the infiltration trench was 566 ft³, which was 9 percent of the WQV for the watershed. The peak 10-year flow was 25.9 cfs, obtained by the methods explained in section 2.2.1.

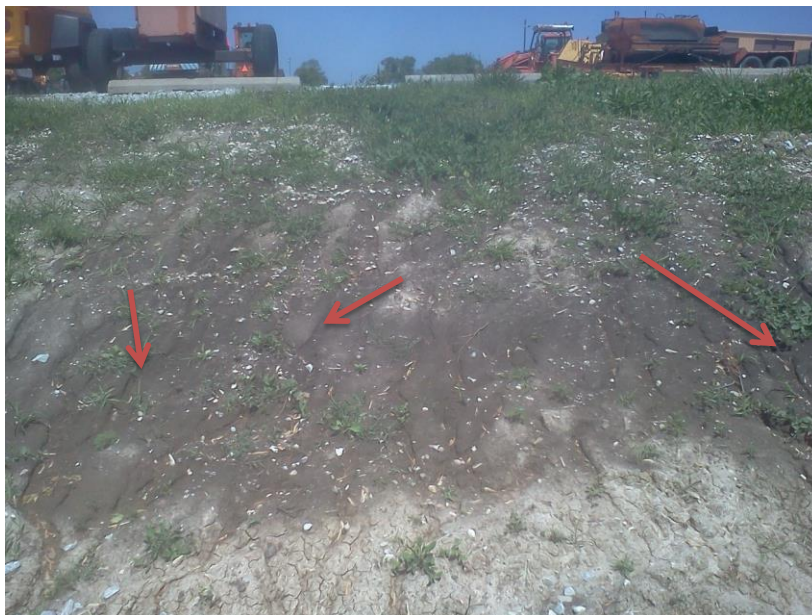
Figure 2.20 Filter trench side slope rills

fencing installed along the bottom of the slope. Because no baseline measurement was taken, accurate monitoring of these rills was not accomplished. In the future, monitoring of rills can be done by counting the number of rills and measuring their size and length to get a volume of soil eroded, which can also be linked with rain events if such measurements are done before and after the rain events.

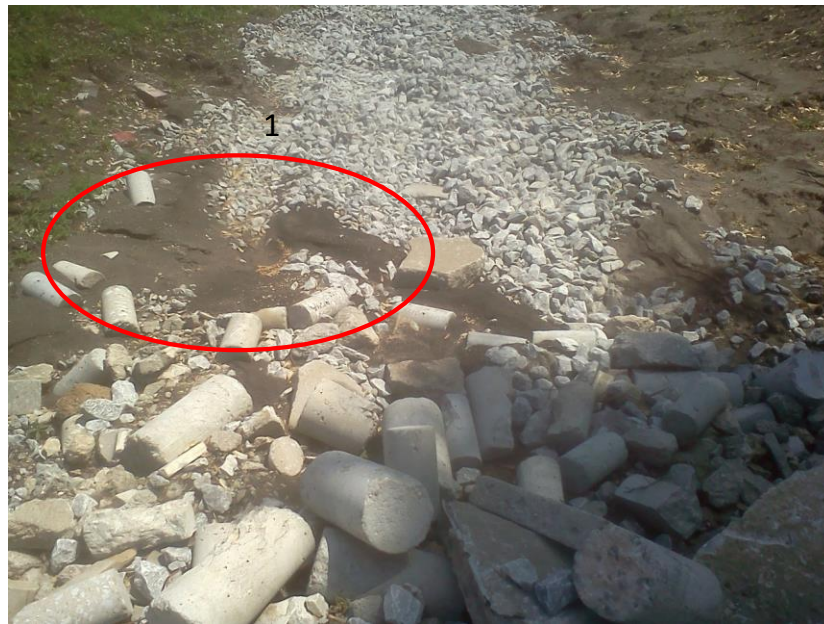
Figure 2.21 Filter trench sediment buildup on armorings and check dams

By the end of the observation period, weeds (cycle 2) and plants (cycle 1) were growing in the accumulated sediment (Figure 2.22). The amount of sediment buildup was enough to sustain root establishment in the trench. The clogging and plant growth can prevent water from being able to enter the trench. The best effort to prevent vegetative growth on the rock covering of the trench is to prevent organic matter or sediment buildup. It may be more feasible to build a BMP designed with a fast infiltrating top layer that support plant growth which would improve infiltration rates and stabilize the plant roots would BMP.

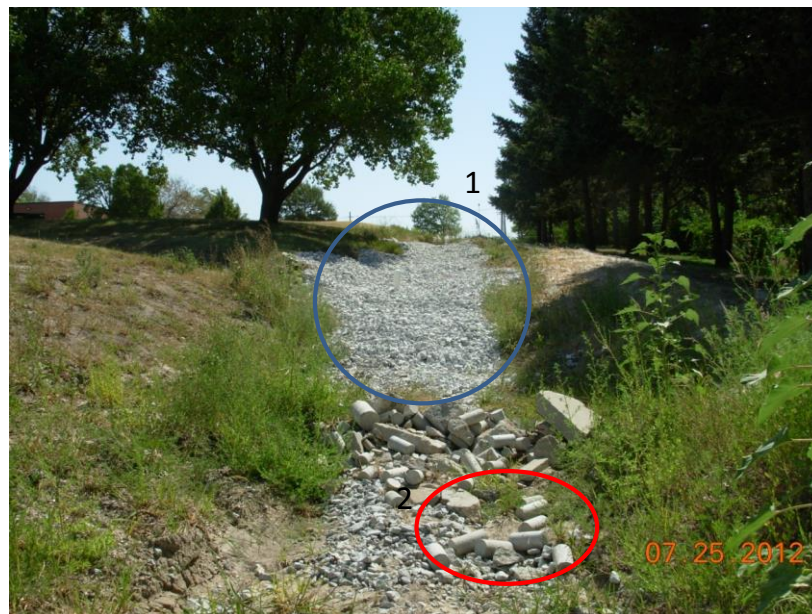
Figure 2.24 Filter trench added 1-3 inch rock at beginning and check dam material migration (water flow direction: from the top to bottom of the picture)

Flows in the ditch were high because evidence shows that some of the check dam material (used concrete core samples) was being washed or moved down slope (shown in the red circle in Figure 2.24). This is a good example that concrete debris (i.e. used core samples and broken concrete) is not as useful as rip rap because the shape of the concrete debris is not irregular or interlocking like rock brought in from a quarry. The force of water can move this concrete debris more easily.

Some problems arose related to the structural integrating of the filter trenches setup. Undermining occurred at the beginning of the trench, creating a hole as shown in Figure 2.23. This problem was mitigated by adding more rock material up to the top of the ditch as shown in the blue circle where the hole was located at the bottom of the blue

circle Figure 2.24. The knowledge gained from this situation is that the armoring needs to extend above the beginning of the trench or the trench needs to start at the pipe outlet to the ditch. Undermining also occurred at a couple spots along the trench as shown in Figure 2.25. This is thought to be from higher than expected flow velocities within the pea gravel filter media eroding the sides of the underground trench. This could be fixed by filling the hole with 1-3 inch rock or in the design of the trench by using smaller treatment media to slow the filter flow rate.

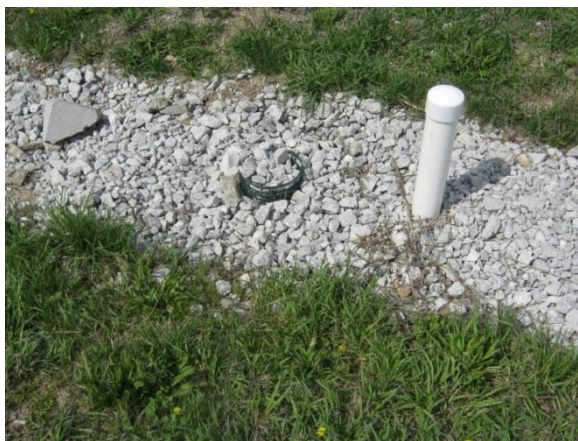
Figure 3.8 Upstream infiltration trench basket rock and observation well

the basket was 0.002905 m^3 , resulting in a bulk porosity of $0.285 \text{ m}^3/\text{m}^3$. The baskets were deployed on 4/20/13 and were collected on 6/20/13, and then deployed again on 4/21/13 and collected on 8/9/13. The collection and extraction process involved taking the baskets back to the lab where the rocks were washed with 2 liters of de-ionized water and rubbed with a brush. The 2 liters of washing water was then evaporated at 105° C in an oven and the mass of the residue was determined.

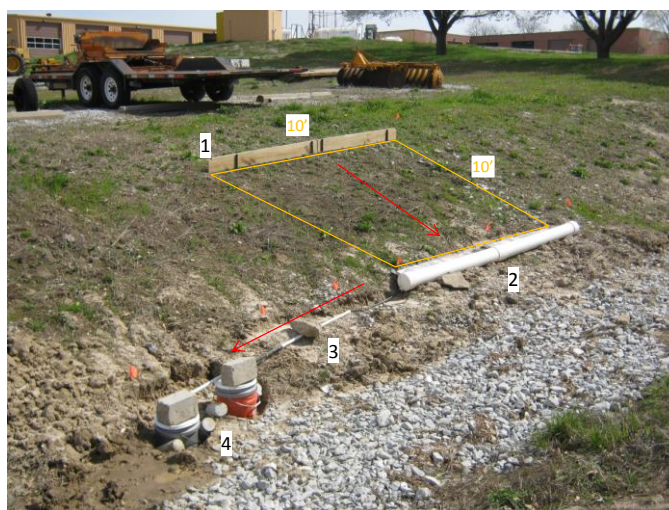
Figure 3.10 Filter trench side slope TSS collector setup

Side Slope Collector. To achieve a better understanding of the amount and sources of sediments or Total Suspended Solids (TSS) that were entering the filter trench,

a device was designed as per Ming-Han et al. (2010) and built to monitor the TSS loading from the side slope of the filter trench (Figure 3.10). A 10 ft by 10 ft area of the side slope was sectioned by a board (1) on the uphill slope, and a 6-inch PVC pipe (2) with a collection slot cut into it on the downhill slope. Once water and sediment collected in the 6 inch pipe (2) it traveled through 1- inch tubing (3) to two covered five gallon buckets (4) for collection. The buckets were collected after each or multiple storm events and taken back to the lab for TSS testing per EPA method 2540 D. Figure 3.11 shows the rain events and dates for sampling side slope TSS.
