DEVELOPMENT AND TESTING OF A BRIDGE RAIL FOR LOW-VOLUME ROADS

MIDWEST ROADSIDE SAFETY FACILITY

NEBRASKA DEPARTMENT OF TRANSPORTATION

MwRSF Research Report No. TRP-03-407-20

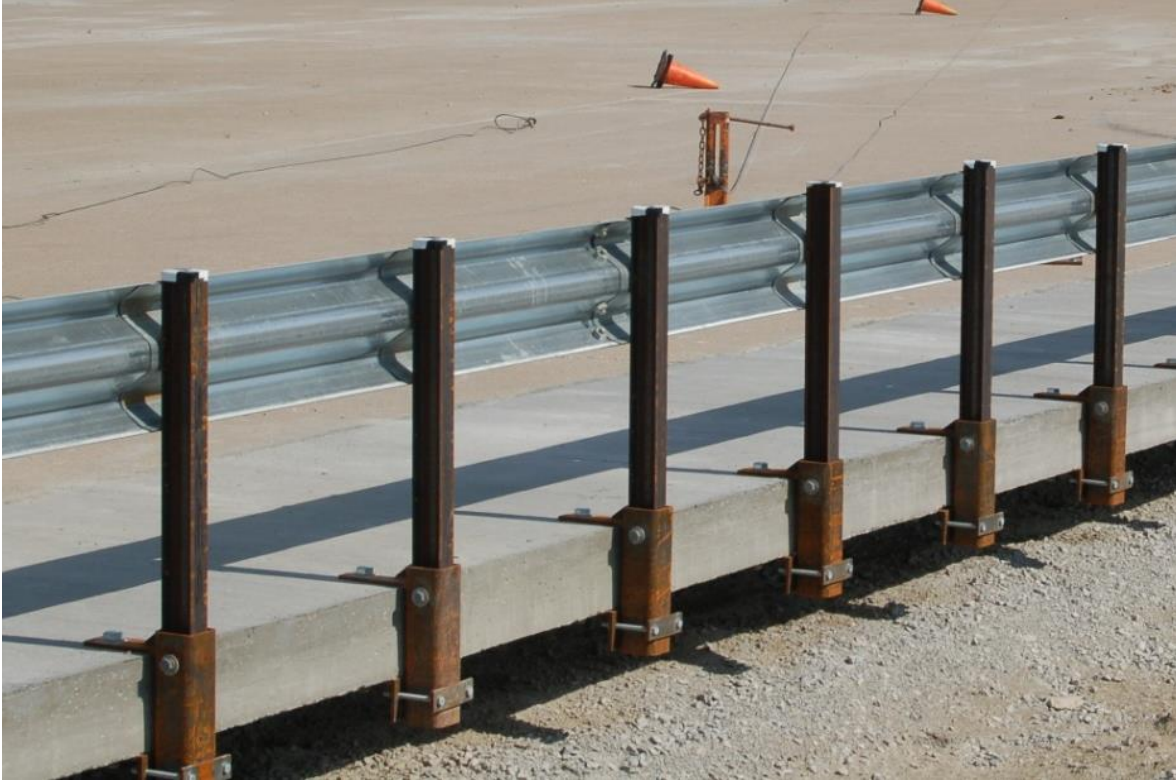
Figure 1. MGS Bridge Rail Test Installation [3]

Two W-beam bridge rails have previously been designed for use on low volume roads that satisfy MASH TL-2 and TL-3 safety standards. Both systems utilized a 31-in. tall W-beam rail supported by S3x5.7 weak posts, thereby limiting both the loads transferred to the bridge deck and the associated risk for deck damage. The first system, the Midwest Guardrail System (MGS) Bridge Rail, was a MASH TL-3 side-mounted system that was supported by steel sockets placed adjacent to the side of the deck [3], as shown in Figure 1. The system utilized a 37.5-in. post spacing, and the sockets were attached to the bridge deck with a 1-in. diameter bolt that went through the thickness of the deck. A steel angle was mounted below the deck to provide additional length for the force couple which resisted post bending. The system was full-scale crash tested according to MASH test designation nos. 3-10 and 3-11 with a small car and pickup truck, respectively.

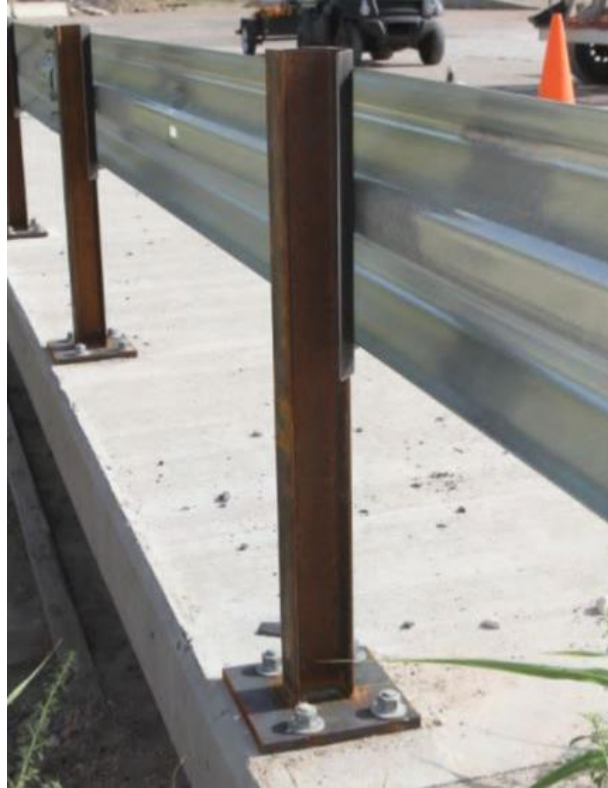
Figure 2. TxDOT T631 Test Installation [4-5]

Texas Department of Transportation's (TxDOT) T631 bridge rail was mounted to the top of the bridge deck with a $\frac{5}{8}$ -in. thick base plate bolted to the top of the bridge deck with four $\frac{5}{8}$ -in. diameter bolts [4-5], as shown in Figure 2. The posts were welded to the base plates with continuous $\frac{1}{4}$ -in. thick fillet welds. The system satisfied MASH TL-2 criteria and was successfully tested under MASH test designation nos. 2-10 and 2-11 with a 75-in. post spacing. A modified version of the system with a 37.5-in. post spacing was also crash tested and satisfied MASH TL-3 criteria. MASH test designation no. 3-11 was conducted on the system with a 75-in. post spacing, but the test resulted in failure due to rail tearing. Thus, the 75-in. post spacing is only crashworthy at MASH TL-2.

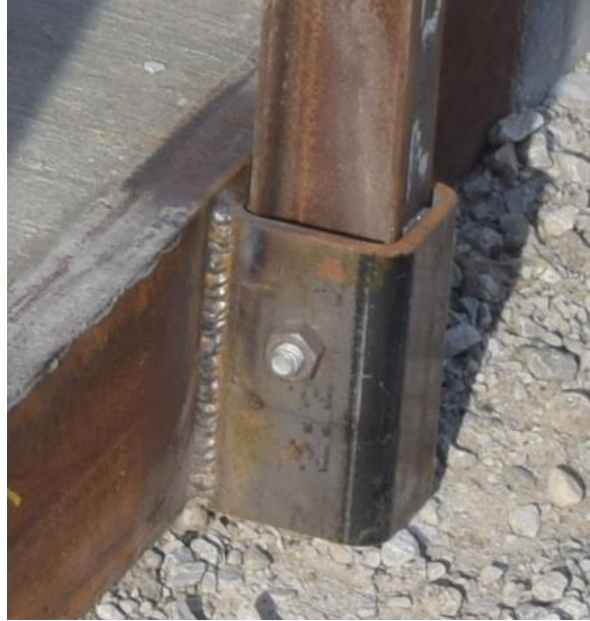
Figure 8. Socket Welded Directly to a 7-in. CIP Deck

A welded attachment of the tube socket to the side channel of the deck was an option explored for use in the new bridge railing design. Directly welding the socket to the channel, as shown in Figure 8, minimized the number of components in the socket assembly by eliminating the need for an attachment plate. Also, many of the installers that work on rural bridges have experience with welding posts to deck edges. Thus, a welded attachment would provide a simple and cost-efficient mechanism for attaching the sockets to the bridge deck.

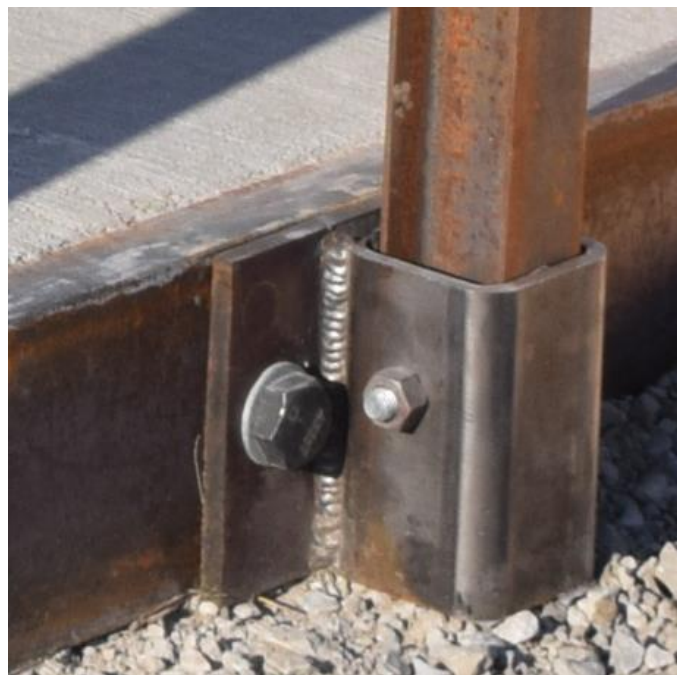
Figure 11. Coupling Nut and Threaded Rod Attachment of Socket Assembly to Deck

During an impact, this new post-to-deck attachment design directly transfers the tensile loads from the attachment bolts through the coupling nuts and into the threaded rod anchors. The impact loads are never transferred to the channels (except for compression as part of the force couple resisting the moment created from post bending), so there would be minimal risk of damage to the side channels or the deck. Finally, the coupling nuts, threaded rods, and bolts would all be standard hardware, so only the socket assembly would need to be fabricated as part of the socket-to-deck attachment.

A bolted socket-to-deck attachment was desired to address many of the concerns raised with a welded attachment. Bolted attachments can use all galvanized components, thereby minimizing the risk of rusting. To create a bolted socket-to-deck attachment, the socket had to first be welded to a mounting plate. However, this socket assembly could be welded in the shop and galvanized prior to installation. Bolted attachments can also be assembled quickly on site and do not require the skilled/certified labor or extra equipment associated with welding. Finally, damaged components are much easier to replace in a bolted attachment in comparison to welded joints.

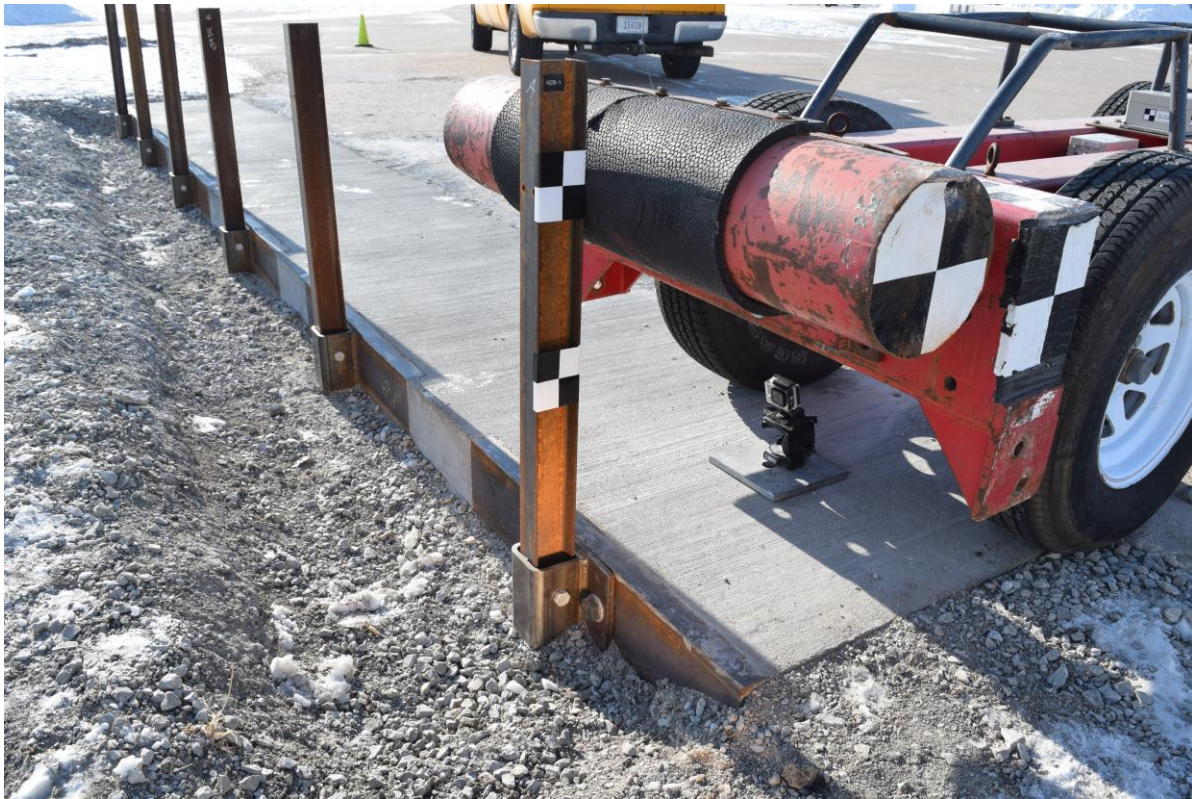
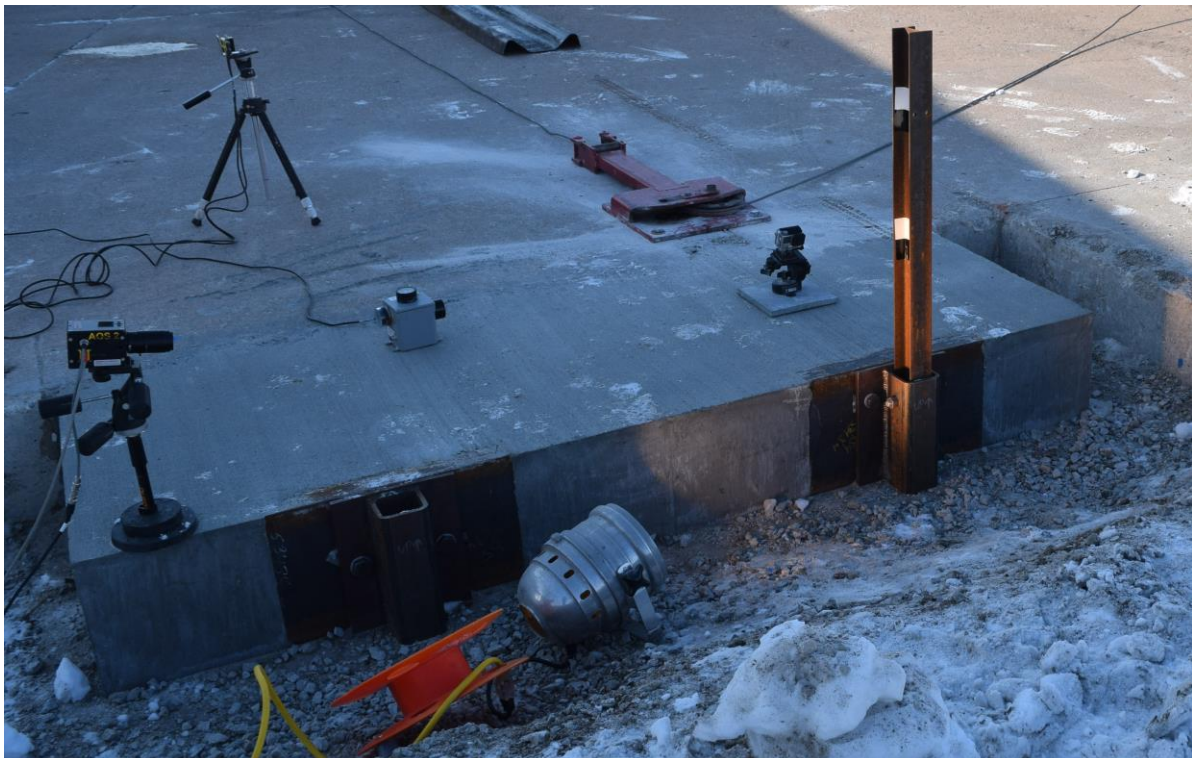
Figure 36. Installation Photographs for the (a) 7-in. CIP Deck and (b) 12-in. Precast Beam-Slab

(a)

(b)

The simulated concrete decks were designed to replicate typical CIP and pre-stressed concrete beam-slabs used on rural Nebraska roadways. Note, the simulated concrete beam-slab was not pre-stressed and only utilized standard rebar reinforcement. This change saved on installation costs without affecting the results of the component tests. Both concrete decks had a targeted minimum compressive strength of 6,000 psi. The actual concrete compressive strength was 5,660 psi. Design details for the test installations are shown in Figures 12 through 35, and installation photographs are shown in Figure 36. Material specifications, mill certifications, and certificates of conformity for the simulated decks, posts, and attachment hardware used for the component tests are shown in Appendix A.

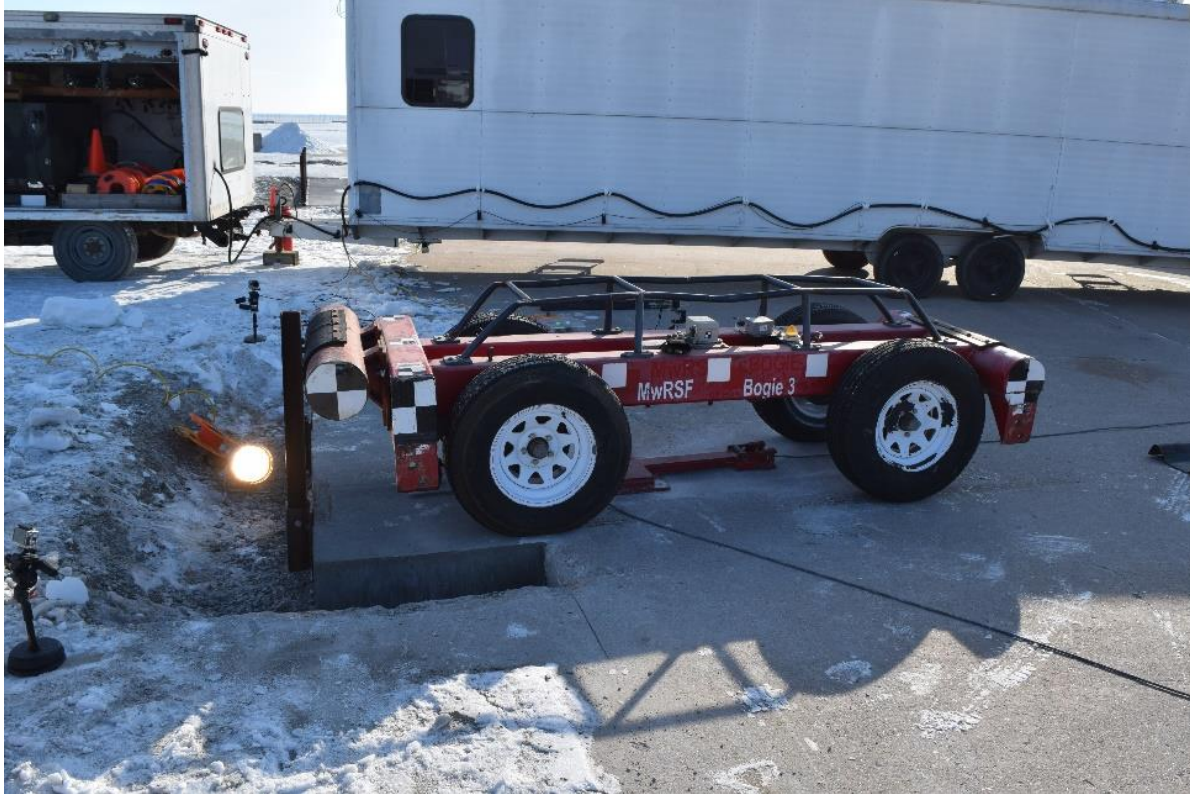
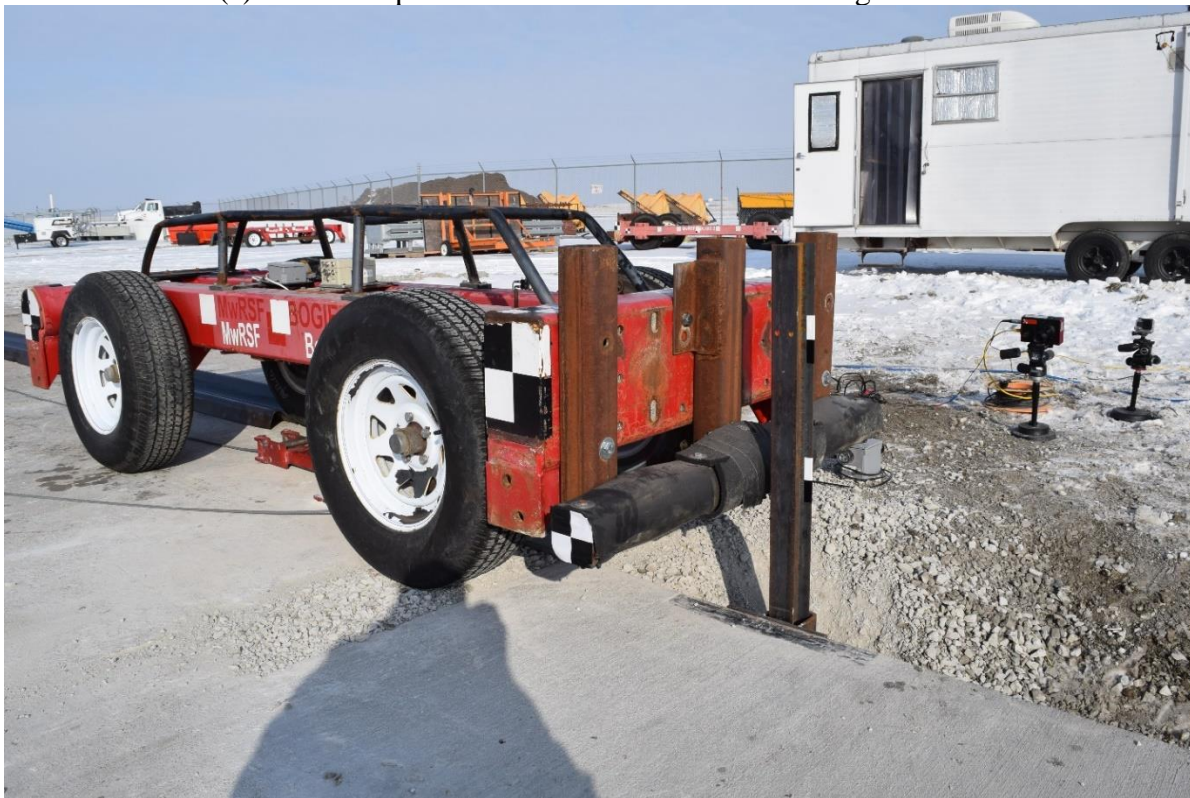
Figure 37. Bogie Vehicle with (a) Lateral Impact Head and (b) Longitudinal Impact Head

A rigid-frame bogie was used to impact the post and socket assemblies. Two different impact heads were used in the testing. For lateral impacts, the bogie head was constructed of 8-in. diameter, ½-in. thick standard steel pipe, with ¾-in. neoprene belting wrapped around the pipe. The lateral impact head was bolted to the bogie vehicle at a height of 25 in. for test nos. N2B-1 through N2B-4. The combined weight of the bogie used in test nos. N2B-1 through N2B-4, with the addition of the mountable impact head and accelerometers, was 1,786 lb. For longitudinal impacts, the bogie head consisted of a 2½-in. x 2½-in. x 5/16-in. square tube mounted on the outside flange of a W6x25 steel beam with reinforcing gussets. The longitudinal impact head was bolted to the bogie vehicle at a height of 12 in. for test nos. N2B-5 and N2B-6. The combined weight of the bogie used in test nos. N2B-5 and N2B-6, with the addition of the mountable impact head and accelerometers, was 1,690 lb. Photographs of the bogie with both impact heads are shown in Figure 37.

(a) Lateral Impact Head - Test Nos. N2B-1 Through N2B-4

(b) Longitudinal Impact Head - Test Nos. N2B-5 and N2B-6

The tests were conducted using a steel corrugated beam guardrail to guide the bogie vehicle. A pickup truck was used to push the bogie vehicle to the required impact velocity. After reaching the target velocity, the push vehicle braked, allowing the bogie to be free rolling as it came off the track. A remote braking system was installed on the bogie allowing it to be brought safely to rest after the test.

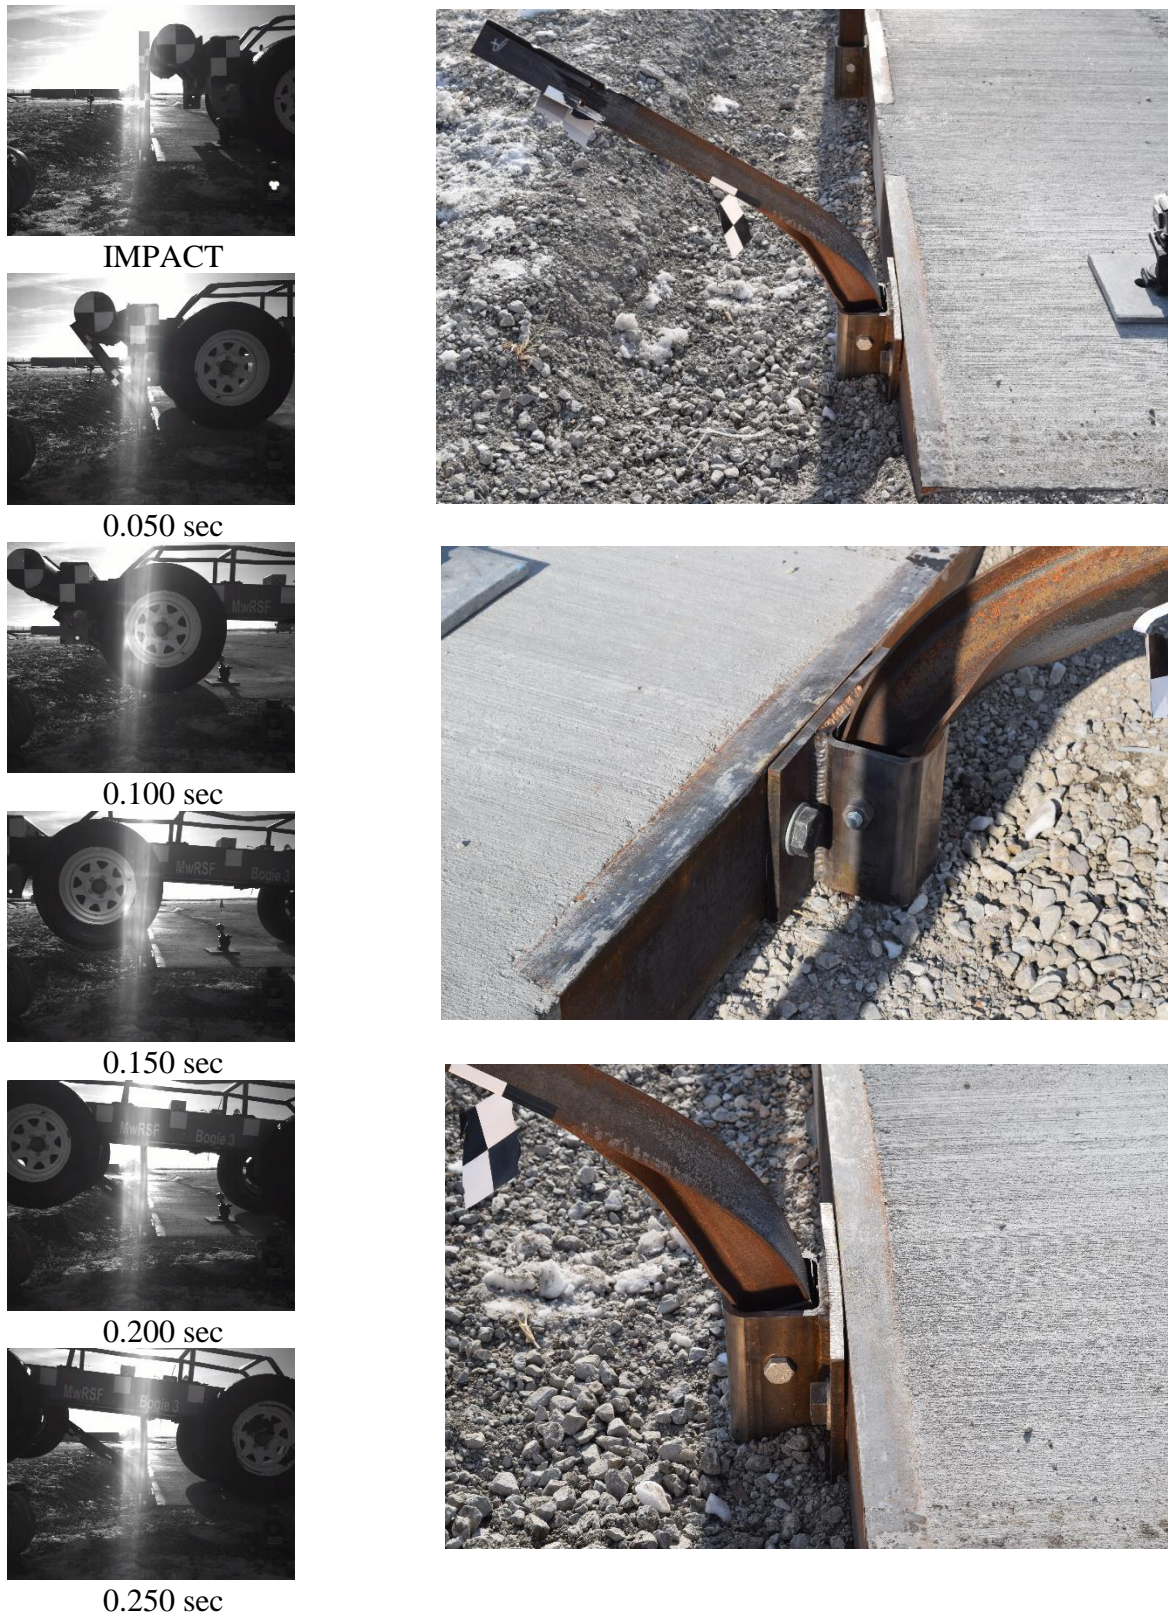
Figure 38. Time-Sequential and Post-Impact Photographs, Test No. N2B-1

The test article for test no. N2B-1 used Deck Location A and Channel Assembly A. The test article consisted of a bolted socket attachment utilizing 1-in. diameter bolts and a 7-in. thick simulated CIP bridge deck. See Section 3.2 for further details. Test no. N2B-1 was conducted with the bogie impacting the S3x5.7 post at a height of 25 in. and an angle of 90 degrees (through the strong axis of the post) at a speed of 21.2 mph. The impact caused the post to deflect backward as a plastic hinge formed in the post near the top of the socket and the post twisted. The bogie ultimately overrode the post at a displacement of 30.2 in. No damage occurred to the bridge deck, socket assembly, or attachment hardware. Time sequential photographs and post-test photographs are shown in Figure 38.

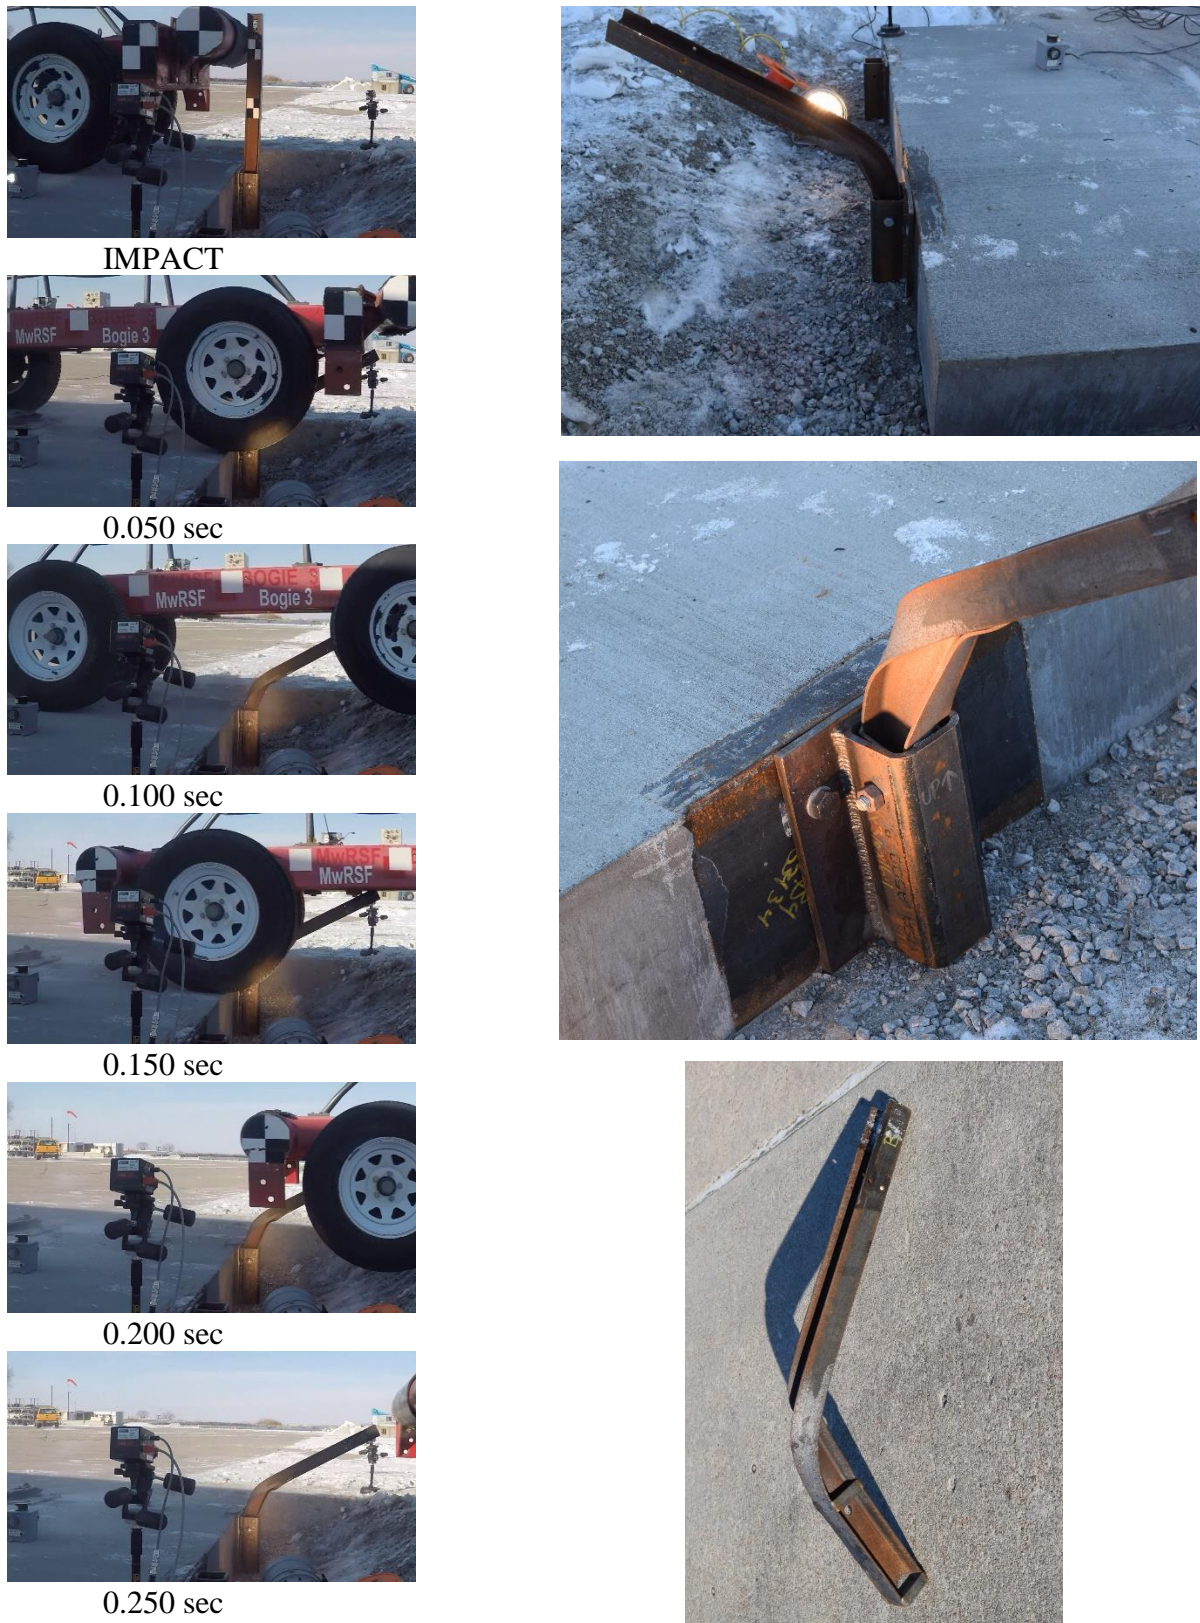
Figure 40. Time-Sequential and Post-Impact Photographs, Test No. N2B-2

The test article for test no. N2B-2 used Deck Location G and Channel Assembly F. The test article consisted of a bolted socket attachment utilizing $\frac{3}{4}$ -in. diameter bolts and a 12-in. thick simulated precast beam-slam bridge deck. See Section 3.2 for further details. Test no. N2B-2 was conducted with the bogie impacting the S3x5.7 post at a height of 25 in. and an angle of 90 degrees (through the strong axis of the post) at a speed of 21.4 mph. The impact caused the post to deflect backward as a plastic hinge formed in the post near the top of the socket and the post twisted. The bogie ultimately overrode the post at a displacement of 29.6 in. No damage occurred to the deck, socket assembly, or attachment hardware. Time sequential photographs and post-test photographs are shown in Figure 40.

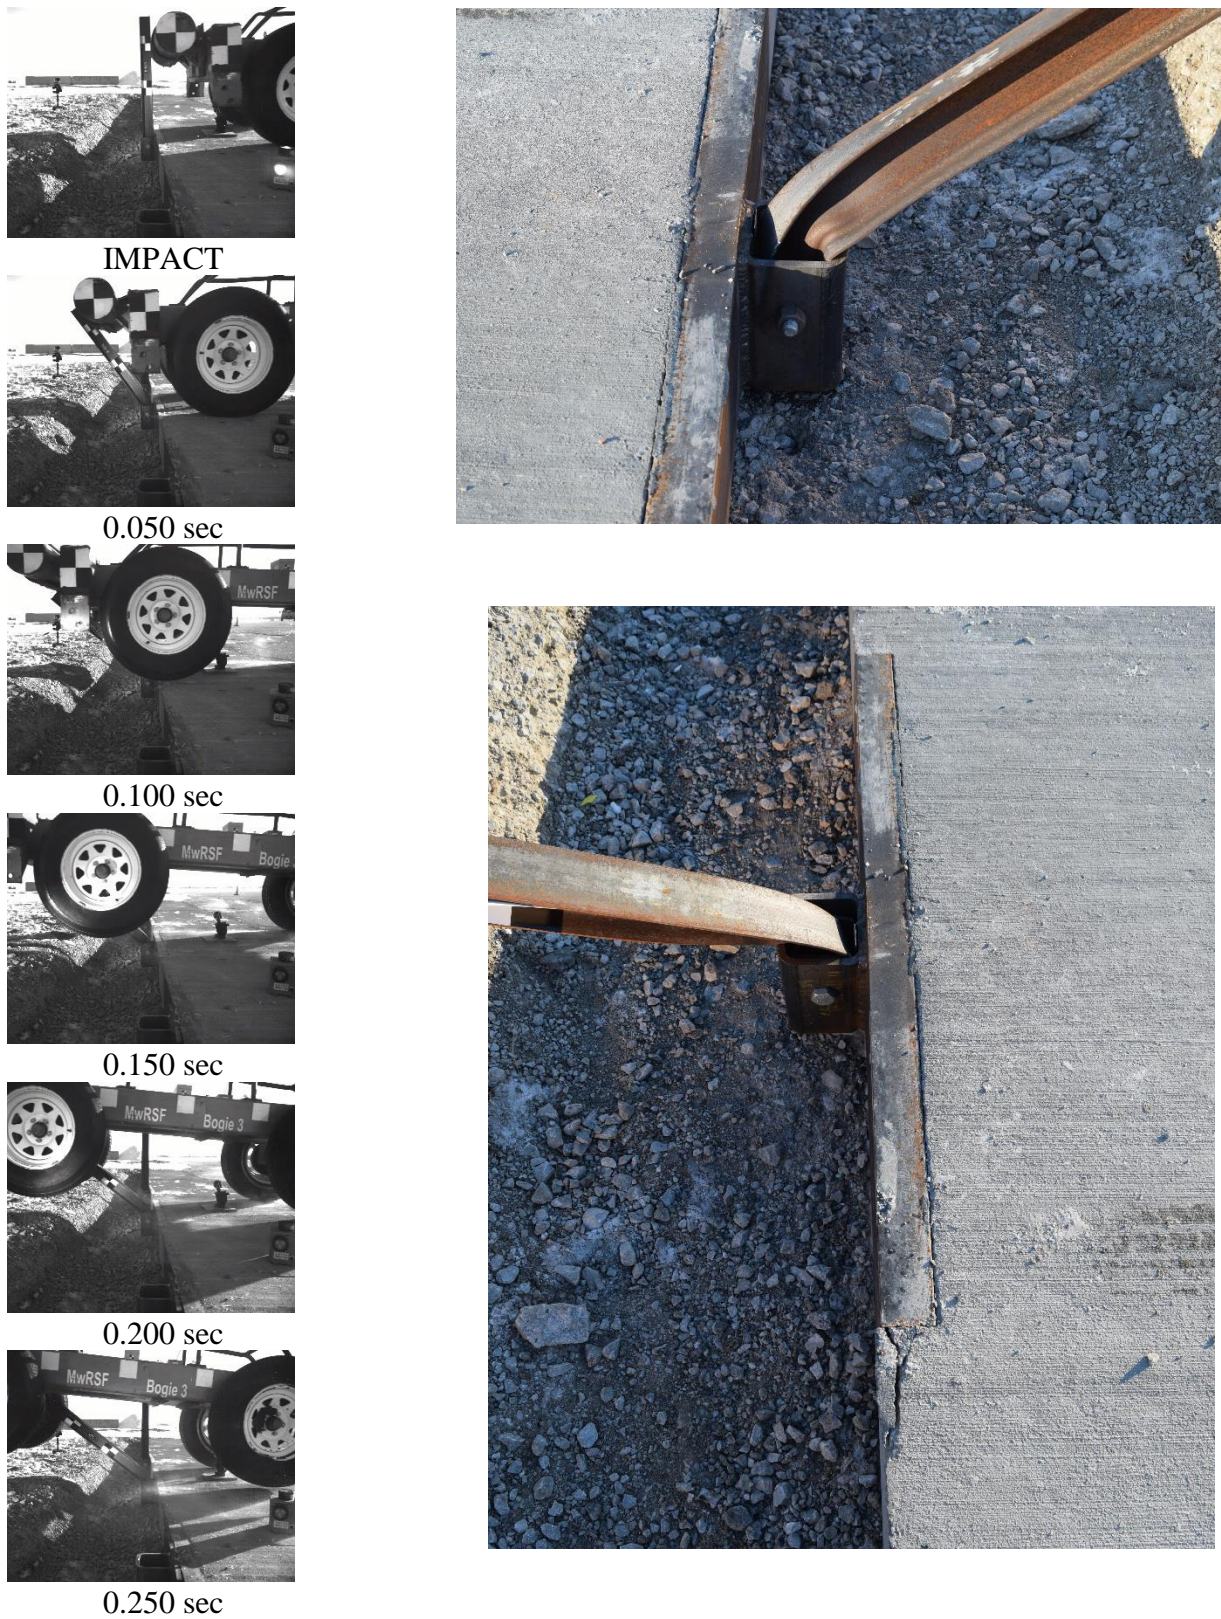
Figure 42. Time-Sequential and Post-Impact Photographs, Test No. N2B-3

The test article for test no. N2B-3 used Deck Location B and Channel Assembly B. The test article consisted of a welded socket attachment to the 7-in. thick simulated CIP bridge deck. The channel was anchored to the deck using straight segments of ASTM A706 rebar. See Section 3.2 for further details. Test no. N2B-3 was conducted with the bogie impacting the S3x5.7 post at a height of 25 in. and an angle of 90 degrees (through the strong axis of the post) at a speed of 21.2 mph. The impact caused the post to deflect backward as a plastic hinge formed in the post near the top of the socket. The bogie ultimately overrode the post at a displacement of 30.6 in. Due to the impact loads, the top flange of the socket had begun to pry away from the deck, and a 1/8-in. wide crack was found between the channel and the concrete. Additionally, some concrete spalling was found on the top edge of the deck adjacent to the channel. The socket and welds remained undamaged. Time sequential photographs and post-test photographs are shown in Figure 42.

Throughout all six tests, only test no. N2B-3, where the top flange of the channel was pulled outward $\frac{1}{8}$ in. and minor concrete spalling was observed adjacent to the channel, resulted in any damage to the simulated decks. Thus, the straight rebar anchorage design did not provide

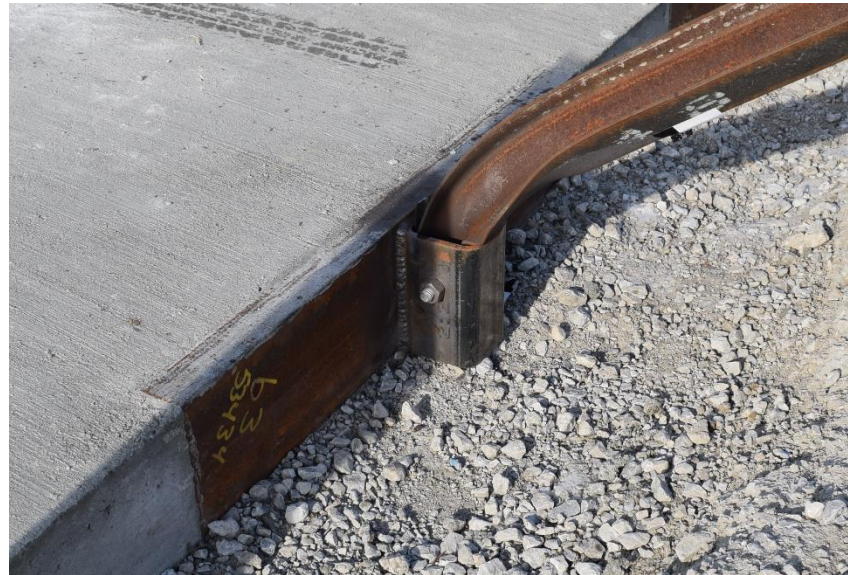
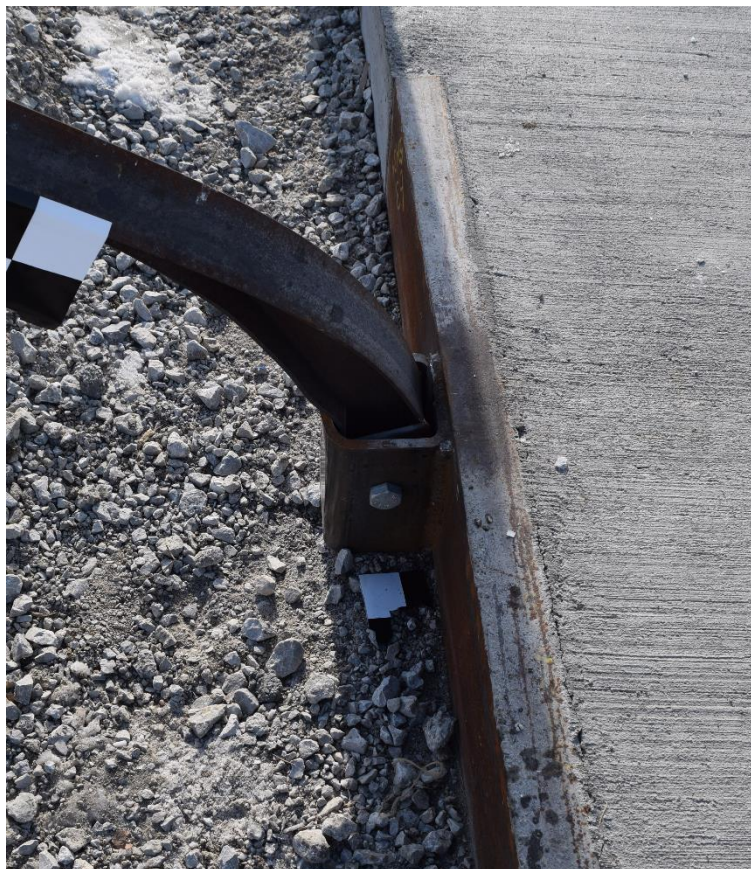
Figure 44. Time-Sequential and Post-Impact Photographs, Test No. N2B-4

The test article for test no. N2B-4 used Deck Location E and Channel Assembly D. The test article consisted of a welded socket attachment to the 7-in. thick simulated CIP bridge deck. The channel was anchored to the deck using a U-bar welded to the upper bend of the channel and additional #4 straight bars. See Section 3.2 for further details. Test no. N2B-4 was conducted with the bogie impacting the S3x5.7 post at a height of 25 in. and an angle of 90 degrees (through the strong axis of the post) at a speed of 21.5 mph. The impact caused the post to deflect backward as a plastic hinge formed in the post near the top of the socket. The bogie ultimately overrode the post at a displacement of 30.8 in. No damage was observed to the bridge deck or socket assembly. Time sequential photographs and post-test photographs are shown in Figure 44.

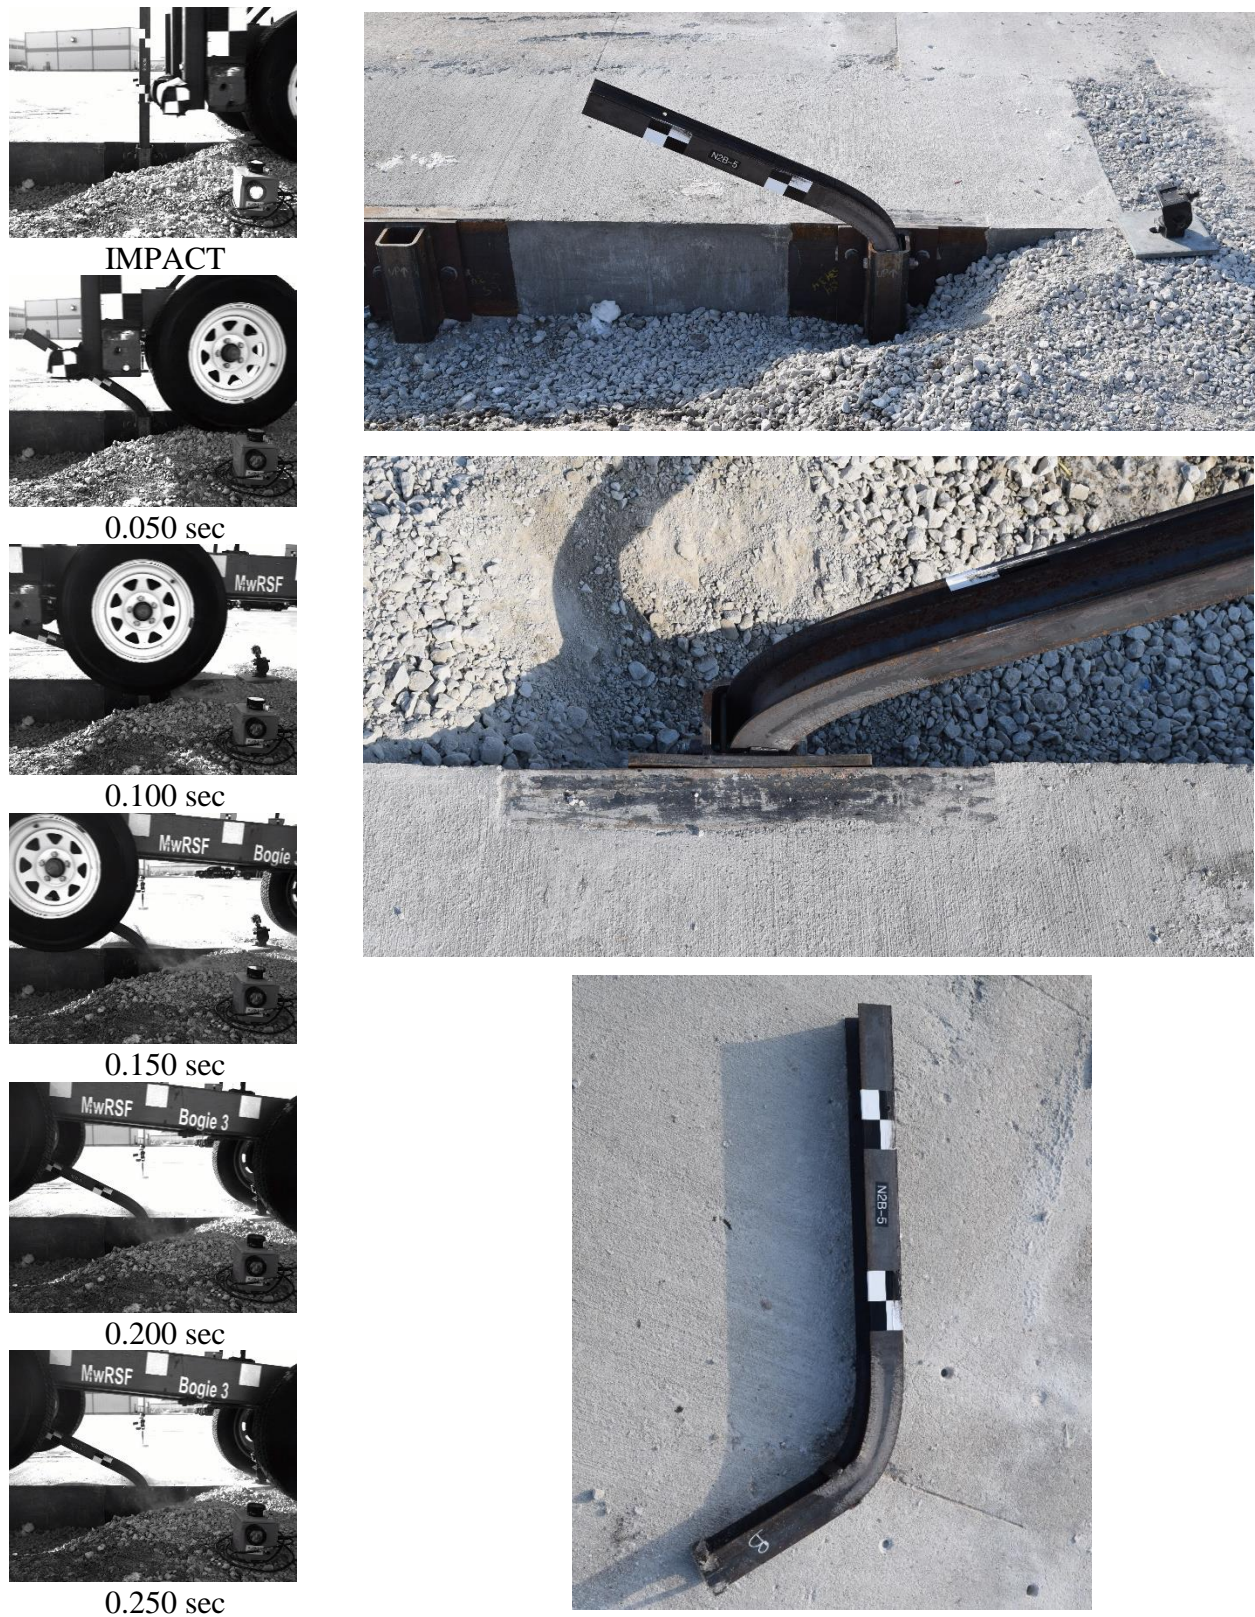
Figure 46. Time-Sequential and Post-Impact Photographs, Test No. N2B-5

The test article for test no. N2B-5 used Deck Location G and Channel Assembly F. The test article consisted of a bolted socket attachment utilizing $\frac{3}{4}$ -in. diameter bolts and a 12-in. thick simulated precast beam-slab bridge deck. See Section 3.2 for further details. Test no. N2B-5 was conducted with the bogie impacting the S3x5.7 post at a height of 12 in. and an angle of 0 degrees (through the weak axis of the post) at a speed of 20.1 mph. The impact caused the post to deflect downstream as a plastic hinge formed in the post near the top of the socket. The bogie overrode the post at 34.0 in. of displacement. No damage occurred to the deck, socket assembly, or attachment hardware. Time sequential photographs and post-test photographs are shown in Figure 46.

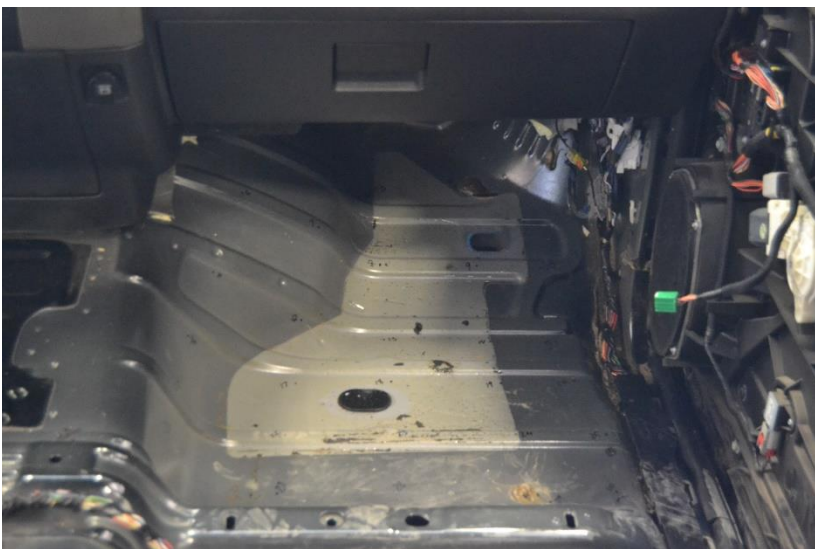
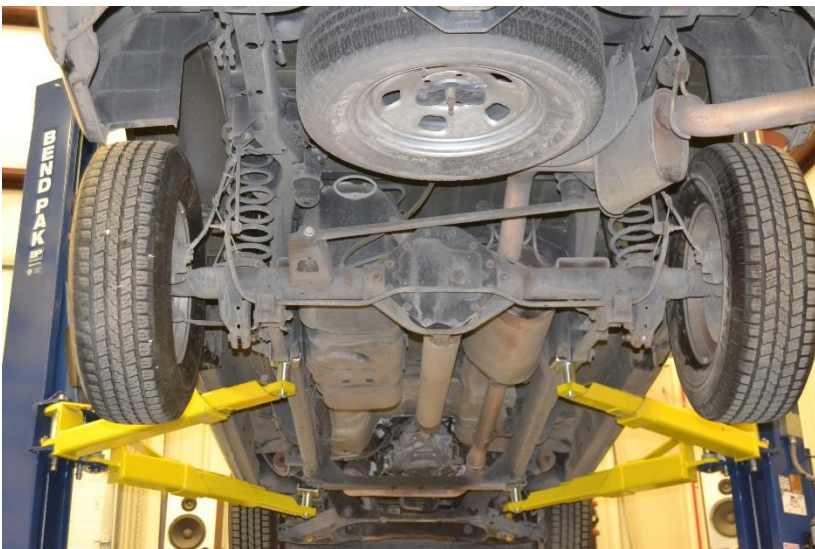
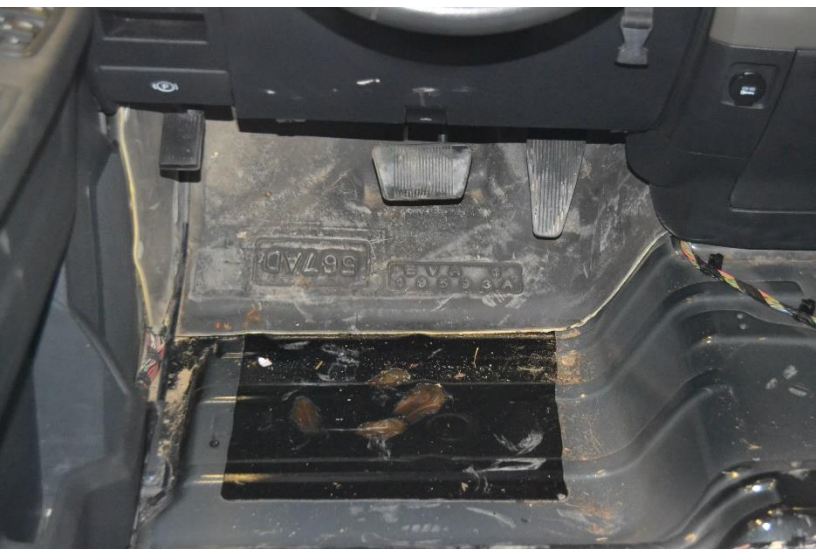
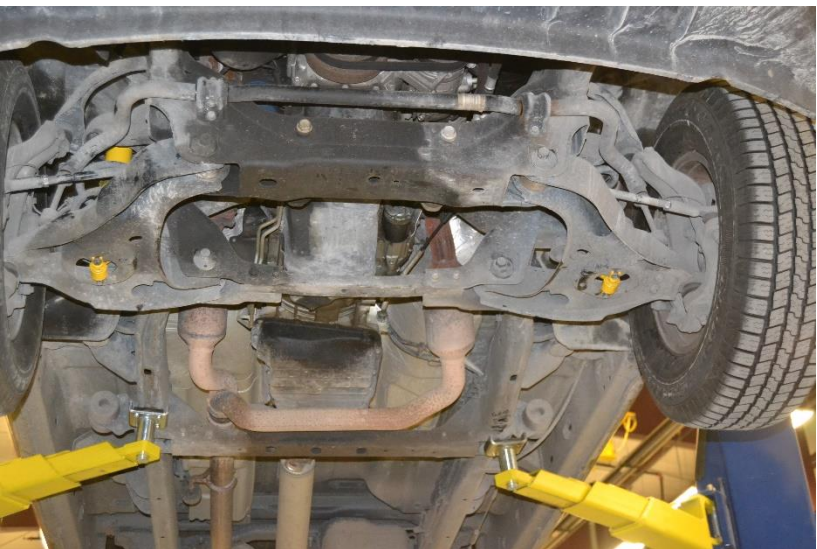
Figure 83. Vehicle Floor Pan and Undercarriage Prior to Test No. N2BR-1

For test no. N2BR-1, a 2011 Dodge Ram 1500 was used as the test vehicle. The curb, test inertial, and gross static vehicle weights were 5,111 lb, 4,999 lb, and 5,160 lb, respectively. The test vehicle is shown in Figures 82 and 83, and vehicle dimensions are shown in Figure 84. Note that the test vehicle was within six model years of the 2017 research project contract date.

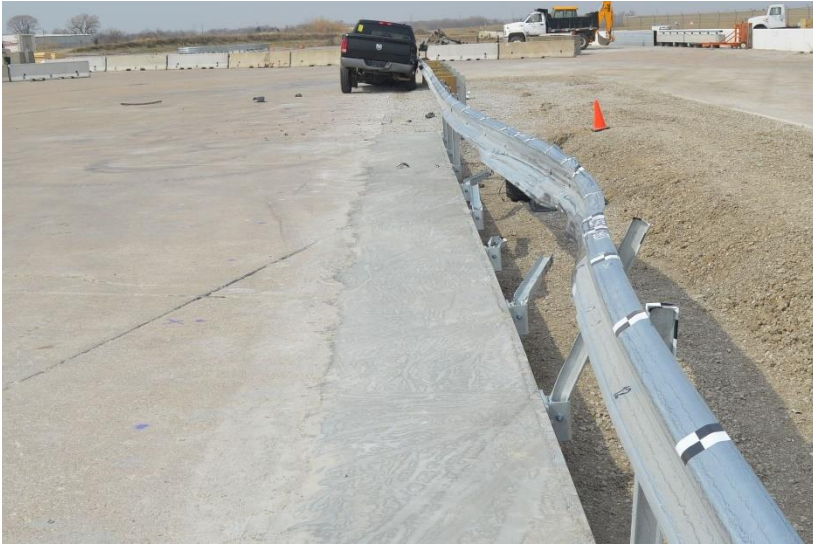
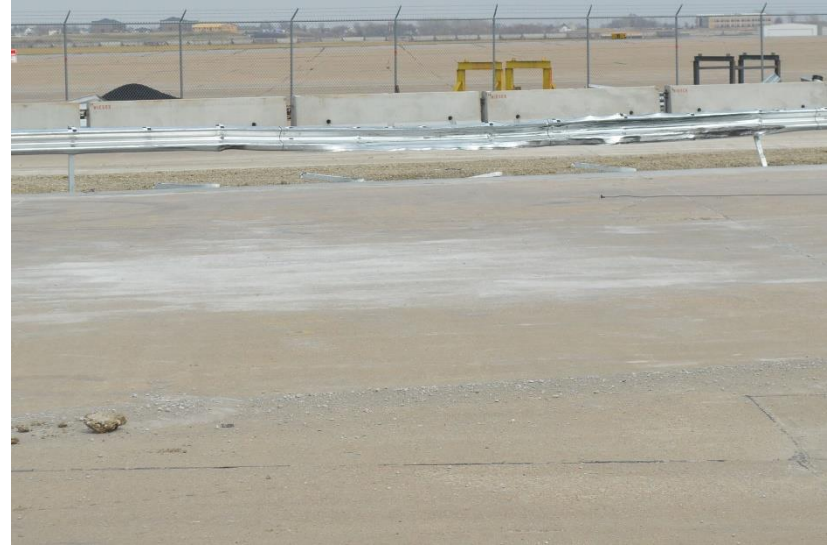
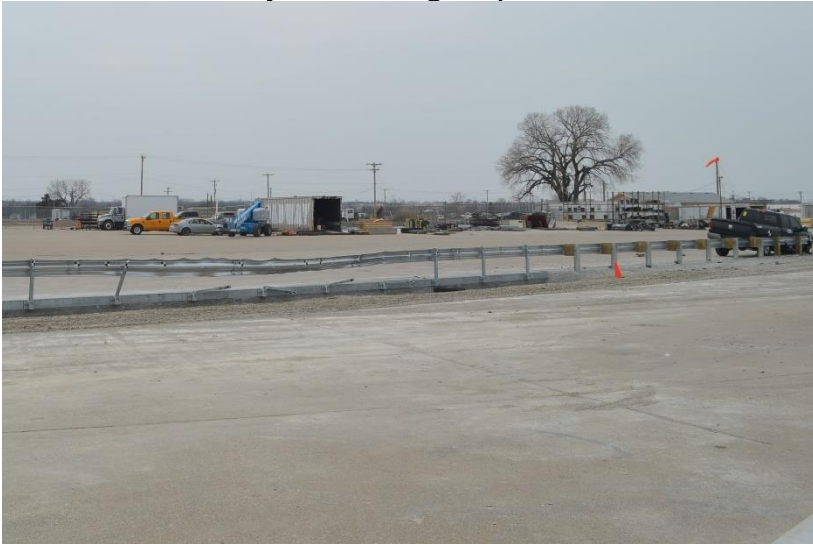
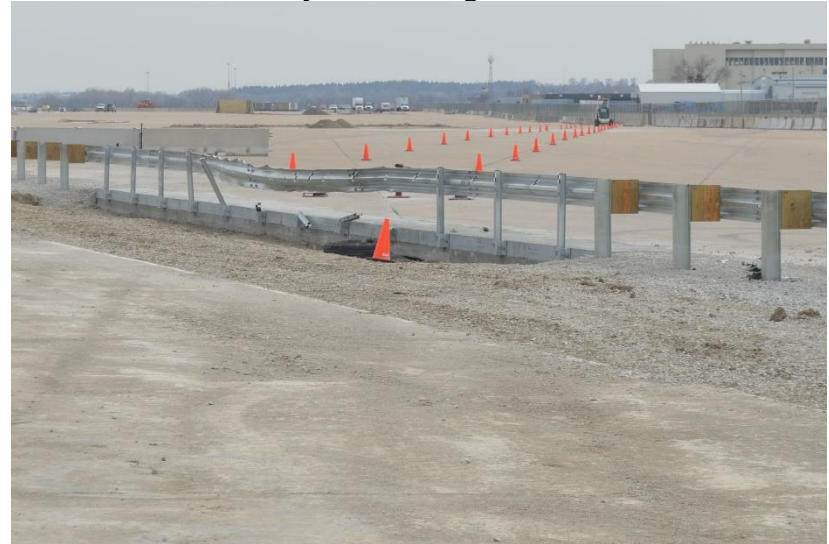
Figure 92. System Damage, Test No. N2BR-1

The maximum lateral permanent set of the barrier system was 20 in., which occurred on the guardrail located at mid-span between post nos. 14 and 15, as measured in the field. The maximum lateral dynamic barrier deflection was 32.6 in. measured on the guardrail at mid-span between post nos. 14 and 15, as determined from high-speed digital video analysis. The working width of the system was found to be 38.4 in., also determined from high-speed digital video analysis.
