DEVELOPMENT AND TESTING OF A BRIDGE RAIL FOR LOW-VOLUME ROADS

MIDWEST ROADSIDE SAFETY FACILITY

NEBRASKA DEPARTMENT OF TRANSPORTATION

MwRSF Research Report No. TRP-03-407-20

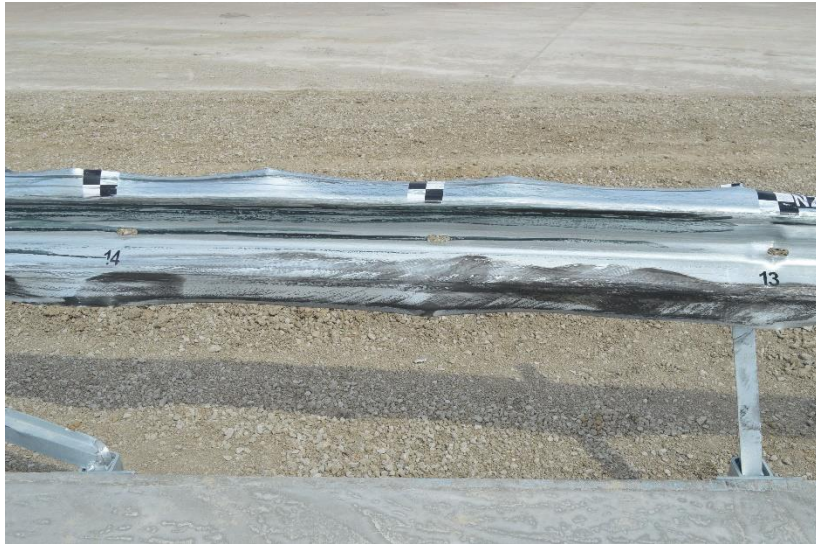
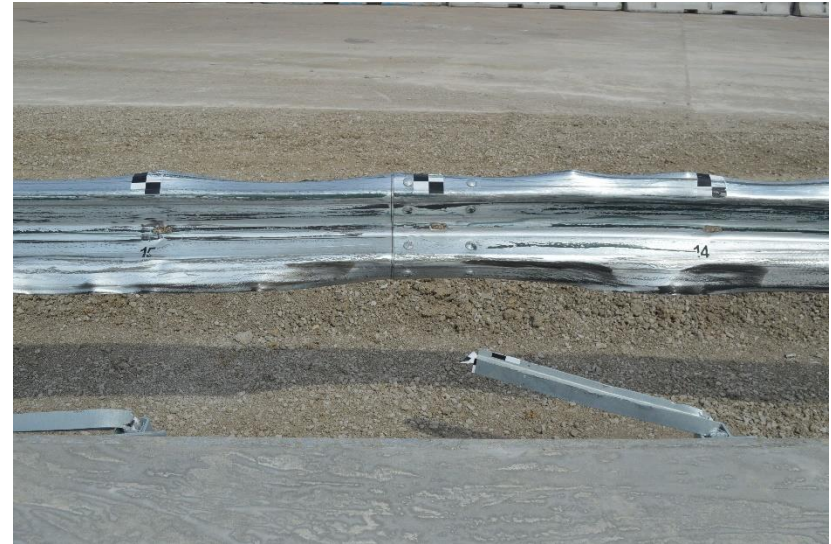
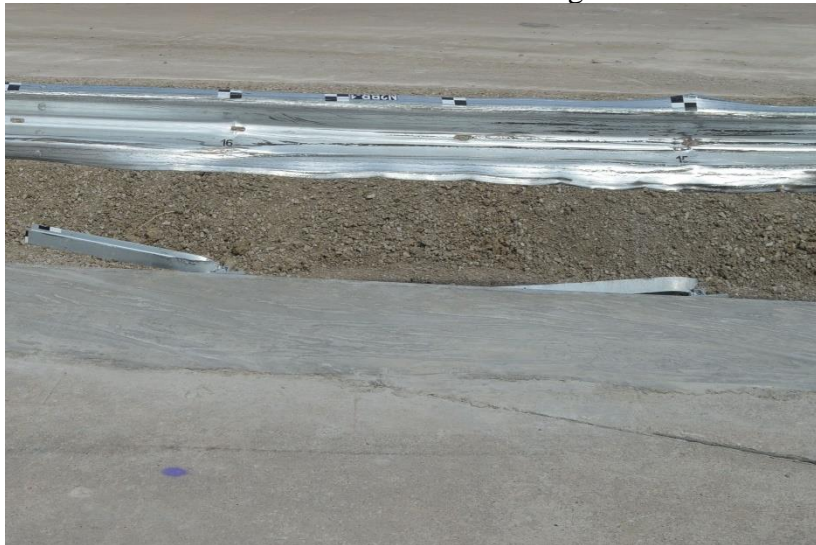
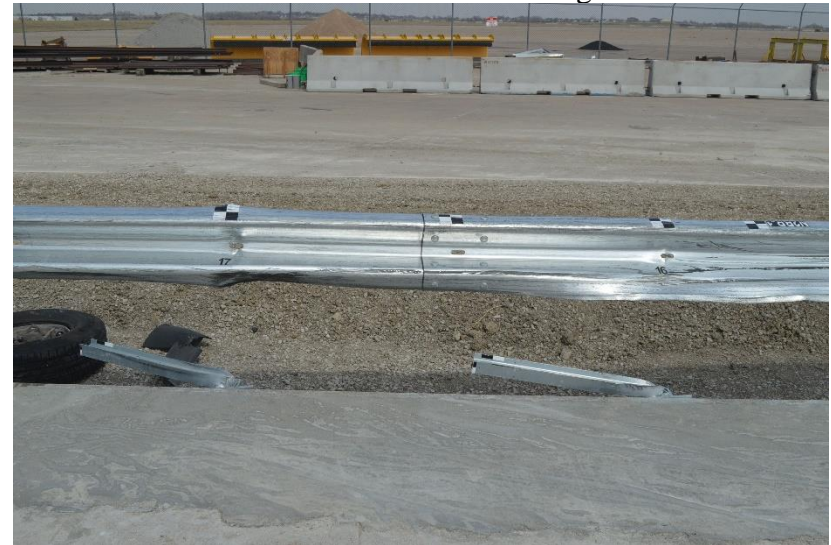
Figure 93. System Damage, Front-Side Views, Test No. N2BR-1

Damage to the barrier was moderate, as shown in Figures 92 through 95. Barrier damage consisted of contact marks extending from post nos. 13 to 17, as well as rail deformations, post bending and tearing, and guardrail bolt release. The length of vehicle contact along the barrier was approximately 27 ft which spanned from 6½ in. upstream from the impact point to 5 in. downstream from post no. 17. Guardrail scrapes and deformations in the form of kinking and flattening were observed throughout the contact region. Four additional kinks were observed downstream from post no. 17, outside of the contact region. Guardrail bolt fracture occurred in post nos. 13 through 17.

Post Nos. 13 and 14 Damage

Post Nos. 14 and 15 Damage

Post Nos. 15 and 16 Damage

Post Nos 16 and 17 Damage

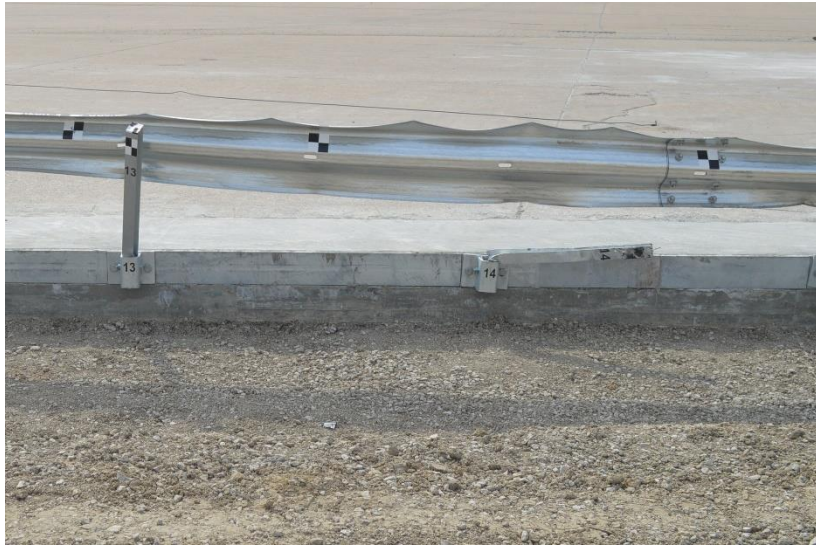
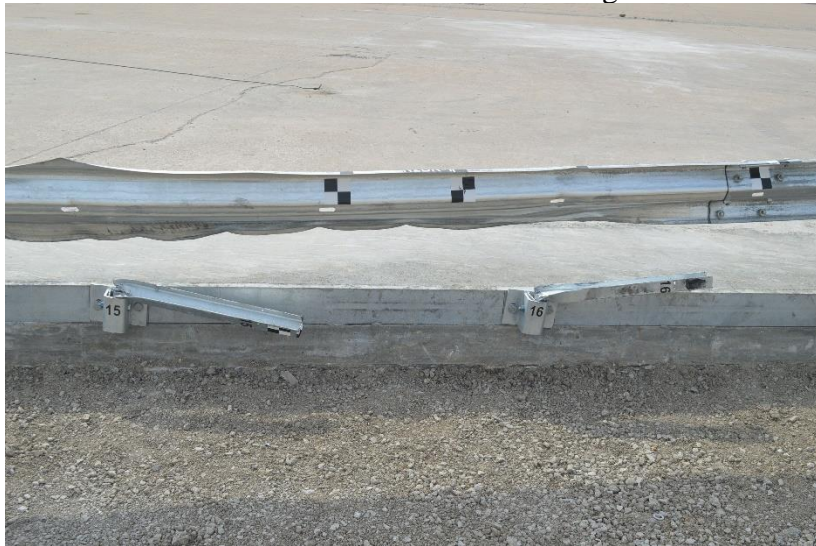
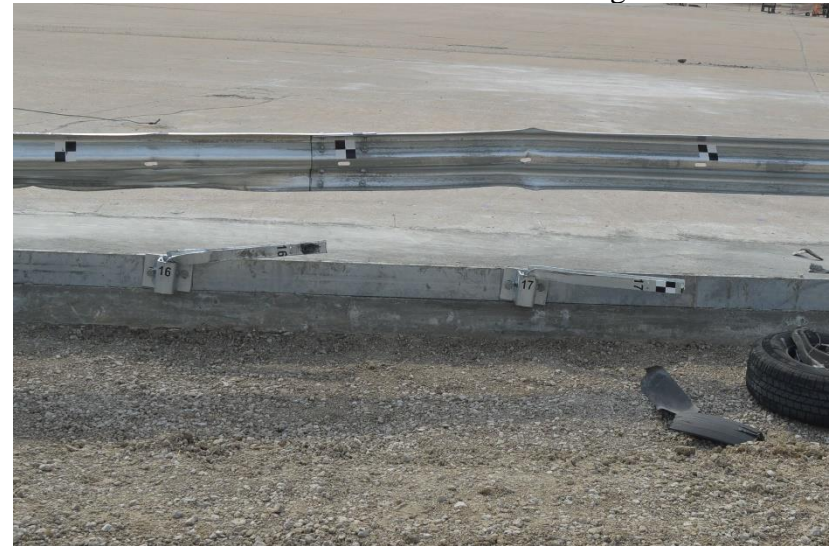
Figure 94. System Damage, Back-Side Views, Test No. N2BR-1

Post Nos. 13 and 14 Rear Damage

Post Nos. 15 and 16 Rear Damage

Post Nos. 16 and 17 Rear Damage

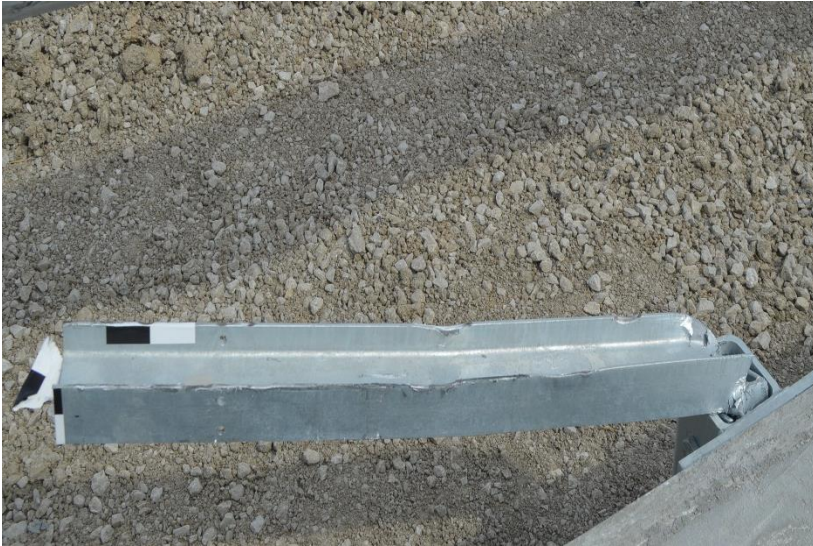
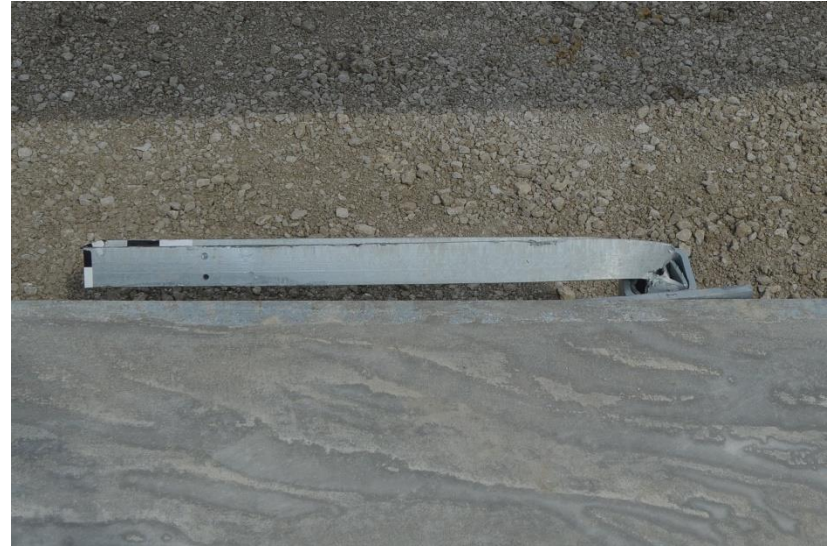
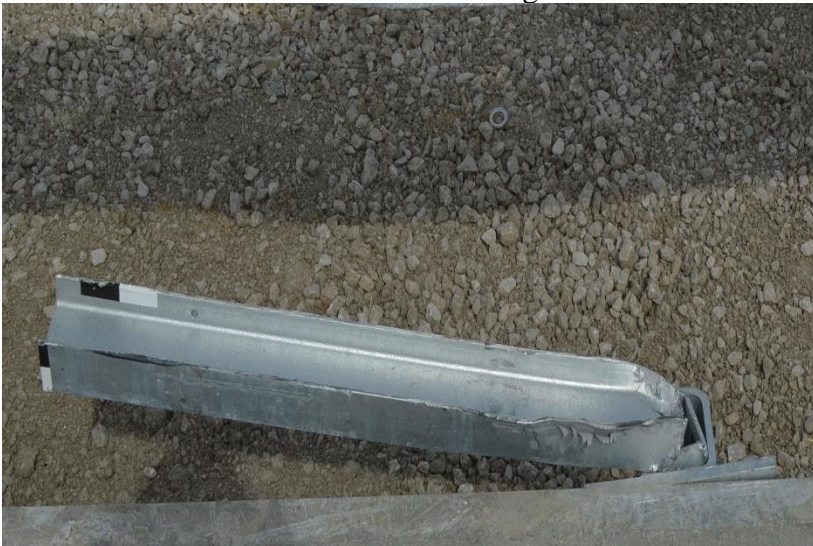
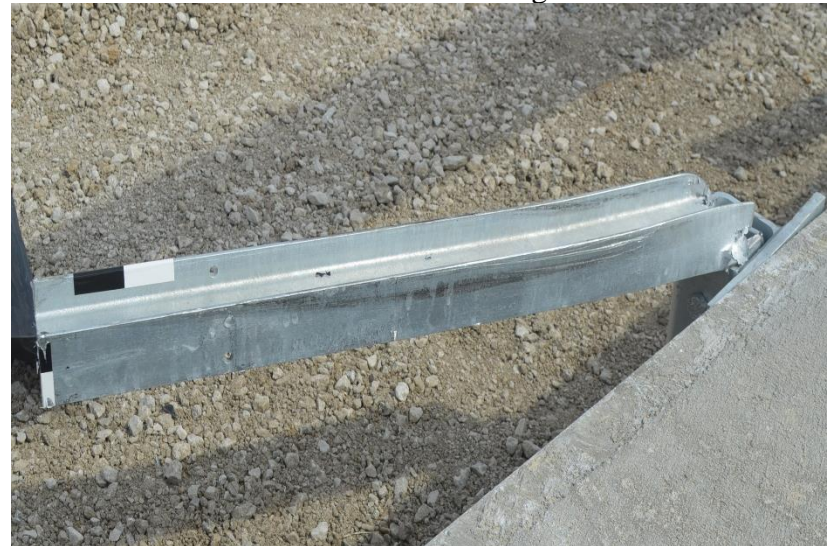
Figure 95. System Damage, Post Bending and Tearing, Test No. N2BR-1

Post No. 14 Tearing

Post No. 15 Tearing

Post No. 16 Tearing

Post No. 17 Tearing

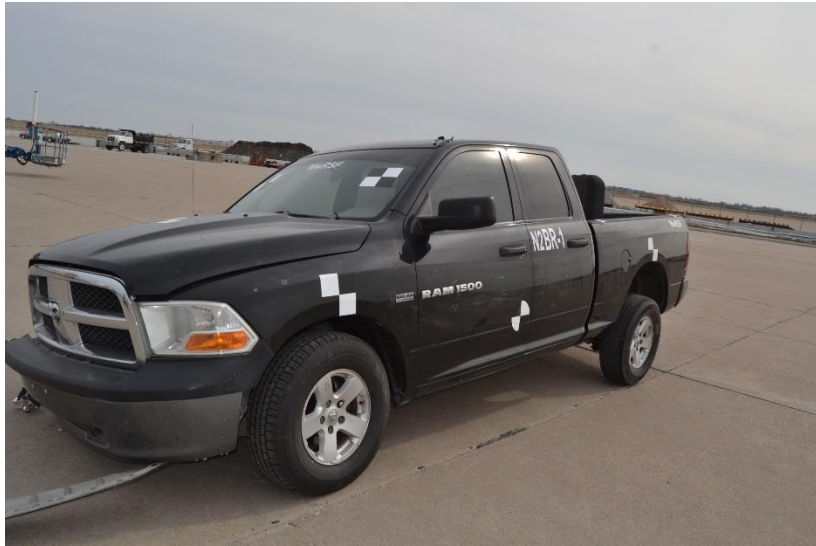
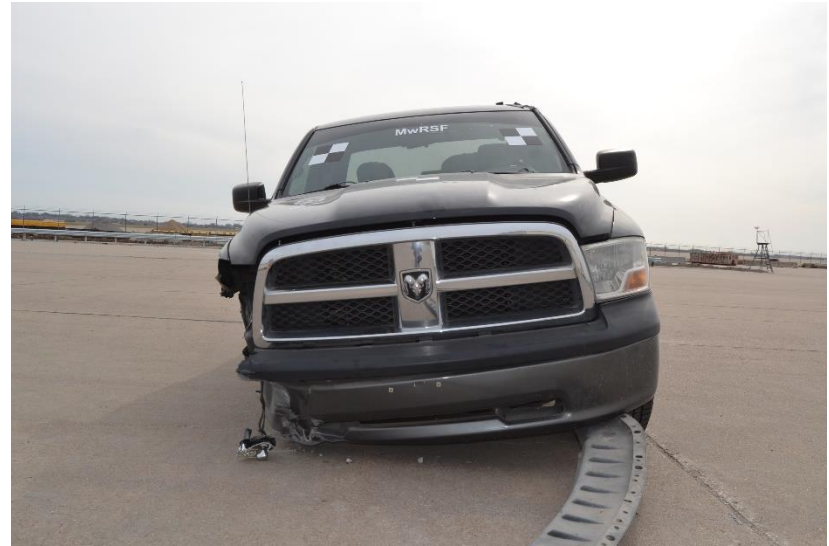
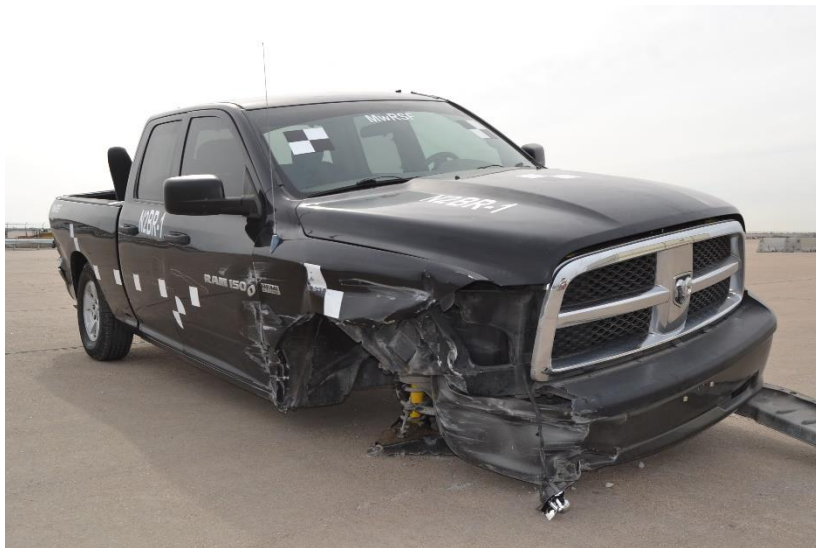
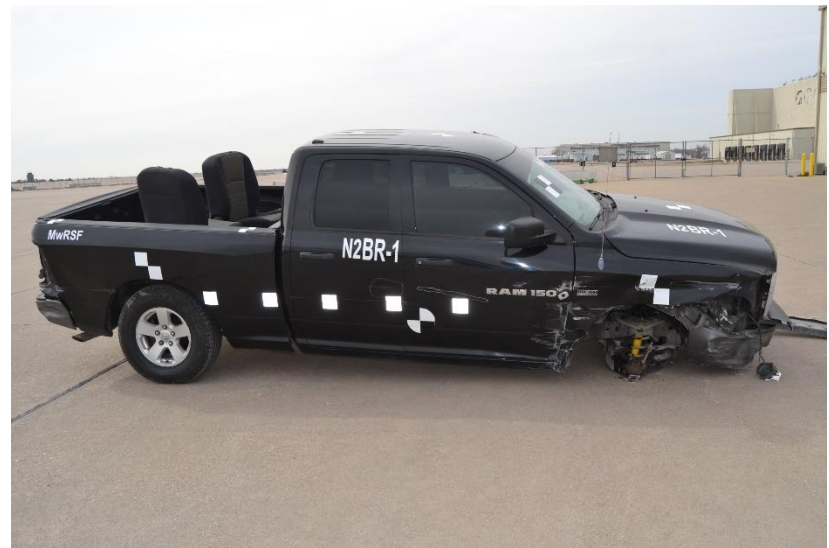
Figure 96. Vehicle Damage, Test No. N2BR-1

The majority of the damage was concentrated on the right-front corner of the vehicle where the impact had occurred. The right-front bumper and fender were crushed inward. The right-front tire and right-front headlight were disengaged from the vehicle, and the bumper bent back and under the vehicle. Scraping was observed along the vehicle's entire right side. Denting was observed on the right-rear fender. Scraps and minor dents were observed to undercarriage components on the right side of the vehicle. Damage to the suspension consisted of scrapes to the right front and right rear shocks, as well as to the lower control arm. The steering knuckle assemblies, tie rod, and lower control arm all disengaged from the right side of the vehicle. Damage to the chassis consisted of minor scrapes on the lower rear end shock mount. The drive train remained undamaged.

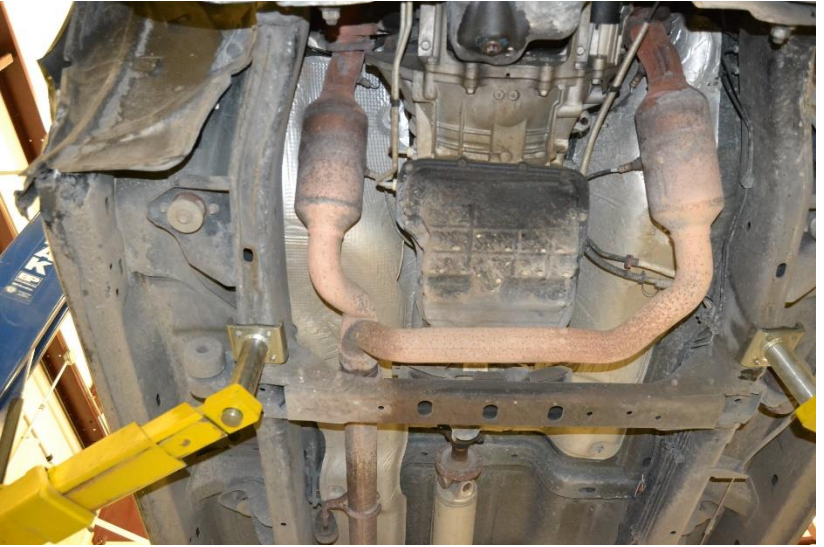
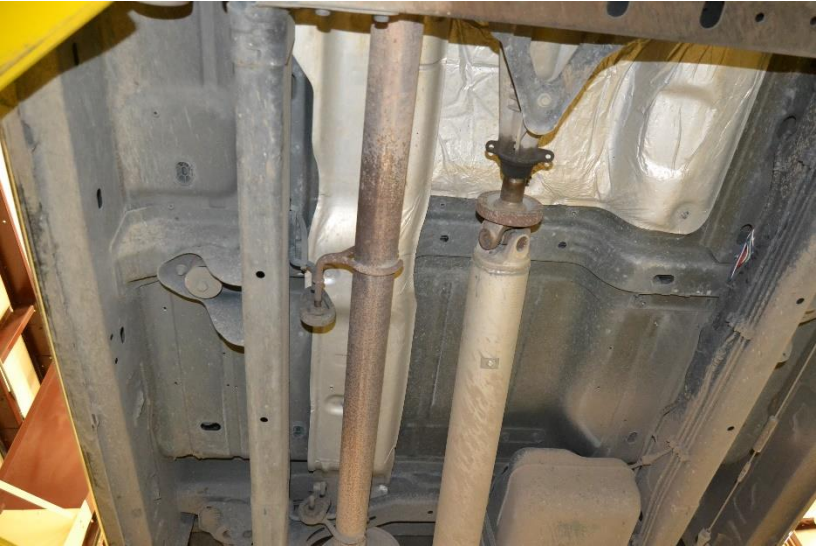
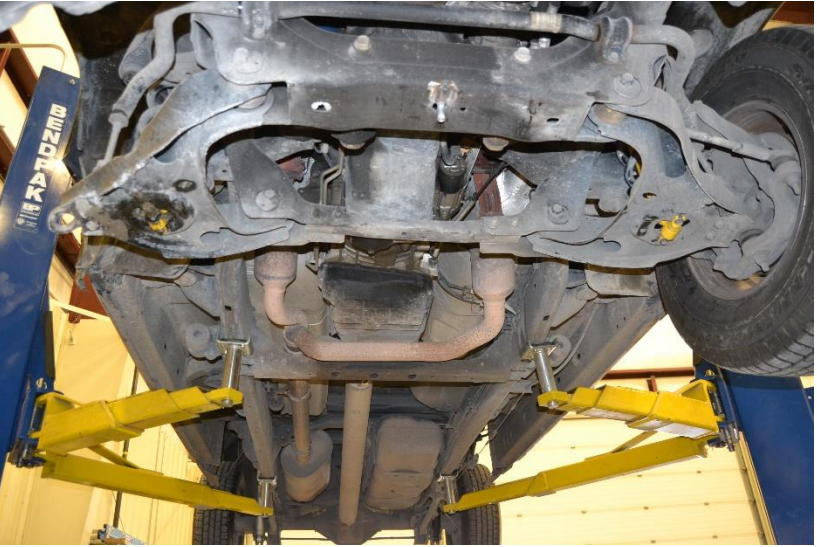
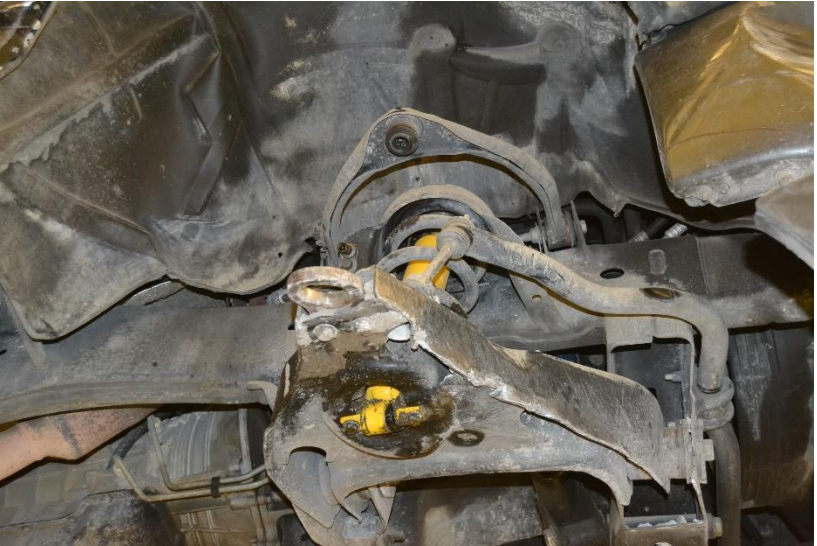
Figure 97. Vehicle Undercarriage Damage, Test No. N2BR-1

The damage to the vehicle was moderate, as shown in Figures 96 through 98. The maximum occupant compartment deformations are listed in Table 8 along with the intrusion limits established in MASH 2016 for various areas of the occupant compartment. Complete occupant compartment and vehicle deformations and the corresponding locations are provided in Appendix F. MASH 2016 defines intrusion or deformation as the occupant compartment being deformed and reduced in size with no observed penetration. There were no penetrations into the occupant compartment and none of the established MASH 2016 deformation limits were violated. Outward deformations, which are denoted as negative numbers in Appendix F, are not considered crush toward the occupant, and are not evaluated by MASH 2016 criteria.

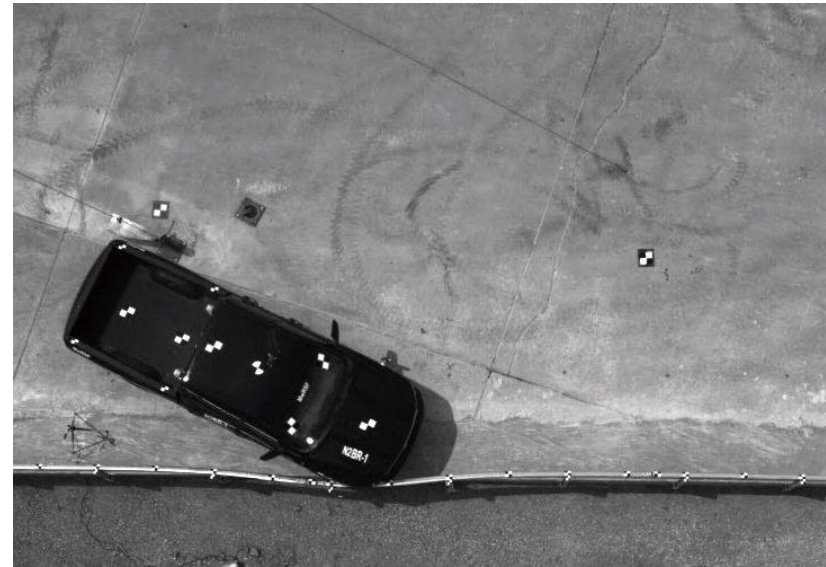
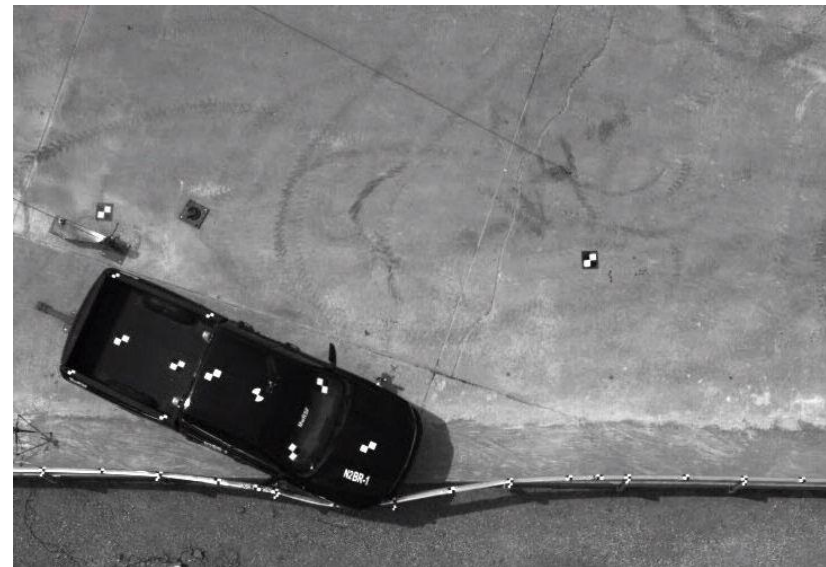
Figure 100. Sequential Figures from BARRIER VII Simulation and Test No. N2BR-1

The BARRIER VII simulation matched the results of the full-scale crash test rather well over the first 0.400 sec of the impact. The vehicle parallel time and speed were very similar, the system displacements were nearly identical, and the maximum pocketing angles were within 2 degrees. Post failure was defined in the BARRIER VII simulations as post displacements greater than 15 in. BARRIER VII determined 4 posts failed according to this failure criteria, and post nos. 14 through 17 had bent completely over in the physical test. A graphical comparison of the simulation to the physical test is shown in Figures 100 through 106. After approximately 0.400 s, the model began to deviate from the full-scale test. BARRIER VII is known for having difficulties simulating system rebound and restoration forces. As such, the results do not match up as well as the vehicle exits the system. Fortunately, all the evaluation metrics for the simulations (e.g., maximum displacements and pocketing angles) occur before the vehicle reaches parallel and starts to exit the system. Therefore, based on the comparison to the physical test described herein, the model of the new TL-2 bridge rail was considered validated.
