BIOPOLYMERIZED SLOPE AND SUBGRADE STABILIZATION AND ADVANCED FIELD MONITORING

**F
I
N
A
L
R
E
P
O
R
T**

**Nebraska Department of Transportation and U.S. Department
of Transportation Federal Highway Administration**

April, 2021

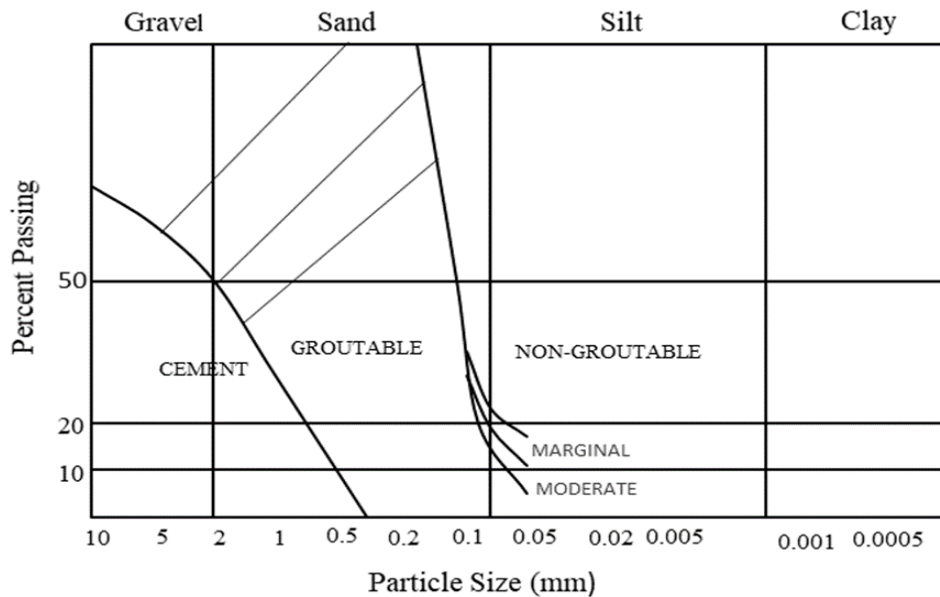
Figure 2.2 Grain size ranges for chemically groutable soil (Replotted from Lees & Chuaqui, 2003)

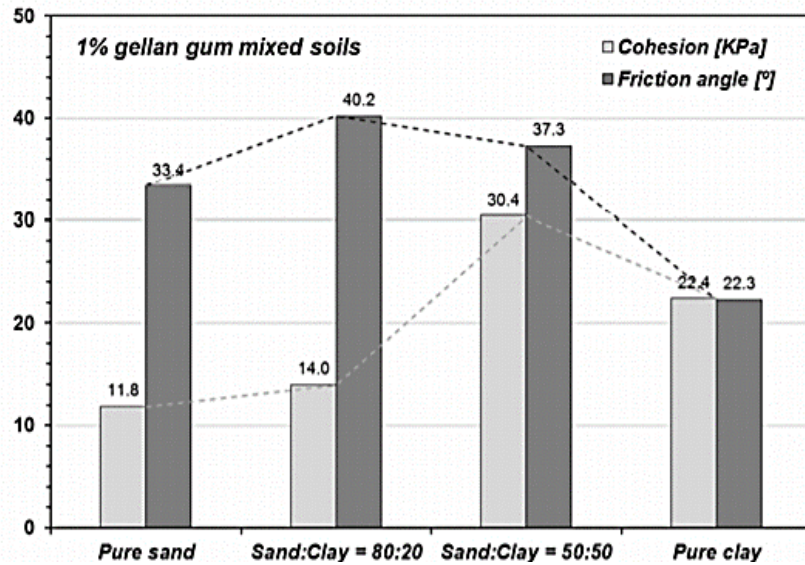
Figure 2.12 Cohesion and friction angle variation in sand-clay mixtures treated with 1 % Gellan (Chang et al., 2016)

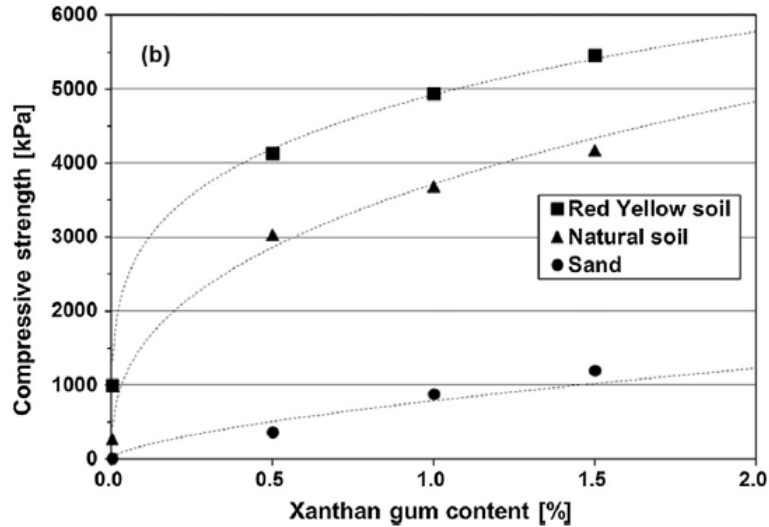
Figure 2.15 The effect of different contents of Xanthan on the compressive strength of three different types of soils (Chang et al., 2015)

The biopolymer content is one of the main factors that affect the strength of biopolymer treated soils. For that reason, Chang et al. (2015) studied the effect of Xanthan content on the compressive strength of three types of soils. The selected soils were sand, natural soil (SP-SM), and Red Yellow soil (CL) treated with different concentrations of Xanthan (0.5%, 1%, and 1.5% by weight). Figure 2.15 shows the unconfined compressive test results after curing 28 days. Increasing the biopolymer content increases the compressive strength of the soils. Higher Xanthan content causes wider and thicker linkages between the particles in the coarse soils and more chemical interactions between the biopolymer and the surface of the fine soils. But at the same time, the authors mentioned that the most effective range of Xanthan concentrations is 1%-1.5%. Higher contents of Xanthan interact directly with the fine soils and water, forming a highly viscous solution that separates the particles easily and reduces the dry density. Besides, the highly viscous solution affects the workability of the biopolymer mixed with the soil. The author found that the dry density will slightly increase in the coarse soils due to the Xanthan gel matrices around the particle and in the voids.

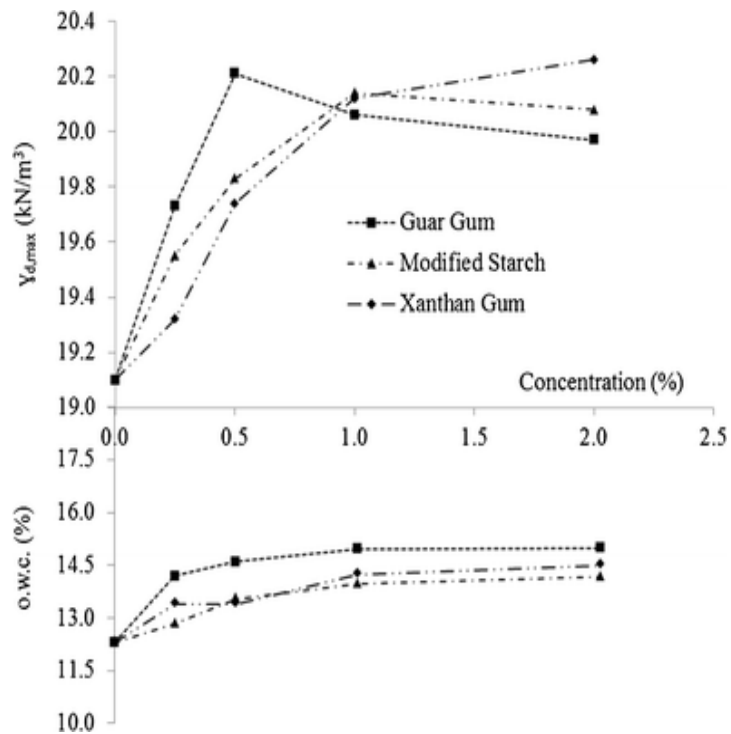
Figure 2.16 Compaction characteristics for sand/biopolymer mixtures (Ayeldeen et al., 2016)

Guar gum and Modified Starch leads to form a highly viscous solution that separates the sand particles and reduces the dry density. Unlike the behavior of the other mixtures, the dry density of the Xanthan/sand mix increased with increasing the concentration. On the other hand, the optimum moisture content increased with increased biopolymer concentrations for all cases. This behavior is due to the increased amount of water absorbed by the biopolymer, effectively reducing the amount of free water in soils.

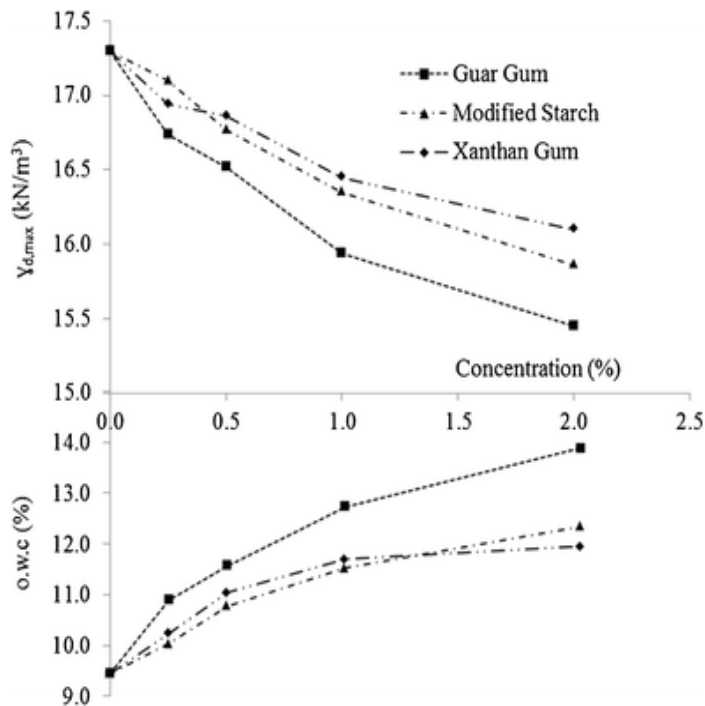
Figure 2.17 Compaction characterizations for silt/biopolymer mixtures (Alydeen et al., 2016)

Figure 2.17 shows the compaction results conducted on silt/biopolymer mixtures. Increasing the biopolymer concentrations caused a decrease in the density. According to Ayeldeen et al. (2016), the silt particles were separated by the effect of the viscosity of the solution regardless of the biopolymer contents. The optimum moisture content increased with increasing the biopolymer concentrations, like the sand mixtures case.

Even though the dry density of the soil/biopolymer mixture (sand and silt/Guar gum) was lower at higher Guar gum content than that at lower Guar gum content, the figure gave a higher strength at 5 weeks curing period (Figures 2.13 and 2.14). The linkages between the soil particles were much thicker in the soils treated with Guar gum (Alydeen et al., 2016). Higher Guar gum content increases the density and thickness of these linkages. As a result, these linkages fill the voids between the soil particles leading to a higher compressive strength.

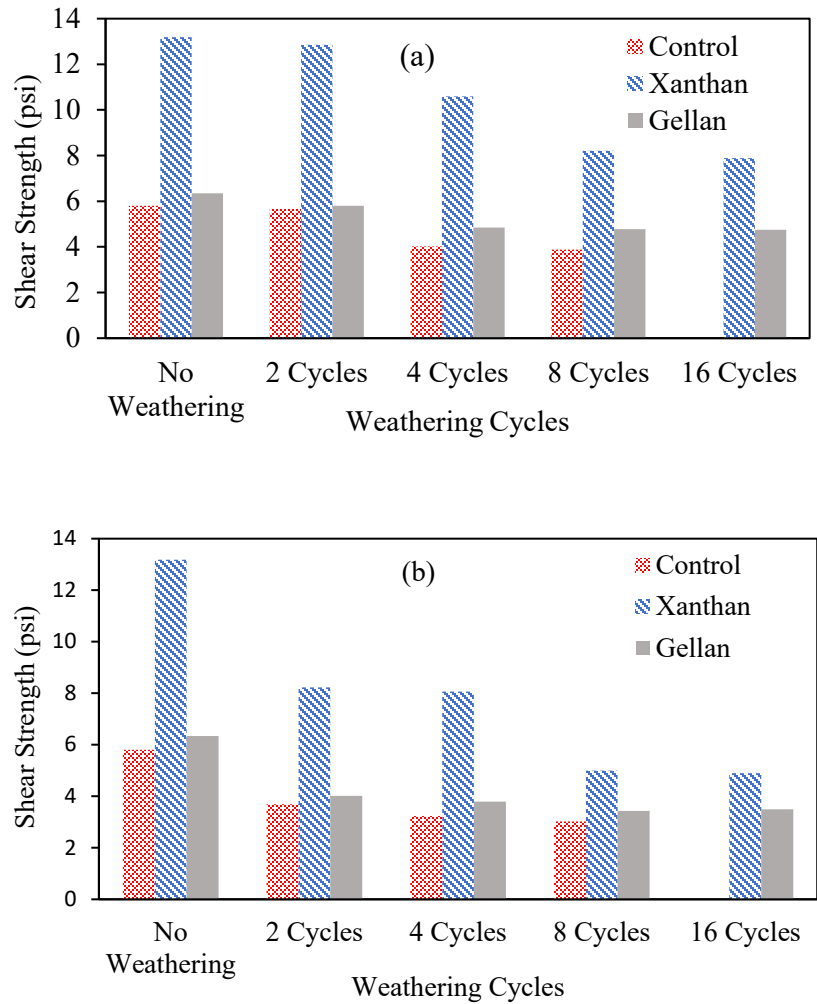
Figure 2.19 Direct shear test results for glacial tills (a) wet-dry condition (b) wet-freeze-thaw-dry condition (Song et al., 2018)

the shear strength of glacial tills and weathered shales under wet-dry conditions and wet-freeze-thaw-dry conditions was presented in Figures 2.19 and 2.20, respectively.

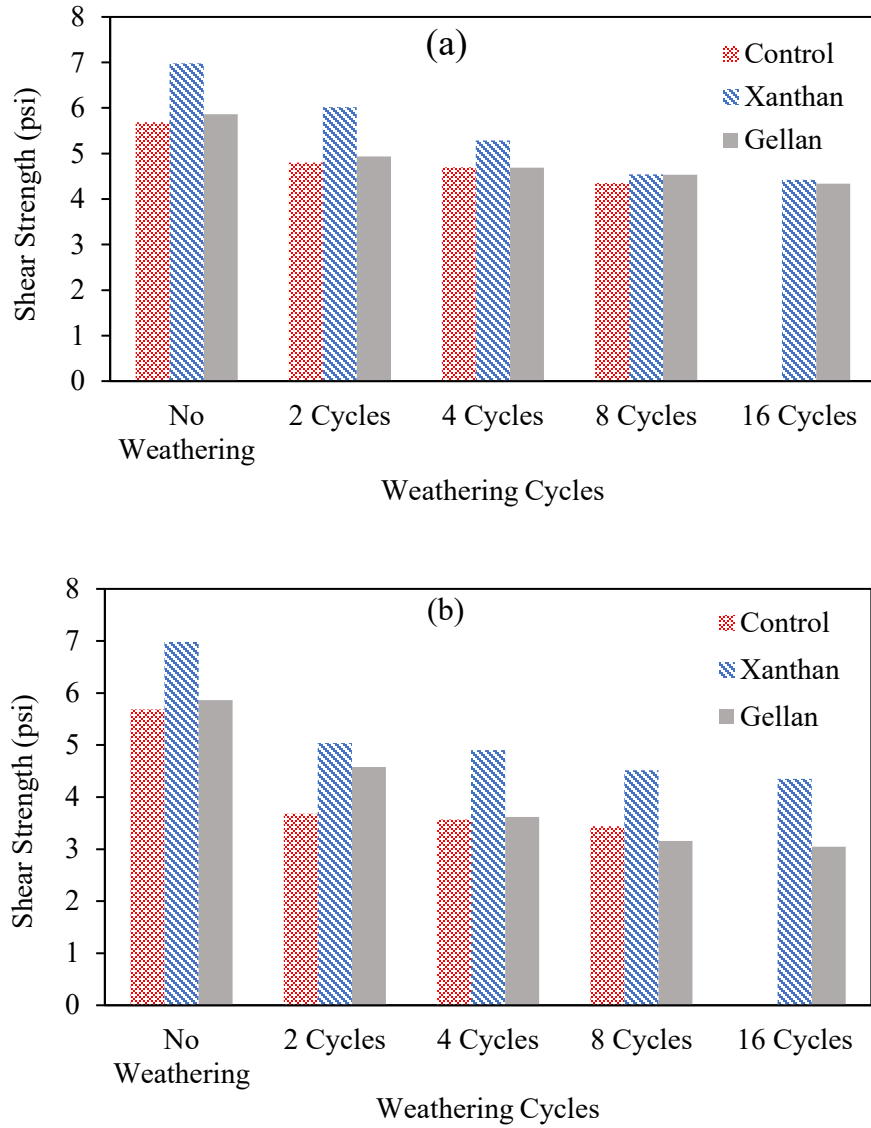
Figure 2.20 Direct shear test results for weathered shales (a) wet-dry condition (b) wet-freeze-thaw-dry condition (Song et al., 2018)

Both biopolymers increased the shear strength of the soil, but Xanthan showed higher strength than Gellan. The shear strength of the weathered shales decreased as the number of weathering cycles increased. The reduction in the shear strength stabilized after 8 weathering cycles. At the same number of weathering cycles, samples weathered under wet-freeze-thaw-dry conditions presented lower shear strength than the samples weathered under wet-dry conditions. This behavior highlighted the significance of freezing in

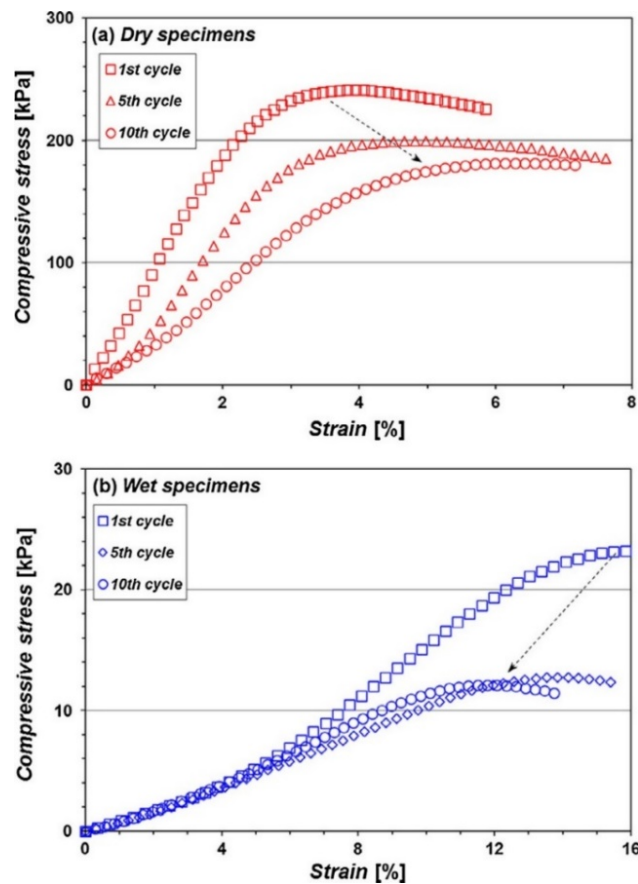
Figure 2.21 Stress-strain curves of dry (a) and wet (b) 1% Gellan-treated sands obtained from unconfined compression tests at different cycles (Chang et al., 2017).

Another study by Chang et al. (2017) evaluated the behavior of sandy soils treated with 1% Gellan after several wet/dry cycles, up to 10 cycles. As shown in Figure 2.21, the strength of the treated soil decreased in both wet and dry conditions at the increased number of cycles. Furthermore, there was a relatively negligible strength reduction in samples from the fifth to the tenth cycles. On the other hand, the results showed that the strength of the soil in the dry condition was much higher than in the wet condition.

The strength reduction with the increased number of dry-wet cycles appears to be due to the hydrophilic property of Gellan. When the sand/Gellan samples are in wet condition, the dried gel absorbed the water and separated from the surface of the sand particles based on Chang et al. (2017). By redrying the test samples, the new soil particles may attach to the remaining Gellan gel in the main structure, but the original structure of soils may not fully recover.

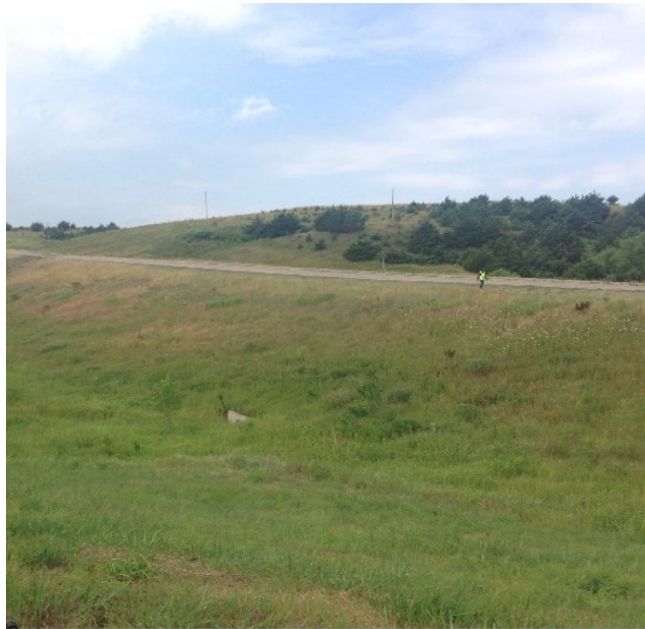
Figure 3.1 Verdigre slope at Highway 84 (Song et al., 2018)

Verdigre is a small town in Knox County, North Central Nebraska. The failed slope is shown in Figure 3.1 and is located about 2 mi east of Verdigre along Highway 84. The slope is designed and constructed based on Nebraska's road construction standard (3:1=H:V). The width and height of the slope are 250 ft and 30 ft (Lindemann, 2011). A boring log showed that the slope soils primarily consist of weathered shale layers. Weathered shales from Verdigre are derivatives of old marine deposits formed during the Cretaceous era. Several cracks parallel to the highway shoulder appeared at the top of the slope during Summer, 2018 as shown in Figure 3.2.

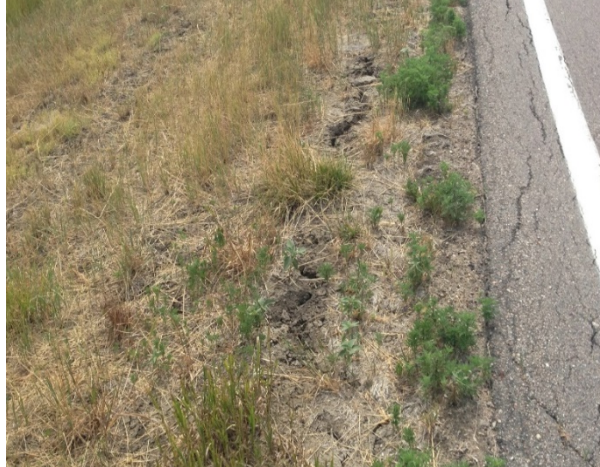
Figure 3.2 Longitude crack on top of the Verdigre slope at Highway 84
(Song et al., 2018)

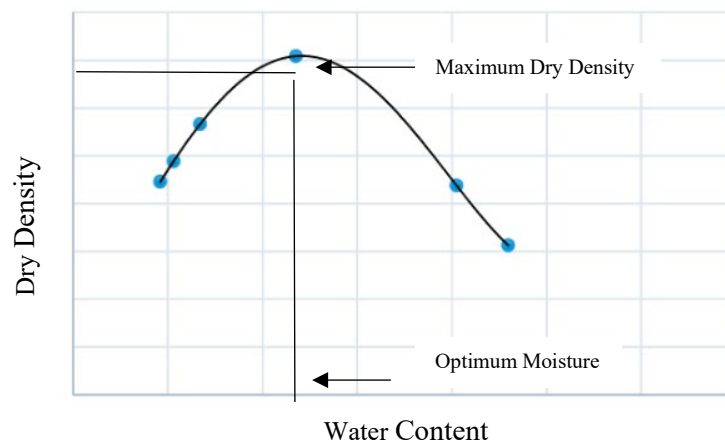
Figure 3.8 Variation of dry unit weight with moisture content (Proctor Curve)

The standard proctor test was conducted according to ASTM D-698 to determine the maximum dry unit weight and the optimum moisture content of the soils. The soils were mixed with predetermined moisture content. In a 4-inch diameter mold, the soils were compacted in three layers using a hammer weighing 5.5 pounds and a drop height of 12 inches (Figure 3.7). The optimum moisture content and the maximum dry density were obtained, as illustrated in Figure 3.8.

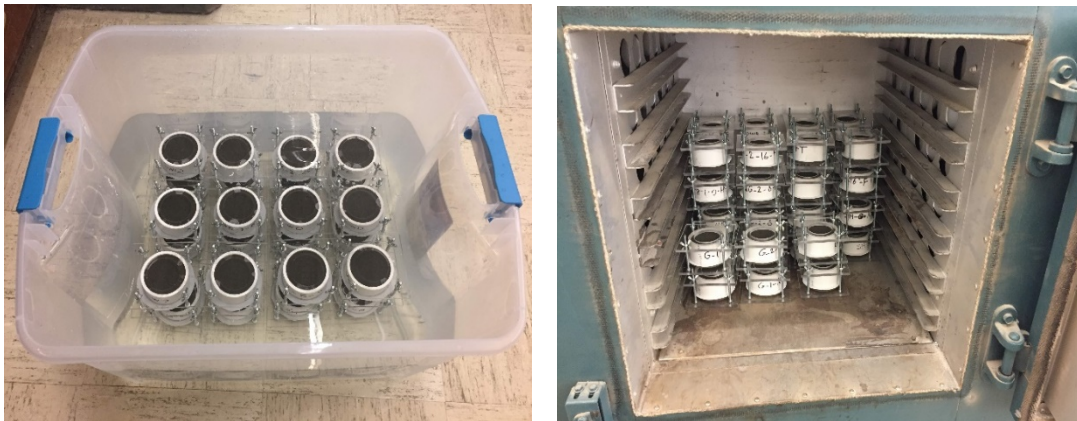
Figure 3.20 Water bath and oven used for wetting and drying soil samples, respectively

Wet-freeze-thaw-dry cycles were selected to mimic the weathering conditions in Nebraska. One cycle of weathering was achieved by first placing the samples in the water bath for 24 hours (68 °F), and then keeping them in the freezer at -6 °F for 24 hours, followed by drying and heating the samples in the oven at 167 °F for 24 hours (Figure 3.20). Three different weathering cycles, including 2, 4, and 8 were chosen referring the previous research of Song et al. (2018) to see the effect of weathering cycles on the strength of the soil samples. It should be noted that one set of samples was also included as a control group, samples for this group did not go through any weathering cycles.

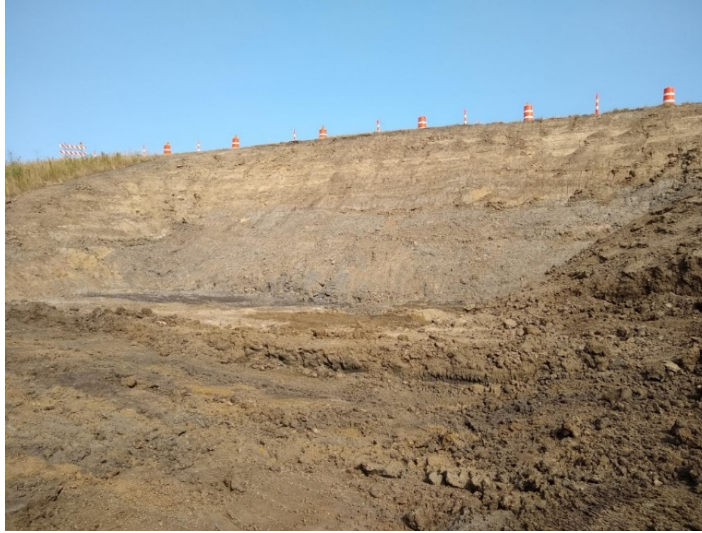
Figure 5.2 View of the slope with loose materials removed (Note: The total height is about 30 ft.)

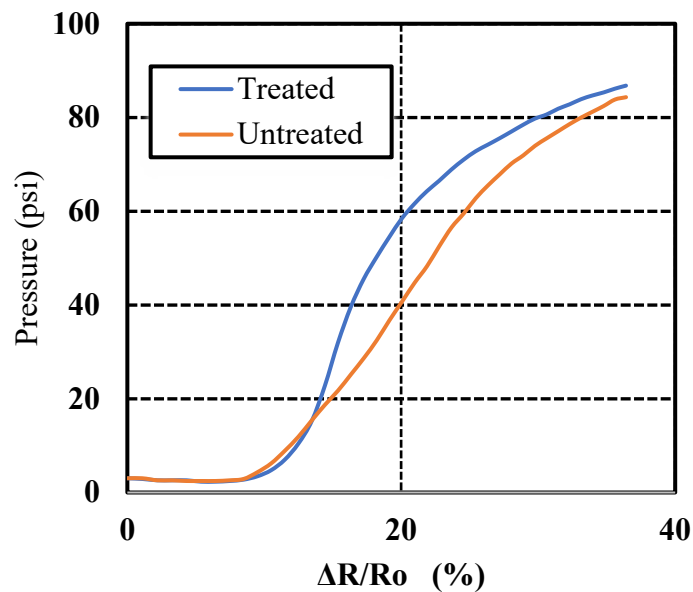
Figure 5.15 Pressuremeter test result (Measurement Date: Nov. 20, 2020)
