**Report #: SPR-P1 (11) M305**

## **EFFECTIVENESS STUDY ON TEMPORARY PAVEMENT MARKING REMOVALS METHODS**

June 2011

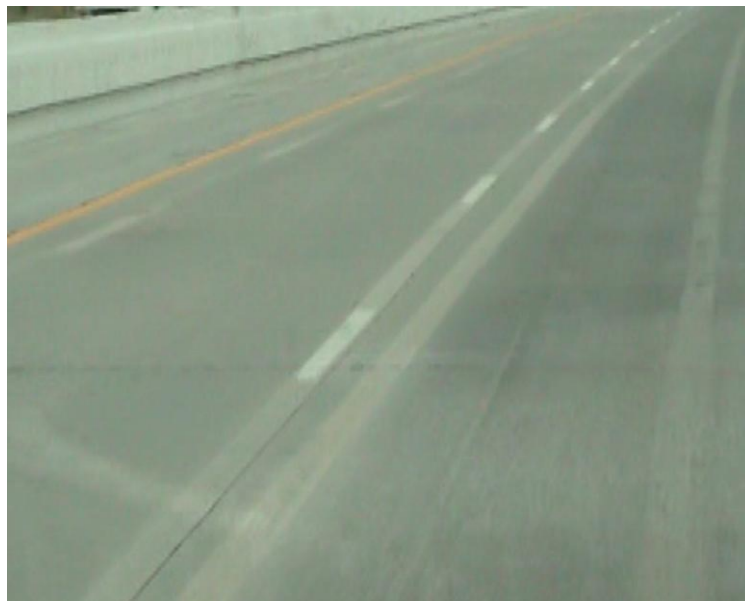
Figure 2.1. Scars on I-80 that can confuse drivers

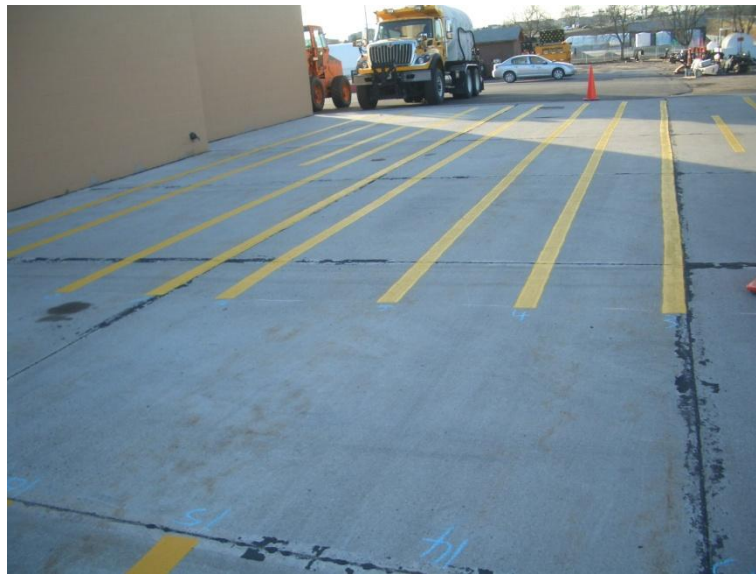
Figure 4.1. Concrete site used for testing

The research team used the NDOR District 1 office parking lot (Figure 4.1) and yard (Figure 4.2) to test onto concrete and asphalt sites. Marking lines were applied onto each site for testing. A total of 40 lines were made with yellow paint, each measuring about 50 feet in length. To test differences in paint types, 12 and 20 mils of water-based and oil based paint were used to make lines 6 inches wide on both the concrete and asphalt pavements. Additionally, 5 preformed foil-backed tape lines also measuring about 50 feet were installed on both sites.

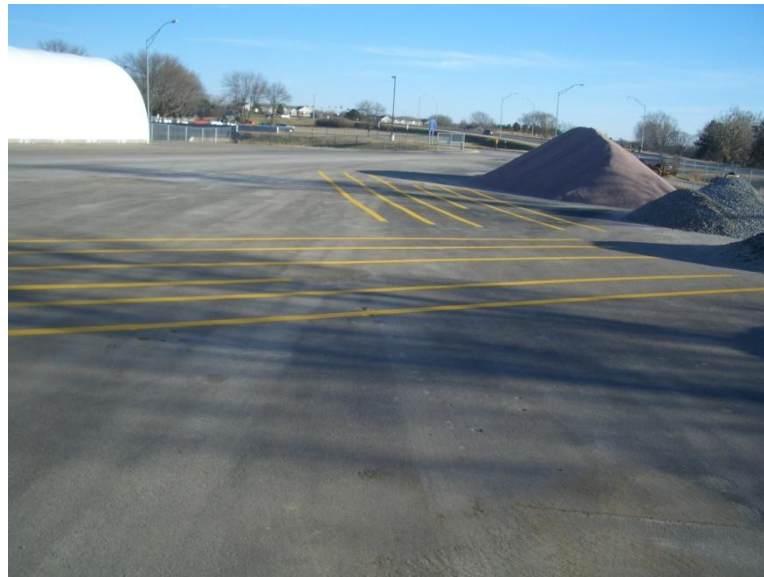
Figure 4.2. Asphalt yard used for tests

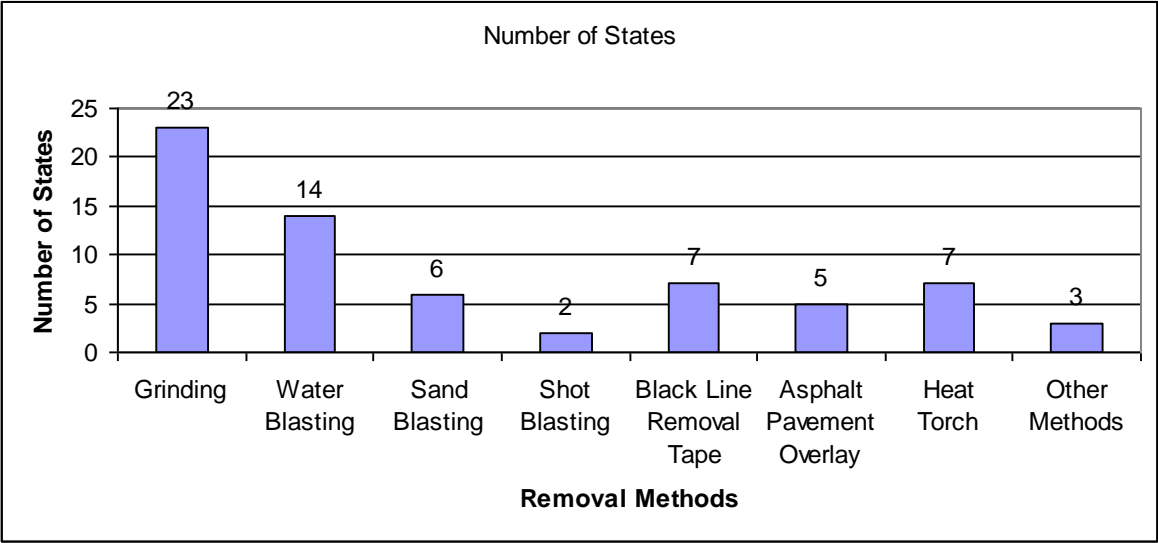
Figure 5.2. Most commonly used methods frequency graph

The responses to the most commonly used methods are summarized in Figure 5.2, and broken down by percentage in Table 5.2.

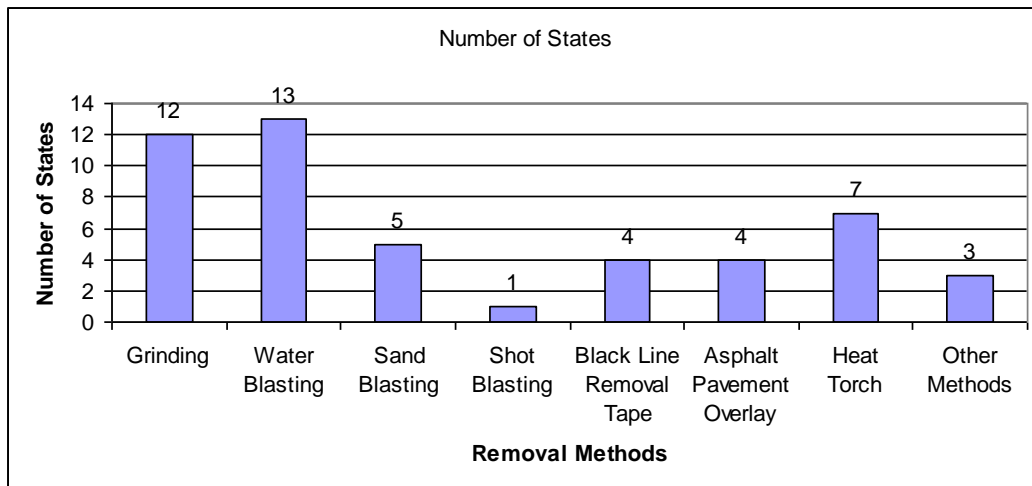
Figure 5.3. Most satisfactory used techniques frequency graph

Figure 5.3 and Table 5.3 summarize the answers received from question 5, which asked for the pavement marking removal(s) that has (have) been the most satisfactory to the agencies.

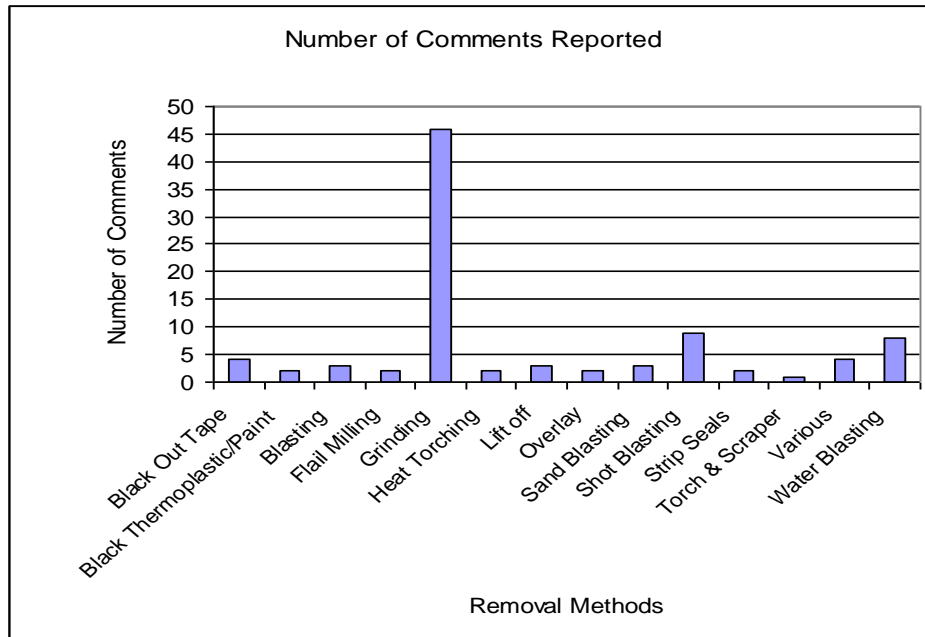
Figure 5.5. Problems and/or comments per removal technique

In summary, grinding and water blasting are the two most commonly used techniques, but water blasting has been the most satisfactory. When asked about problems associated with the removal techniques, grinding was the one that had the most faults, as shown in Figure 5.5. The same

problems that were mentioned above in the literature review section were the same provided by the survey respondents. Scarring of the pavement, color and texture discrepancies of the surface all can lead to motorists' confusion.

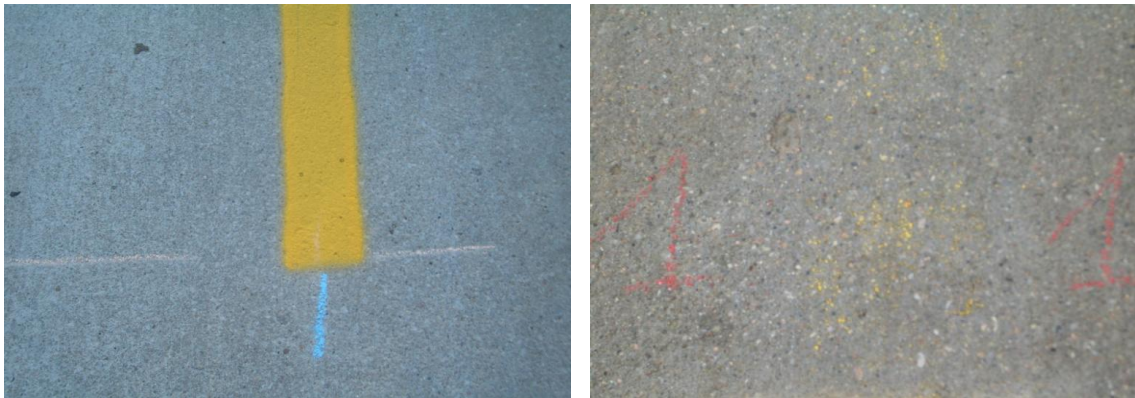
Figure 6.1. Concrete pavement condition before (left) and after (right) 12 mils water-based paint has been removed by water blasting

Water blasting removed the marking on all surfaces, but left a scar that could lead to confusion. Water blasting worked the best on concrete while removing water based paint of 12 mils (Figure 6.1). Figures 6.2 and 6.3 show the results of water blasting on oil-based paint concrete and water-based paint on asphalt, respectively.

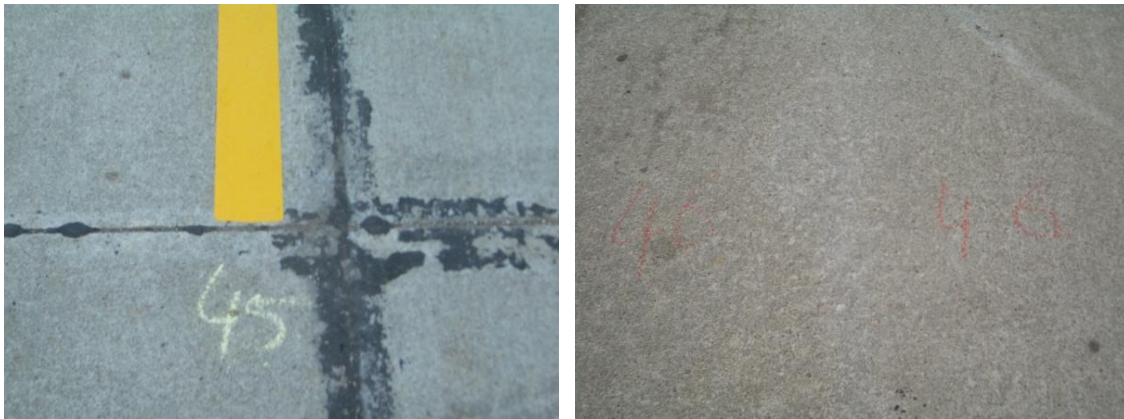
Figure 6.4. Concrete pavement condition before (left) and after (right) tape has been removed by water blasting

The process of water blasting was much slower compared to the other methods, but was very fast and effective on tape (Figure 6.4). It was relatively easier to remove the tape by water blasting. The surface was free of scars as shown in Figure 6.4. It should be noted here that the tests were performed at non-favorable weather condition for the tape. The temperature outside may not have allowed the tape to have properly set down before testing.

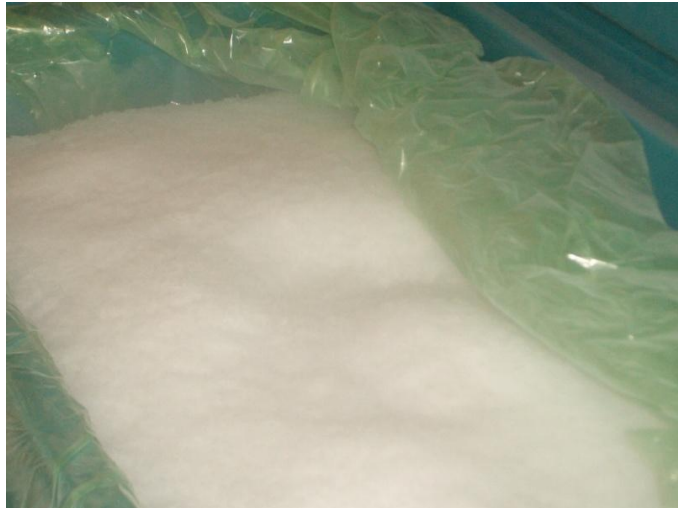
Figure 6.5. Container full of dry ice

improved as the operator spent longer times on the markings. Both pavement surfaces were left with scars and texture change after removal. As mentioned previously, a container of dry ice pellets (Figure 6.5) is attached to a hose that shoots the dry ice onto the pavement (Figure 6.6).

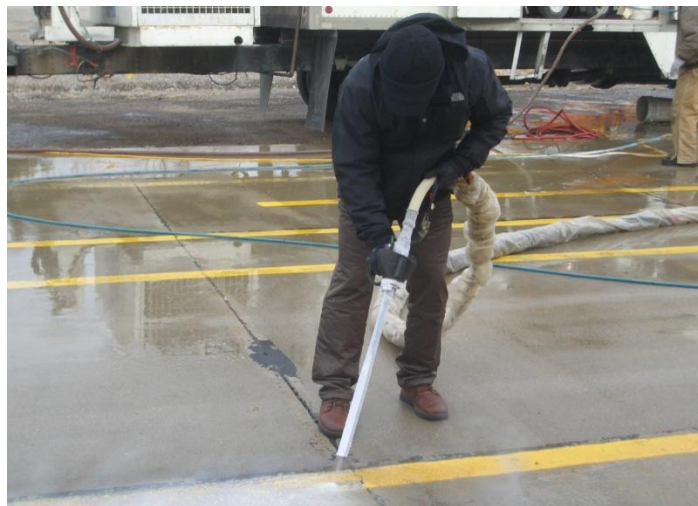
Figure 6.6. Dry ice is shot onto the markings

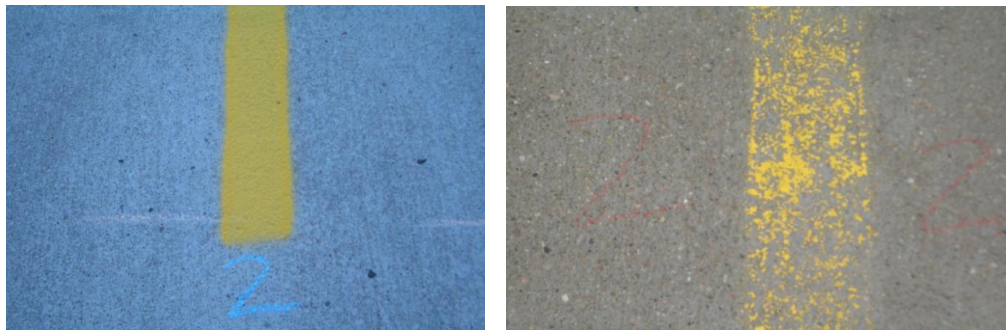
Figure 6.7. Concrete pavement condition before (left) and after (right) 10 mils water-based paint has been removed by dry ice blasting

Dry ice blasting did not entirely remove the paint markings on the concrete surface, as shown in Figures 6.7 and 6.8. On asphalt pavement, however, the removal was well completed, but left a scar on the pavement (Figure 6.9). Dry ice blasting was the slowest method of removal. Results

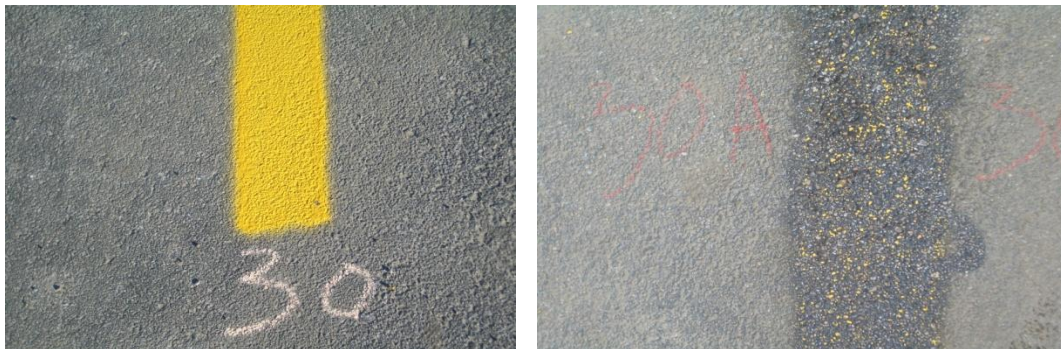
Figure 6.9. Asphalt pavement condition before (left) and after (right) paint has been removed by dry ice blasting

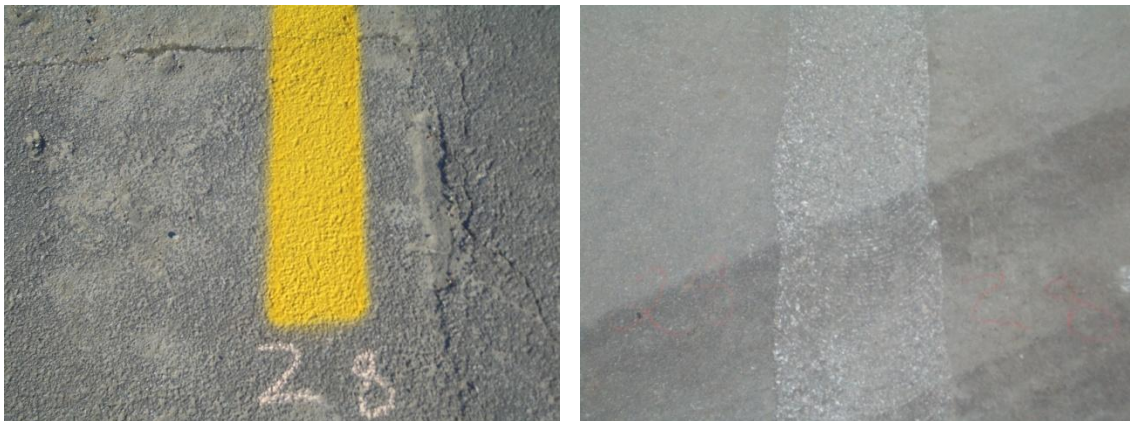
Figure 6.11. Asphalt pavement condition before (left) and after (right) paint has been removed by grinding

increases. The grinder damaged the pavement by causing minimal color and texture discrepancies. Regardless of the pavement type or marking material, the grinder did leave scars, as shown by Figure 6.10 on concrete and Figure 6.11 on asphalt.

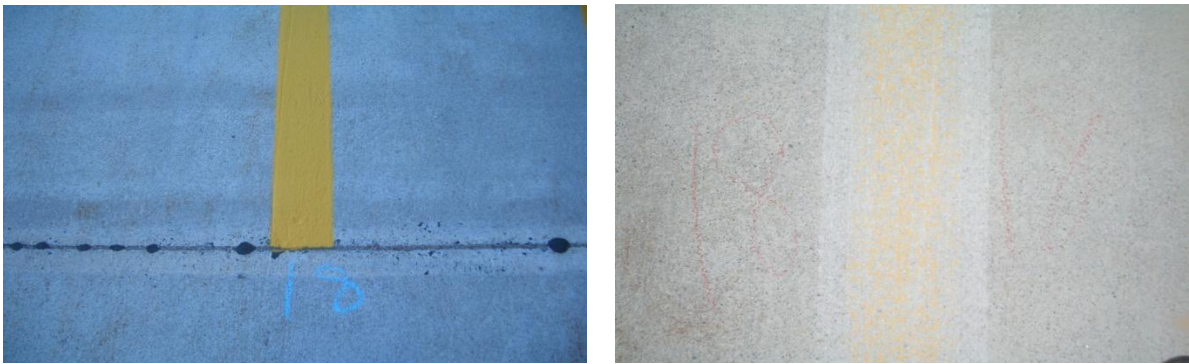
Figure 6.12. Concrete pavement condition before (left) and after (right) paint has been removed with scarifier

The scarifier is just like a grinder except the cutting blade heads never leave the surface while cutting in forward and reverse directions. While the scarifier is a fast process, it damages the pavement and does not completely remove the paint markings. The scarifier also left scars on the pavements. Figures 6.12 and 6.13 show the results of using a scarifier on concrete and asphalt pavements, respectively.

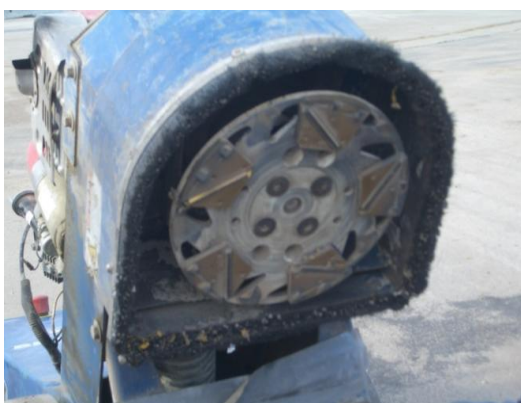
Figure 6.14. PCD plate cutter

This method is also a form of grinding, but the only difference here is that the cutter is made of polycrystalline diamond material, which generates less heat during the cutting process and increases the grinding efficiency (Figure 6.14). The PCD scrapper allows the operators to decrease the intensity of labor while effectively removing the markings.

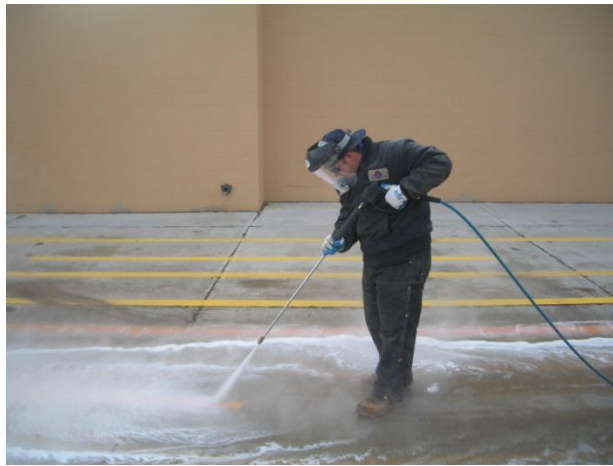
Figure 6.17. Operator with proper protection while removing marking by chemical method

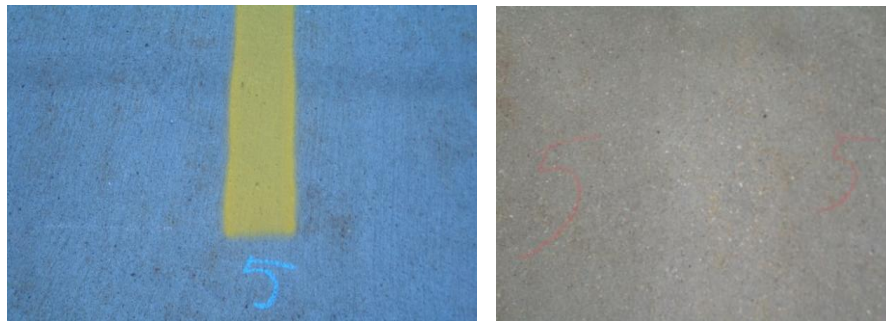
Figure 6.18. Concrete pavement condition before (left) and after (right) paint has been removed by chemicals

The chemical stripping method was the most effective during tests and left no or very little paint on both surfaces (Figure 6.18 and 6.19).

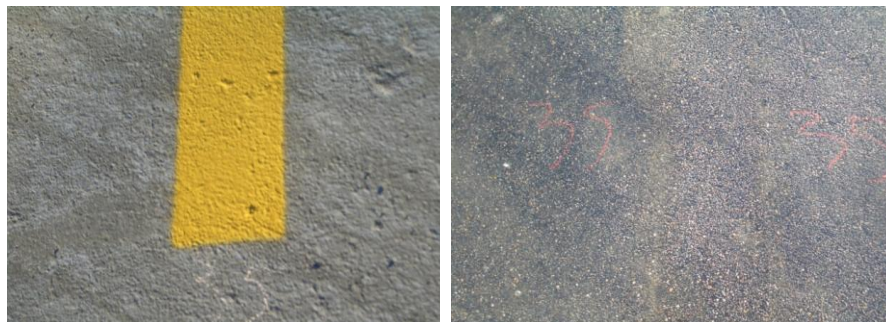
Figure 6.19. Asphalt pavement condition before (left) and after (right) paint has been removed by chemicals

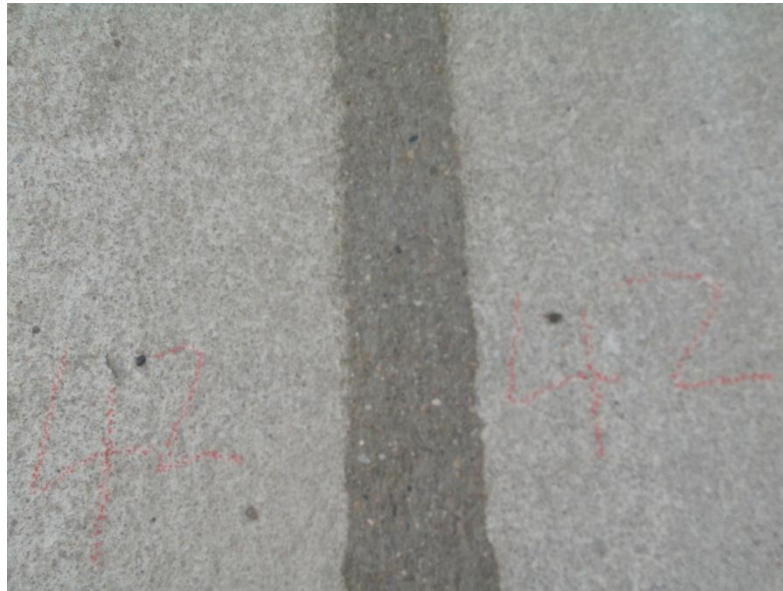
Figure 6.20. Condition of concrete pavement after heat torch applied on tape

laid down on the pavements; therefore, most of the tape did not stick well to the surface, and some were not even entirely set. Almost every method used on tape was successful except for dry ice and heat torching which left some marks on the pavement. Figure 6.20 shows the result of the heat torch on concrete pavement.
